MINERALS PROGRAM INSPECTION REPORT
PHONE: (303) 866-3567

MINE NAME: Sunday Mine	MINE/PROSPECTING ID#: M-1977-285	MINERAL: Uranium and vanadium	COUNTY: San Miguel
INSPECTION TYPE: Multi Person Inspection	WEATHER: Clear	INSP. DATE: November 13, 2024	INSP. TIME: 12:45
OPERATOR: Pinon Ridge Mining LLC	OPERATOR REPRESENTATIVE: Mike Rutter, Bruce Smith	TYPE OF OPERATION: 112d-2 - Designated Mining Operation	
REASON FOR INSPECTION: Normal I&E Program	BOND CALCULATION TYPE:	BOND AMOUNT: \$330,242.00	
DATE OF COMPLAINT: NA	POST INSP. CONTACTS: None	JOINT INSP. AGENCY: None	
INSPECTOR(S): Lucas West	INSPECTOR'S SIGNATURE:

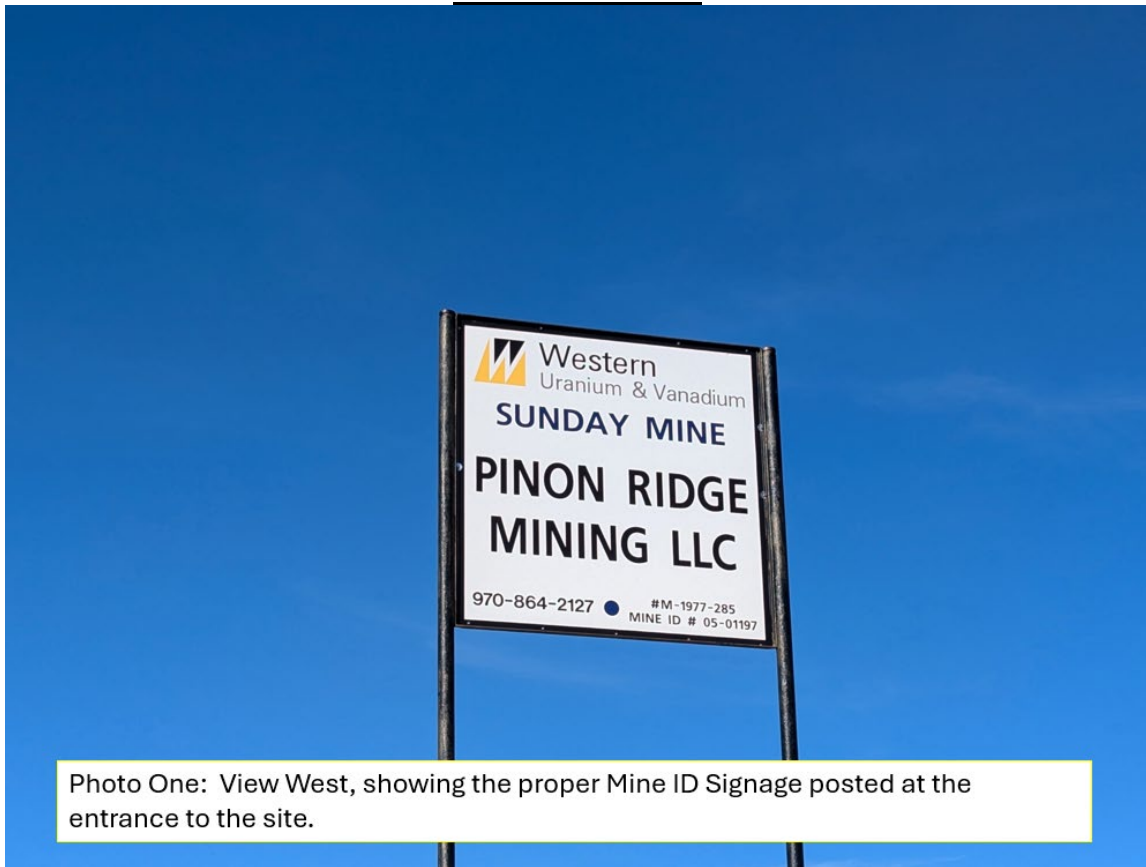
As seen in Photo **One**, the permit ID sign was observed at the entrance to the site. The permit boundary markers were also observed. The site is currently mining and stockpiling ore underground, but no ore has been brought to the surface. Improvements to security, surface structures and storm water controls have been on going. The shop and office facilities have been upgraded to facilitate constant on-site operations and are in excellent condition. Various mining equipment and supplies were observed on site and were all stored in a neat and orderly fashion. Examples of the equipment and facilities can be seen in Photo **Two**.

Photo One: View West, showing the proper Mine ID Signage posted at the entrance to the site.

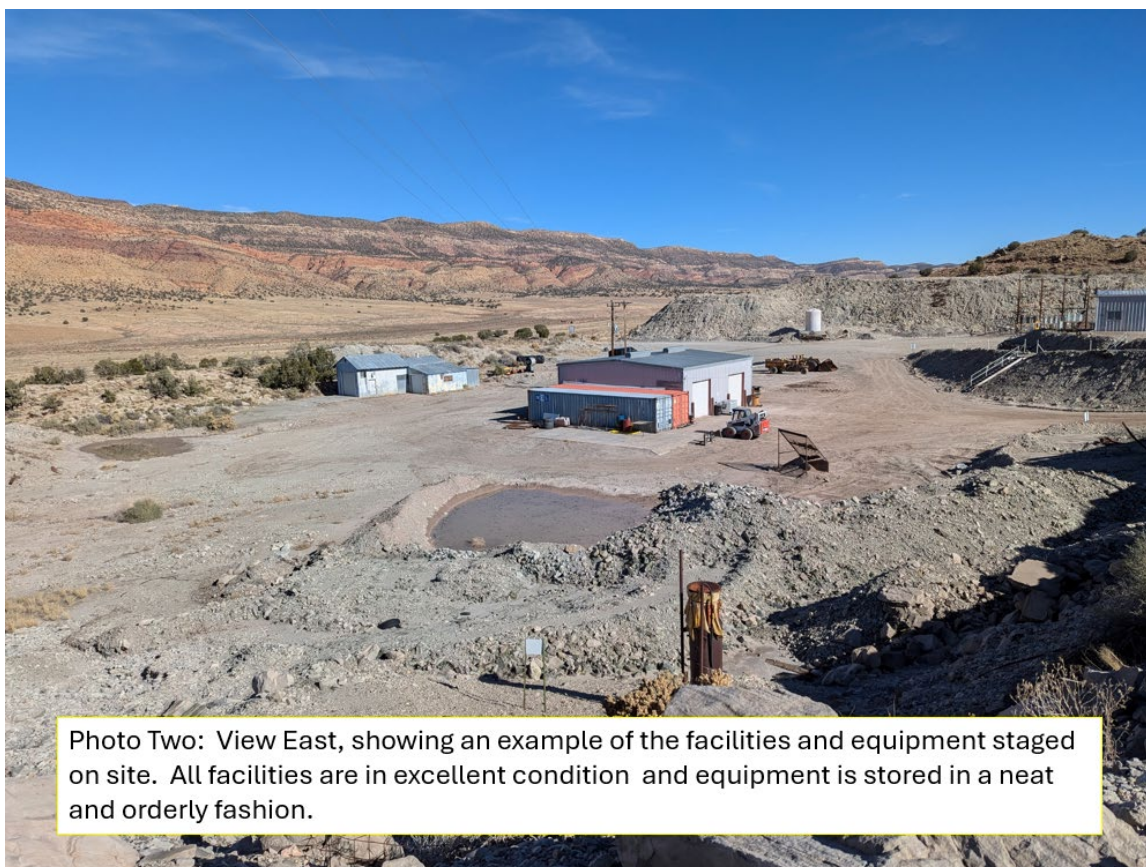
Photo Two: View East, showing an example of the facilities and equipment staged on site. All facilities are in excellent condition and equipment is stored in a neat and orderly fashion.

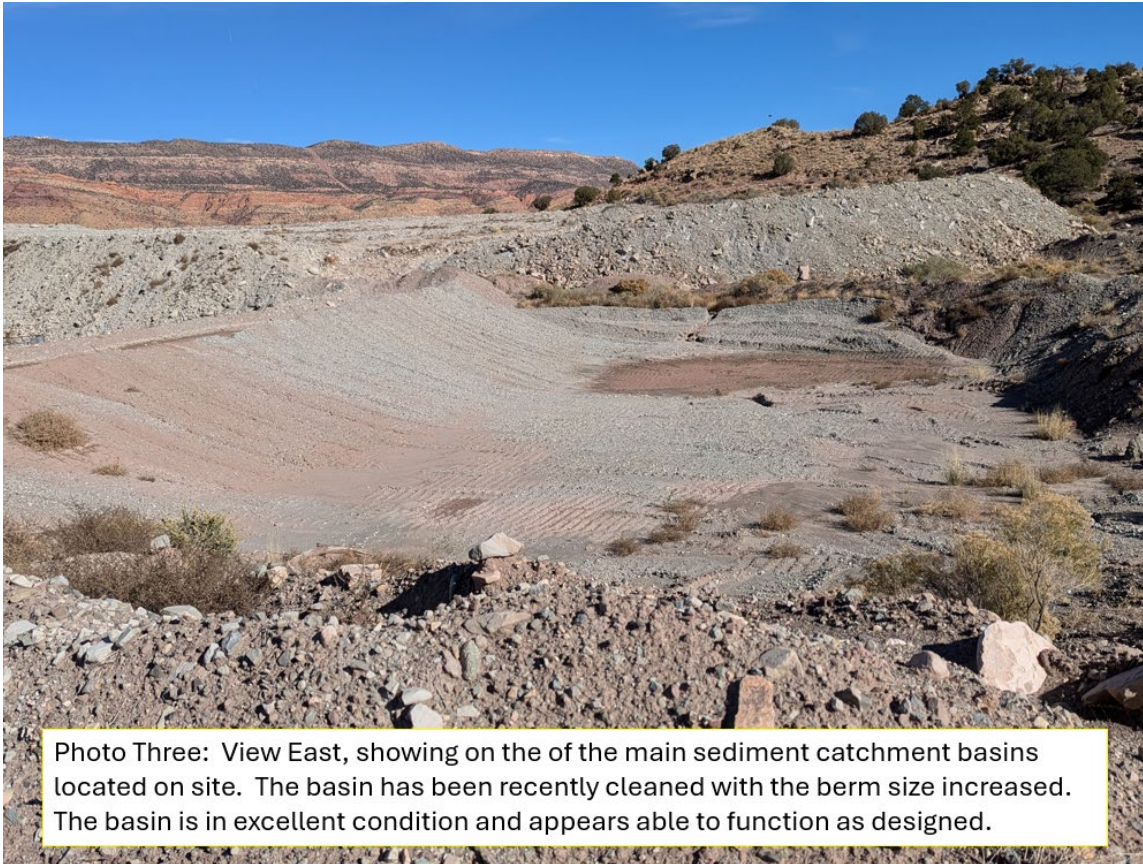
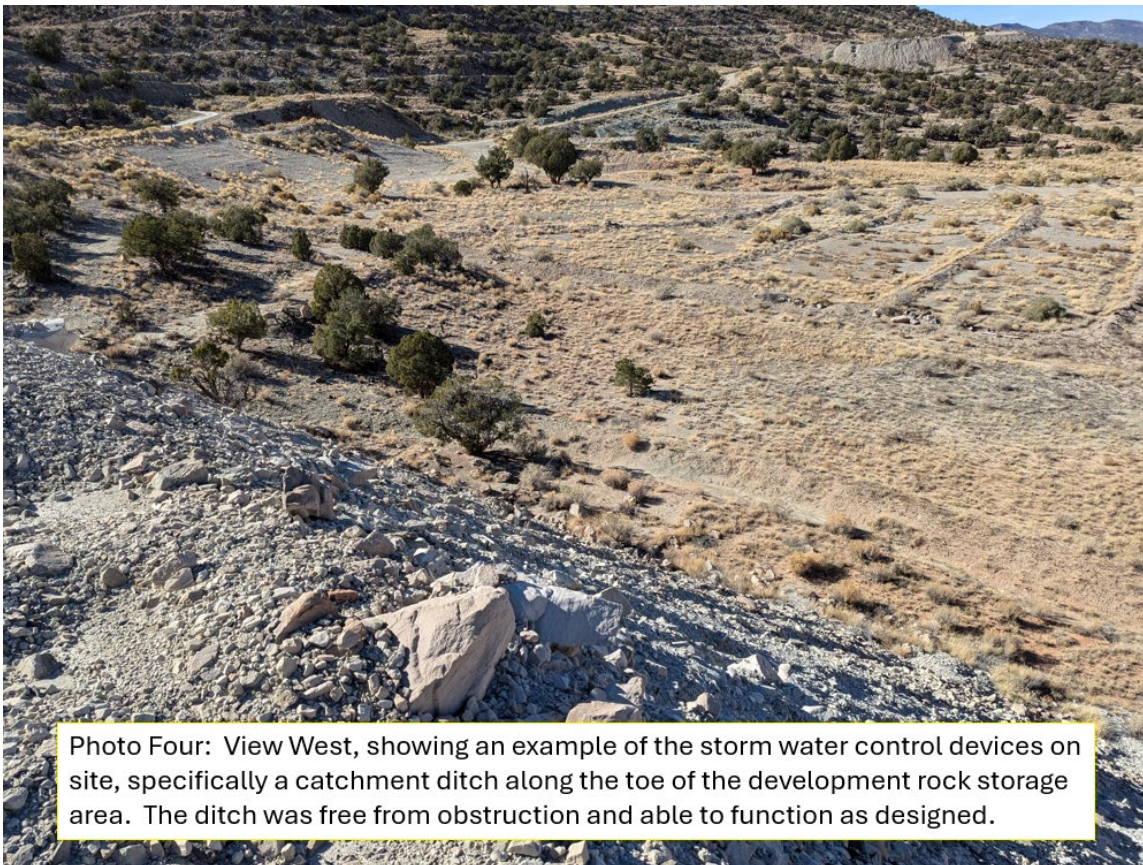
As stated previously, maintenance to the storm water control systems throughout the site is ongoing, and all observed storm water control ditches and basins are in excellent condition and appear to be functioning as designed. Photos **Three** and **Four** shows an example of the sediment catchment basins that are located on site as part of the storm water management plan. The low grade ore stockpile located on the south end of the site is in good condition, with no signs of settling or slumping. The cap material is in good condition with no signs of significant wind erosion or material transport of any kind. The outslopes of the stockpile show no signs of instability and remain in the condition of previous inspections. Examples of the slopes as well as top of the stockpile can be seen in Photos **Five** and **Six**.

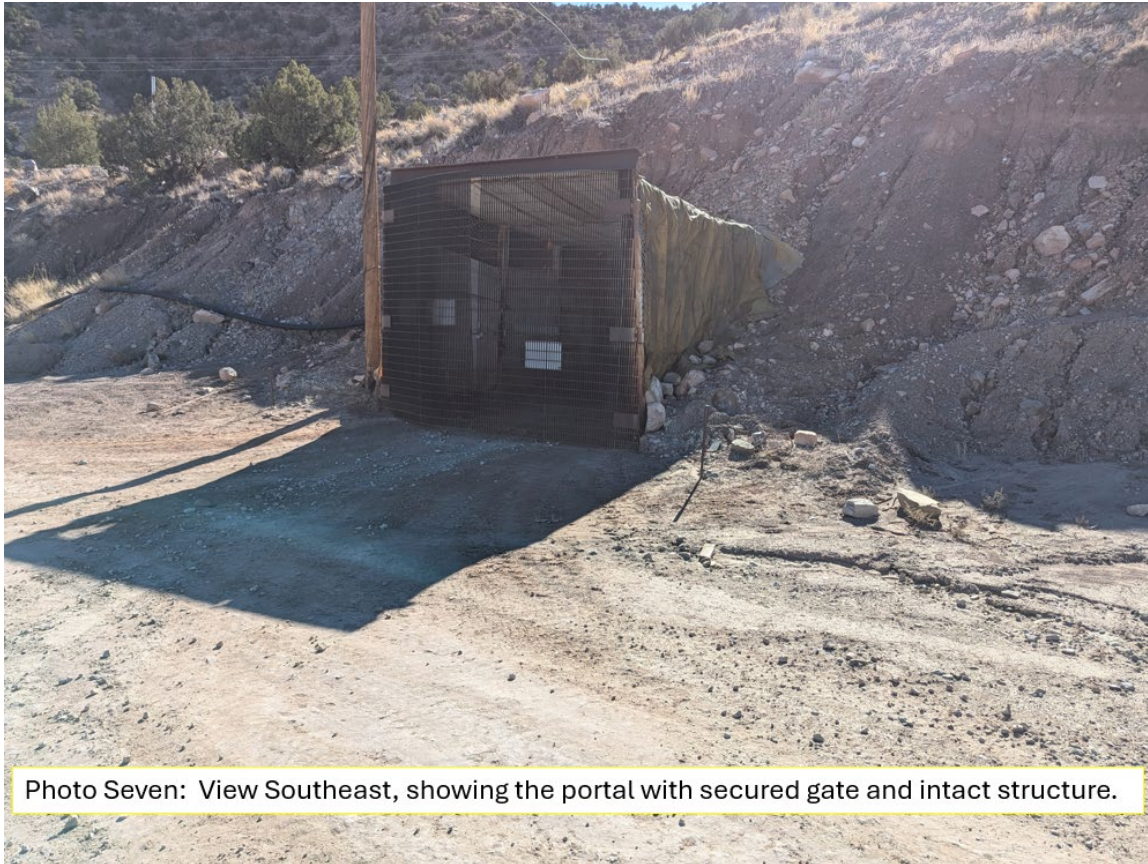
As the underground crews were off the day of the inspection the portal was closed and secured. The portal structure is in good condition, with gates showing no signs of vandalism or attempted unauthorized entry. The portal and its structure can be seen in Photo **Seven**. Vent shaft S-2, located to the Northwest of the shop facilities is covered with a steel grate and has been secured as shown in Photo **Eight**. All loadouts, roads and pad areas that exist on site were observed and in good condition. The lined Ore Pad was observed to be in good condition. The face of the pad shows no evidence of surface stockpiling and no observable impacts from precipitation was noted. The out slopes and berms of the pad appear stable. The pad can be seen in Photos **Nine** and **Ten**. To date, no ore material has been brought to the surface and stockpiled on the pad since it's construction, however the permitting has been conducted to allow those activities to take place whenever the Operator is ready.

Photo Seven: View Southeast, showing the portal with secured gate and intact structure.

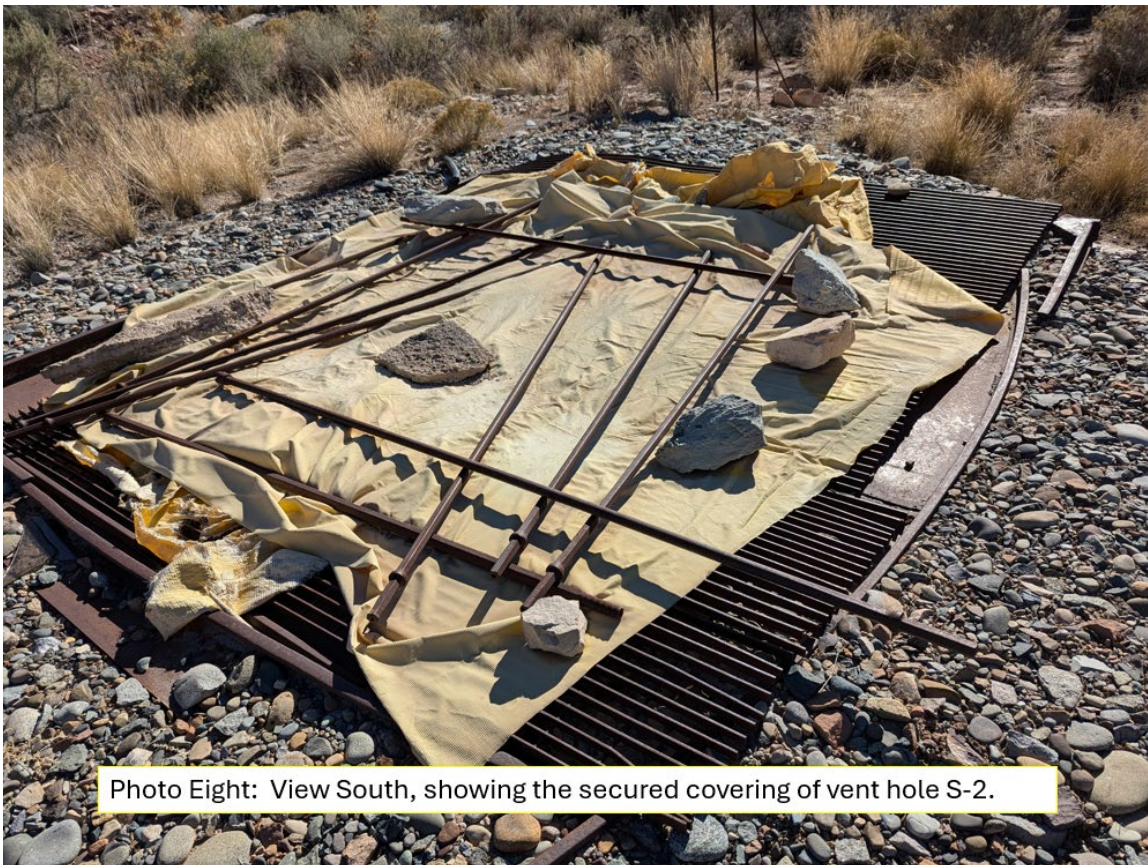
Photo Eight: View South, showing the secured covering of vent hole S-2.
