MINERALS PROGRAM INSPECTION REPORT
PHONE: (303) 866-3567

MINE NAME: Carnation Mine	MINE/PROSPECTING ID#: M-1977-416	MINERAL: Uranium and vanadium	COUNTY: San Miguel
INSPECTION TYPE: Multi Person Inspection	WEATHER: Clear	INSP. DATE: November 13, 2024	INSP. TIME: 12:30
OPERATOR: Pinon Ridge Mining LLC	OPERATOR REPRESENTATIVE: Mike Rutter	TYPE OF OPERATION: 110d - Designated Limited Impact	
REASON FOR INSPECTION: Normal I&E Program	BOND CALCULATION TYPE:	BOND AMOUNT: \$40,245.00	
DATE OF COMPLAINT: NA	POST INSP. CONTACTS: None	JOINT INSP. AGENCY: None	
INSPECTOR(S): Lucas West	INSPECTOR'S SIGNATURE:

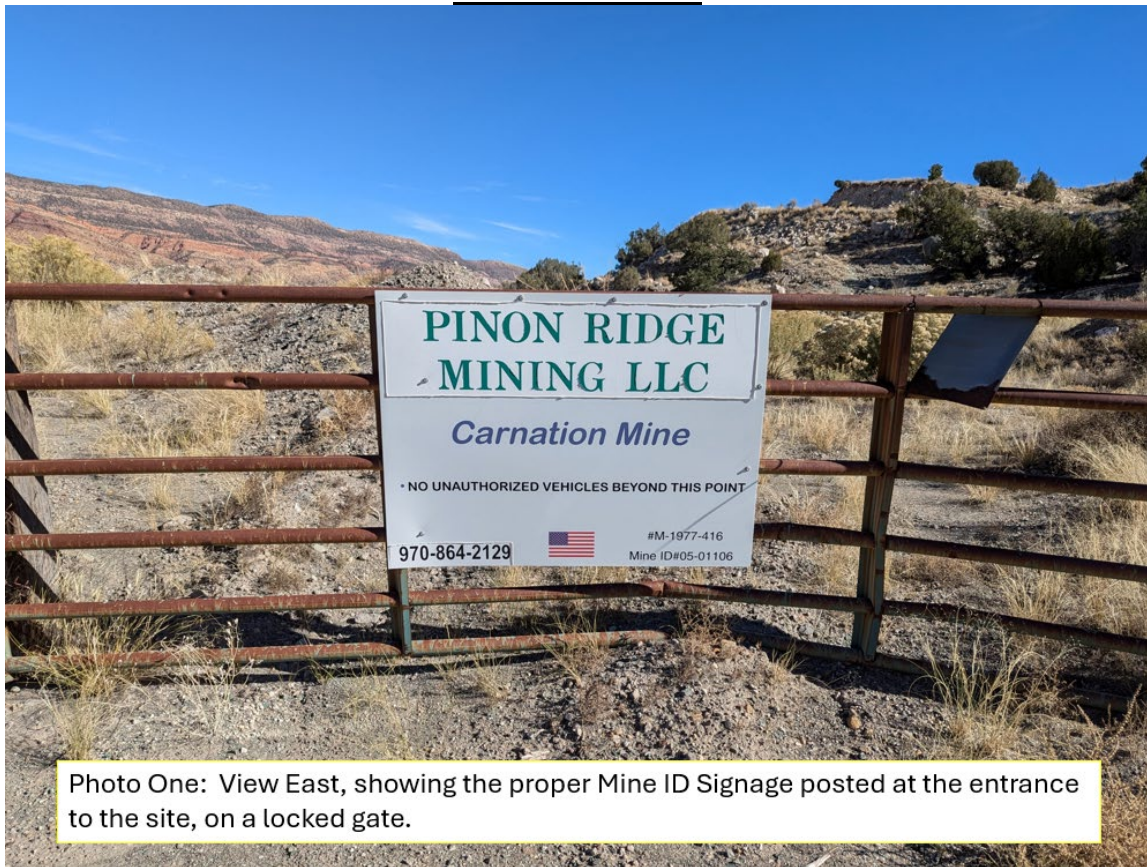
The permit ID sign was observed at the entrance to the site, on a secured gate, as seen in Photo One. The permit boundary markers were also observed, and all disturbances were confined within the permitted area. Evidence that the diversion ditches and storm water control devices are functioning as designed and no significant erosion was observed throughout the site. The lower permit area was also in good condition with no signs of significant erosion. The lower area has begun to revegetate itself and appears to be in good condition.

Photo One: View East, showing the proper Mine ID Signage posted at the entrance to the site, on a locked gate.

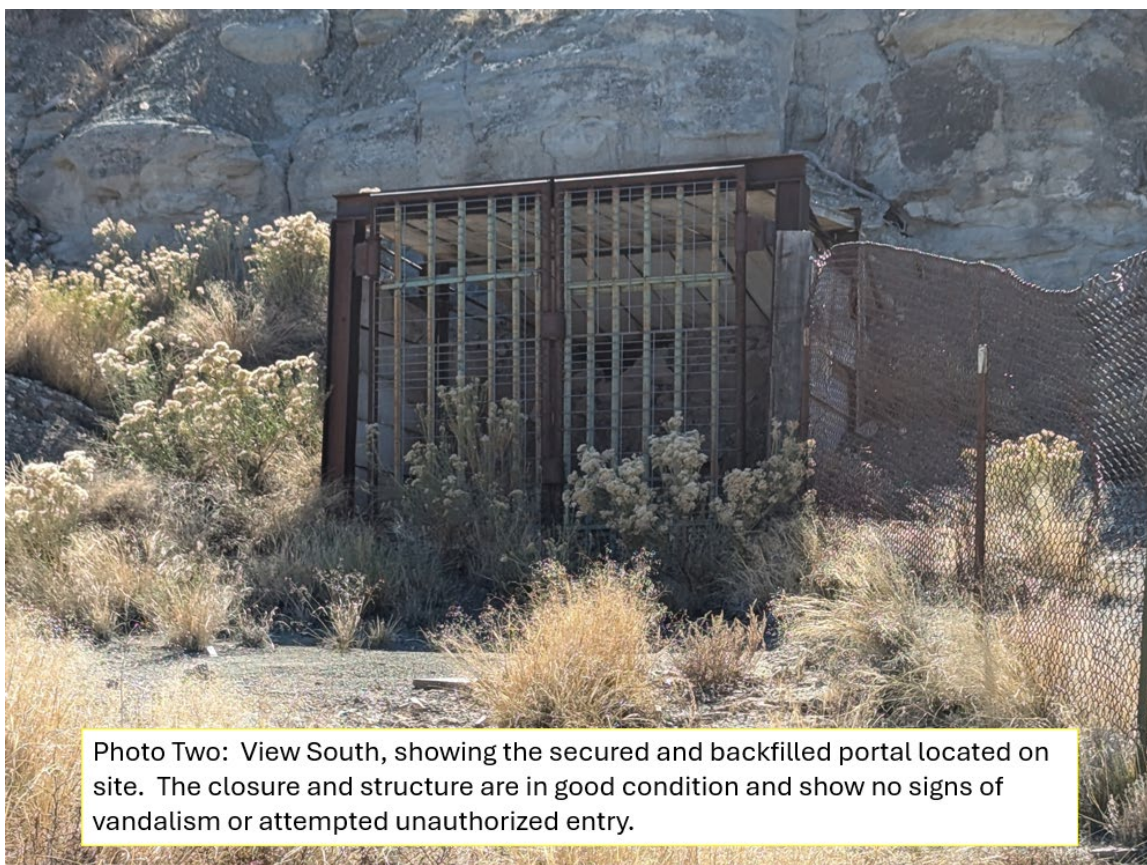
The portal, shown in Photo Two, located on site was also secured. it has been backfilled, closed off with steel grates as well as encompassed by a small berm. No fuel storage containers were observed on site. The main pad and work area was in good condition, evidence of weed management during the growing season was observed. The whole site exhibits positive drainage, and no erosional issues were observed at this time. The portal pad area has begun to revegetate itself with volunteer species as seen in Photo Three.

Photo Two: View South, showing the secured and backfilled portal located on site. The closure and structure are in good condition and show no signs of vandalism or attempted unauthorized entry.
