MINERALS PROGRAM INSPECTION REPORT
PHONE: (303) 866-3567

MINE NAME: St Jude Mine	MINE/PROSPECTING ID#: M-1978-039-HR	MINERAL: Uranium and vanadium	COUNTY: San Miguel
INSPECTION TYPE: Multi Person Inspection	WEATHER: Clear	INSP. DATE: November 13, 2024	INSP. TIME: 12:06
OPERATOR: Pinon Ridge Mining LLC	OPERATOR REPRESENTATIVE: Mike Rutter	TYPE OF OPERATION: 110d - Designated Limited Impact	
REASON FOR INSPECTION: Normal I&E Program	BOND CALCULATION TYPE:	BOND AMOUNT: \$69,828.00	
DATE OF COMPLAINT: NA	POST INSP. CONTACTS: None	JOINT INSP. AGENCY: None	
INSPECTOR(S): Lucas West	INSPECTOR'S SIGNATURE:

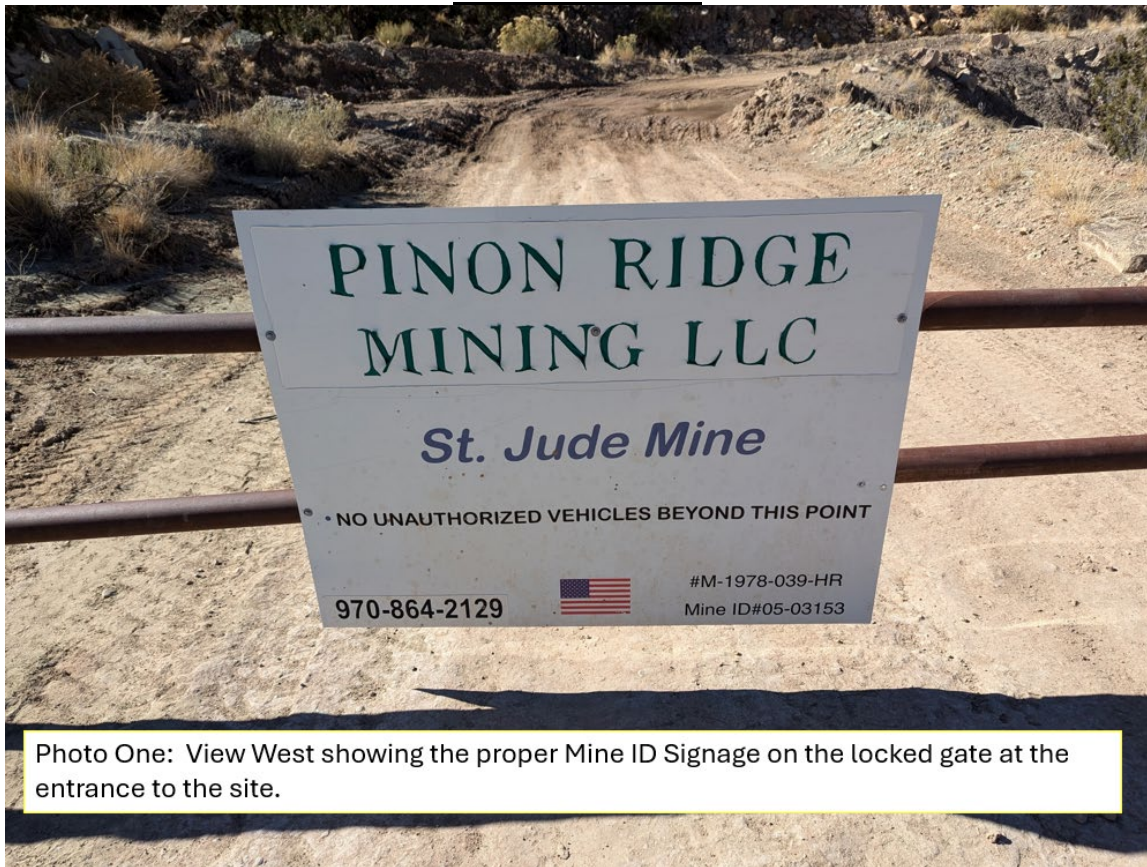
As seen in Photo One, the permit ID sign was observed at the entrance to the site. The permit boundary markers were also observed. All disturbances are contained within the permitted areas. The remote vent shaft sites were not inspected at this time. The diversion ditches and storm water control devices appear to be functioning as designed and no significant erosion was observed throughout the site. The main work area, adjacent to the portal and shops, appeared to be stable and in good condition. The portal was open and active at the time of the inspection. Four of the Five mines in the Sunday Complex connect underground and the portal is used as secondary egress and ventilation. The portal and it's structure are in excellent condition, shown in Photo Two.

Photo One: View West showing the proper Mine ID Signage on the locked gate at the entrance to the site.

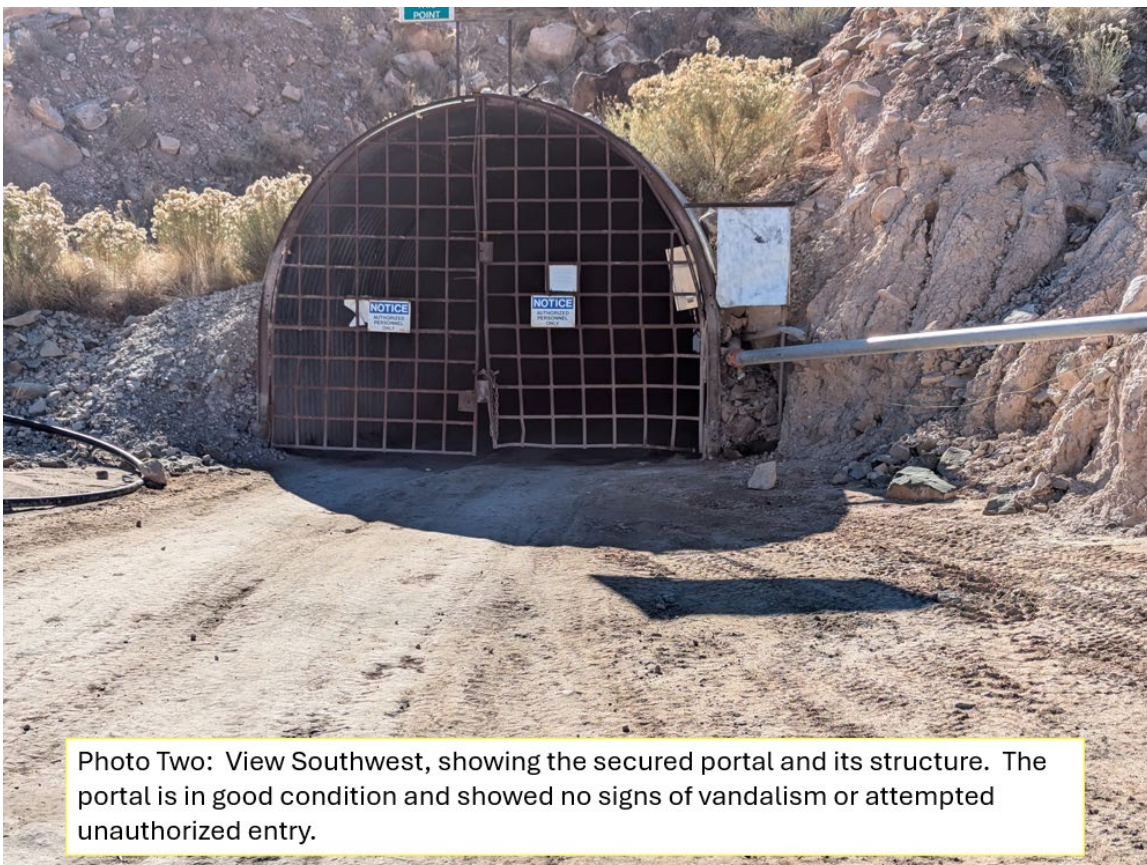
Photo Two: View Southwest, showing the secured portal and its structure. The portal is in good condition and showed no signs of vandalism or attempted unauthorized entry.

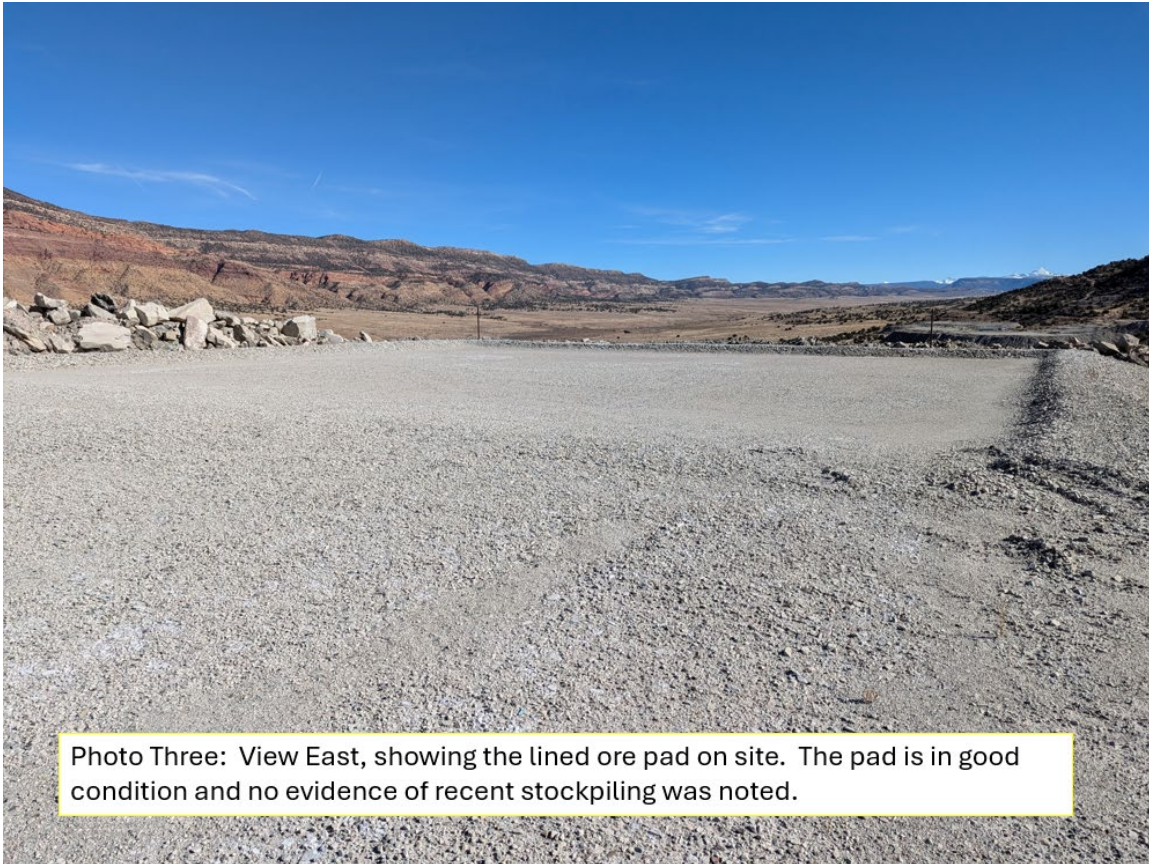
The lined Ore Pad was observed to be in good condition. The face of the pad shows no evidence of surface stockpiling and no observable impacts from precipitation was noted. The out slopes and berms of the pad appear stable. The pad can be seen in Photo Three. All work and shop facilities onsite were secured and appeared to be in good condition as seen in Photo Four. two small above ground fuel tanks are located on site to feed the air compressor, secondary containment of the tanks was observed but needed to be cleaned. Additionally, a mobile compressor was staged near the tanks that had spilled a small amount of oil on the surrounding soil. Both the cleaning of the secondary containment and the oil spillage were considered problems, the Operator has already addressed the issues and provided photo documentation. Therefore, they are not considered problems at this time. Adjacent to the above ground fuel tanks is the new compressor and generator set up as approved in TR-3. The compressor and generator are set on a concrete foundation, however the covering shed has not yet been constructed as seen in Photo Five. Various other items are observed on site however it was stored in an orderly fashion and was not a concern at this time. The waste rock dump storage area was observed and appears to be stable and in good condition. The out slopes show no signs of significant erosion. The waste rock stored in the area and it's outs slopes can be seen in Photos Six and Seven.

Photo Three: View East, showing the lined ore pad on site. The pad is in good condition and no evidence of recent stockpiling was noted.

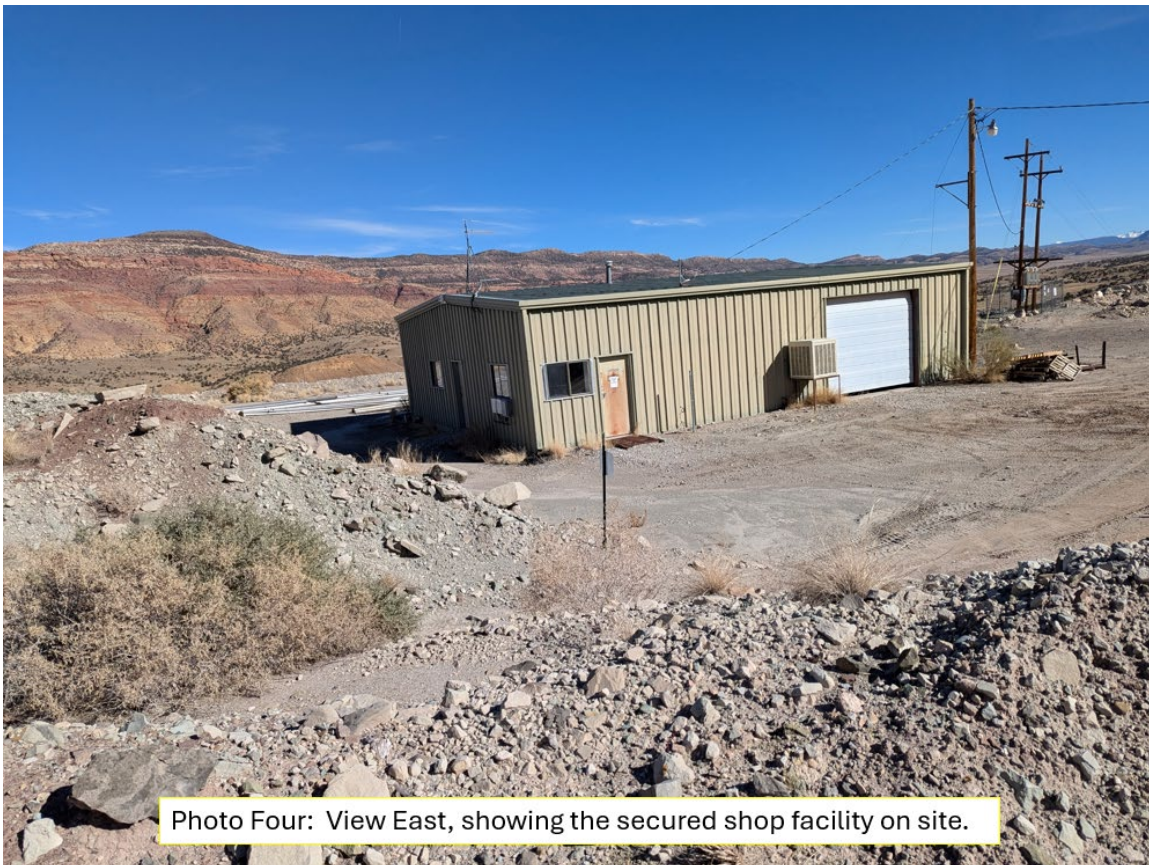
Photo Four: View East, showing the secured shop facility on site.

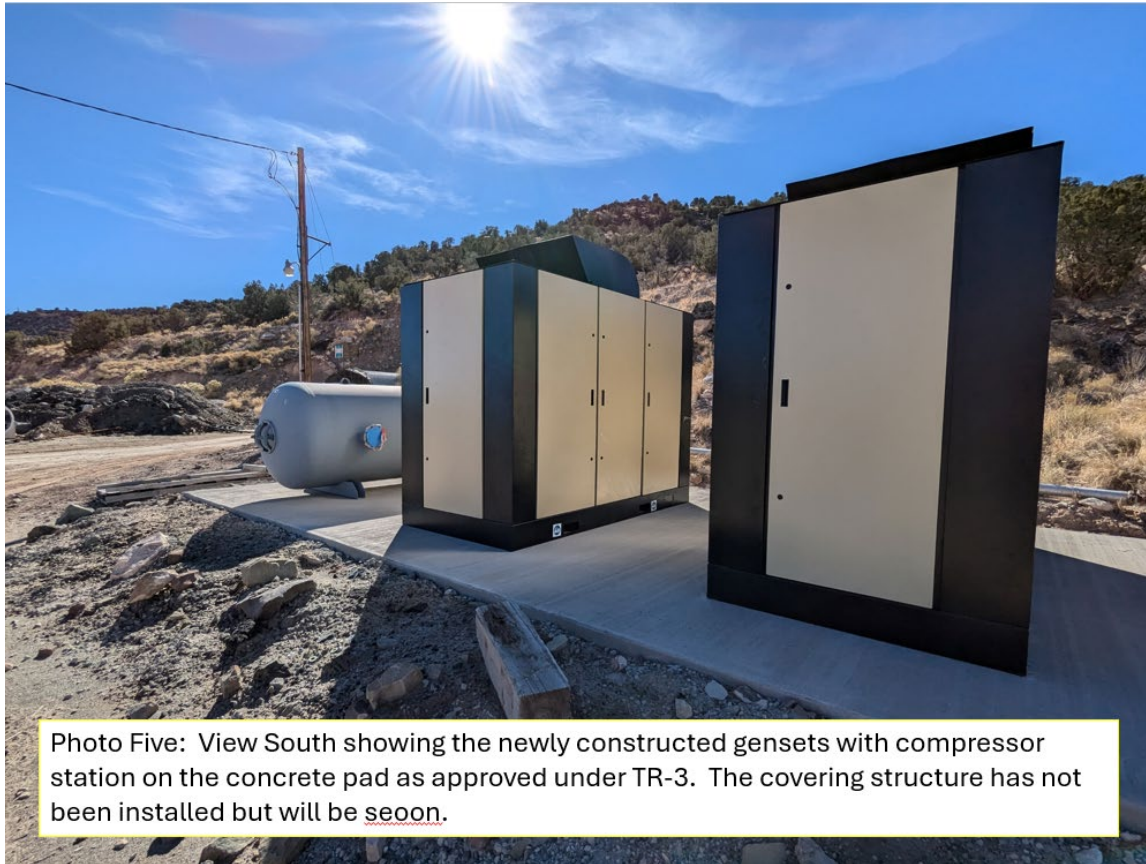
Photo Five: View South showing the newly constructed gensets with compressor station on the concrete pad as approved under TR-3. The covering structure has not been installed but will be soon.

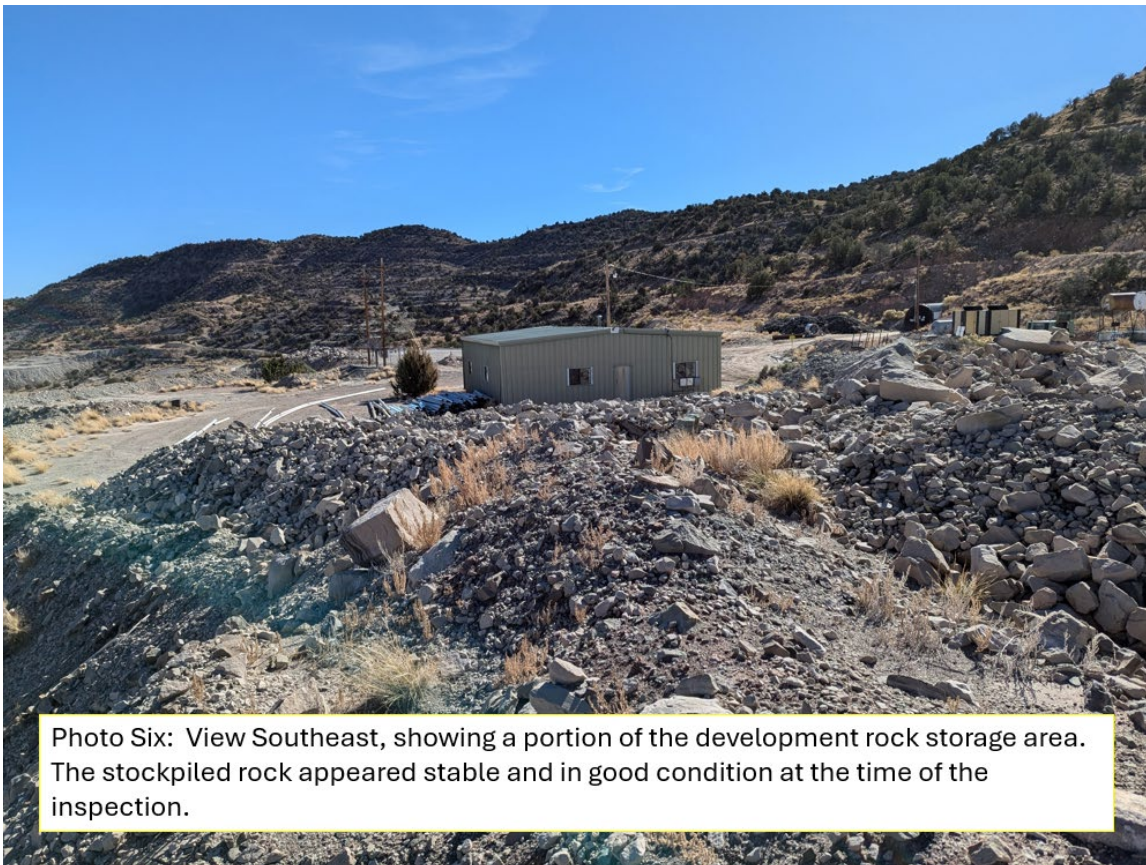
Photo Six: View Southeast, showing a portion of the development rock storage area. The stockpiled rock appeared stable and in good condition at the time of the inspection.
