MINERALS PROGRAM INSPECTION REPORT
PHONE: (303) 866-3567

MINE NAME: Topaz Mine	MINE/PROSPECTING ID#: M-1980-055-HR	MINERAL: Uranium and vanadium	COUNTY: San Miguel
INSPECTION TYPE: Multi Person Inspection	WEATHER: Clear	INSP. DATE: November 13, 2024	INSP. TIME: 11:18
OPERATOR: Pinon Ridge Mining LLC	OPERATOR REPRESENTATIVE: Mike Rutter	TYPE OF OPERATION: 112d-3 - Designated Mining Operation	
REASON FOR INSPECTION: Normal I&E Program	BOND CALCULATION TYPE:	BOND AMOUNT: \$99,893.00	
DATE OF COMPLAINT: NA	POST INSP. CONTACTS: None	JOINT INSP. AGENCY: None	
INSPECTOR(S): Lucas West	INSPECTOR'S SIGNATURE:

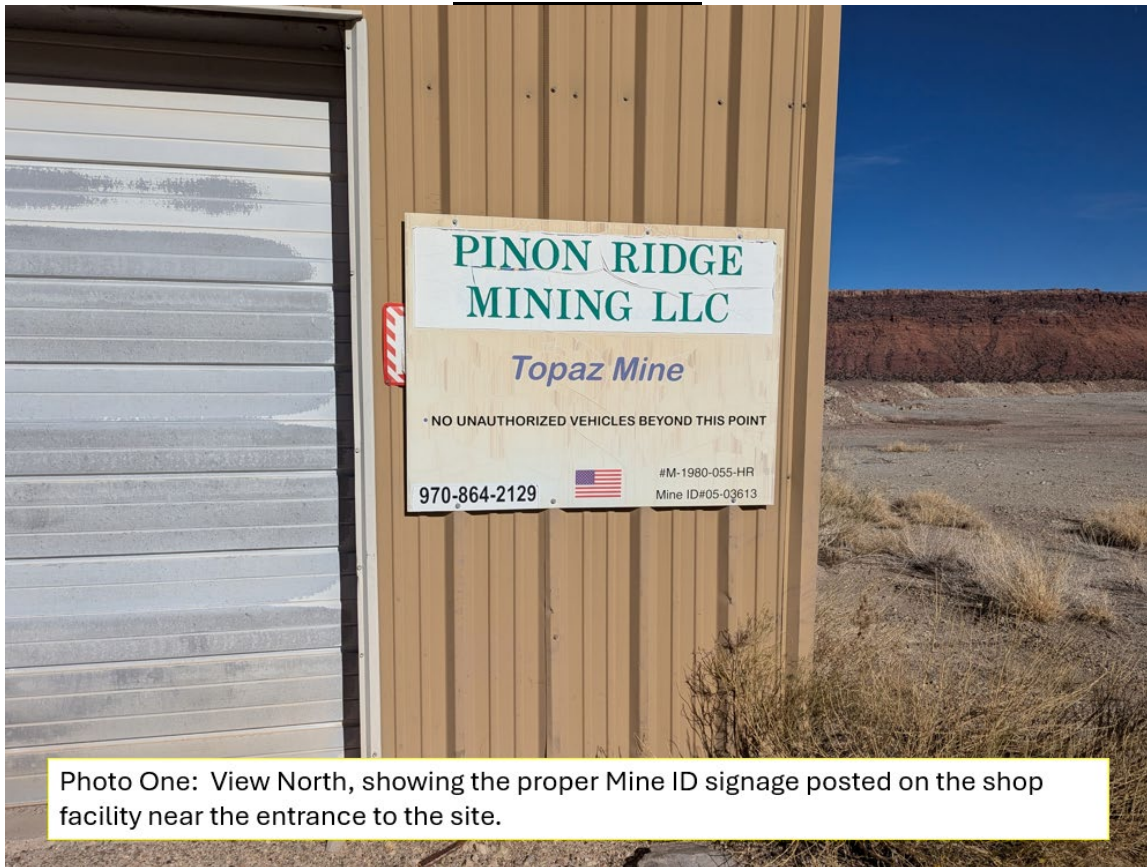
As seen in Photo One, the permit ID sign was observed posted on the shop facility near the entrance. The permit boundary markers were also observed. Evidence that the diversion ditches and storm water control devices are functioning as designed was noted and no significant erosion was observed throughout the site. Maintenance of the storm water control structures has not been needed and all structures were in good condition at the time of the inspection.

Photo One: View North, showing the proper Mine ID signage posted on the shop facility near the entrance to the site.

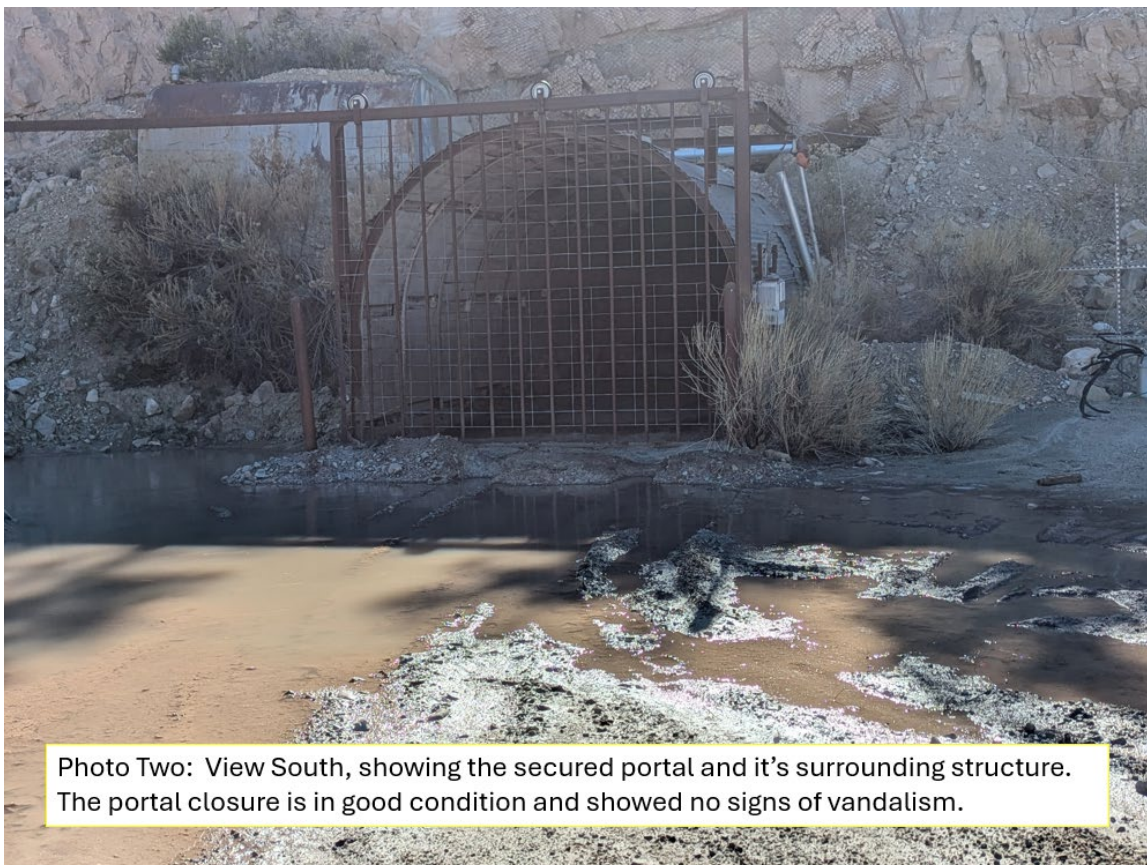
The shop facility located on site was observed to be secure and is in good working order. No damage or signs of vandalism was noted during the inspection. The portal located on site was also secured, it has been closed off with steel grates as well as encompassed by a small berm as seen in Photo Two. The previously stored items that had been on site for some time have been removed, and no trash or debris was noted. No fuel storage containers were observed on site.

Photo Two: View South, showing the secured portal and it's surrounding structure. The portal closure is in good condition and showed no signs of vandalism.

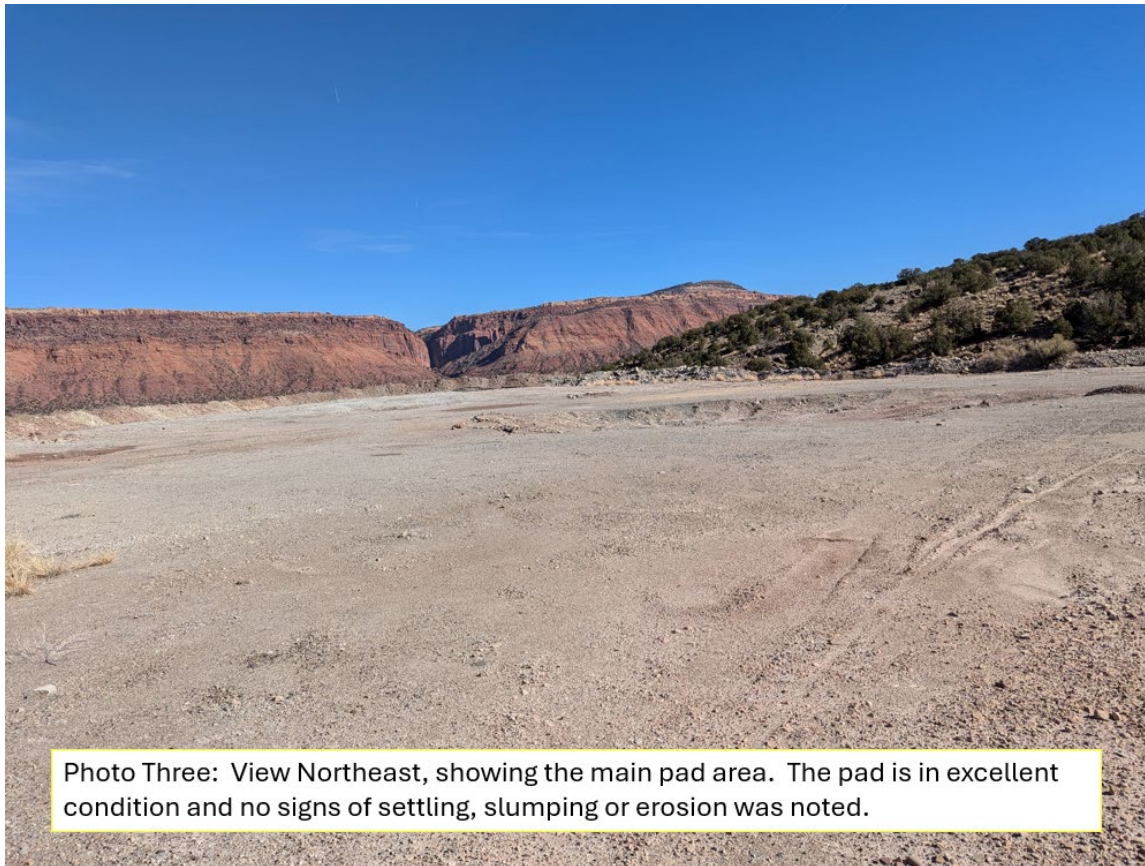
The main pad and work area was in good condition as seen in Photo Three. The outslopes of the pad area appeared stable at the time of the inspection and no evidence of settling or slumping was noted. The outslopes can be seen in Photo Four. A small depression was dug in the center of the pad, and the material was used to increase the size of the berm around the perimeter of the pad. At the time of the inspection a small amount of storm water was impounded in the depression but it is not considered a problem at this time. Evidence of weed management during the growing season was observed. Some areas around the perimeter of the pad area have begun to revegetate themselves with volunteer species. The whole site exhibits positive drainage, and no erosional issues were observed at this time.
