MINERALS PROGRAM INSPECTION REPORT
PHONE: (303) 866-3567

MINE NAME: West Sunday	MINE/PROSPECTING ID#: M-1981-021	MINERAL: Uranium and vanadium	COUNTY: San Miguel
INSPECTION TYPE: Multi Person Inspection	WEATHER: Clear	INSP. DATE: November 13, 2024	INSP. TIME: 11:42
OPERATOR: Pinon Ridge Mining LLC	OPERATOR REPRESENTATIVE: Mike Rutter	TYPE OF OPERATION: 112d-3 - Designated Mining Operation	
REASON FOR INSPECTION: Normal I&E Program	BOND CALCULATION TYPE:	BOND AMOUNT: \$85,036.00	
DATE OF COMPLAINT: NA	POST INSP. CONTACTS: None	JOINT INSP. AGENCY: None	
INSPECTOR(S): Lucas West	INSPECTOR'S SIGNATURE:

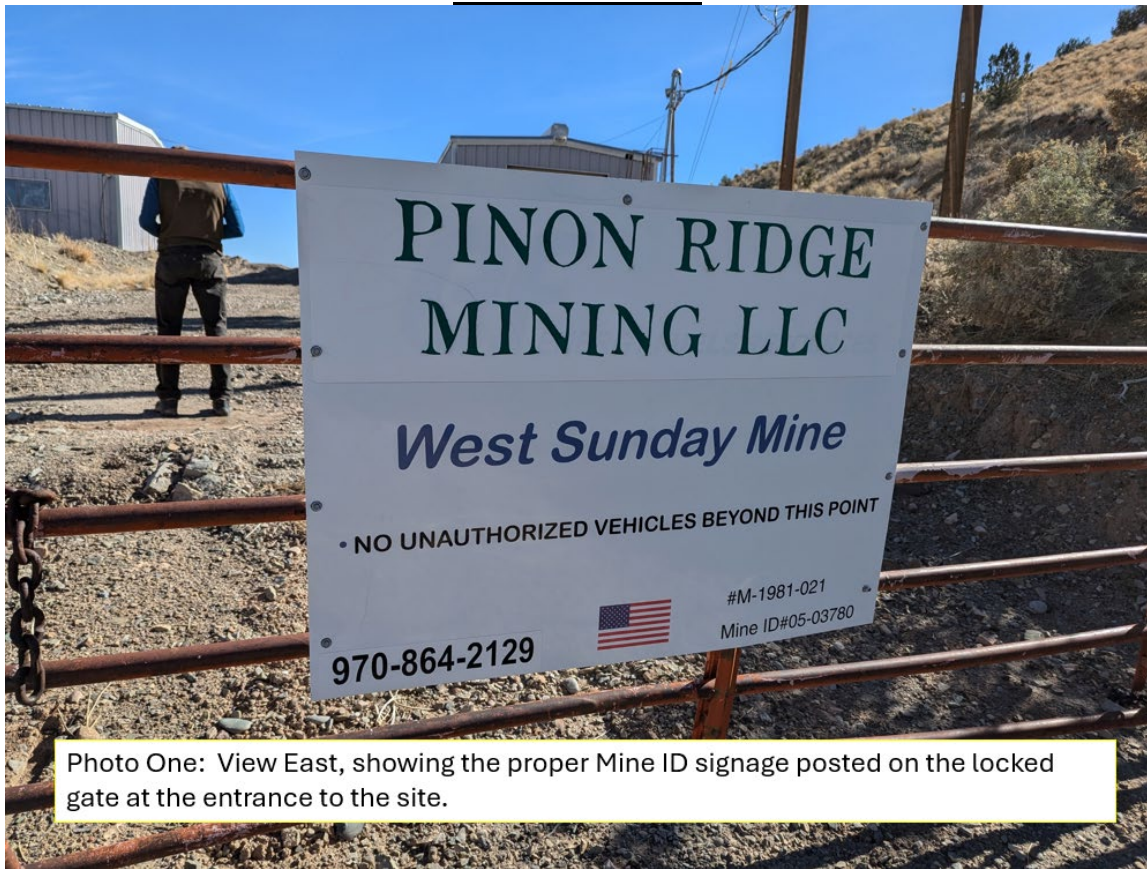
The permit ID sign was observed at the entrance to the site as seen in Photo One. The permit boundary markers were also observed. The remote vent shaft sites were not inspected at this time. Evidence that the diversion ditches and storm water control devices are functioning as designed was observed and no significant erosion was observed throughout the site. All work and shop appeared to be in good condition as seen in Photos Two and Three.

Photo One: View East, showing the proper Mine ID signage posted on the locked gate at the entrance to the site.

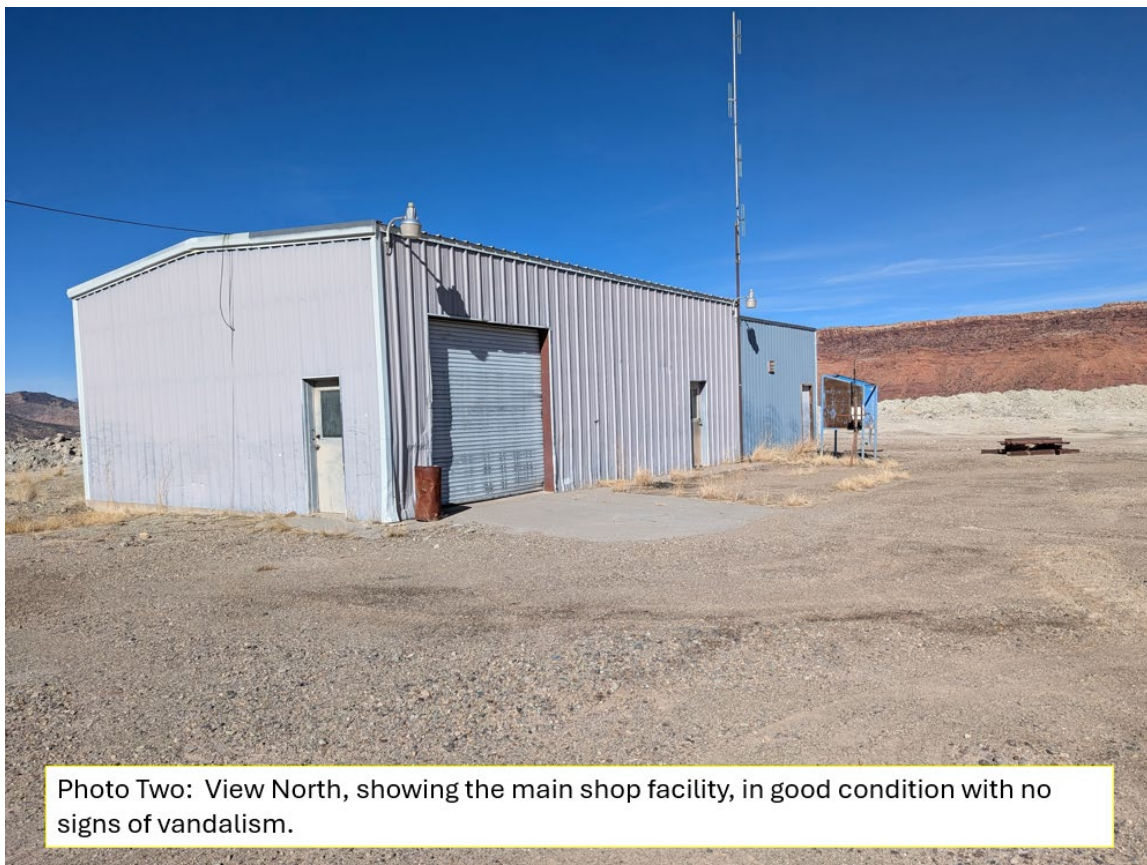
Photo Two: View North, showing the main shop facility, in good condition with no signs of vandalism.

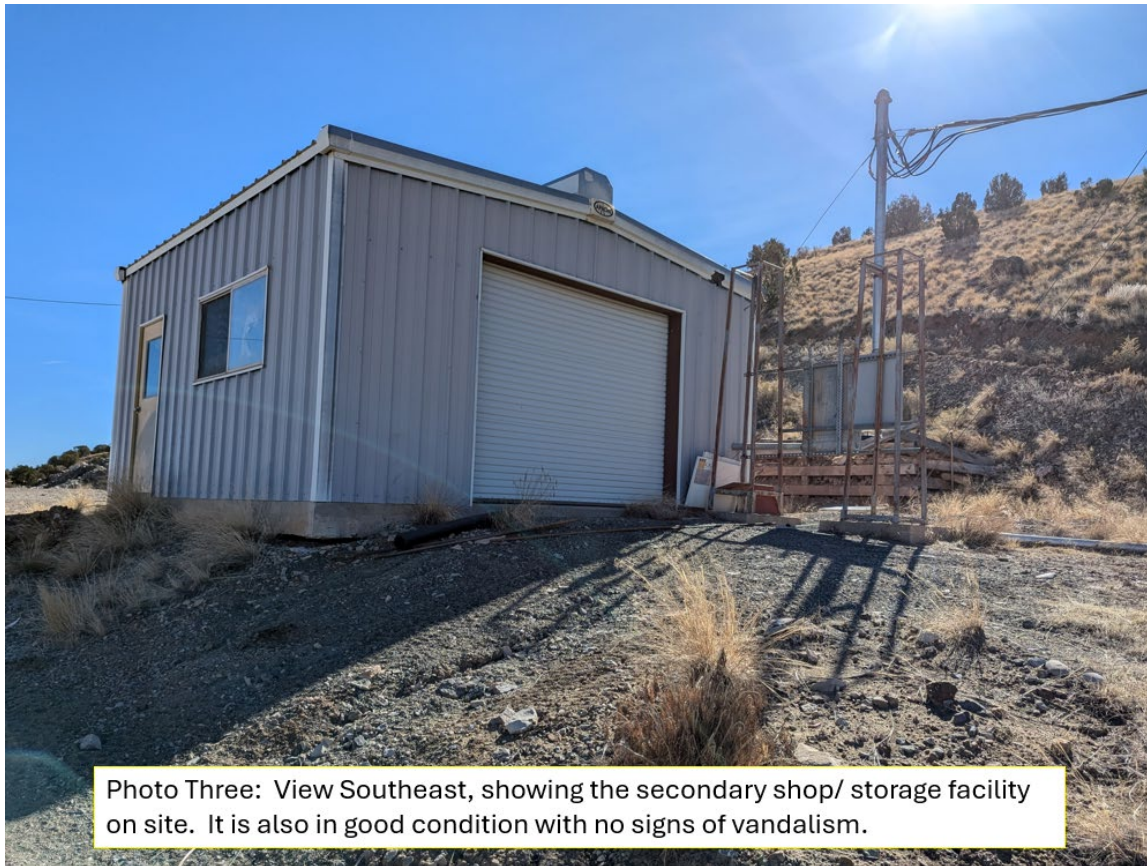
Photo Three: View Southeast, showing the secondary shop/ storage facility on site. It is also in good condition with no signs of vandalism.

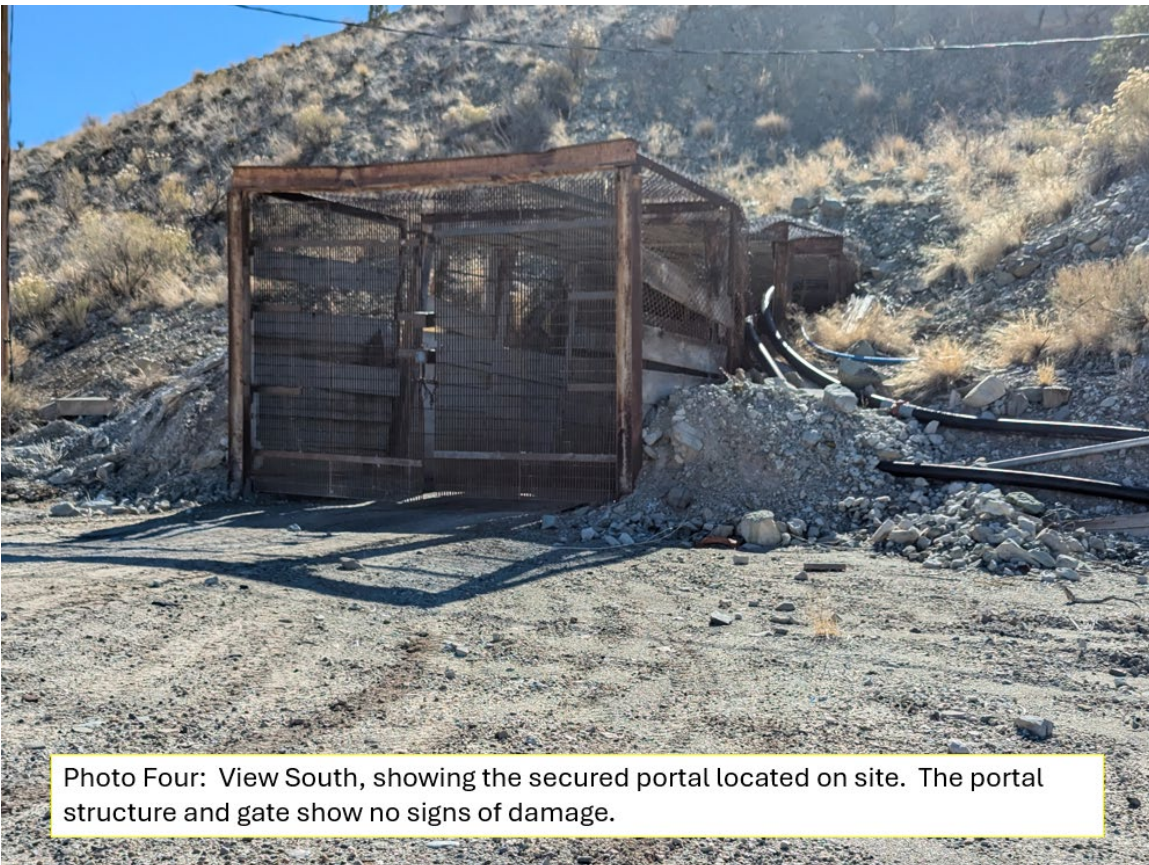
The portal located on site has been opened to be used as ventilation for the underground workings of the entire Sunday Complex. The portal was secure and in good condition at the time of the inspection as seen in Photo Four. The main pad and work area was in good condition, evidence of weed management during the growing season was observed. The whole site exhibits positive drainage, and no erosional issues were observed at this time. Some areas around the perimeter of the pad area have begun to revegetate themselves with volunteer species. The pad showed no signs of settling or slumping during the inspection. The out slopes of the pad are also in good condition, appearing stable during the inspection and showing no signs of significant erosion. An example of the out slopes can be seen in Photo Five.

Photo Four: View South, showing the secured portal located on site. The portal structure and gate show no signs of damage.

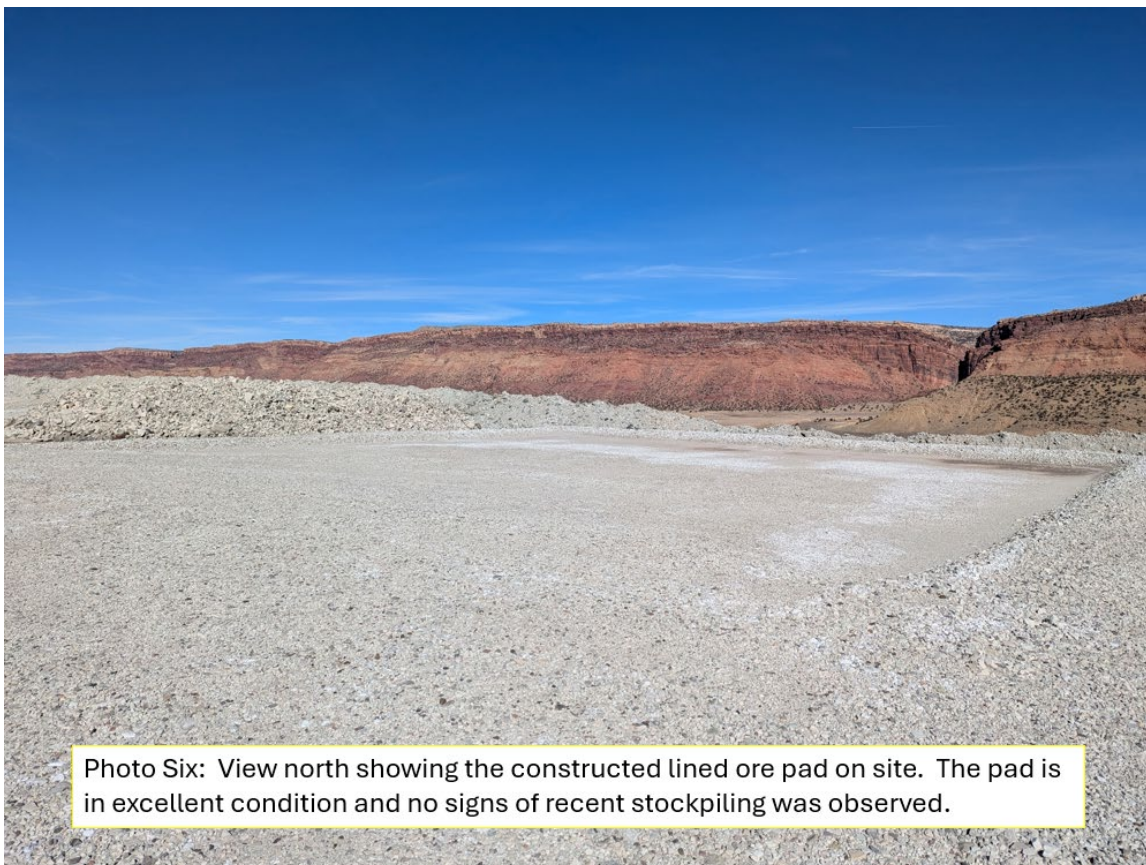
The lined Ore Pad was observed to be in good condition. The face of the pad shows no evidence of surface stockpiling and no observable impacts from precipitation was noted. The out slopes and berms of the pad appear stable. The pad can be seen in Photos Six.
