MINERALS PROGRAM INSPECTION REPORT
PHONE: (303) 866-3567

MINE NAME: Cecil II Gravel Pit	MINE/PROSPECTING ID#: M-1986-124	MINERAL: Sand and gravel	COUNTY: Washington
INSPECTION TYPE: Monitoring	WEATHER: Cloudy	INSP. DATE: December 9, 2024	INSP. TIME: 01:00
OPERATOR: James Cecil	OPERATOR REPRESENTATIVE:	TYPE OF OPERATION: 110c - Construction Limited Impact	
REASON FOR INSPECTION: Normal I&E Program	BOND CALCULATION TYPE:	BOND AMOUNT: \$7,500.00	
DATE OF COMPLAINT: NA	POST INSP. CONTACTS: None	JOINT INSP. AGENCY: None	
INSPECTOR(S): Ben Hammar	INSPECTOR'S SIGNATURE:

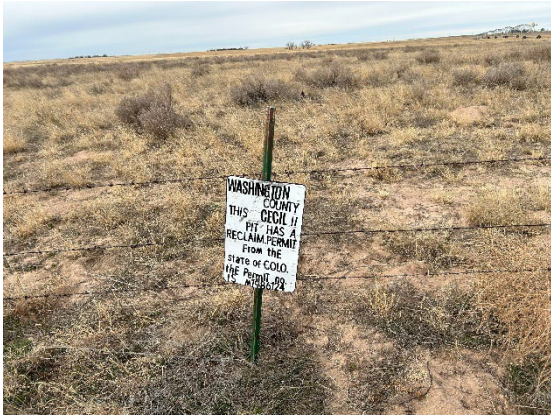
Photo 1: Posted identification sign.

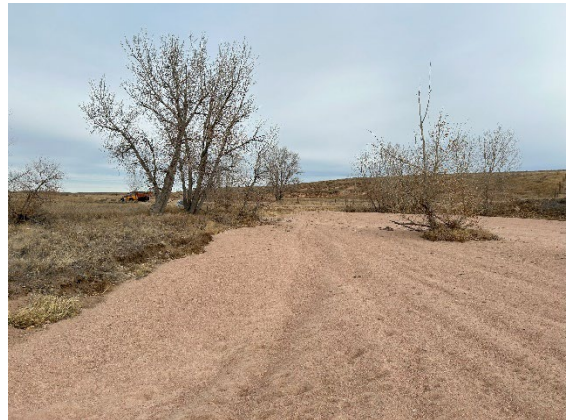
The site is mined intermittently from the channel of the seasonally flowing Arickaree River. Evidence of disturbance within the riverbed was visible at the time of inspection, and no other disturbance was noticeable outside of the area outlined in the current mining plan. The site boundary is clearly marked by a fence line, and the site identification sign was posted and visible.

Photo 2: Currently disturbed riverbed area.

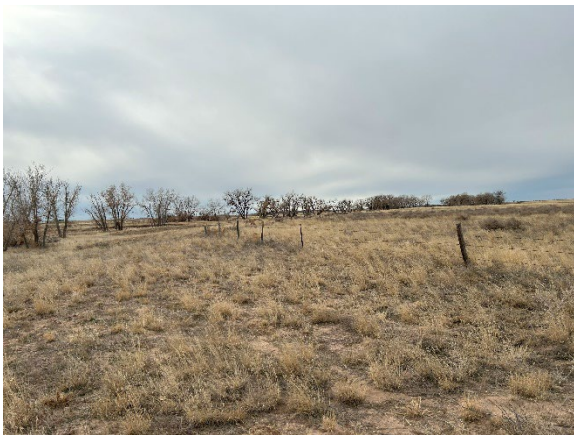
Photo 3: Northern boundary and example fence line.

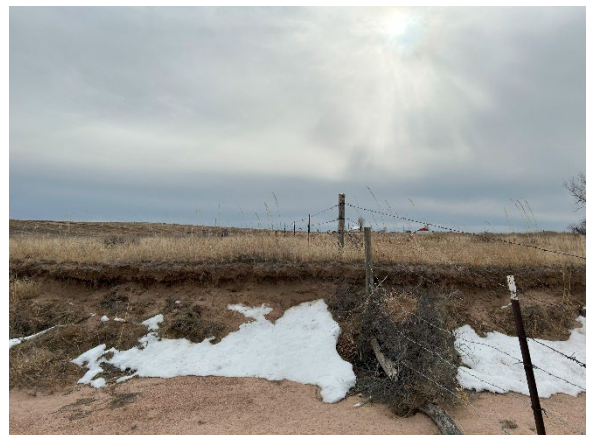
Photo 4: Western boundary and edge of affected riverbed.
