MINERALS PROGRAM INSPECTION REPORT
PHONE: (303) 866-3567

MINE NAME: CLG Farms, LLC	MINE/PROSPECTING ID#: M-2008-060	MINERAL: Gravel and sand	COUNTY: Washington
INSPECTION TYPE: Monitoring	WEATHER: Cloudy	INSP. DATE: December 9, 2024	INSP. TIME: 11:30
OPERATOR: CLG Farms, LLC	OPERATOR REPRESENTATIVE:	TYPE OF OPERATION: 110c - Construction Limited Impact	
REASON FOR INSPECTION: Normal I&E Program	BOND CALCULATION TYPE:	BOND AMOUNT: \$26,500.00	
DATE OF COMPLAINT: NA	POST INSP. CONTACTS: None	JOINT INSP. AGENCY: None	
INSPECTOR(S): Ben Hammar	INSPECTOR'S SIGNATURE:

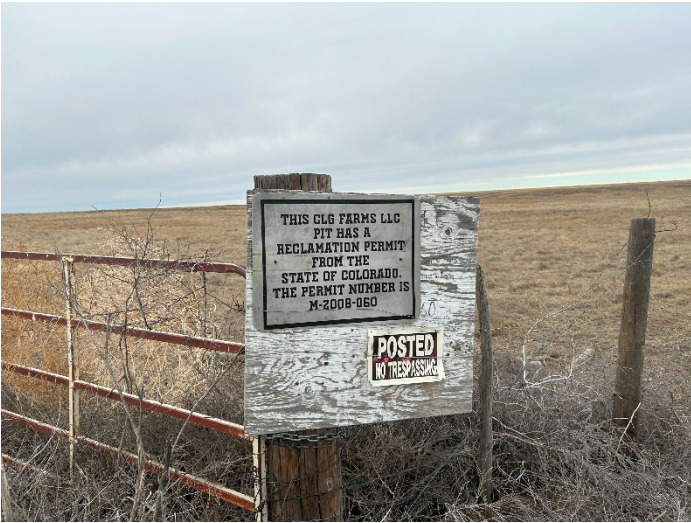
Photo 1: Posted mine identification sign.

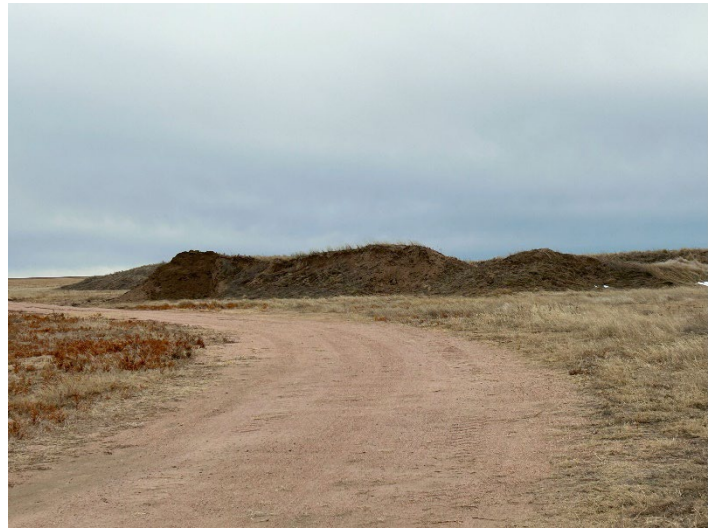
Photo 2: Seeded topsoil pile.

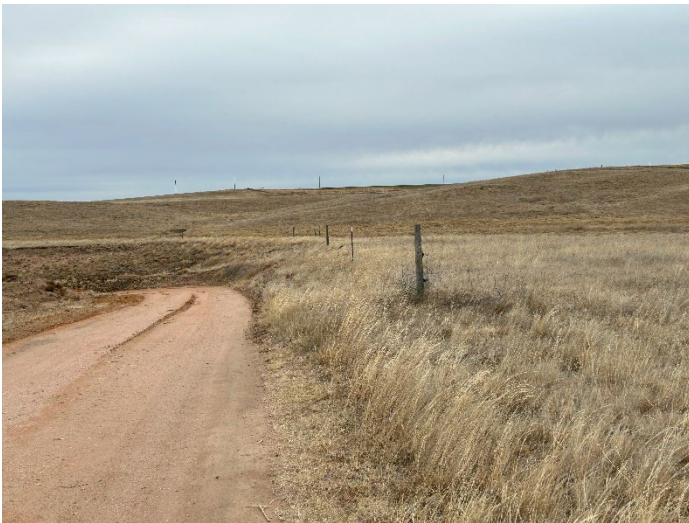
Photo 3: Southern site boundary.

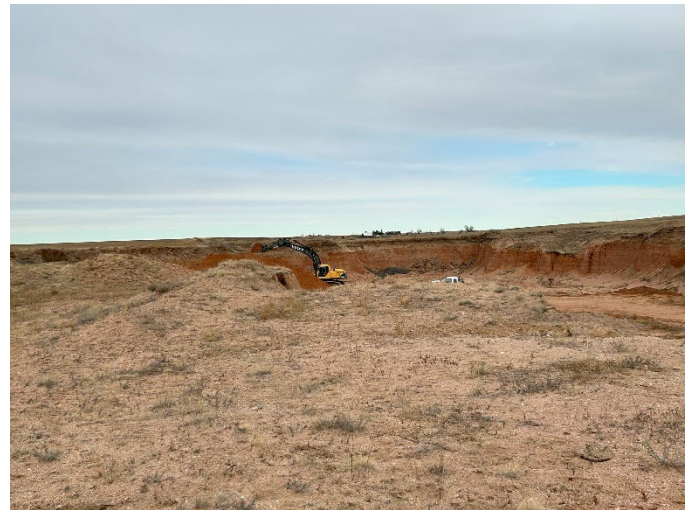
Photo 4: Active highwall.
