Rodeo Dunes Mine- Pre-Operational Inspection Report

MINERALS PROGRAM INSPECTION REPORT
PHONE: (303) 866-3567

MINE NAME: Rodeo Dunes Mine	MINE/PROSPECTING ID#: M-2024-049	MINERAL: Sand	COUNTY: Weld
INSPECTION TYPE: Preoperation Inspection	WEATHER: Clear	INSP. DATE: December 5, 2024	INSP. TIME: 10:00am
OPERATOR: CoProp LLC	OPERATOR REPRESENTATIVE: Tony Waldron	TYPE OF OPERATION: 112c - Construction Regular Operation	
REASON FOR INSPECTION: Pre-operation Inspection	BOND CALCULATION TYPE: Complete	BOND AMOUNT: \$330,925	
DATE OF COMPLAINT: NA	POST INSP. CONTACTS: None	JOINT INSP. AGENCY: None	
INSPECTOR(S): Chris Girardi	INSPECTOR'S SIGNATURE:

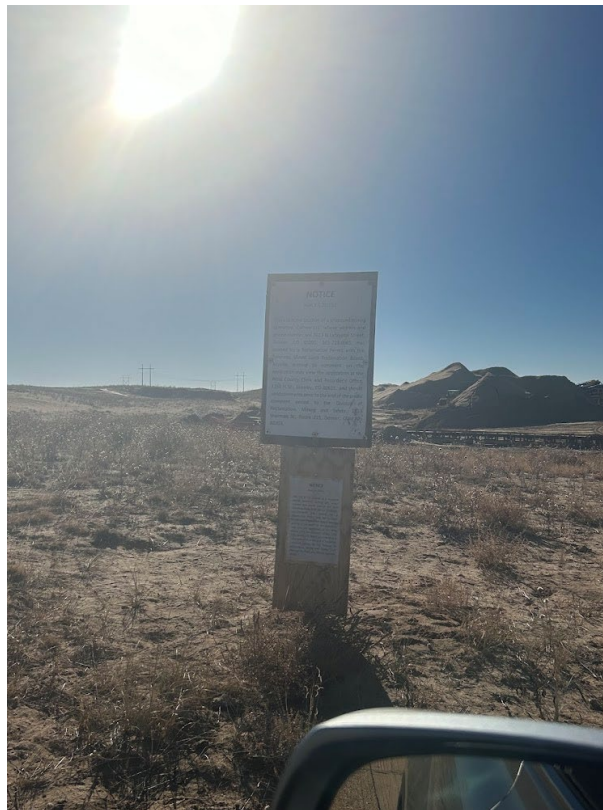
The 112(c) Reclamation Permit was received by the Division on September 17, 2024. The site is a proposed 335.0-acre construction materials mining operation. The site is located approximately 3 miles northwest of Roggen, CO in Weld County. A notice sign (see Photo 1) was observed during the inspection as required by Rule 1.6.2(b). The proposed permit area will also incorporate the M-2023-022 CoProp Pit No.1 110(c) permit, which is still actively being mined at the time of the inspection.

Photo 1: Notice Sign in accordance with Rule 1.6.2(b).

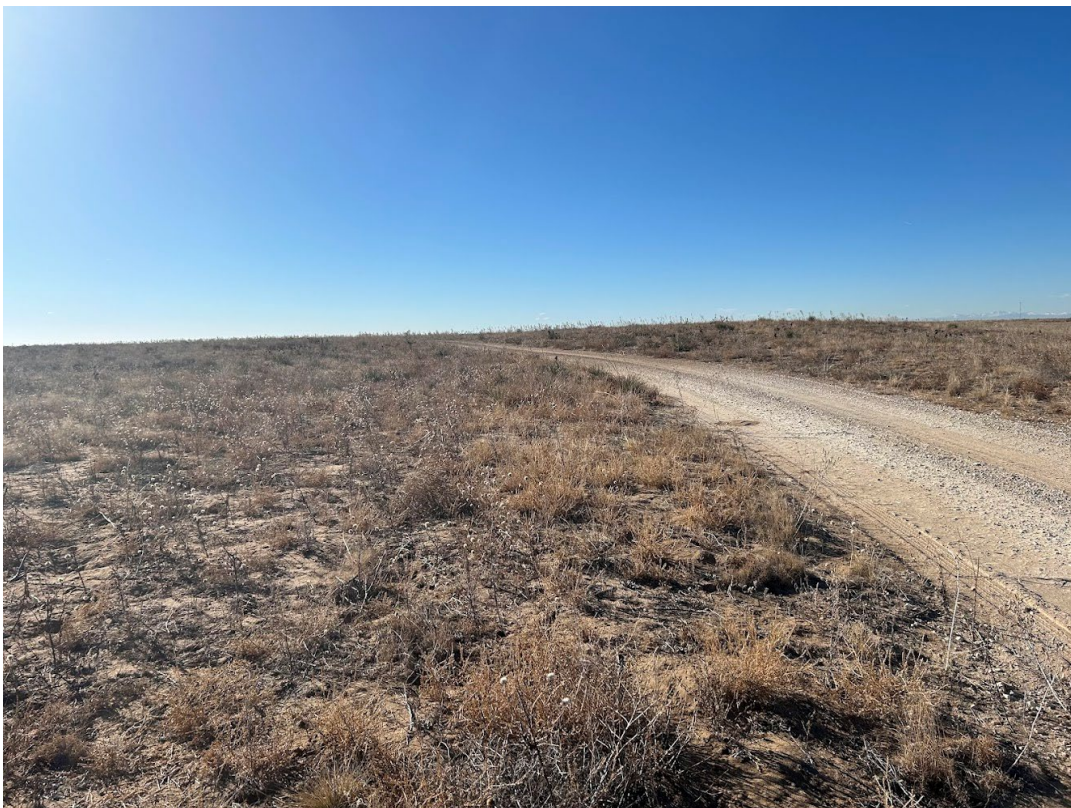
The proposed site consists of rolling hills and diverse rangeland vegetation. Access to the site is from a private access road south of U.S. Highway 34, then another dirt access road (see Photos 2 and 4) that runs along the northern boundary of the permit area. Native vegetation at the site consists of Western wheatgrass, Prairie sandreed, Blue grama, Sand bluestem and Yucca glauca (see Photos 6-8). Russian thistle was also identified. Several sand piles indicative of animal dwellings were observed (see Photo 8). No mining equipment was on-site. Wooden stakes have been installed to delineate the proposed Mine Block Area A in cardinal directions (see Photos 4-5). The primary commodity to be extracted is sand to a depth of approximately fifteen (15) feet to be sold as reclamation fill material for oil and gas operations. Approximately six (6) to twelve (12) inches of topsoil will be stockpiled and stabilized during mining activities in each individual mine block unit. Material processing will consist of sorting based on grain size. The Applicant committed to remaining at least two (2) feet above the highest groundwater elevation as determined by installed piezometers. Pre-existing drainage patterns will not be maintained, however post-mine contouring will allow for drainage to flow to the east. Given the site consists of highly permeable sand, a stormwater permit is not needed as runoff will likely infiltrate within 72 hours.

Photo 2: Dirt access road, facing southwest.

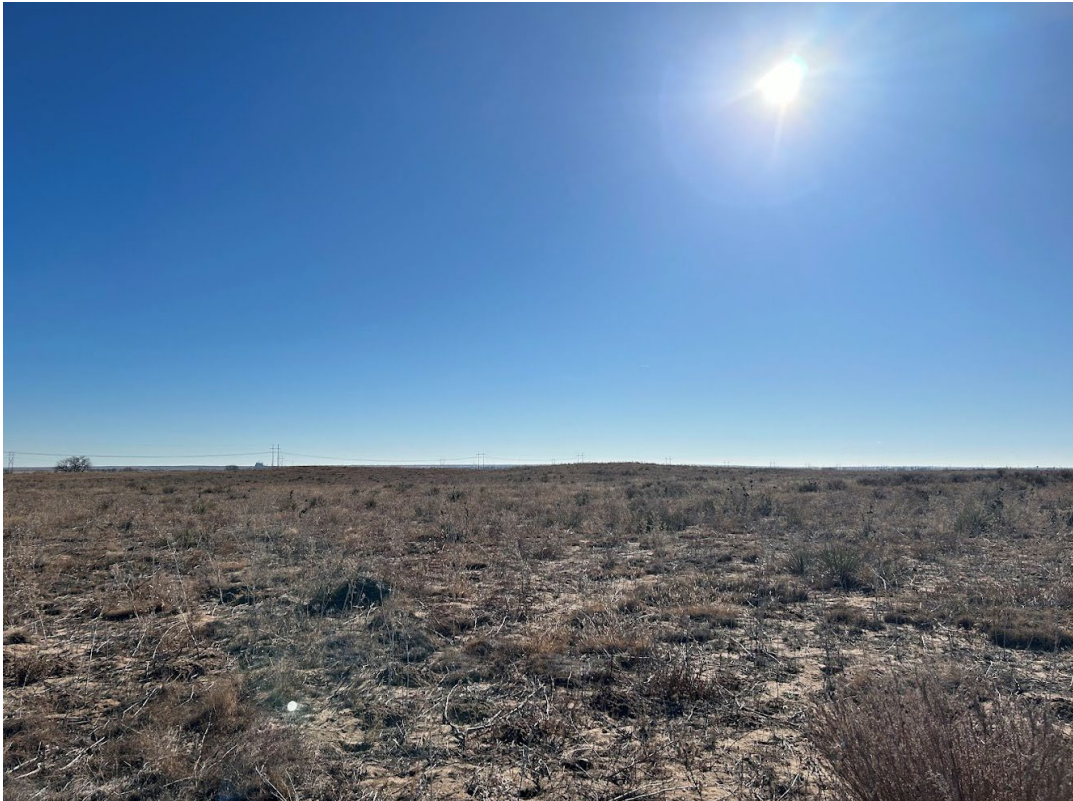
Photo 3: Proposed permit area and power lines to the east of the site, facing east.

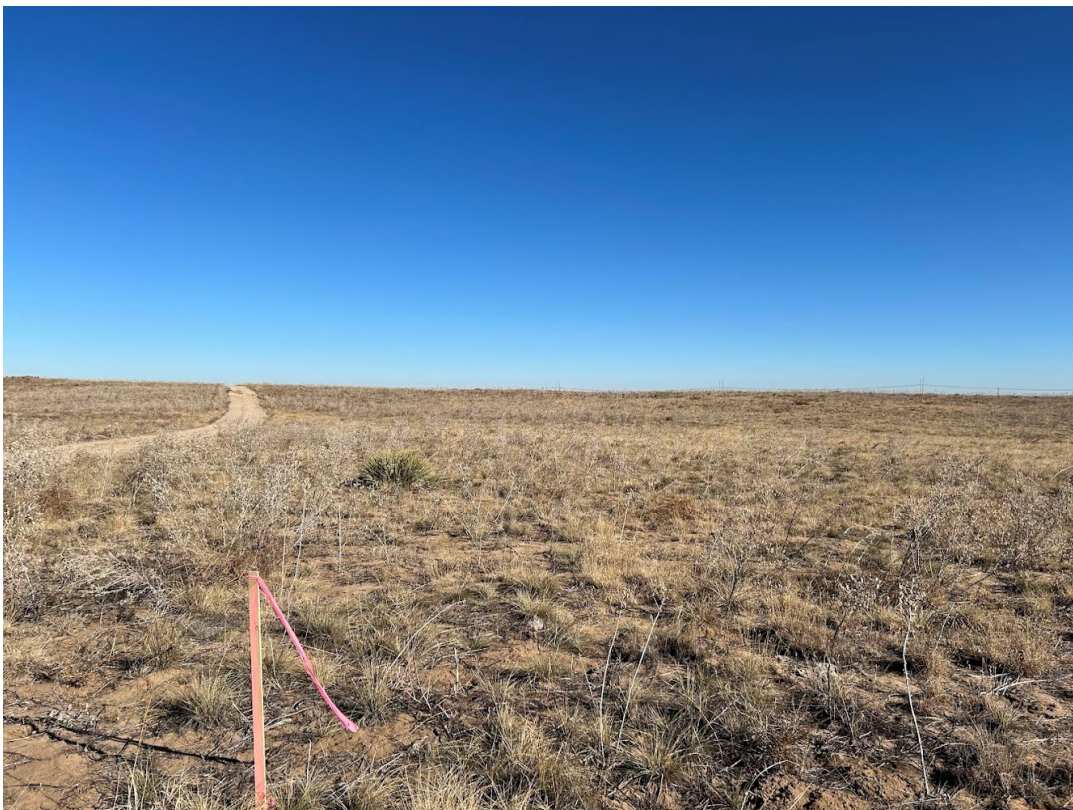
Photo 4: Southwest corner of the Mine Block A, facing north.

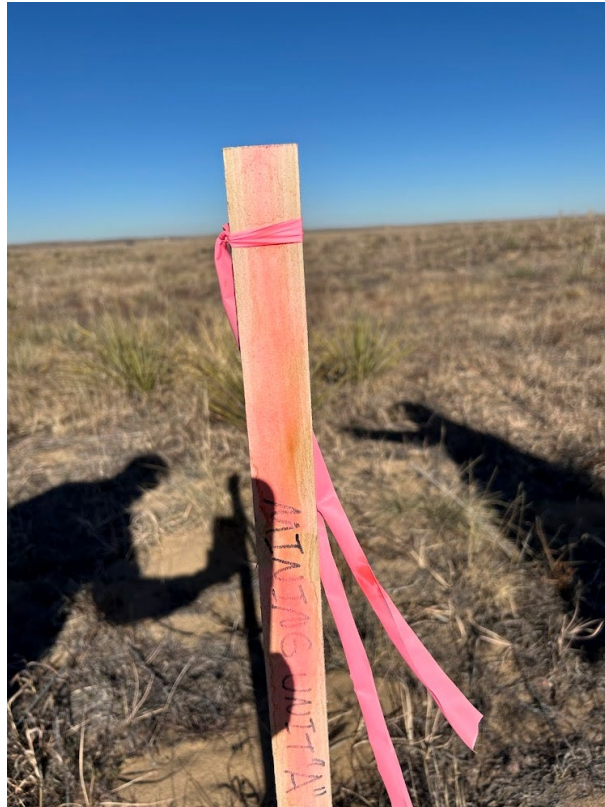
Photo 5: Stake indicating the northeast boundary of Mine Block A.

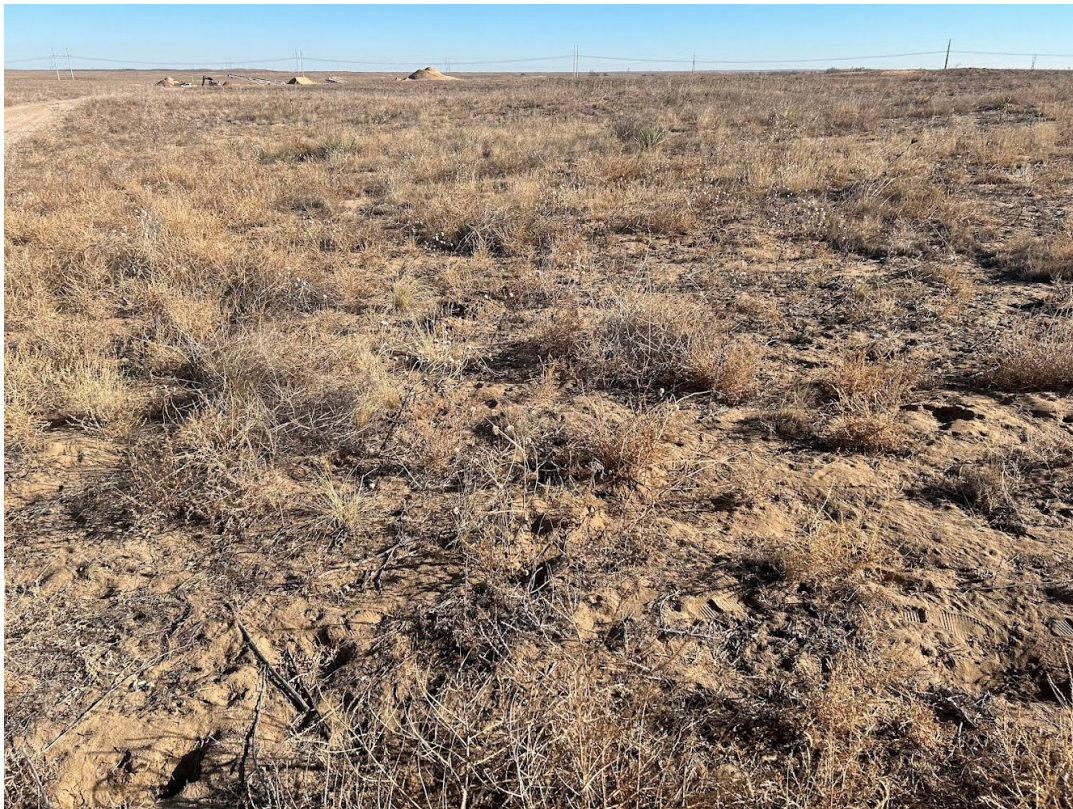
Photo 6: Native vegetation along the dirt access road, facing northeast.

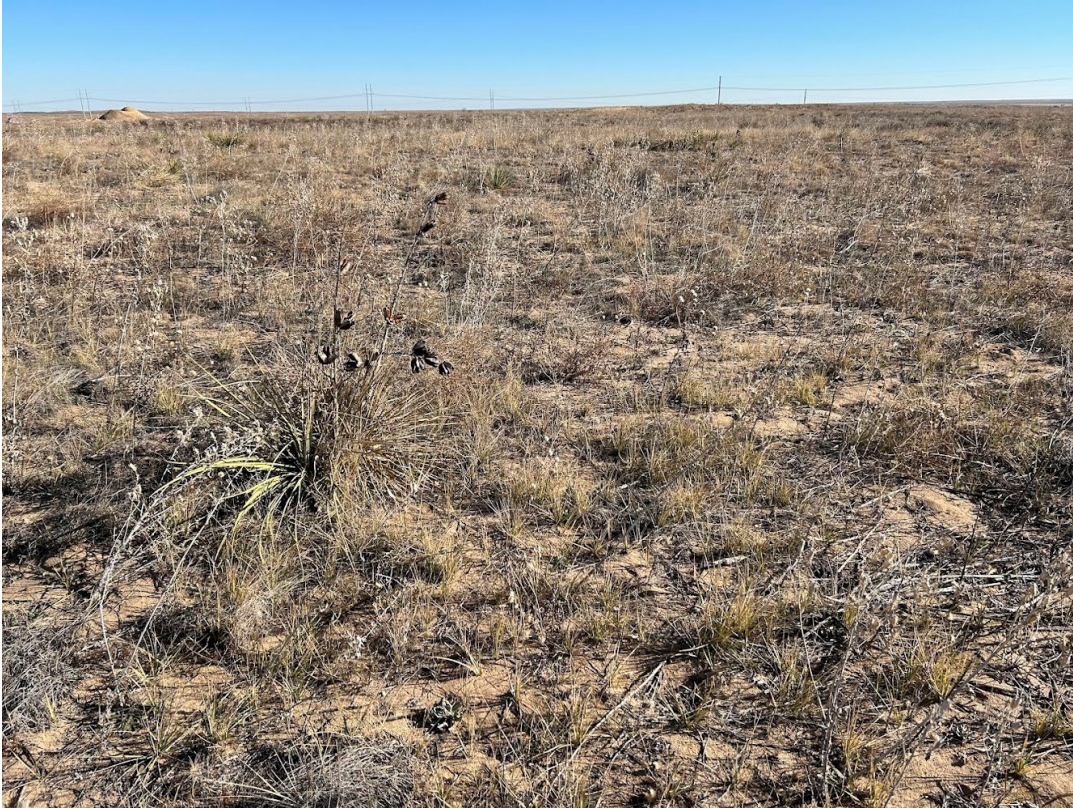
Photo 7: Native vegetation in Mine Block A, facing east.

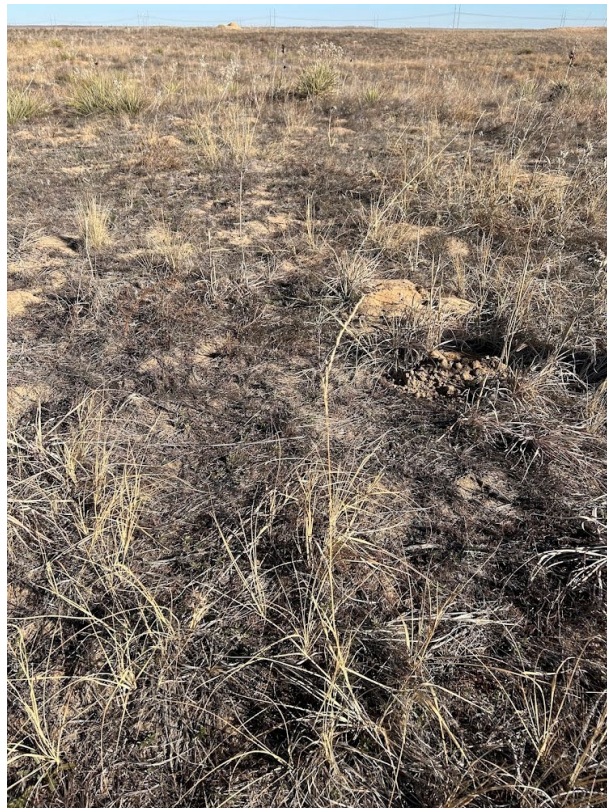
Photo 8: Native vegetation and animal dwellings in Mine Block A, facing northeast.
