## Nissen Farm Resource Inspection Report

**MINERALS PROGRAM INSPECTION REPORT**  
**PHONE: (303) 866-3567**

| <b>MINE NAME:</b><br>Nissen Farm Resource | <b>MINE/PROSPECTING ID#:</b><br>M-2003-001 | <b>MINERAL:</b><br>Sand and gravel | <b>COUNTY:</b><br>Weld |
| <b>INSPECTION TYPE:</b><br>Preoperation Inspection – Amendment 1 | <b>WEATHER:</b> Clear | <b>INSP. DATE:</b><br>November 20, 2024 | <b>INSP. TIME:</b><br>11:30 |

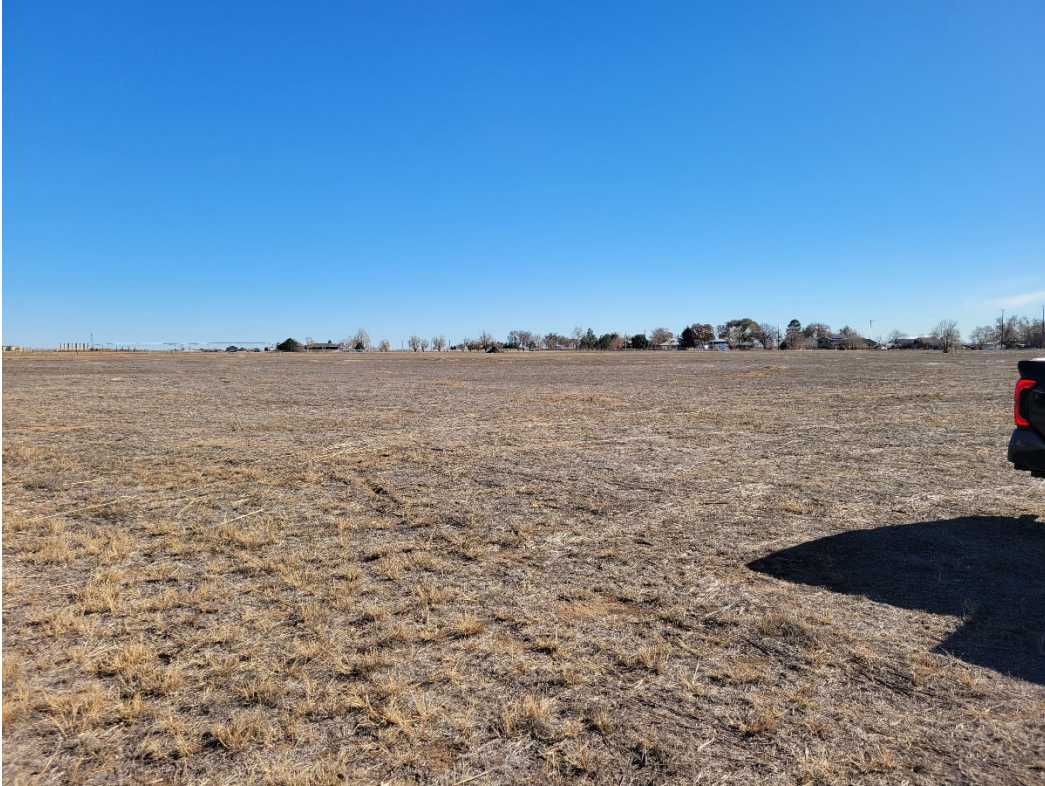
Photo 1: Looking southeast from the northwest corner of the amendment area.

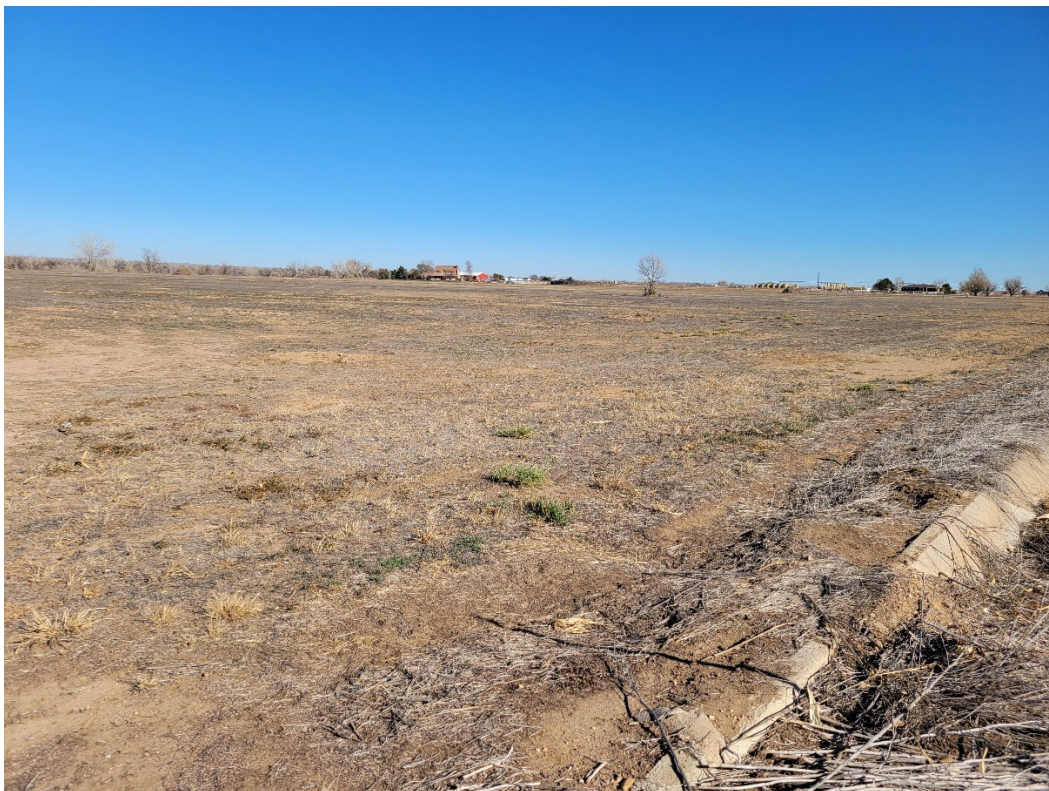
Photo 2: Looking northeast from the southwest corner of the amendment area.

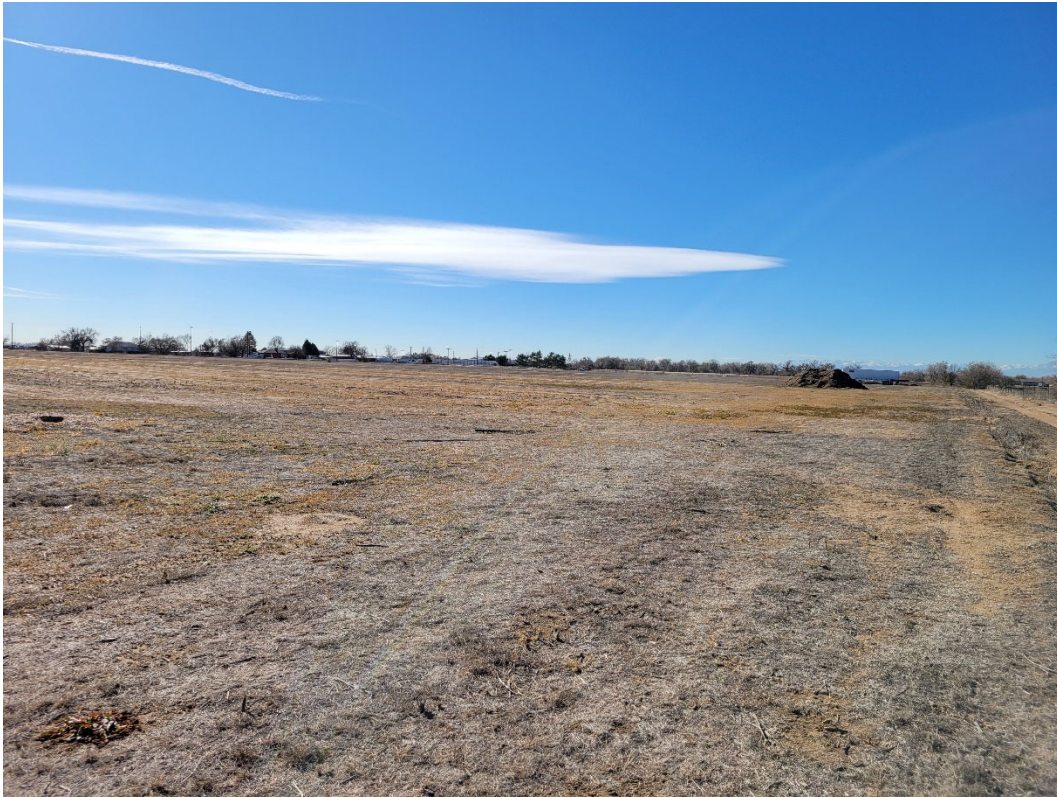
Photo 3: Looking southwest from the northeast corner of the amendment area.

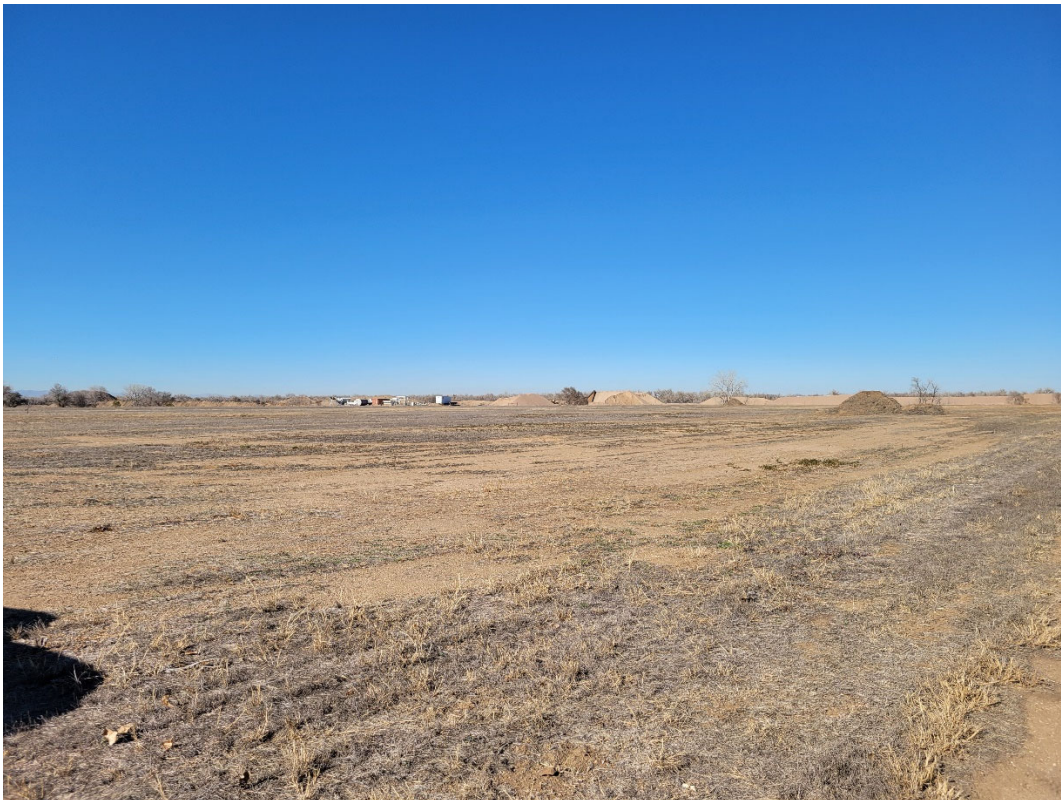
Photo 4: Looking northwest from the southeast corner of the amendment area.

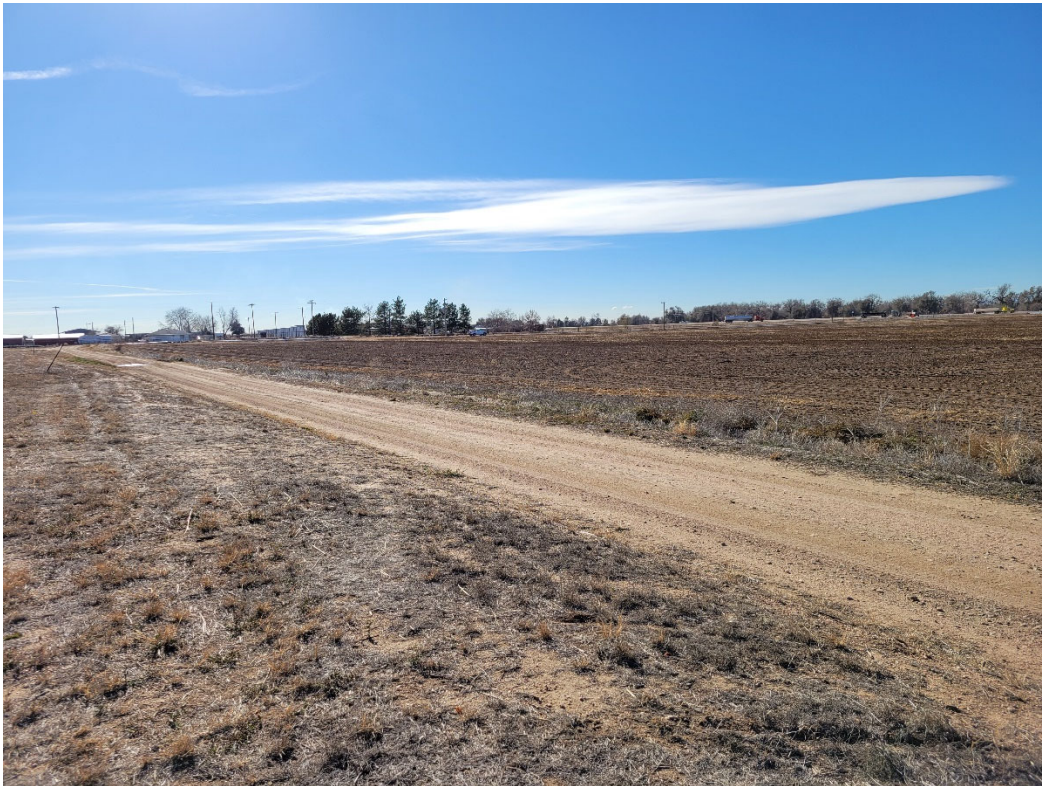
The Plumb Ditch was observed flowing through the north end of the parcel. The processing operation will be constructed in the agriculture field above the ditch. A dirt road along the western side of the amendment area connects the existing mine and the amendment area. The road connecting the two areas is proposed to be utilized by the mining operation. A bridge is constructed across the ditch along this road.

Photo 5: Access road that runs along the west side of the amendment area.

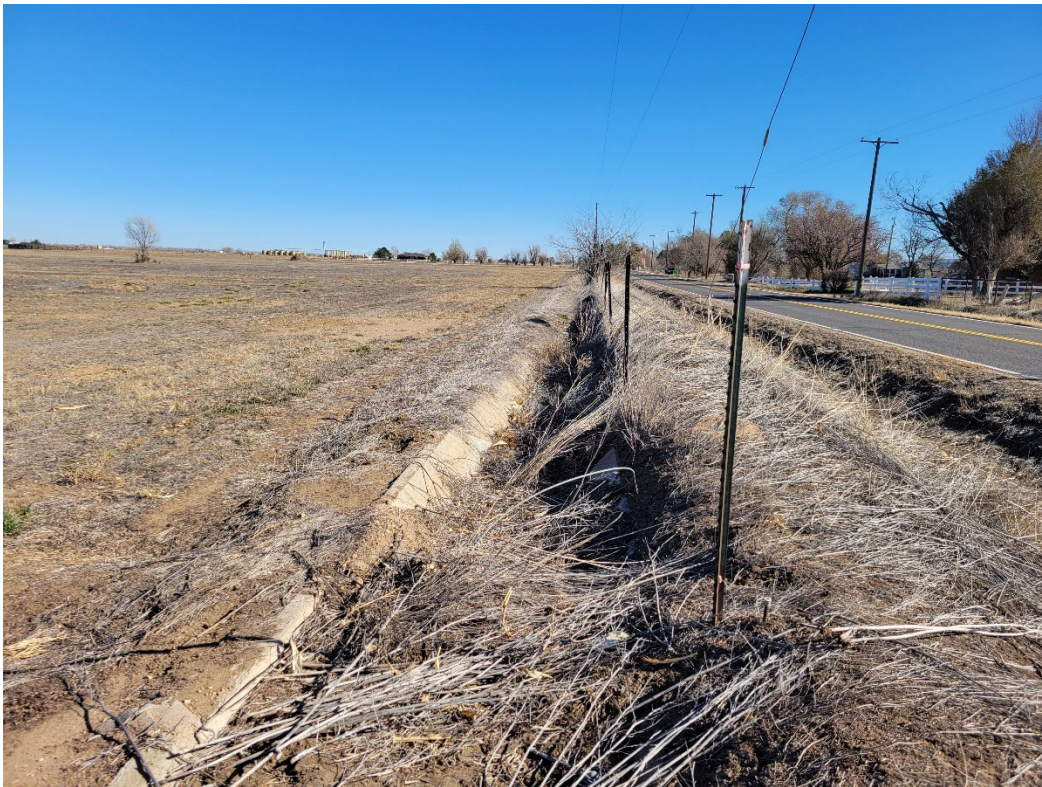
The Division observed a powerline along CR58, a concrete irrigation channel along the south end of the parcel, a gas line marker in the southeast corner, and barbed wire fences installed around the field. Additionally, a two-track dirt road was observed on the north side of the field. It appears the road is utilized for access to an adjacent residence owned by Don and Mary Lee (Hardy) Foster.

Photo 6: Looking down the southern boundary of the amendment area. County Road 58 is on the right, adjacent to the parcel. Agriculture ditch, barbed wire fence and powerlines running along CR 58 were observed. Residences on the south side of CR58.

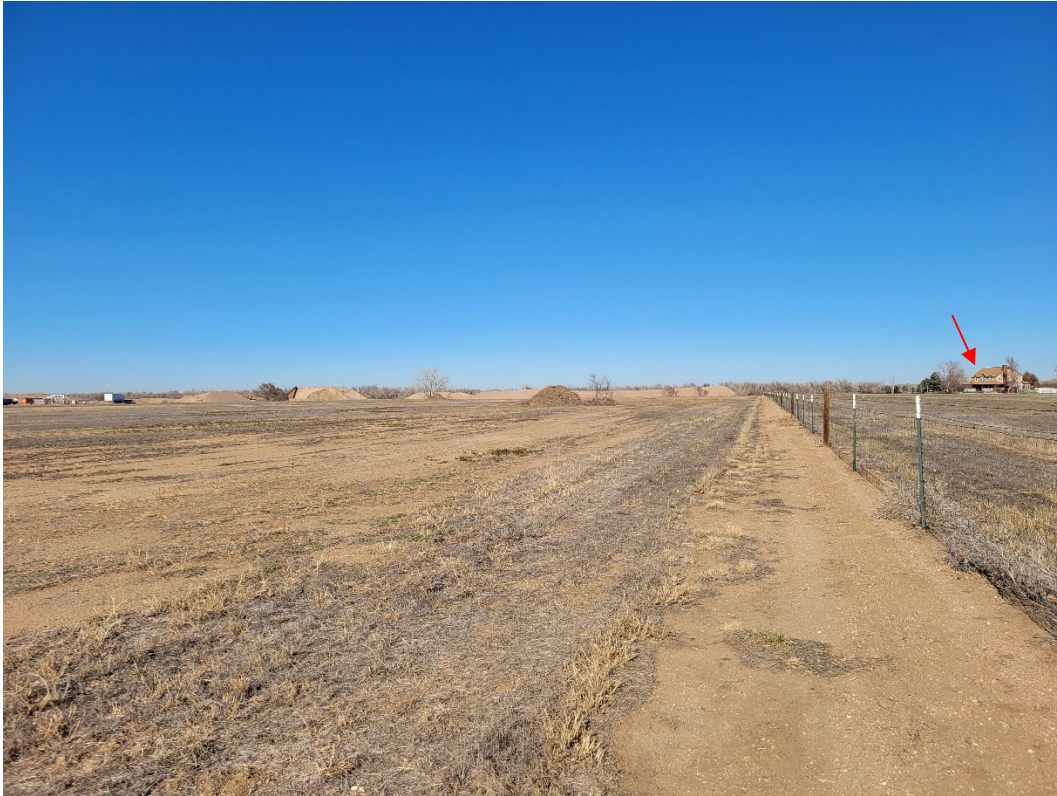
Photo 7: Looking north down the eastern boundary. Adjacent residence is noted by red arrow.

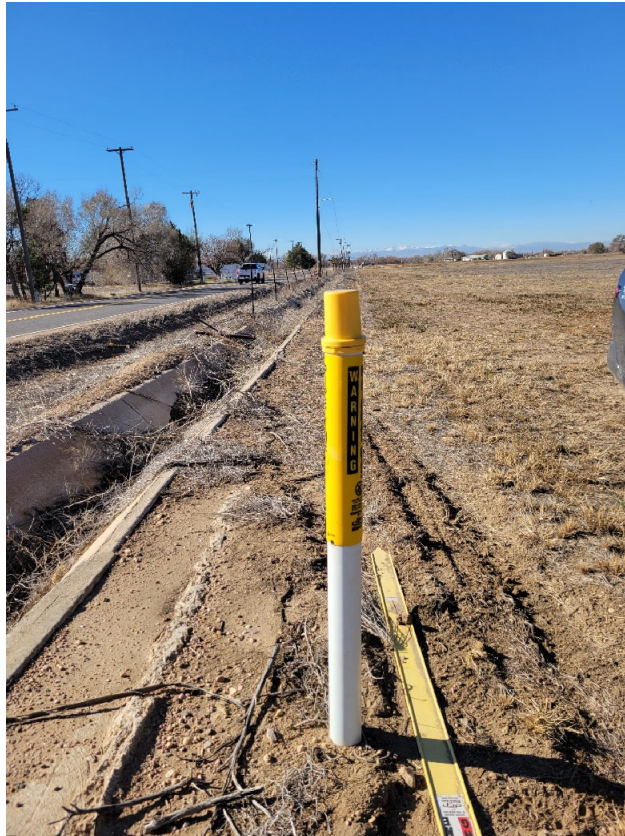
Photo 8: Gas line marker observed in the southeast corner of the permit area.

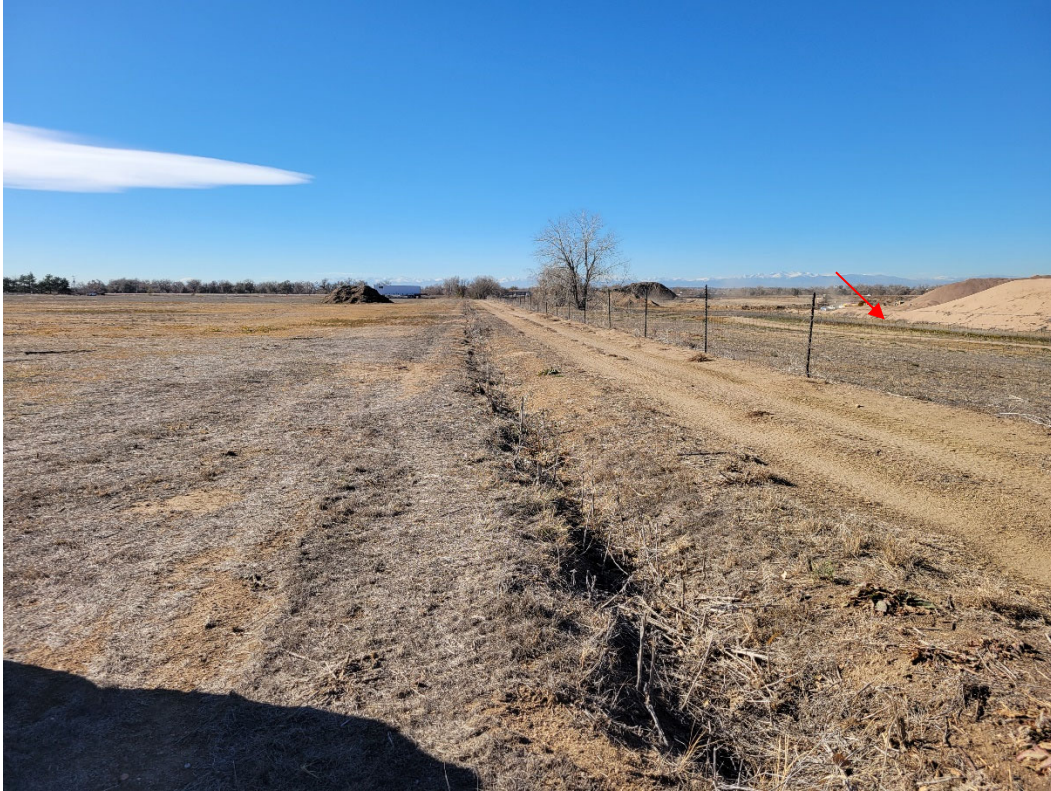
Photo 9: Two-track road observed crossing the Trycycle Lane parcel on the northern end of the amendment area. This road appears to be utilized to access an adjacent residence. Existing mining area is below on the right noted by arrow.

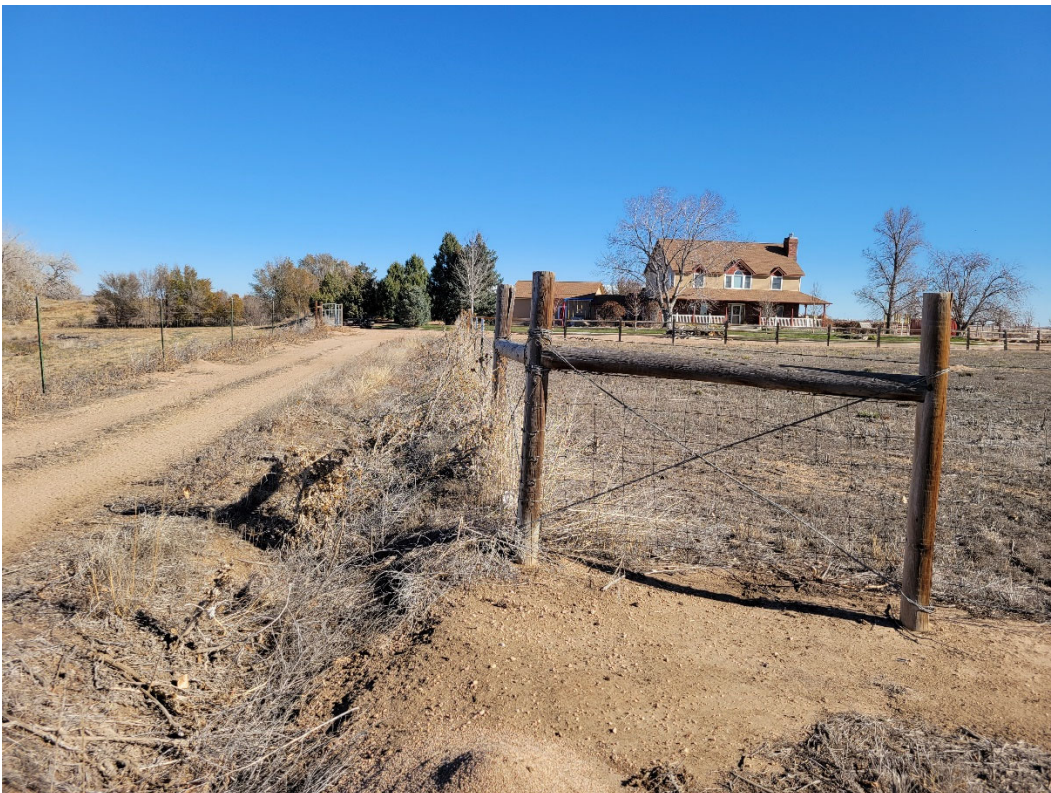
Photo 9: Residence owned by Don and Mary Lee (Hardy) Foster sits adjacent to the northeast corner of the amendment area.

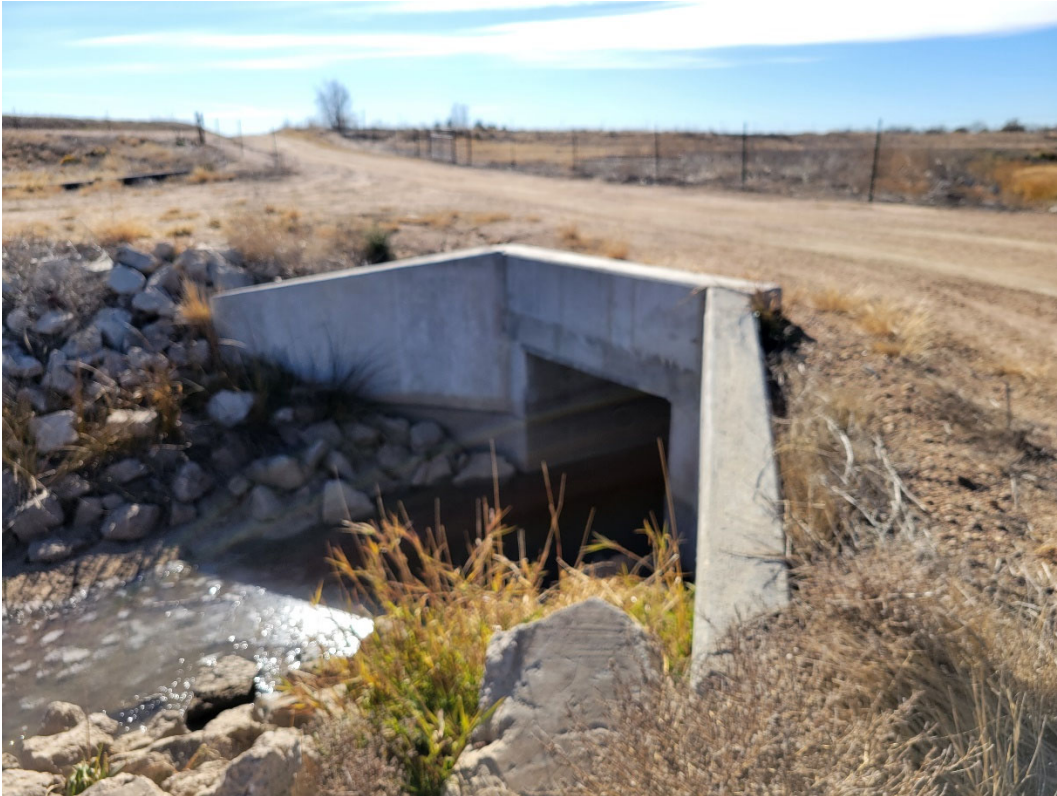
Photo 10: Road and bridge over the Plumb Ditch between the existing mine and the amendment area.

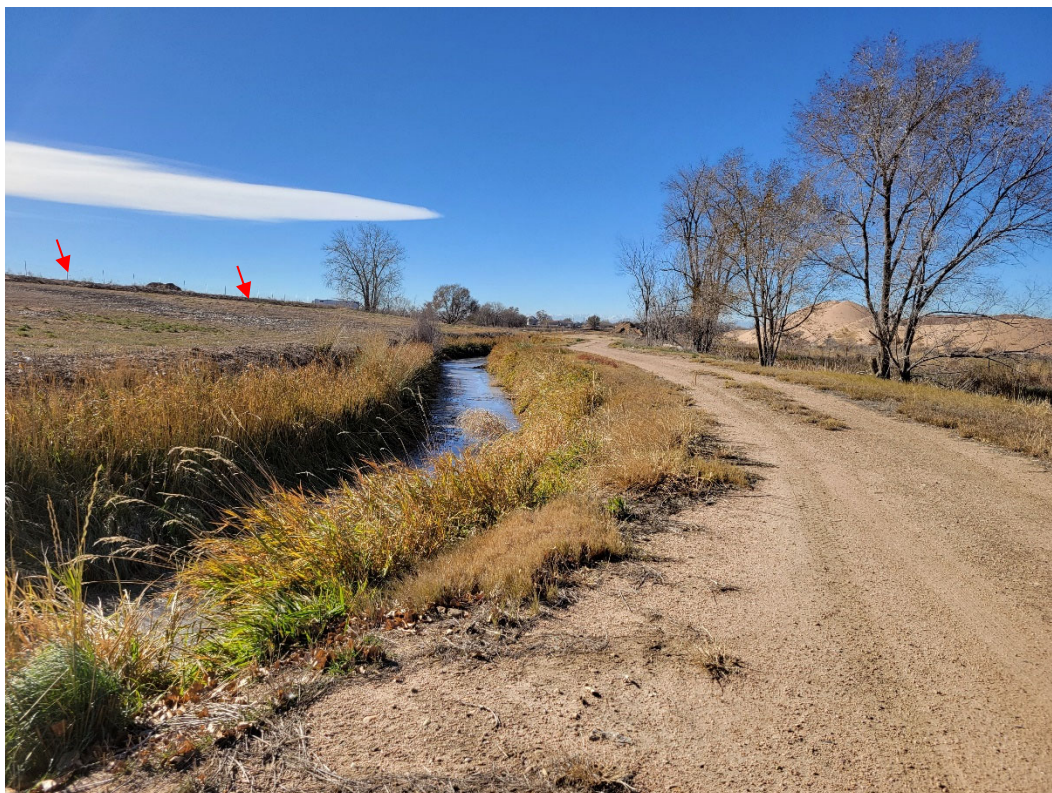
Photo 11: Looking at Plumb Ditch within the amendment area. The ditch is below the proposed processing facility. Arrows point to fenceline marking the northern end of the

agricultural field where the processing facility will be constructed.

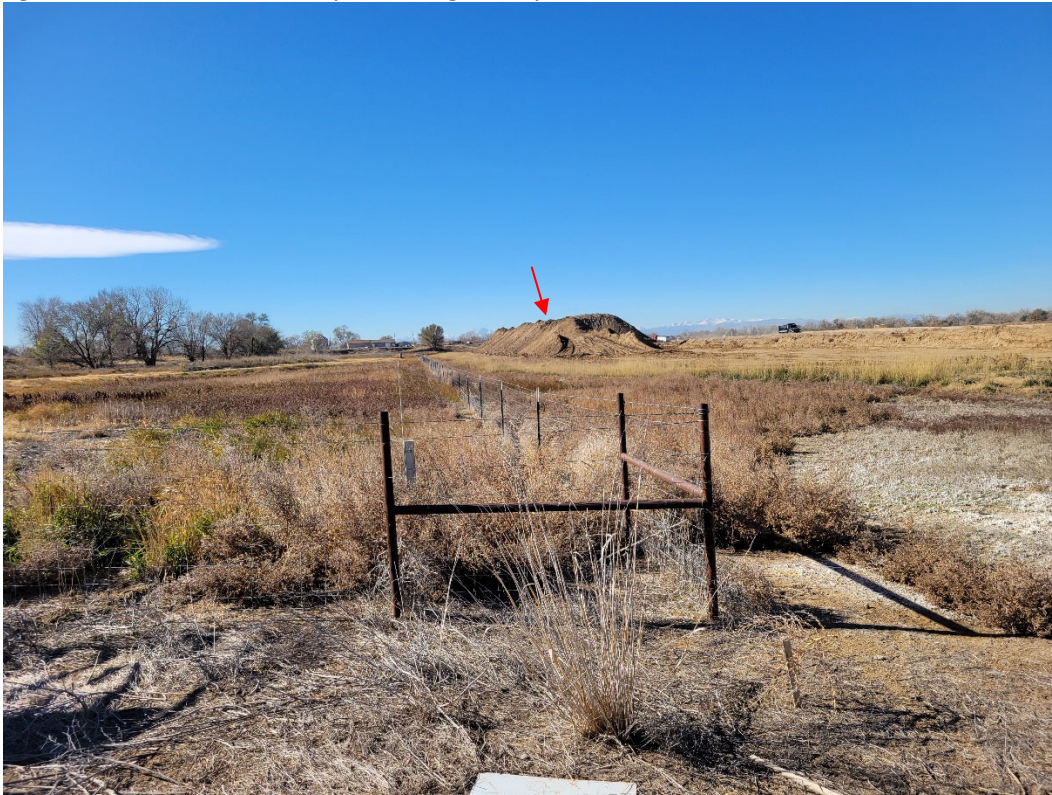
Photo 12: Looking west down the southern boundary of the existing mine at the entrance to the proposed amendment area. Overburden stockpiles located outside the slurry wall are noted by the red arrow.

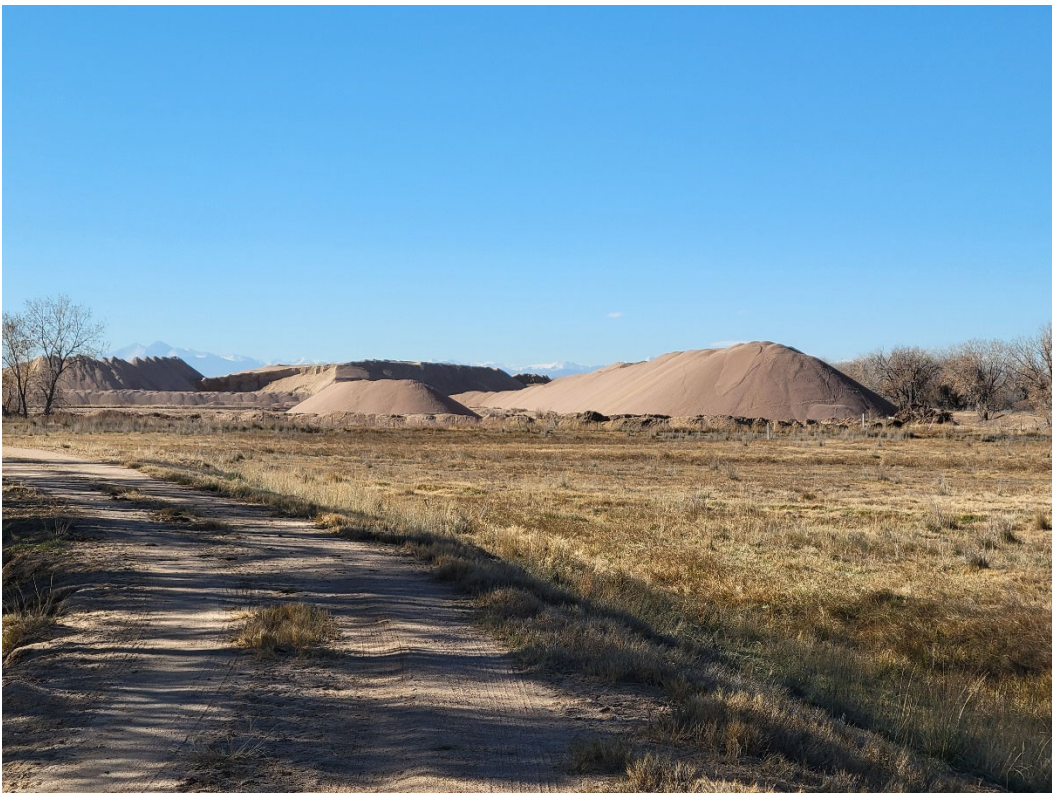
Photo 13: Looking west at stockpiles of material on the eastern side of the existing mine

permit area.

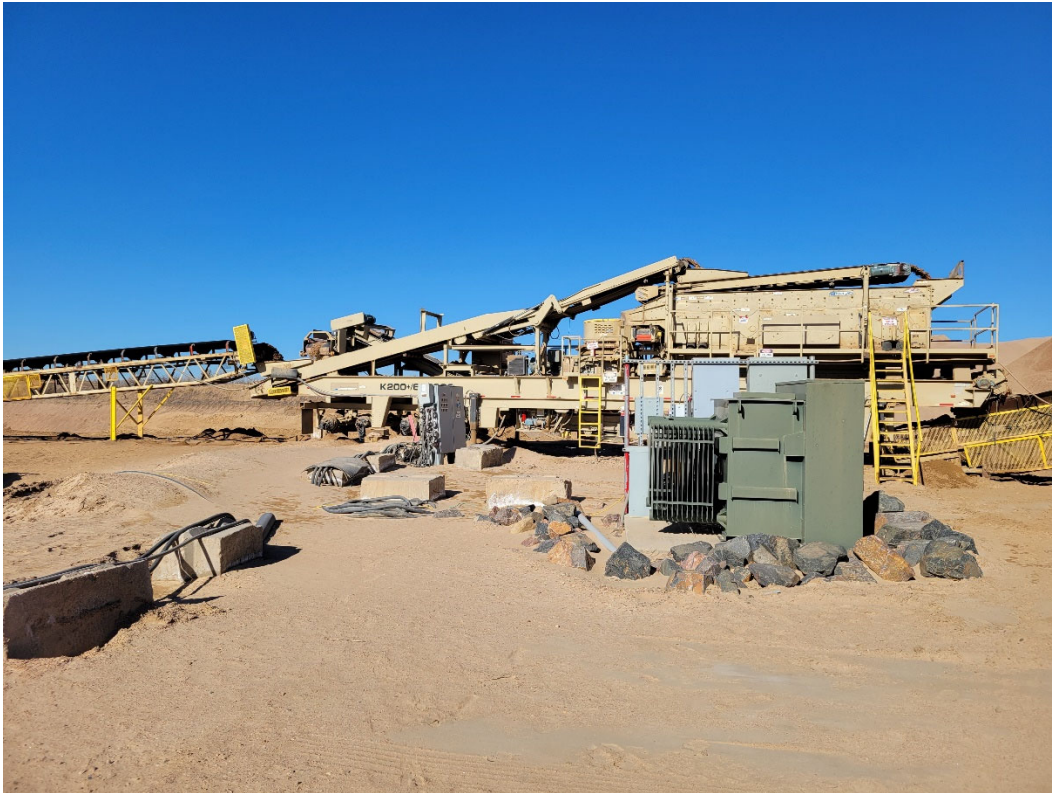
Photo 14: Processing facility in the center of the existing mine site. The amendment proposes to move this equipment to the amended area above pit.

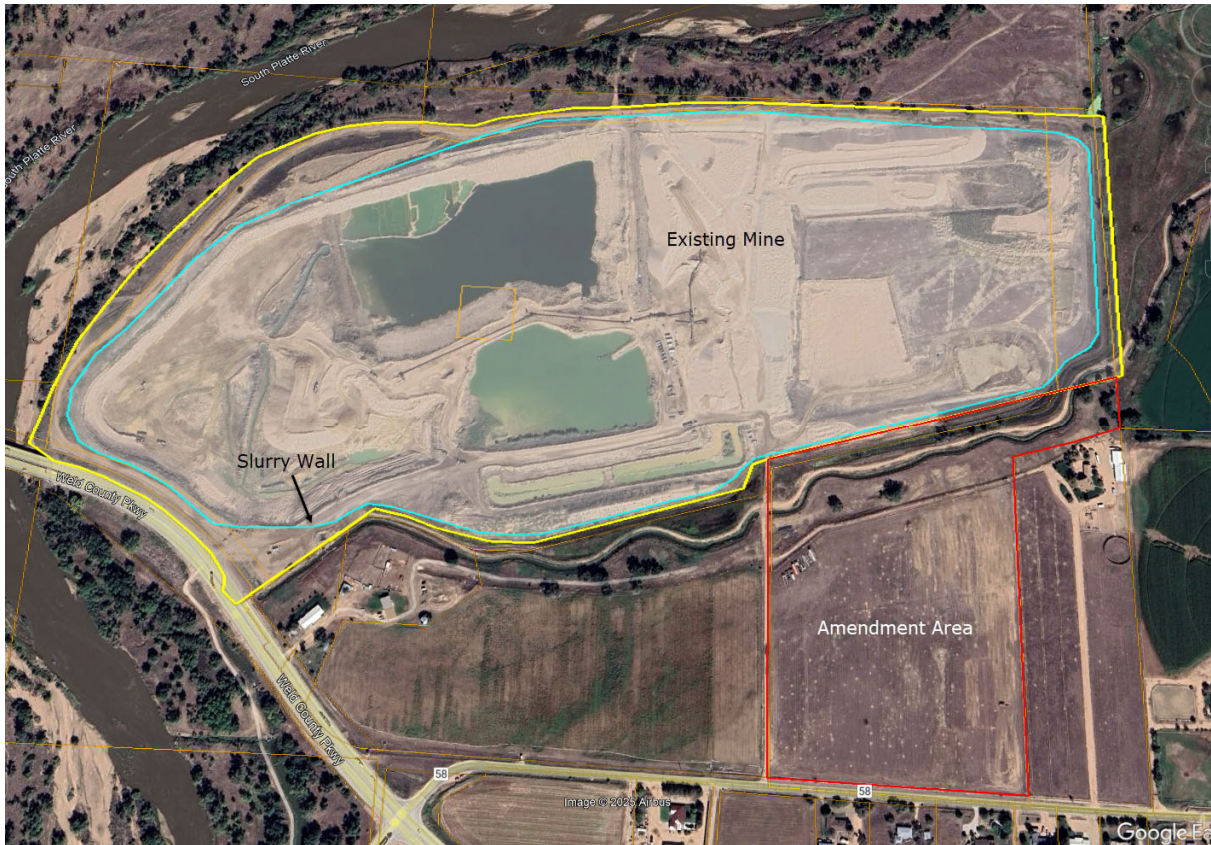
Figure 1: Google Earth image showing the existing mine boundary in yellow and the proposed amendment area in red. Imagery dated 9/22/2024.
