MINERALS PROGRAM INSPECTION REPORT
PHONE: (303) 866-3567

MINE NAME: Sandoval Land and Cattle Pit	MINE/PROSPECTING ID#: M-2001-015	MINERAL: Sand and gravel	COUNTY: Las Animas
INSPECTION TYPE: Monitoring	WEATHER: Clear	INSP. DATE: December 19, 2024	INSP. TIME: 08:28
OPERATOR: Las Animas County	OPERATOR REPRESENTATIVE: Keith Woodring and Nick Lingus	TYPE OF OPERATION: 110c - Construction Limited Impact	
REASON FOR INSPECTION: Normal I&E Program	BOND CALCULATION TYPE: None	BOND AMOUNT: \$0.00	
DATE OF COMPLAINT: NA	POST INSP. CONTACTS: None	JOINT INSP. AGENCY: None	
INSPECTOR(S): Amber M. Gibson	INSPECTOR'S SIGNATURE:

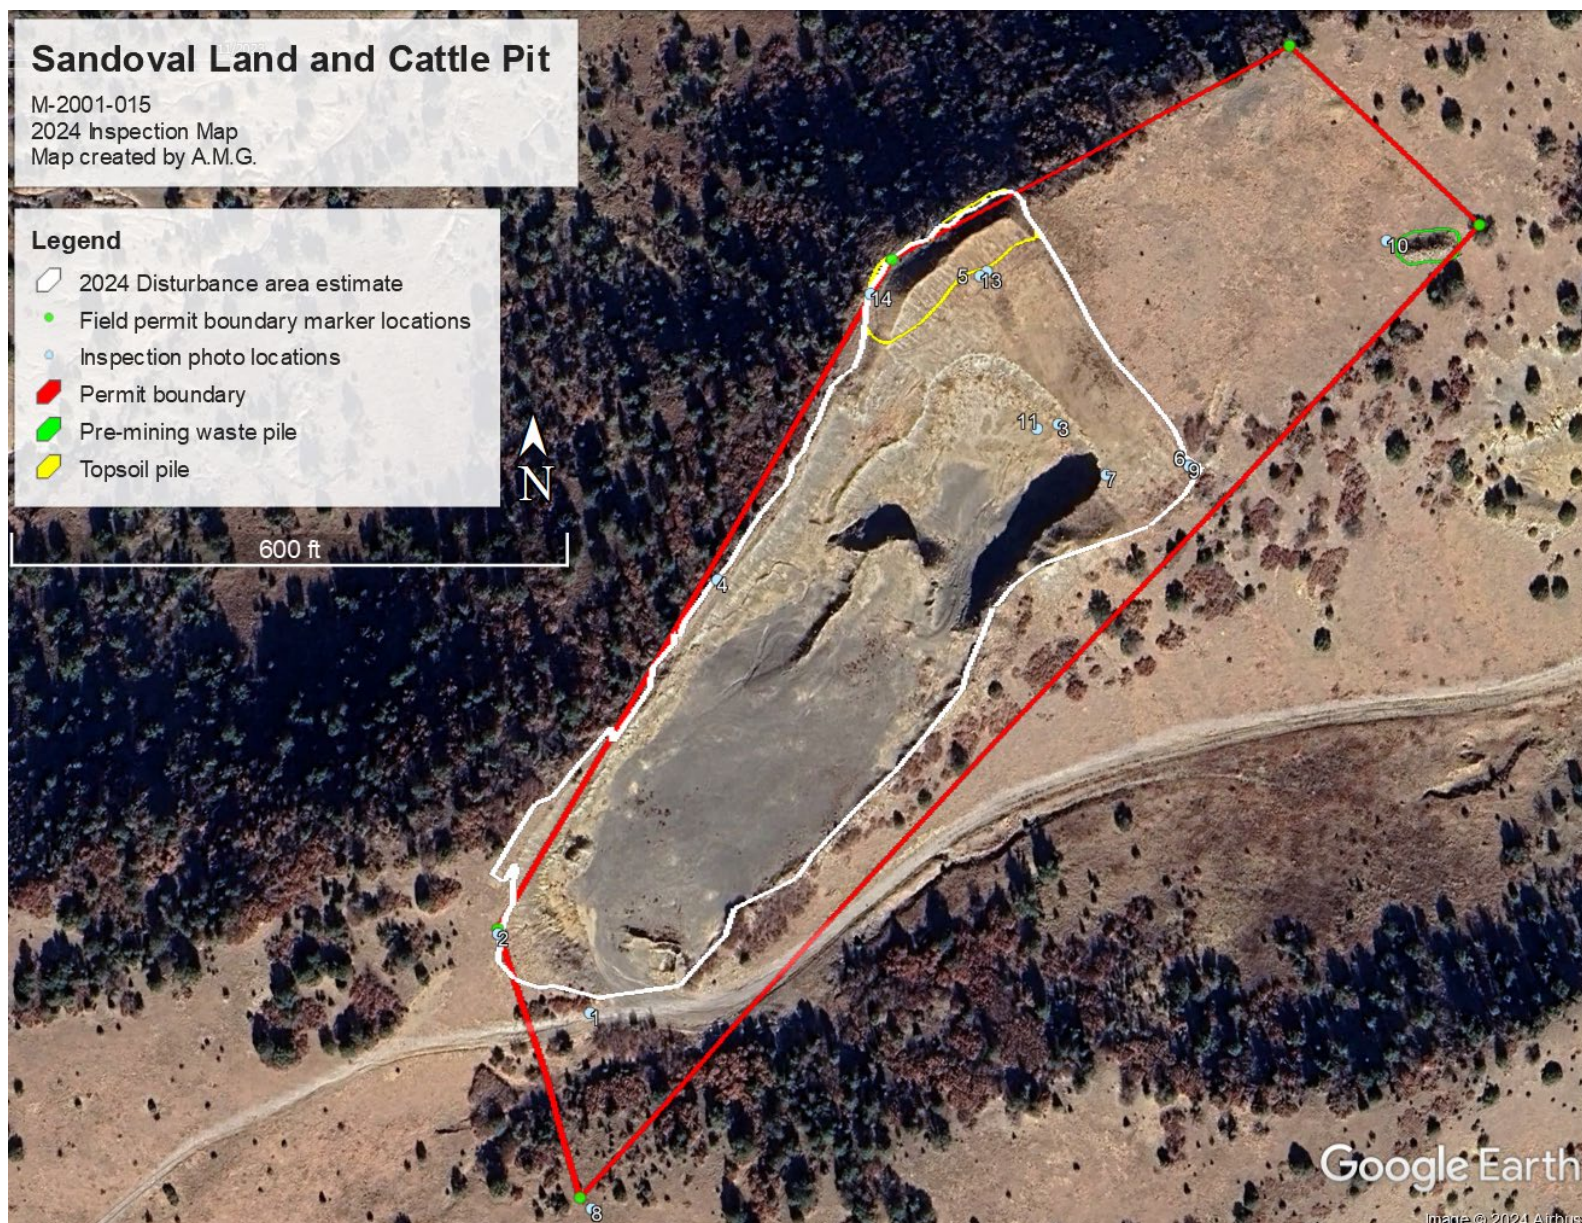
estimates that approximately 4.94 acres of the permit area has been disturbed to date with the remainder of the site undisturbed (except for a waste rock stockpile that was placed on the site during a pre-law mining operation (Photo 10)). The white line on Map 1 shows the estimate for the approximate currently disturbed area. Along the north side of the northwestern most corner, some disturbance appears to be outside of the permit boundary. Additionally, near the topsoil stockpile, some disturbance also appears to be outside of the boundary. There appear to be some discrepancies pertaining to the permit boundary. This is addressed further later in this report in the *Signs and Markers* section.

A permit sign, posted in compliance with Rule 3.1.12(1) was observed at the entrance to the site (Photo 12). The Operators and the inspector walked around the permit boundary and located all five boundary markers (Map 1). As seen in some of the photos, the boundary is marked with t-posts with orange tops. When asked during the inspection, the Operator stated that the markers have been in their original locations since the issuance of the permit. During the inspection, the inspector and the Operator agreed that it may be helpful to add additional markers along the boundary to aid with line-of-sight, especially along the southern boundary.

Map 1: Inspection map generated for the 2024 inspection report. The map was generated in Google Earth Pro in combination with location information gathered in Esri Field Maps during the inspection. The aerial imagery is dated November 25, 2023. The inspection photo icons on the map correspond with the inspection photo numbers within this report.

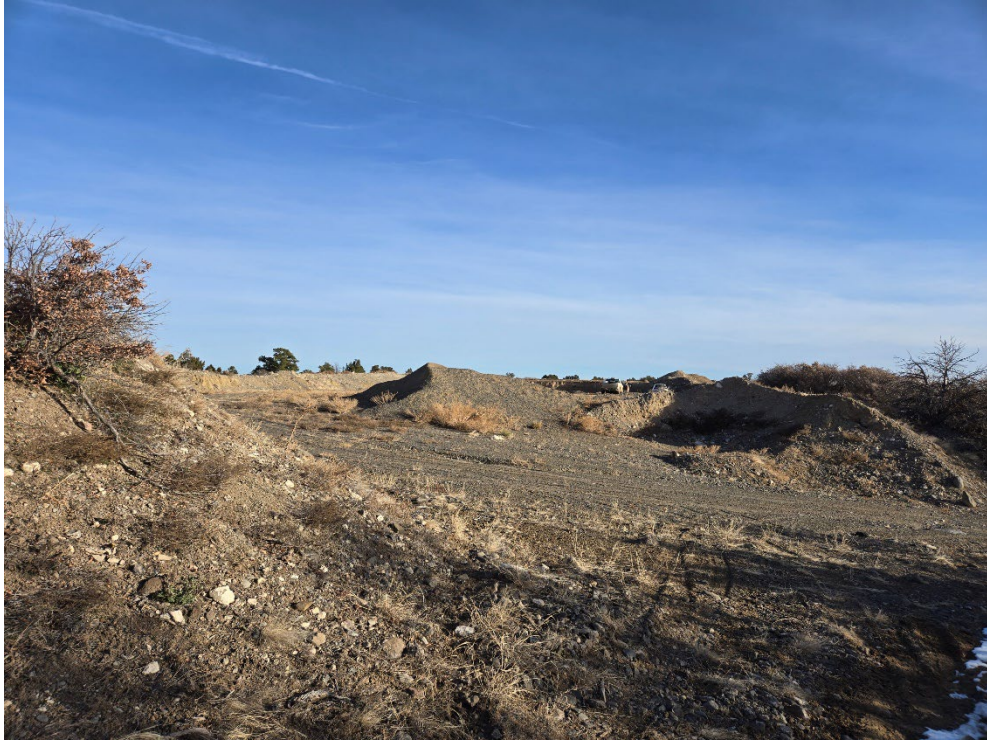
Photo 1: Looking north into the operation from the entrance point on the old ranch road.

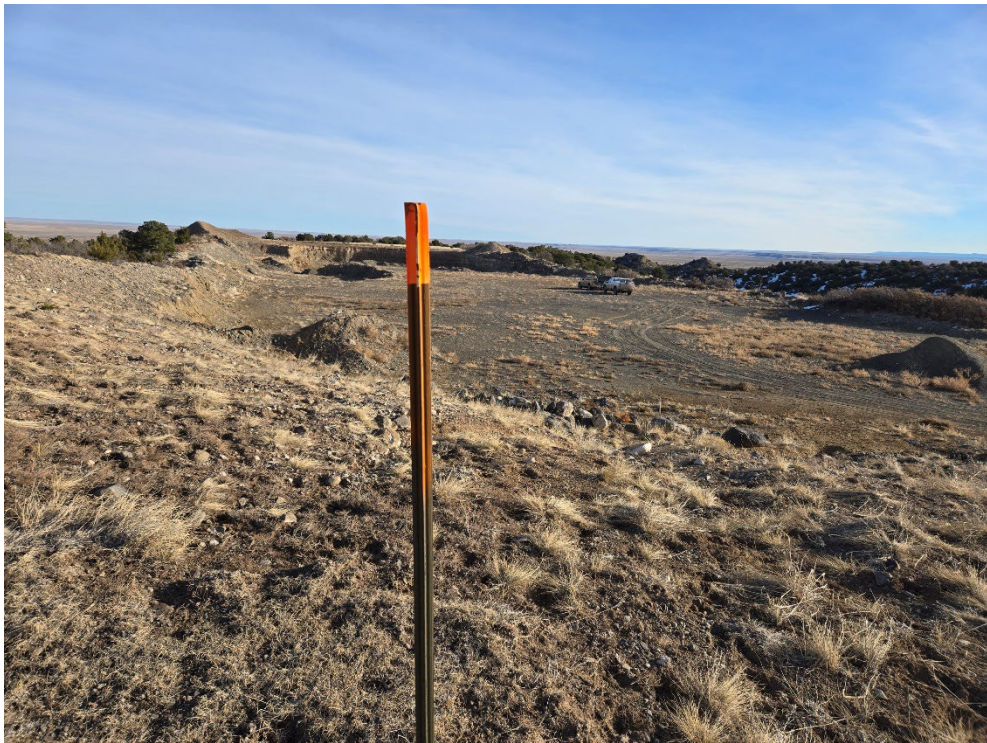
Photo 2: Looking southeast at the processing area and the current pit beyond.

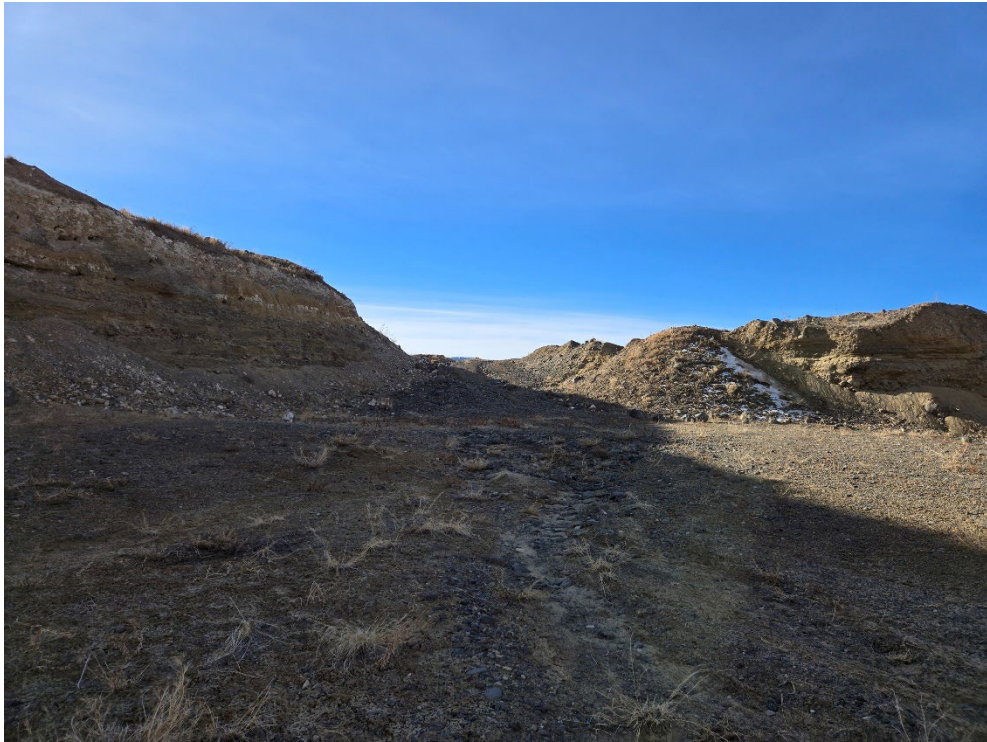
Photo 3: Standing in the current pit, looking at the internal road leading from the processing area to the pit.

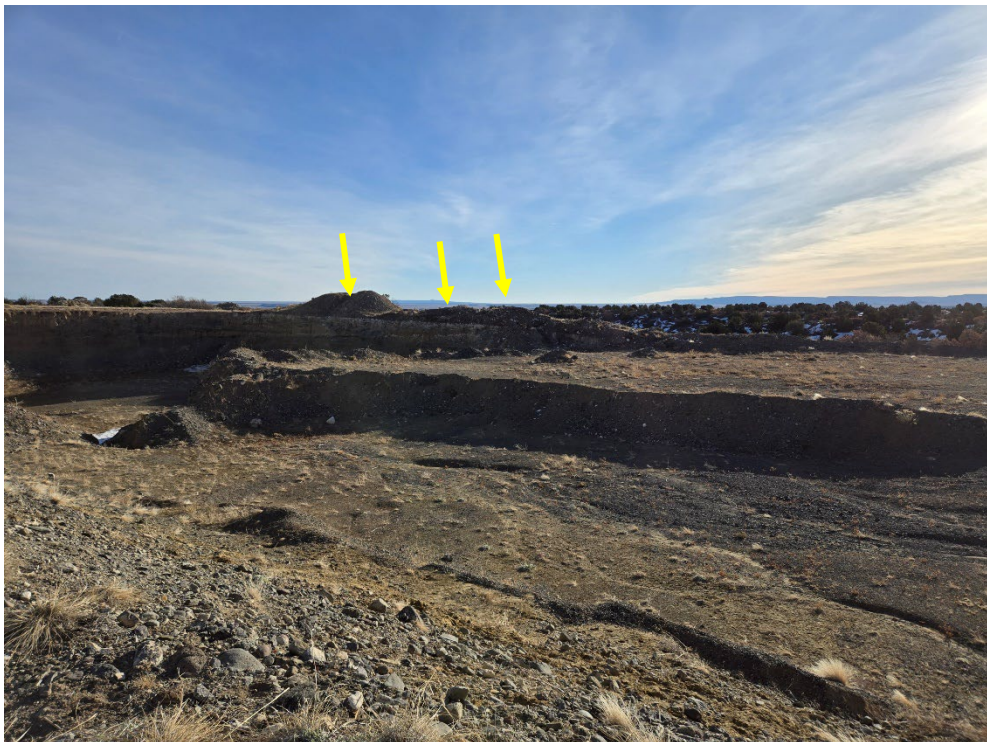
Photo 4: Looking southeast across the pit from the northwest boundary. The arrows point to some overburden/product material.

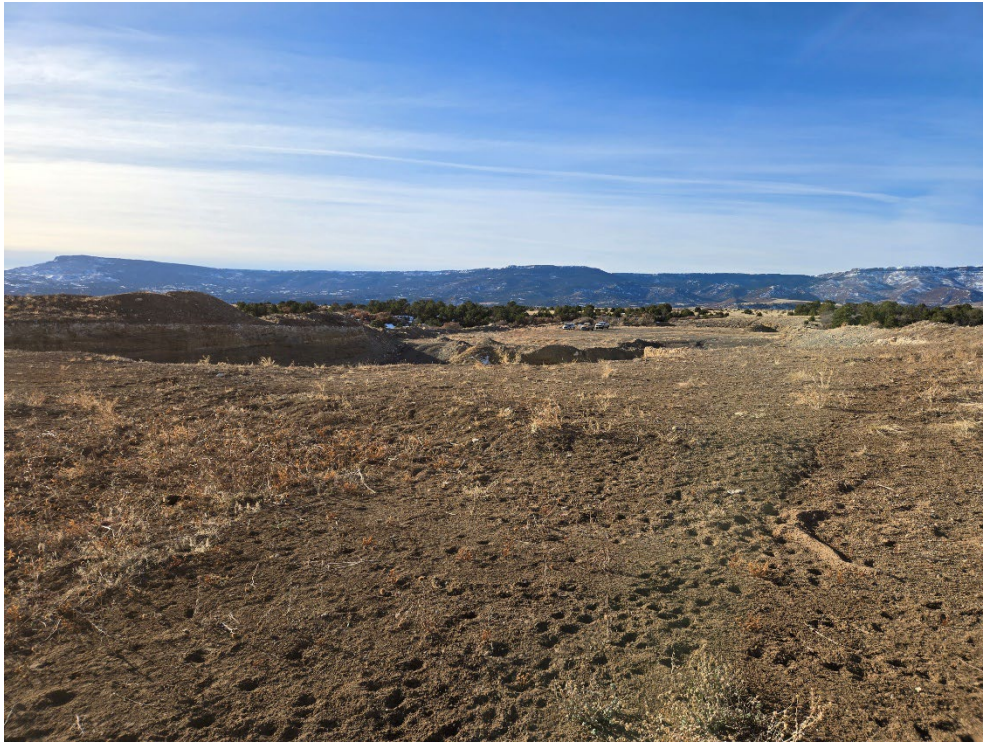
Photo 5: Looking southeast from the northern disturbance boundary across the pit.

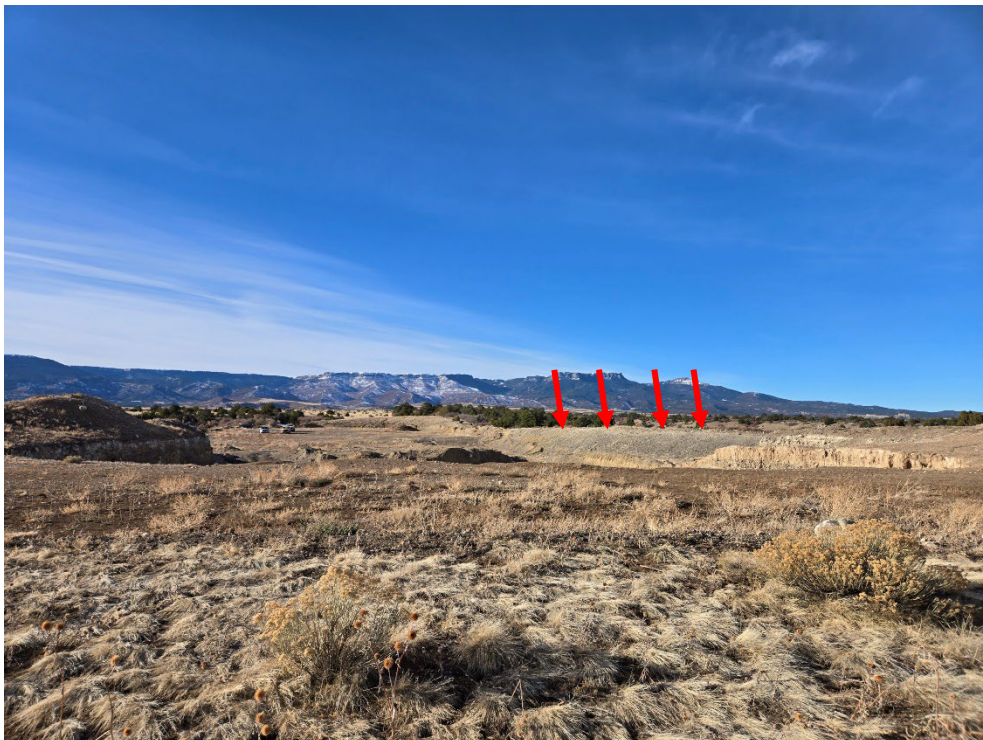
The mining plan states that there will be no slopes greater than a 3H:1V along the sides of the pit. According to previous inspection reports, the highwall was in the center of the pit, on the north/northeast side. The side slopes were graded out to a 3H:1V as mining advanced forward. Some of these graded side walls in the previously mined areas can be seen in Photo 6. According to the Permittee's annual report maps, the newest mining area was opened sometime between 2016 and 2017 (see the enclosed Annual Report Maps). In this new section, there are highwalls along the northwest and southeast sides, in addition to the working face advancing to the northeast. **This has been cited as a problem above.** The Operator shall either backfill and grade the side slopes to a 3H:1V slope, or submit a technical revision to the mining plan to allow for slopes greater than 3H:1V on the sides of the pit by the corrective action date. At the time of the inspection, it seemed as though the technical revision route would likely be the preferable option.

Photo 6: Looking northwest from the northern disturbance boundary across the pit. The arrows point to where the side slopes had been previously been graded to a 3H:1V as mining advanced to the northeast.

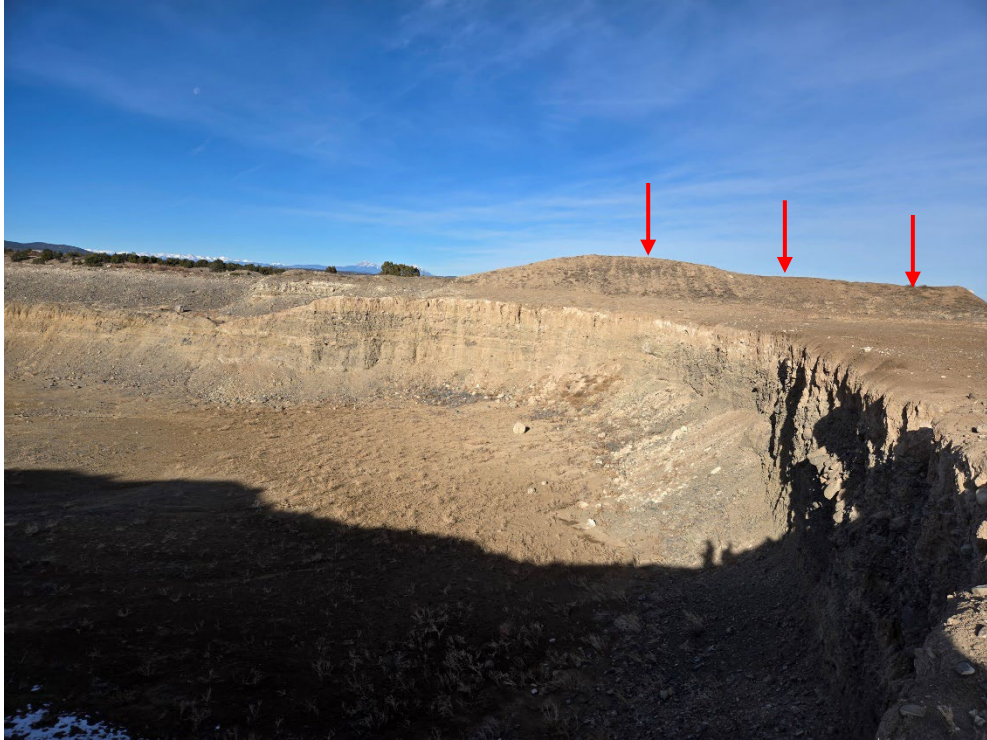
Photo 7: Looking north across the newest opened area of the pit at the northwest and north highwalls. The arrows point to the topsoil stockpile.

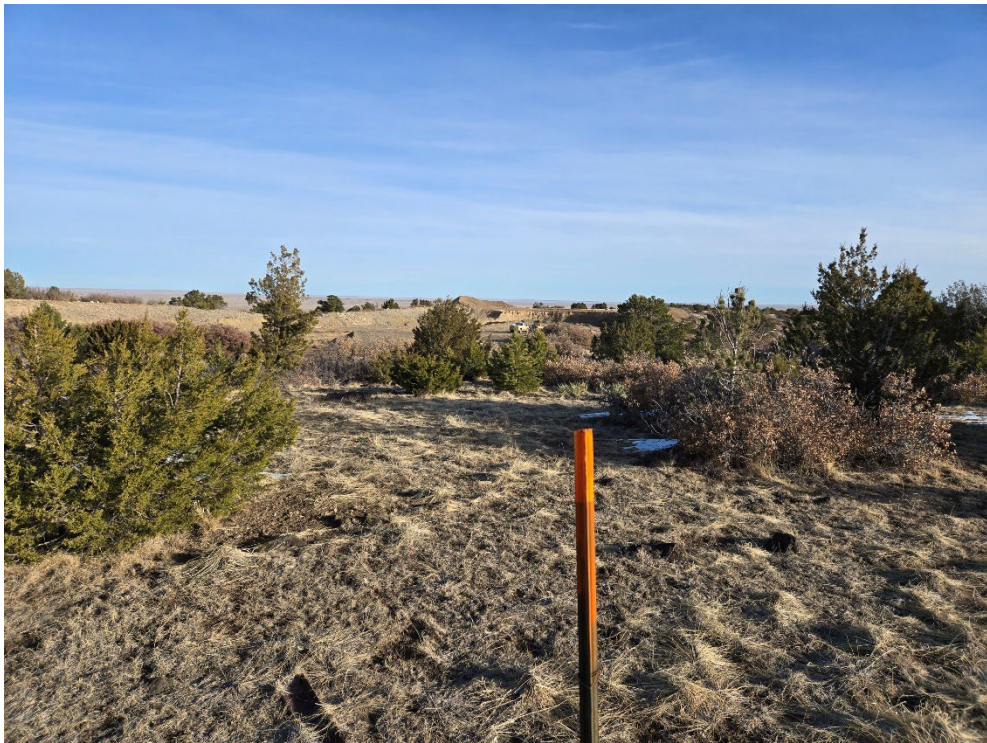
Photo 8: Looking towards the pit from the southeast corner marker. The land south of the access road is undisturbed.

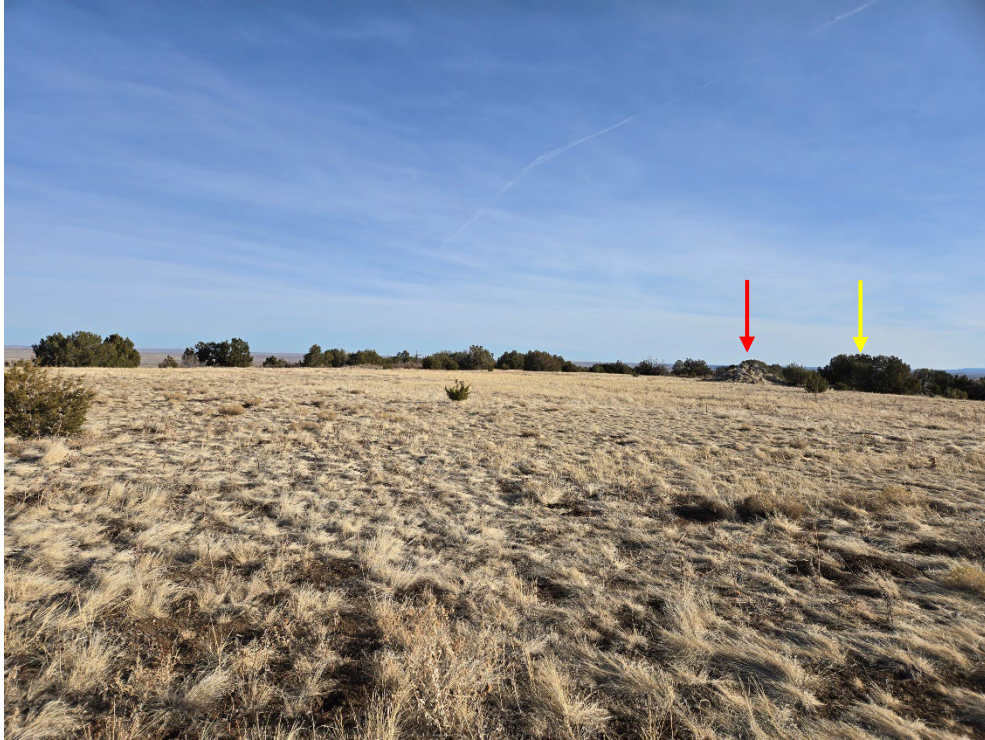
Photo 9: Looking north from the northern most disturbance at the site. This area is undisturbed except for a pre-mining waste pile. The red arrow points to the pre-mining waste pile and the yellow arrow points to the location of the northeast corner marker (see Map 1).

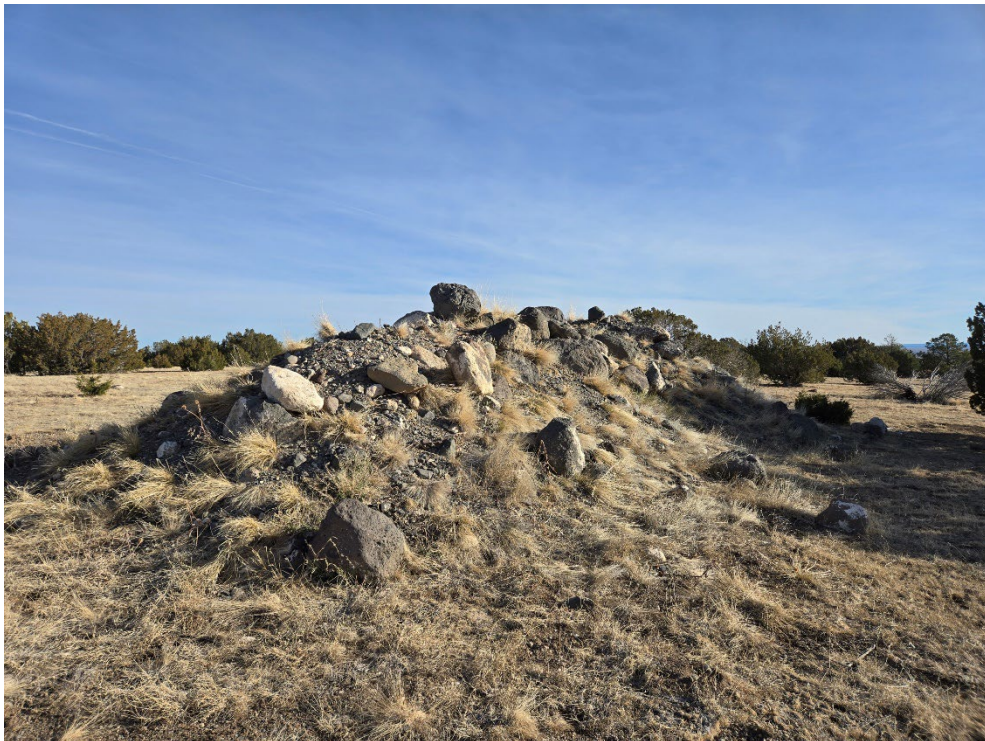
Photo 10: Pre-mining waste pile circled on Map 1. The area around it is undisturbed.

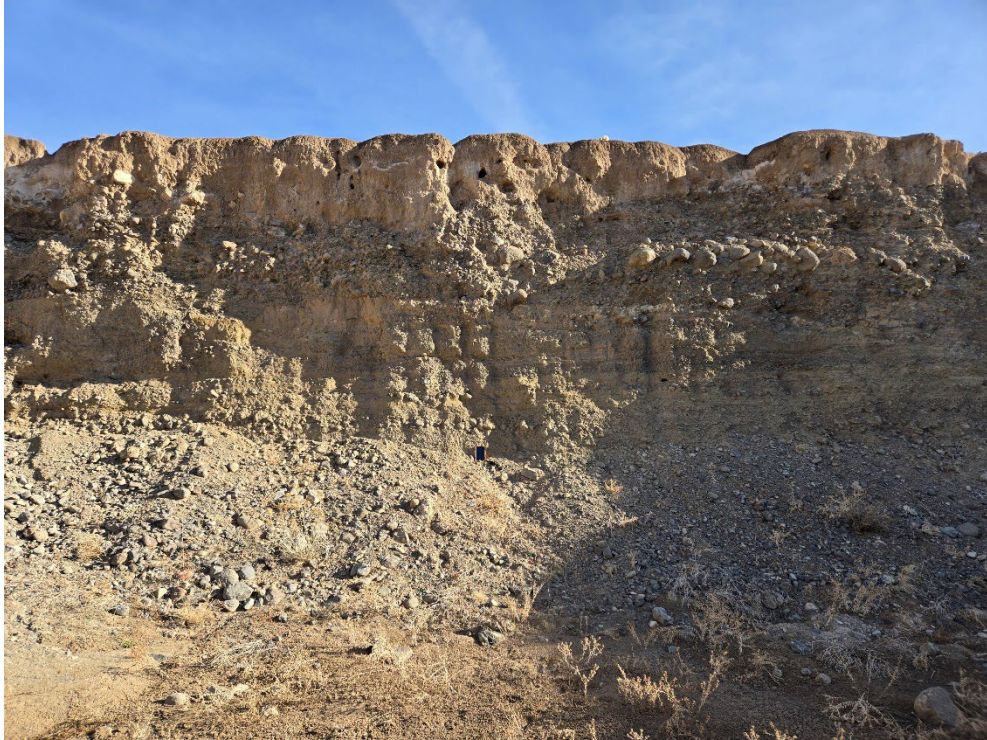
The mining plan states that the depth to deposit at the site is approximately 5 – 25 feet deep with little to no overburden throughout the site. The tallest highwalls onsite are located on the north-east working face and are approximately 25 feet deep (Photo 11). The Operator was asked during the inspection whether they have encountered any overburden and they stated that they have stockpiled some that may still be of crushing quality. If it is determined that that the stockpiled material is truly overburden, the Operator stated that they will use it as backfill material. No equipment was observed onsite at the time of the inspection.

Photo 11: Looking at the north highwall in the pit area. The highwall is estimated to be about 25 feet tall. The 10-inch-tall Samsung tablet in the center of the picture was used for scale.

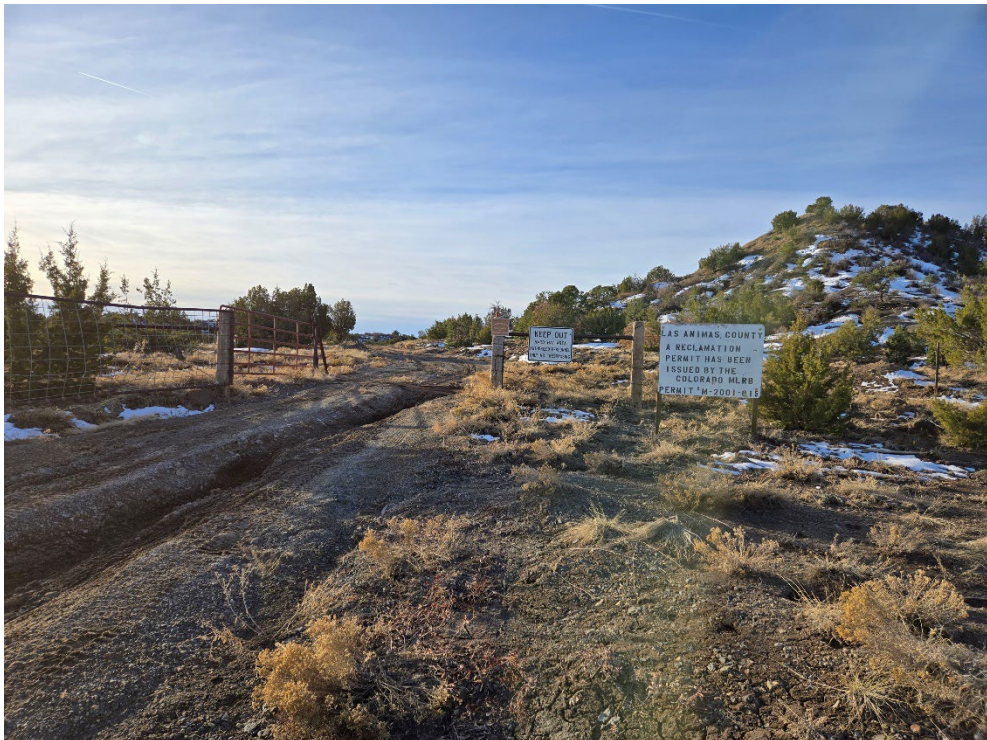
The pre-existing ranch road that is used as the access road is difficult to traverse without a four-wheel drive vehicle (Photo 12). The Operator stated that when the pit is active again, they will likely grade out the entrance so that the site is easier to access.

Photo 12: Looking southwest at the access road and the permit sign.

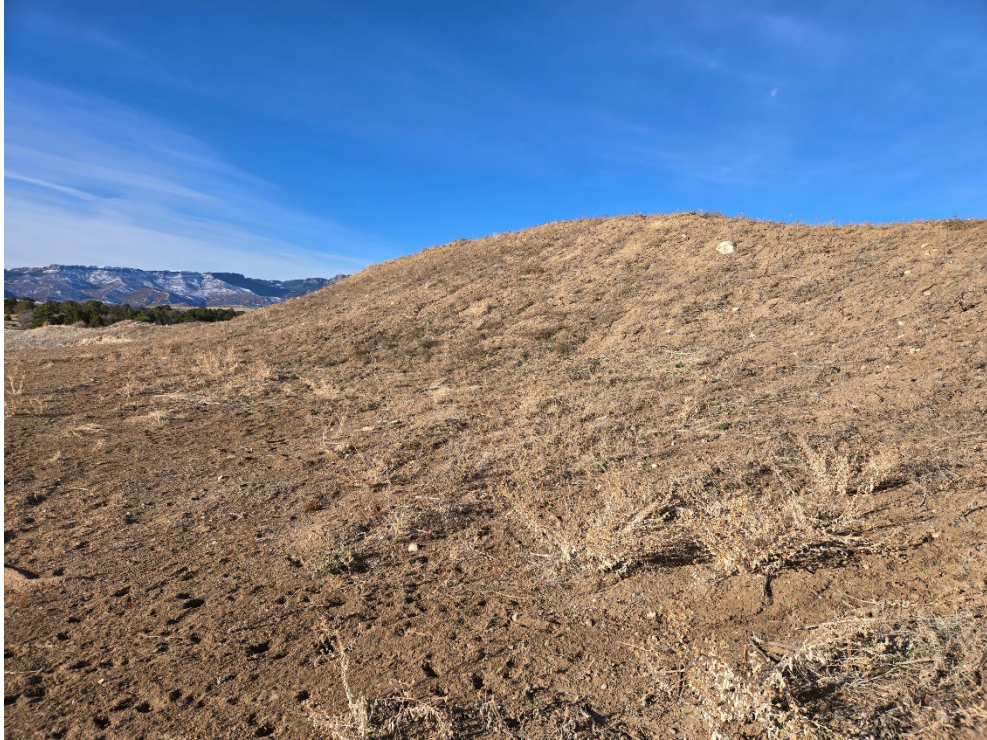
Topsoil has been salvaged and is being stored in stockpiles above and behind the northside of the pit (Map 1). The topsoil pile appears to be in a stable configuration and has some vegetative cover (Photos 13 – 14). As noted in the *General Compliance with the Mine Plan* section above, the topsoil pile appears to be stable at this time, but is extremely close to/possibly outside of the northeast boundary (Map 1). The Operator shall ensure that no more disturbance occurs along the northwestern boundary of the permit area. On the mining plan map, it indicates that topsoil will be stored at the northeast corner of the site. During the Division's pre-op inspection, it was noted that there is pre-mining disturbance located on the site. The area indicated on the mining plan map to be the topsoil stockpile location instead more closely resembles the location of the pre-mining waste rock stockpile. Additionally, the annual report map submitted in 2024 indicates that topsoil is currently being stockpiled along the entire northwest boundary. However, during the inspection it appeared that the only current topsoil stockpile is located to the northwest of the northwestern corner of the pit area. The Operator shall ensure this is updated on the 2025 annual report submittal.

Photo 13: Looking at the south-facing side of the topsoil pile.

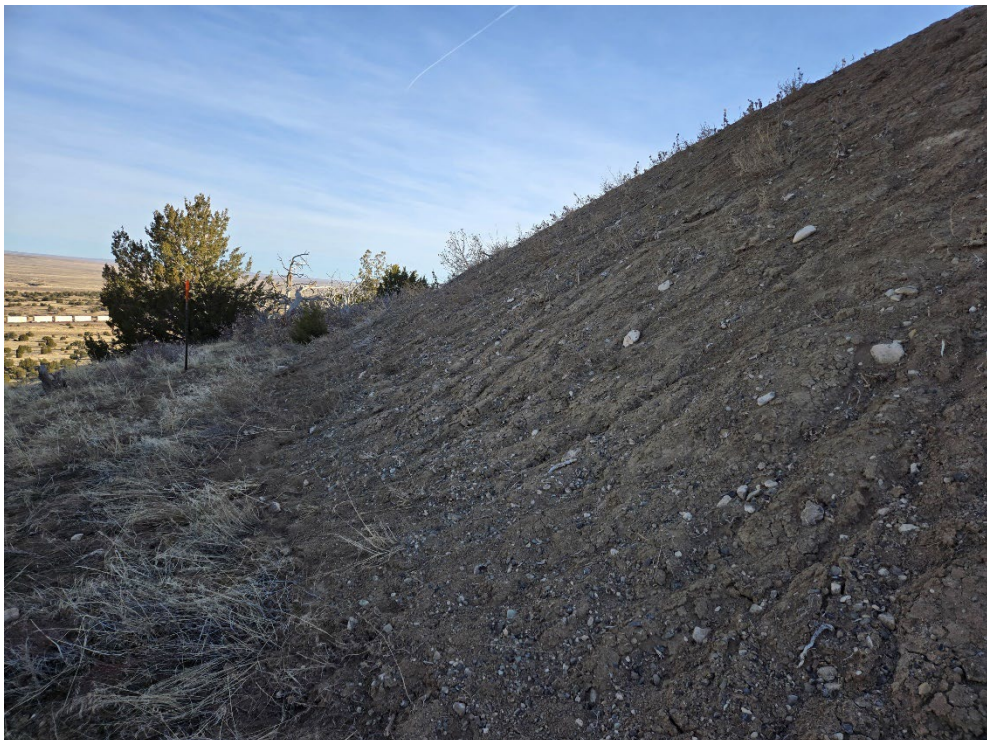
Photo 14: Looking at the north-facing side of the topsoil pile. The t-post in the photo is one of the permit boundary markers.

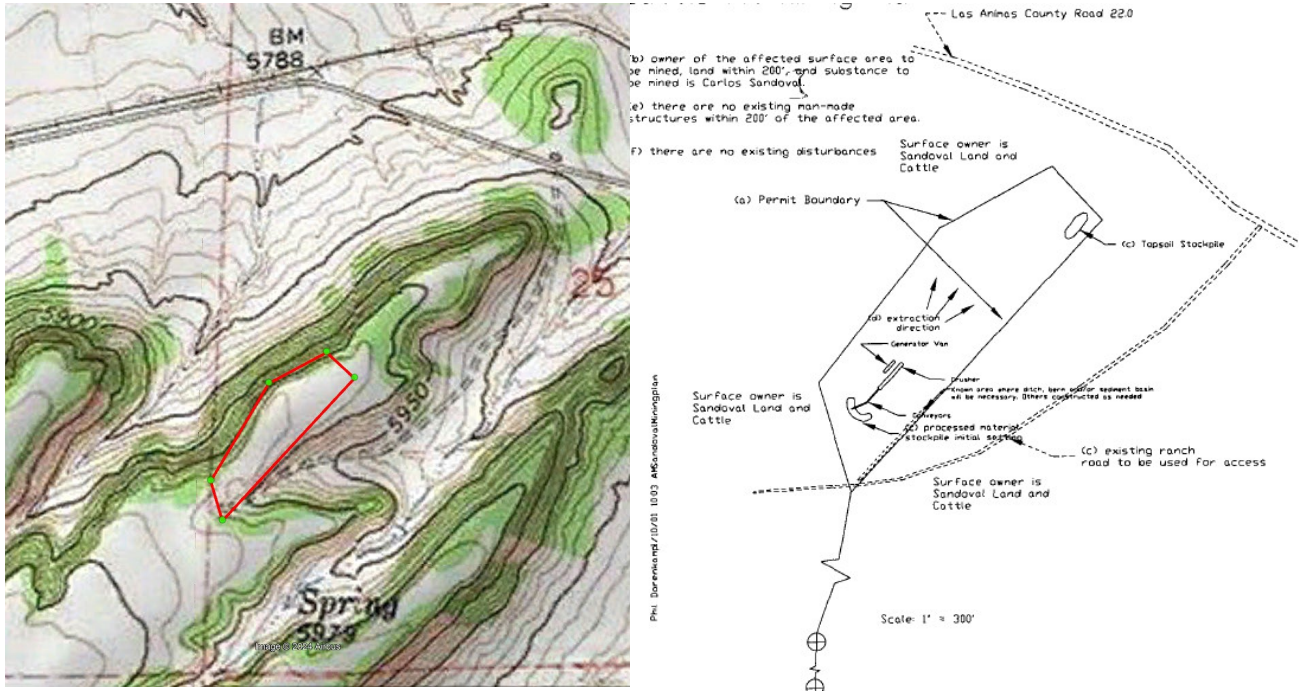
PROBLEM: The affected area boundary markers may be incorrectly placed as the area represented is less than what is approved. This is a problem for failure to maintain boundary markers around the affected area as required by Section 3.1.12(2) of the rule.

Upon post inspection review, the original survey description in the permit application appears to closely resemble the field marker locations. However, the approved mining and reclamation maps are hand-drawn, and although a scale is included, are not drawn to scale. Additionally, upon extrapolating a permit boundary from the collected field marker locations, it appears that the permit area is approximately 8.65 acres. The approved affected acreage for this site is 9.87 acres. Figures 1 and 2 highlight some discrepancies pertaining to old survey maps, the mining plan map, and the on-the-ground orientations of the boundary and nearby features. Due to the discrepancies with the permit boundary, particularly those pertaining to the possible offsite disturbance, **this has been cited as a problem above.** The Operator shall re-survey the permit boundary, provide an updated survey description, updated mining plan and reclamation plan maps, and coordinates with photo evidence for any replaced markers by the corrective action date.

Figure 1: (Left) Permit boundary markers and extrapolated polygon overlain on the USGS topographic basemap in Google Earth Pro. (Right) Screenshot of the Permittee's mining plan map. When compared to old topographic maps, the location of the access road in relation to the southeastern most boundary marker seems to be relatively accurate. However, the size of the permit boundary in relation to the surrounding features is not to scale, as it seems from the map that the permit boundary would expand along most of the length of the mesa top.

CORRECTIVE ACTIONS: The Operator shall conduct a survey and replace the boundary markers in the correct location(s). The Operator shall provide proof to the Division that this has been done by the corrective action date.
