Inspection Report, December 19, 2024 Cresson Project M-1980-244

MINERALS PROGRAM INSPECTION REPORT
PHONE: (303) 866-3567

MINE NAME: Cresson Project	MINE/PROSPECTING ID#: M-1980-244	MINERAL: Gold and silver	COUNTY: Teller
INSPECTION TYPE: Monitoring	WEATHER: Clear	INSP. DATE: December 19, 2024	INSP. TIME: 09:00
OPERATOR: Cripple Creek & Victor Gold Mining Company	OPERATOR REPRESENTATIVE: Brian Doering, Paulina Barela	TYPE OF OPERATION: 112d-3 - Designated Mining Operation	
REASON FOR INSPECTION: Normal I&E Program	BOND CALCULATION TYPE:	BOND AMOUNT: \$292,100,000.00	
DATE OF COMPLAINT: NA	POST INSP. CONTACTS: None	JOINT INSP. AGENCY: None	
INSPECTOR(S): Hunter Ridley Patrick Lennberg	INSPECTOR'S SIGNATURE:

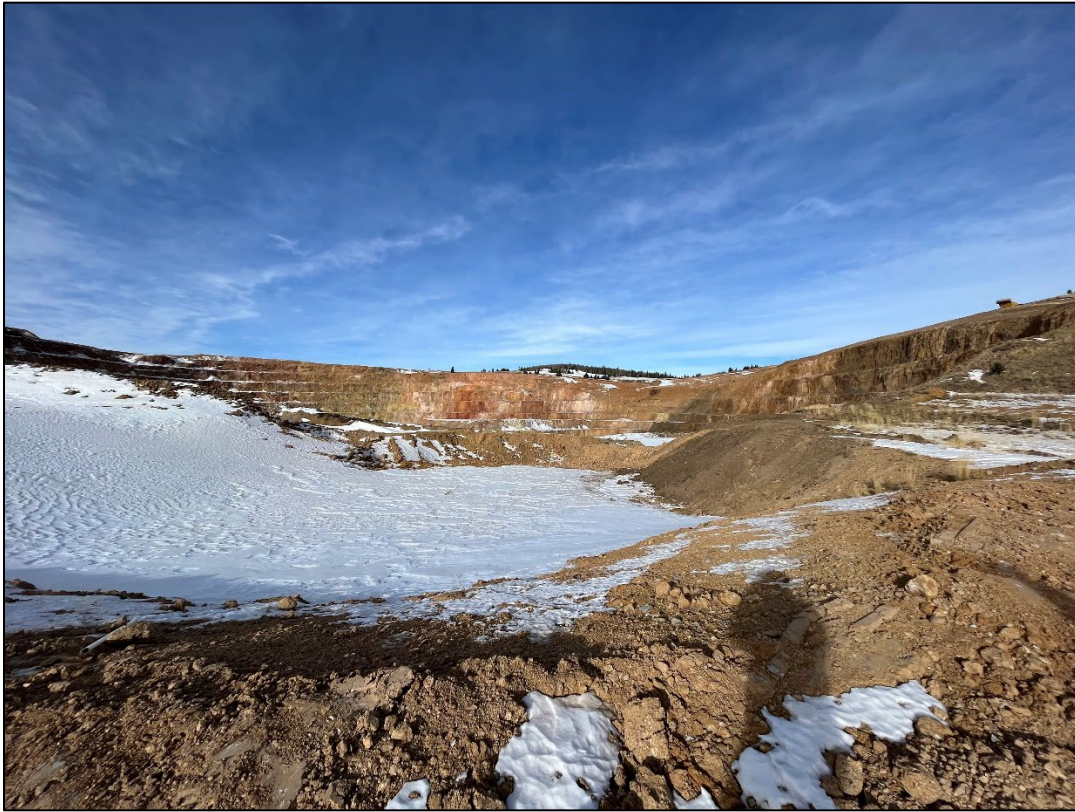
Photo 1: View west into the WHEX pit from the Ironclad Access Road.

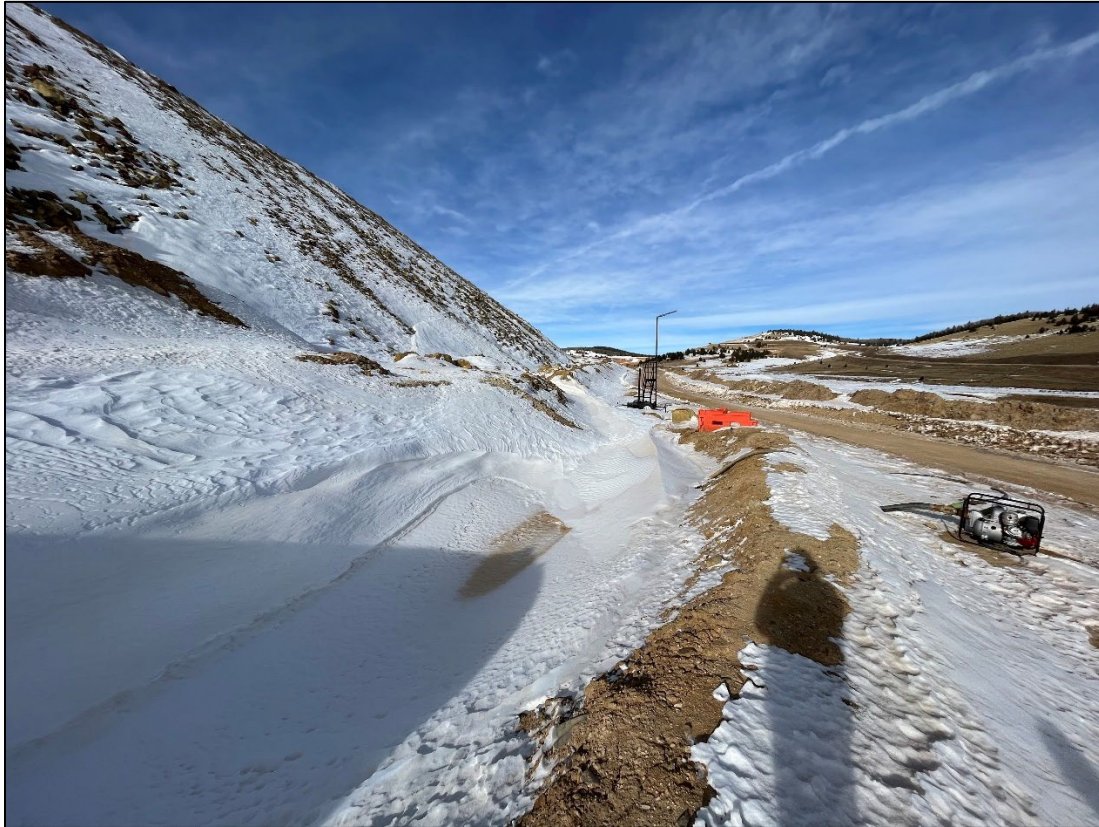
This inspection observed the seeps along the toe of the ECOSA and reviewed the planned locations for EPFs approved under TR-144. TR-144 was approved by the Division on September 25, 2024 and outlines plans for lining the seepage collection trenches and sumps located along the toe of the ECOSA with an HDPE liner designed to contain seep flows. Installation of the EPFs will also potentially help improve water quality in the sediment pond to the east of the toe of the ECOSA. At the time of the inspection, the collection ditches and sumps appear to be functioning. Collection areas are monitored frequently to determine if pumping is necessary. At the time of inspection, all collection sumps were either frozen over or snow covered. Therefore, no pumps were observed to be running. Sumps not completely snow covered showed evidence of water quality impairment in the form of a dark reddish hue to the water (e.g. Photo 3). All sumps appeared to be in good condition, and no evidence of instability was noted. Wells to the east of the toe of the ECOSA were observed and showed that small paths leading to these wells had been cleared to allow personnel to conduct sampling (Photo 4).

Photo 3: Example view of a sump located along the ECOSA, signs of contamination present.

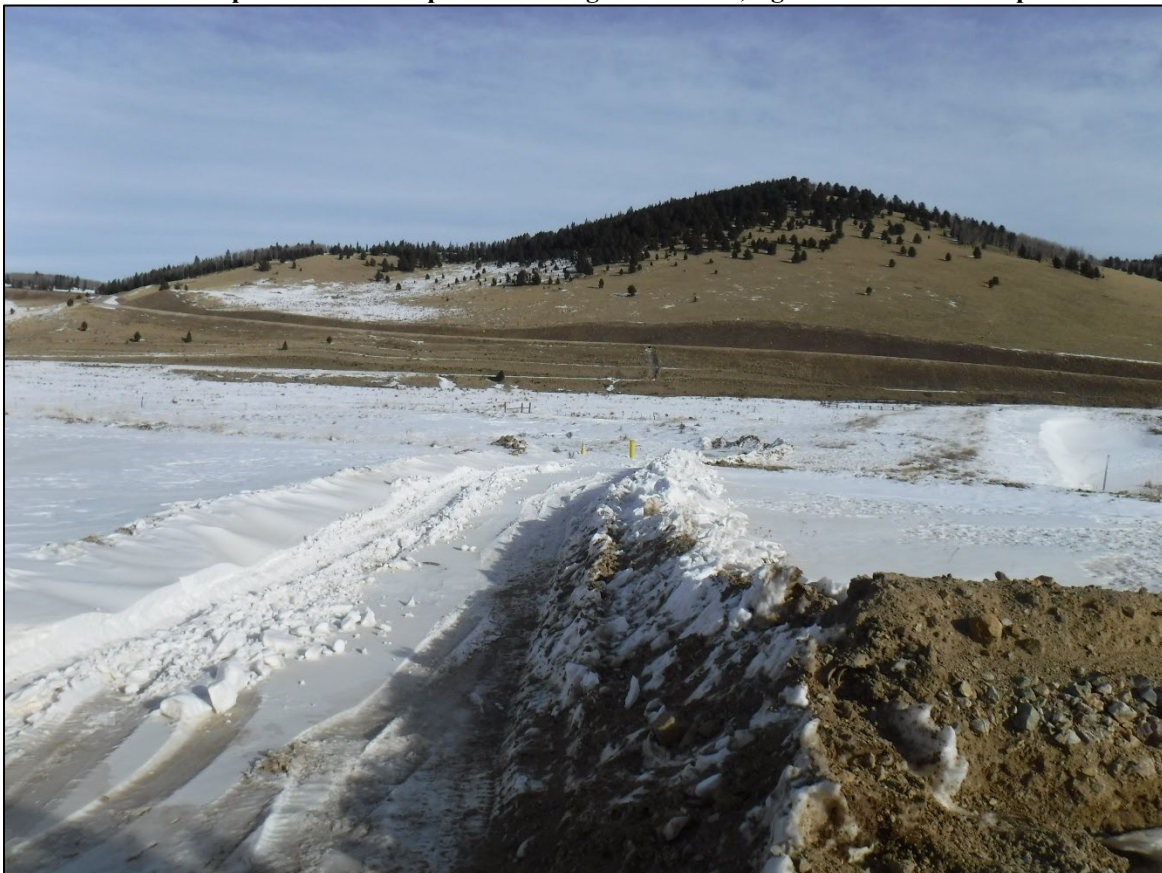
Photo 4: View east of several groundwater monitoring wells and paths cleared for sample collection.

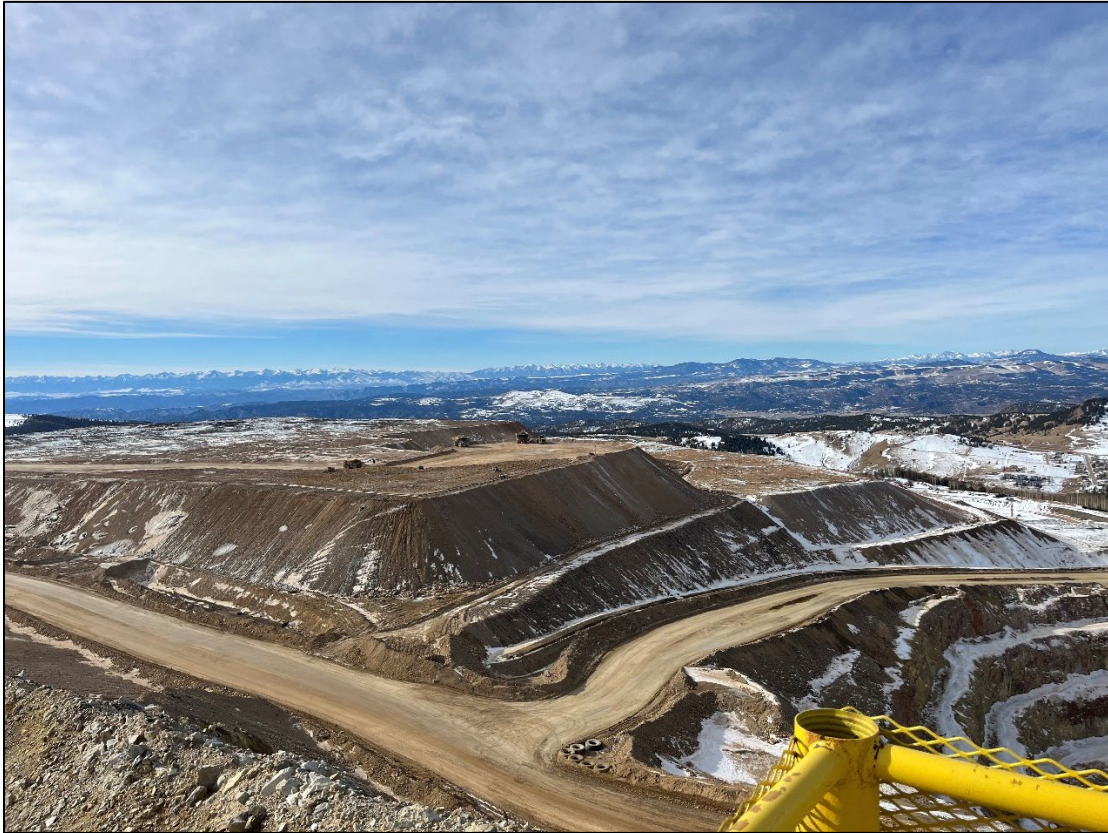
VLF 1 and 2 were inspected visually for any signs of significant ponding. No such problematic ponding was observed across either VLF1 or VLF2. An active area of VLF1 was observed from above (Photo 11). VLF2 Phase 2 and 3 were also observed from the same overview vantage point as Schist Island (Photo 5). Haul trucks were active in both the Schist Island and VLF2 Phase 2 & 3 areas. The crusher area, directly north and adjacent to VLF1 was observed (Photos 12 and 13) and the Division discussed several of the changes proposed in Amendment 13, which pertain to this area.

Photo 5: View southwest of Phase 2 and 3 of VLF 2.

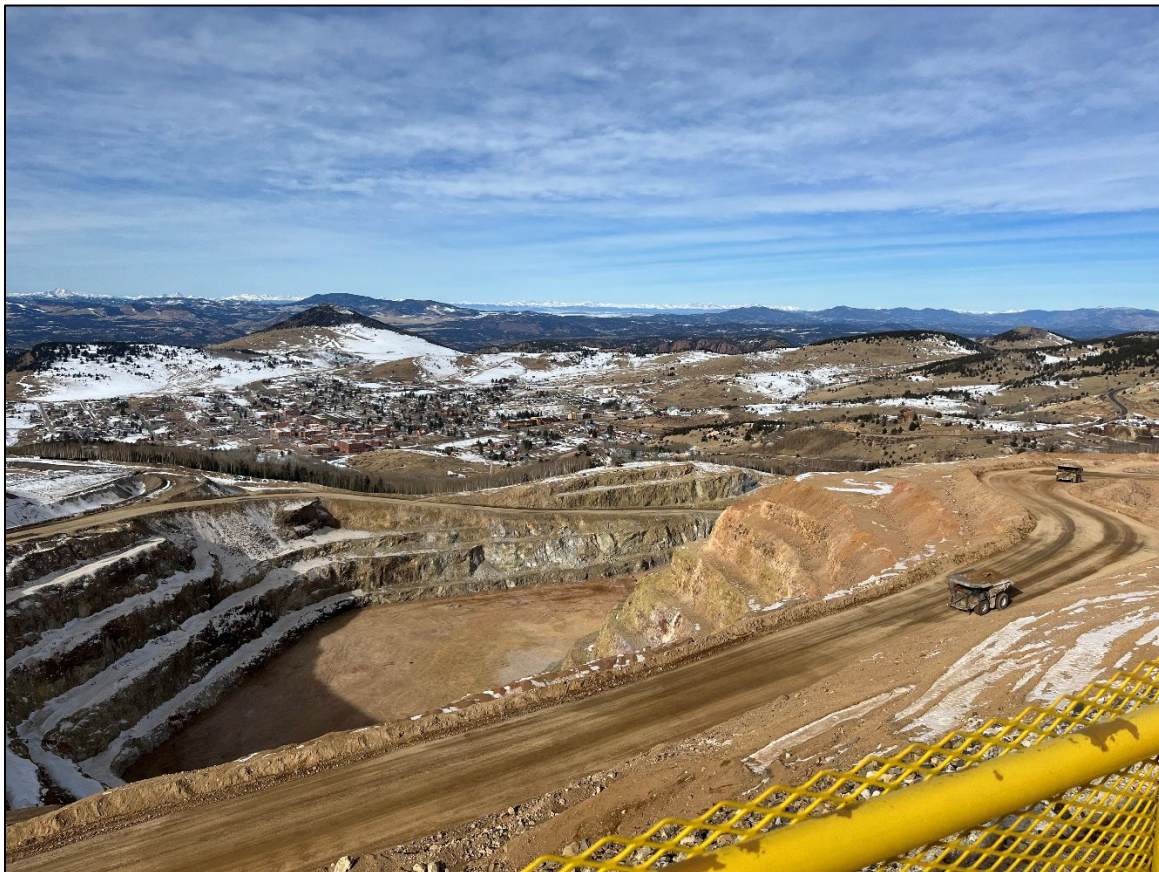
The Schist Island was viewed from above (Photo 6) and from the active backfill area. NewFields representatives stated that work on the structural fill in this area began the week of November 25th. At the time of inspection, New Fields representatives stated that more backfill will be placed towards the northern, high

Photo 6: View west of the Schist Island Pit.

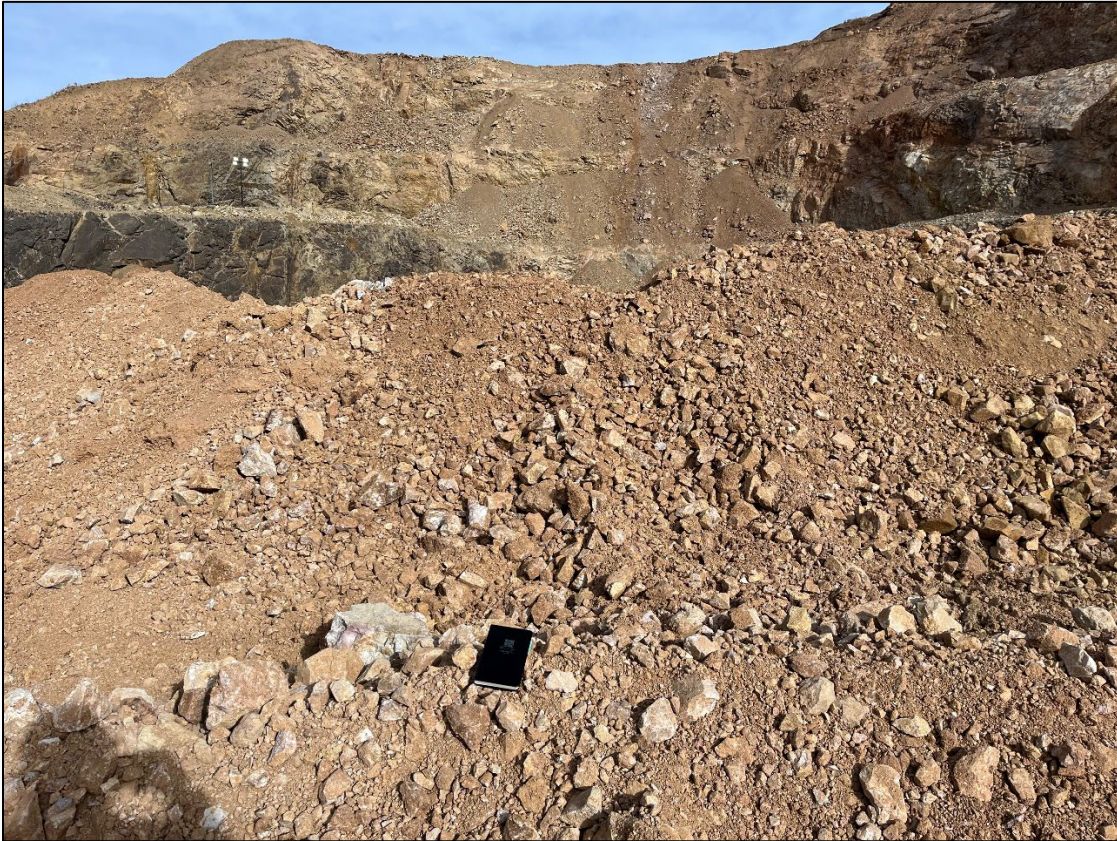
compaction zone as the pit is expanded north towards Globe Hill Pit and that currently trucks were dumping on the 9,765 low compaction level. High compaction zone placement has also begun in the narrow portion of the pit and is working its way north (Photo 8). Material sizes were checked for specifications and found to be within the required limit. No large clumps of rock were observed (Photo 7). The low compaction fill in Schist Island to the south is done in 10 ft lifts and was being added to at the time of inspection from material in the Globe Hill and South Cresson Pits (Photo 9). This level will continue to build as it meets with the high compaction zone, which is being built up faster than the low compaction zone, and will eventually overtop the low compaction. Several adits were observed at the current dumping level. The Division and site representatives discussed and reviewed the remediation protocol for these historical features (Photo 10).

Photo 7: Material size representation, compared to a 4 x 7-inch notepad.

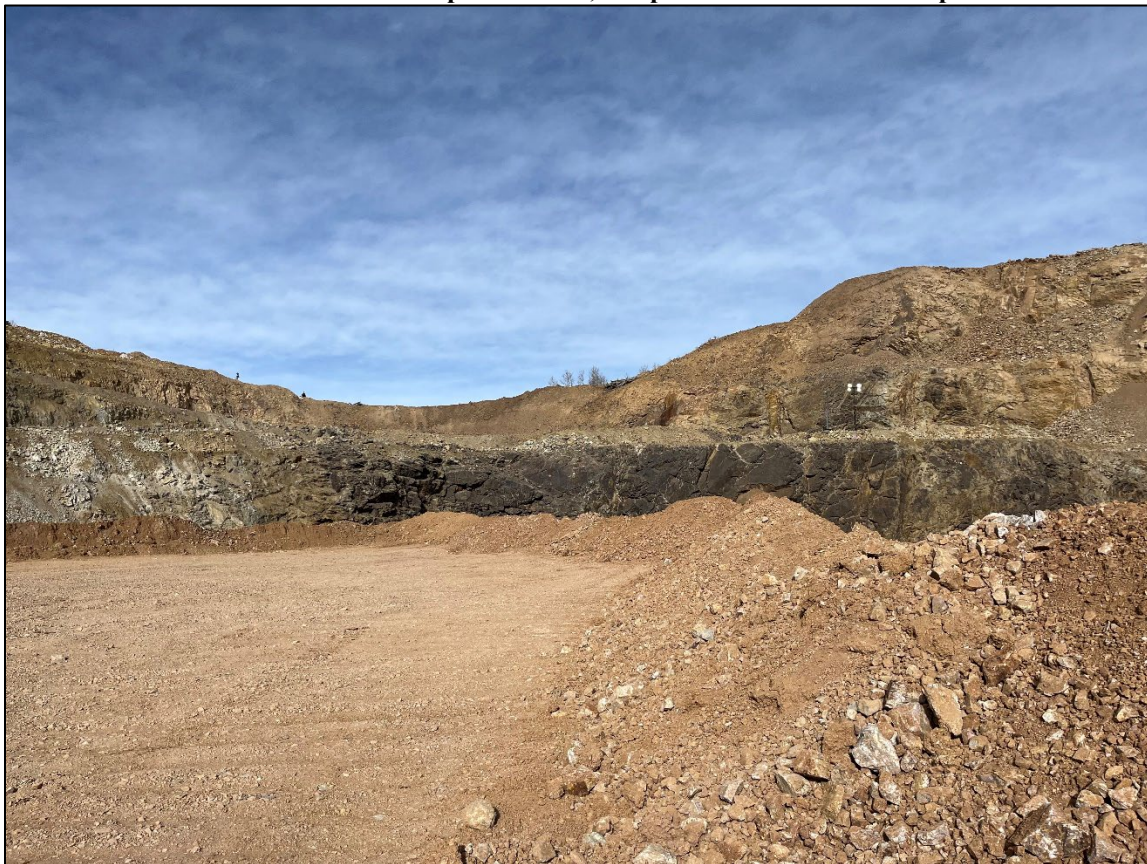
Photo 8: View north of the Schist Island Pit high compaction backfill area.

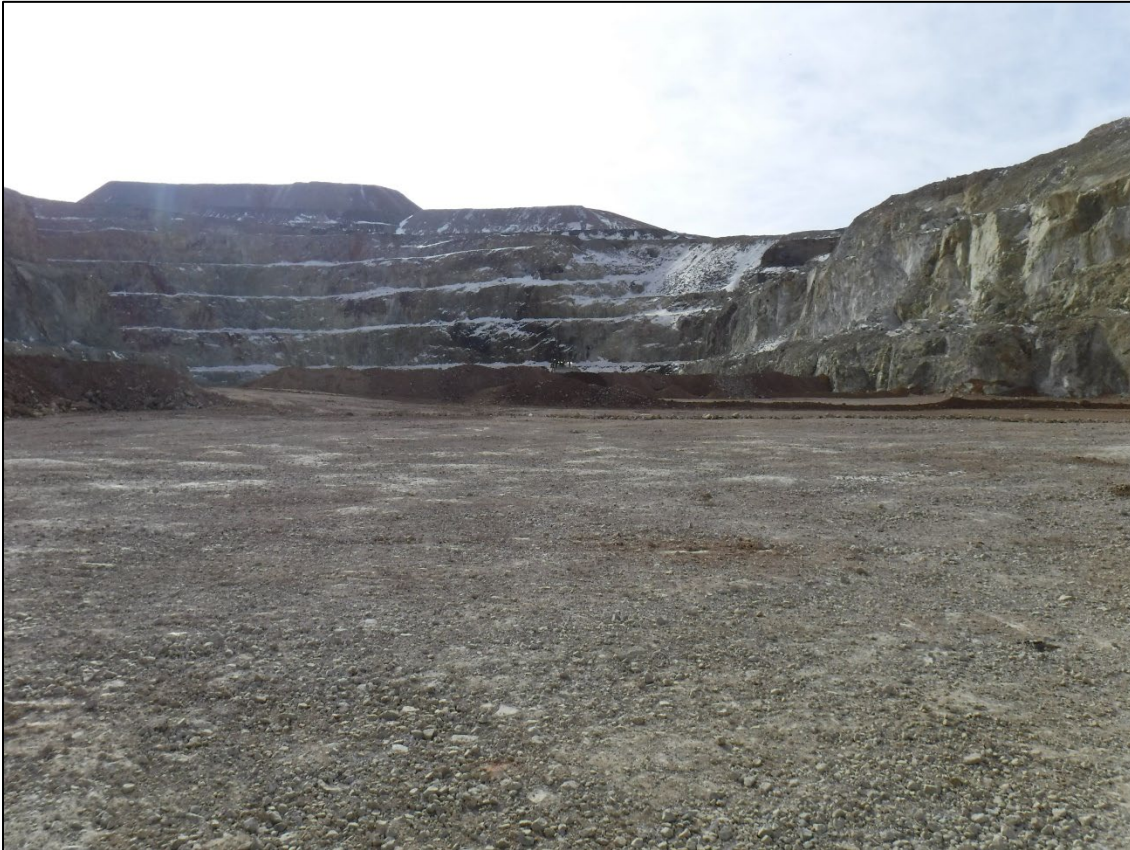
Photo 9: View south of the Schist Island Pit low compaction fill area.

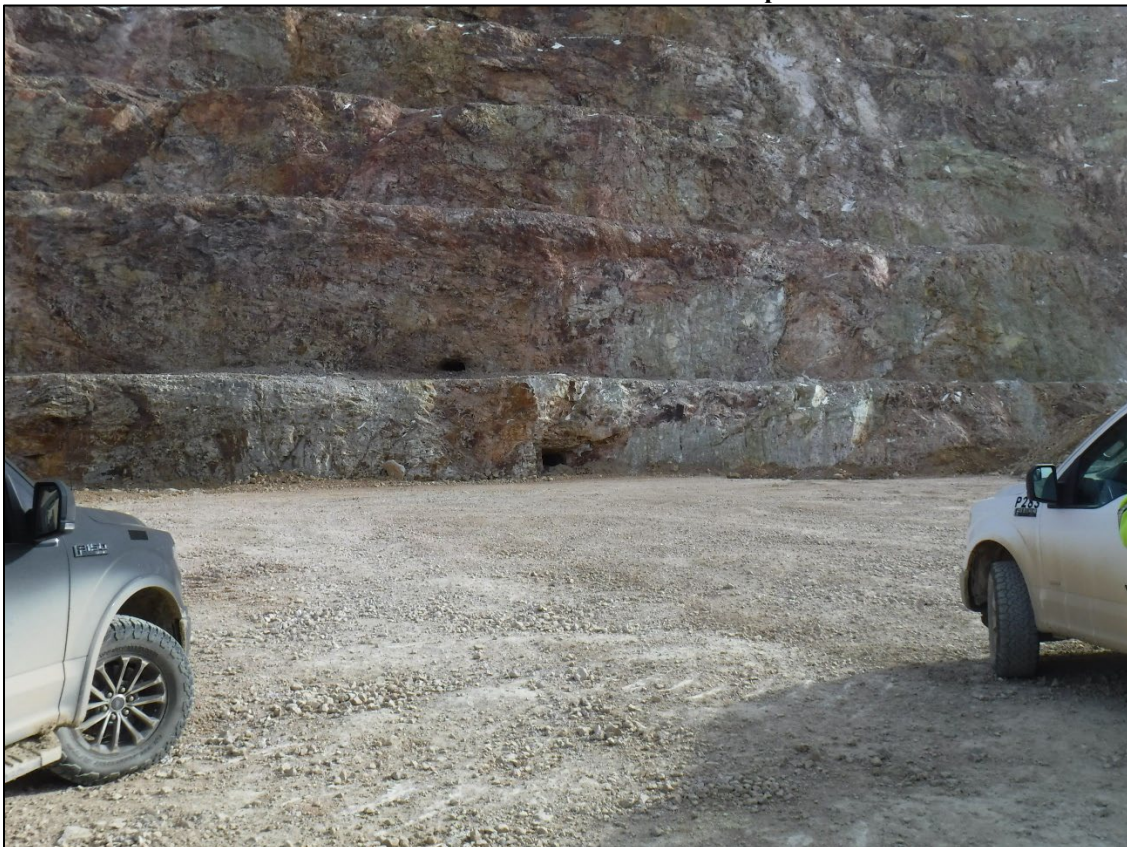
Photo 10: Historical adits seen in Schist Island Pit.

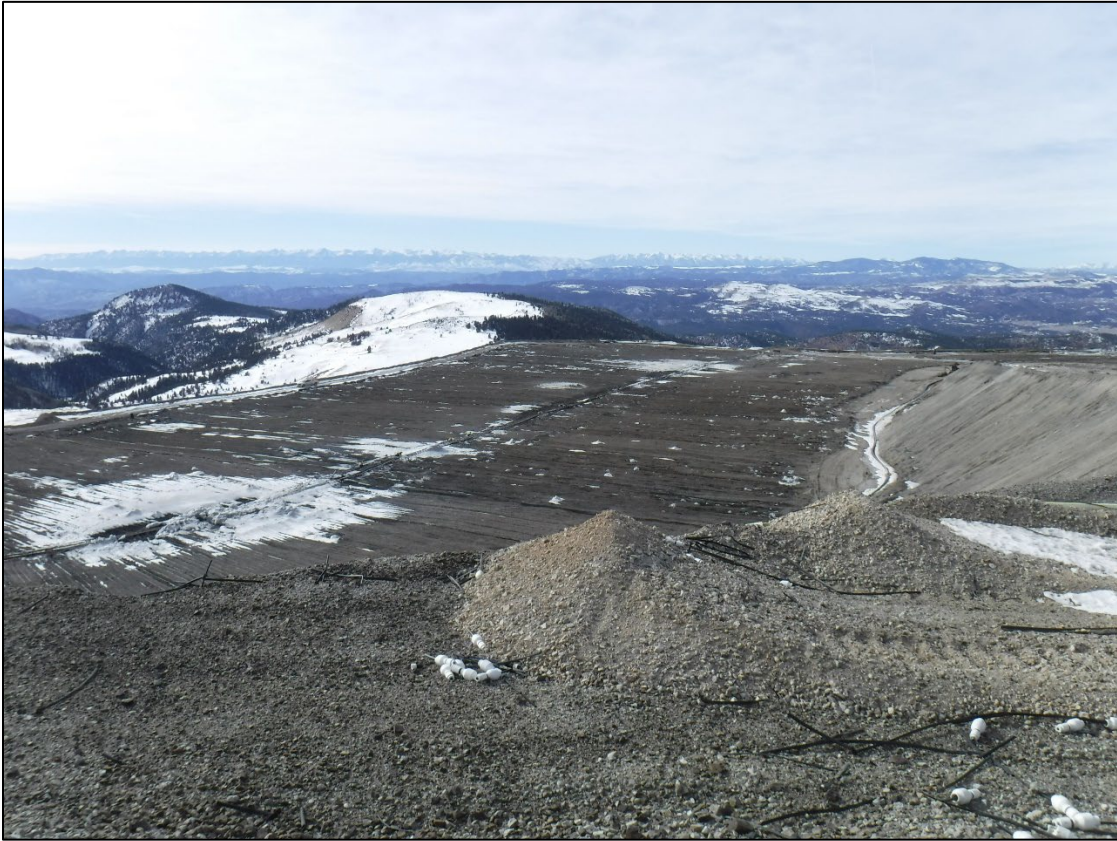
Photo 11: View west of an area within VLF1.

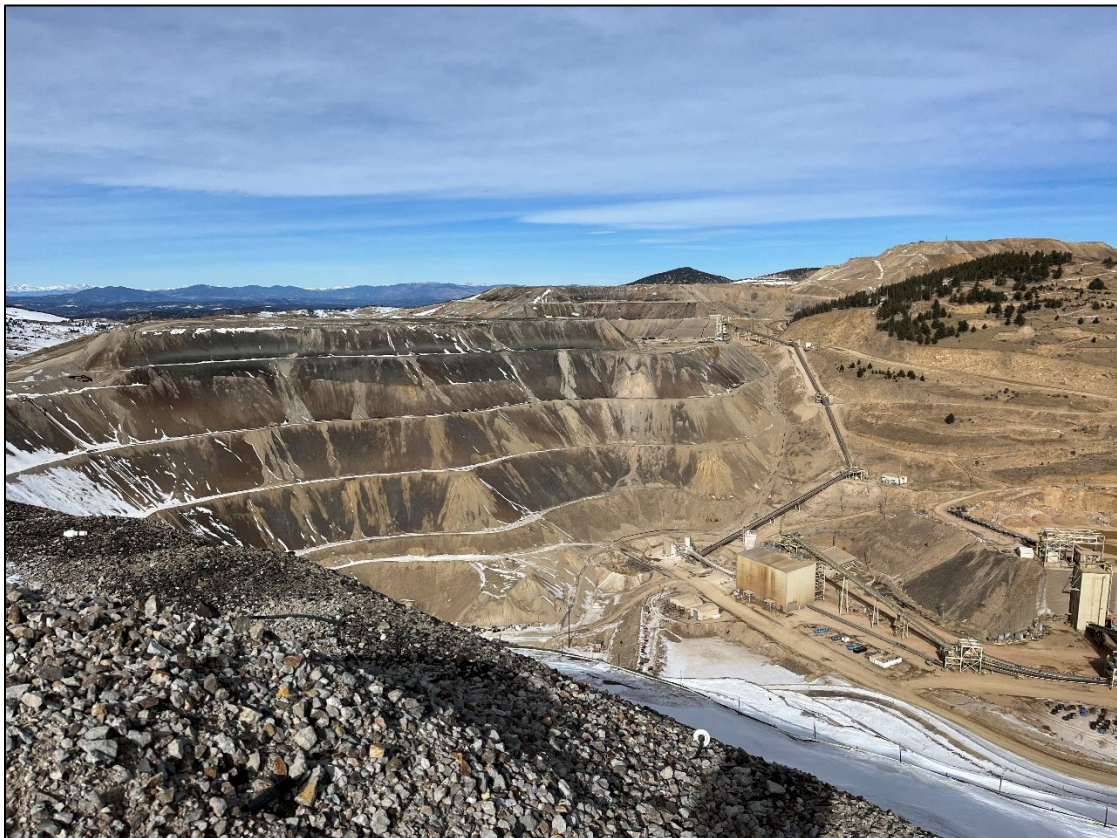
Photo 12: View northwest of the crusher area from atop VLF1.

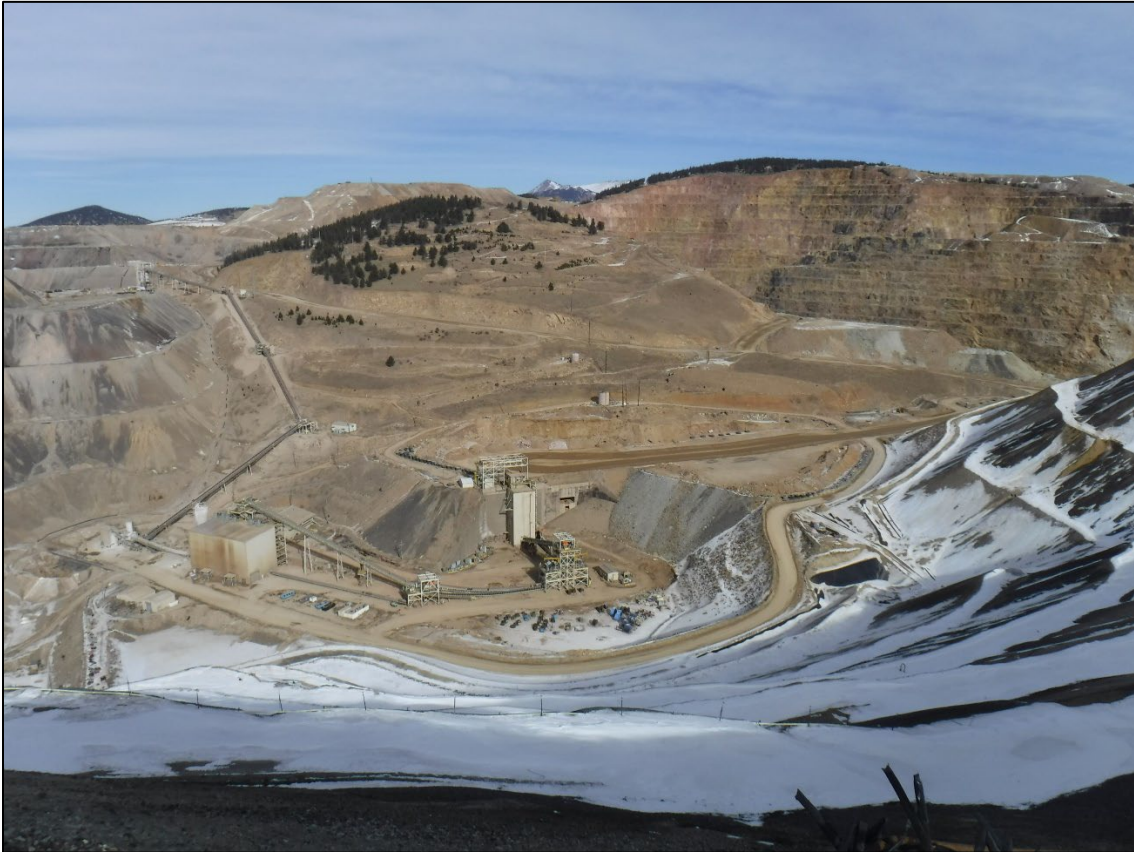
Photo 13: View northeast of the crusher area from atop VLF1.

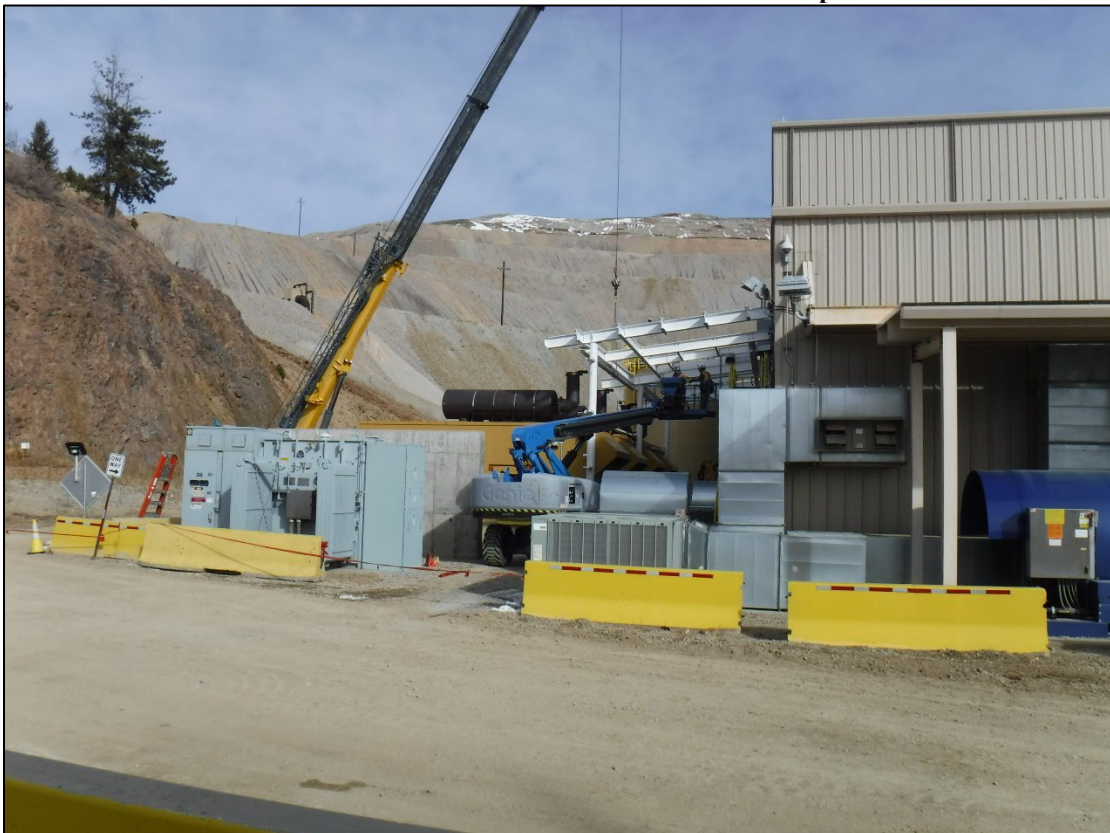
The ADR was inspected, and the remote monitoring system that monitors solution levels in VLF 2 was observed. The Operator provided screen shots of the monitoring system taken at the time of the inspection. All pump levels and flow rates appeared to be within operational norms for the site, and no problems were identified. The screen shots are included with this report. Directly north of ADR2, the Division also observed 'winterization' efforts for the generators adjacent the facility. This effort appears to consist of installing an enclosed roof over the intake portion of the generator to thus avoid any buildup of snow or ice that may cause damage or failure to the generator (Photo 14). A booster station to the north, located on VLF2, was also undergoing these 'winterization' efforts (Photo 15).

Photo 14: 'Winterization' efforts on the generators at ADR2.

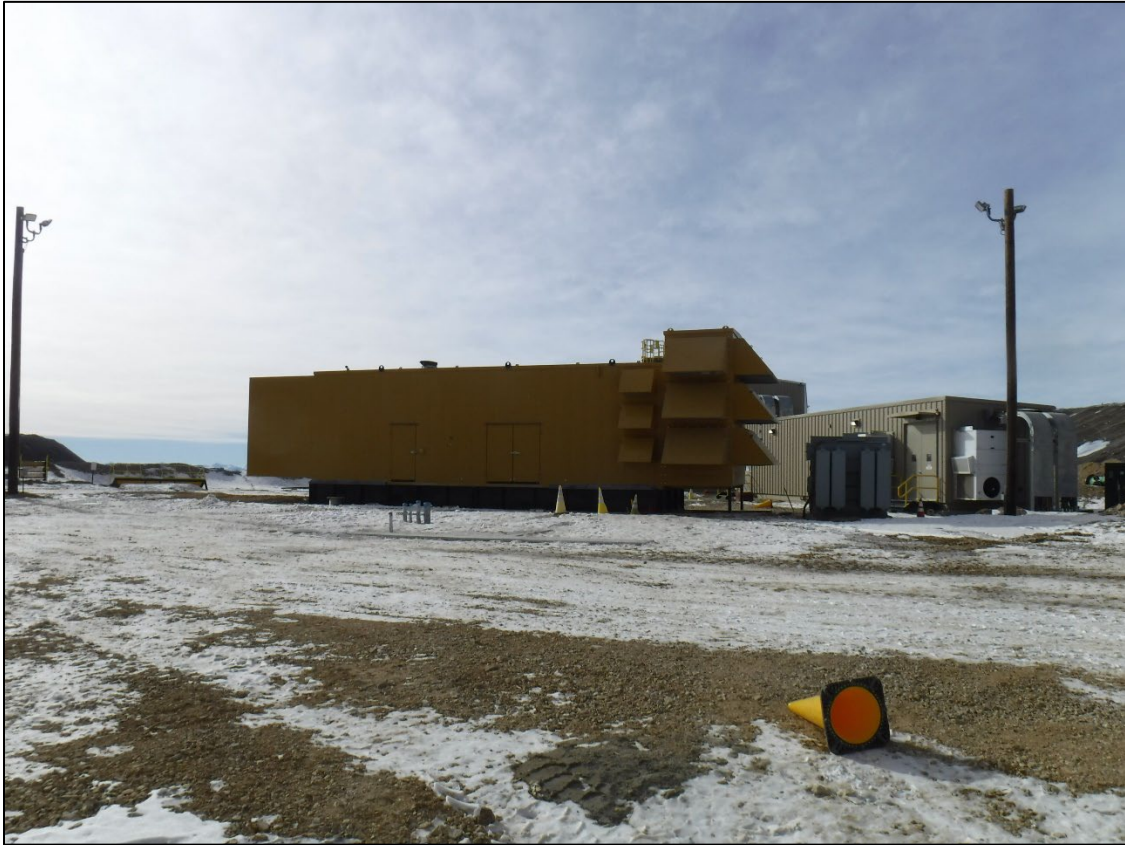
Photo 15: 'Winterization' efforts at the VLF2 booster station.
