C-2010-089 New Horizon North January Partial Inspection Report

PERMIT INFORMATION

Permit Number: C-2010-089 Mine Name: New Horizon North Mine Operator: Elk Ridge Mining and Reclamation, LLC Operator Address: Mr Tony Tennyson P.O. Box 628 27646 West 5th Avenue Nucla, CO 81424	County: Montrose Operation Type: Surface Permit Status: Active Ownership: Private
	Operator Representative Present: Mindy Sickles
Operator Representative Signature: (Field Issuance Only)

INSPECTION INFORMATION

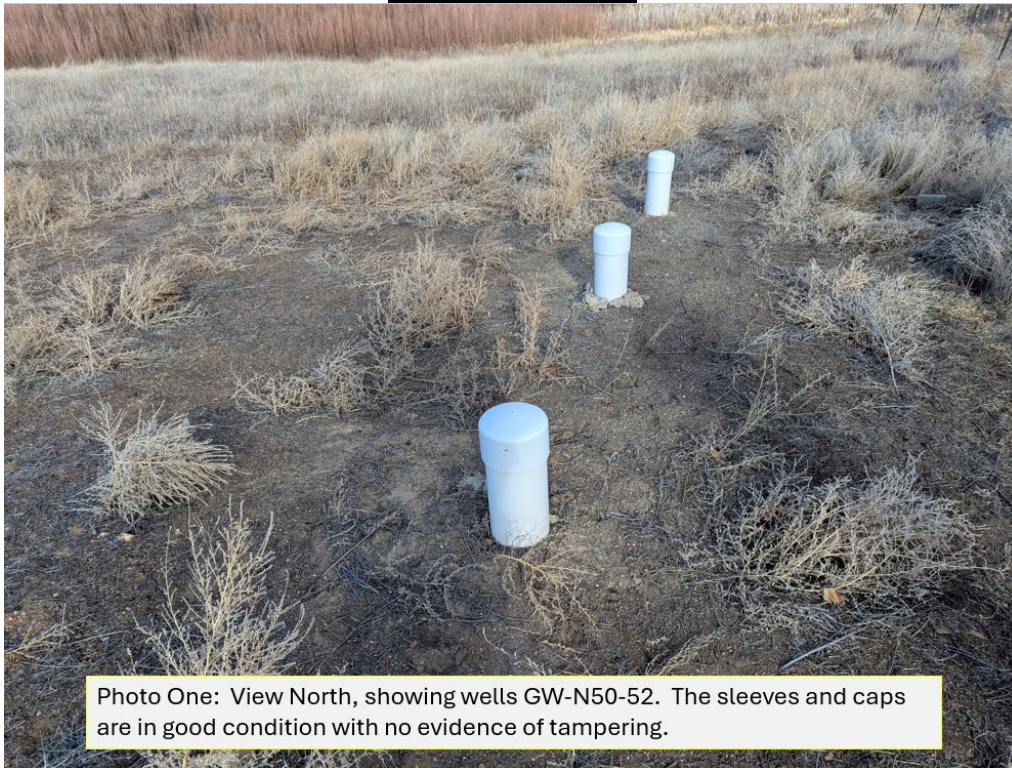
Groundwater monitoring conducted on site is accomplished by way of 3 sets of wells containing 3 wells in each set. The wells are annotated GW-N50 through 58. The first set of three wells observed were wells GW-N50 through 52 located along the Eastern Permit Boundary towards the North end of the site. The wells, seen in Photo One, are behind a locked gate, and protected with a PVC sleeve and associated cap. The caps and sleeves showed no signs of vandalism and appeared to be able to function as designed. The second set of wells, GW-N53-55 are located approximately midway along the Western Permit Boundary of the site. Like the first set, the wells are located behind a locked gate and found to be in good condition as seen in Photo Two. The caps and sleeves showed no signs of vandalism, and each well is marked under the PVC cap with the well name. The third set of wells, GW-N56-58, are located further South along the Western Permit Boundary near the stock pond. The sleeves and caps also showed no signs of vandalism or tampering and can be seen in Photo Three.

Photo One: View North, showing wells GW-N50-52. The sleeves and caps are in good condition with no evidence of tampering.

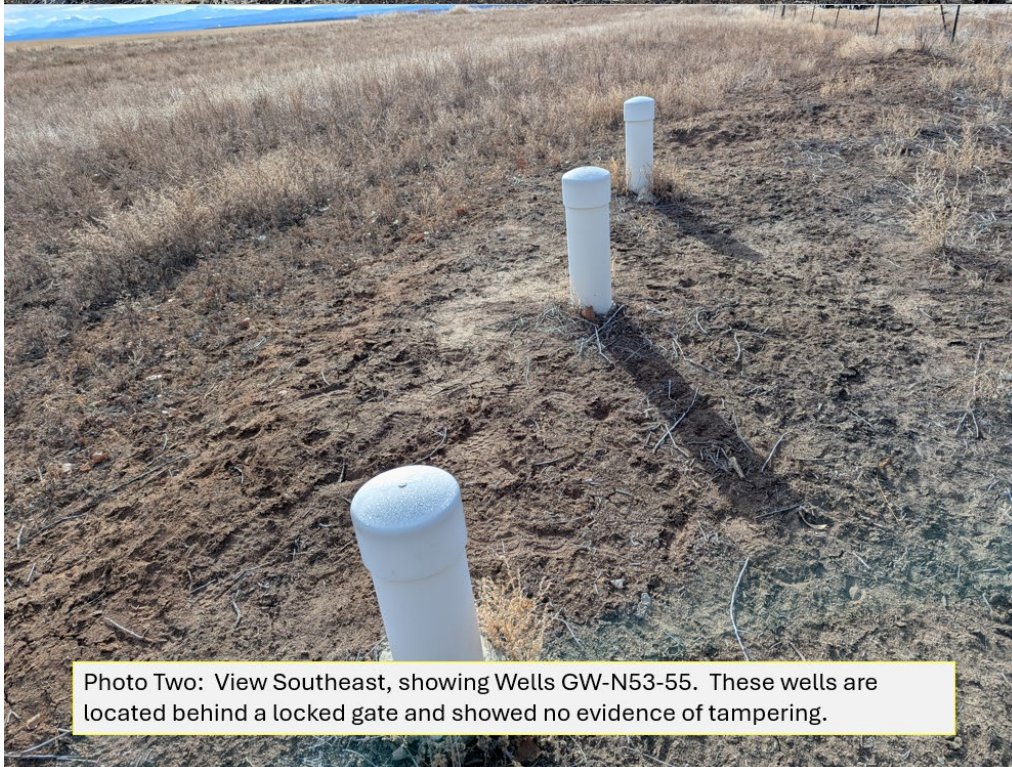
Photo Two: View Southeast, showing Wells GW-N53-55. These wells are located behind a locked gate and showed no evidence of tampering.

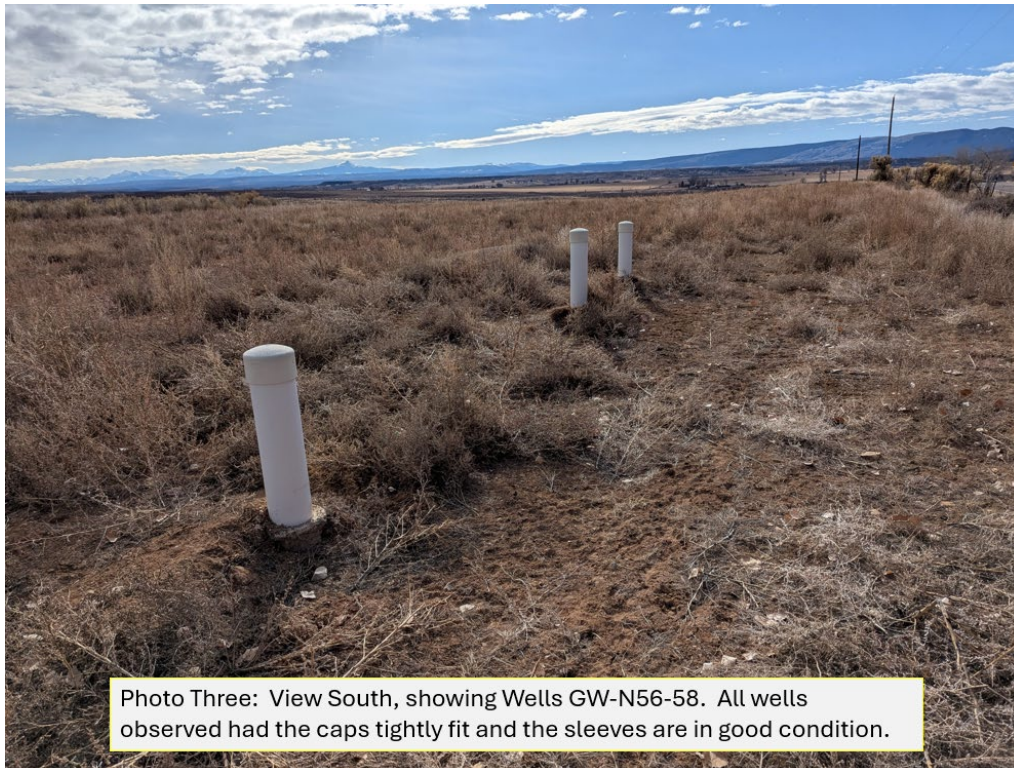
Photo Three: View South, showing Wells GW-N56-58. All wells observed had the caps tightly fit and the sleeves are in good condition.

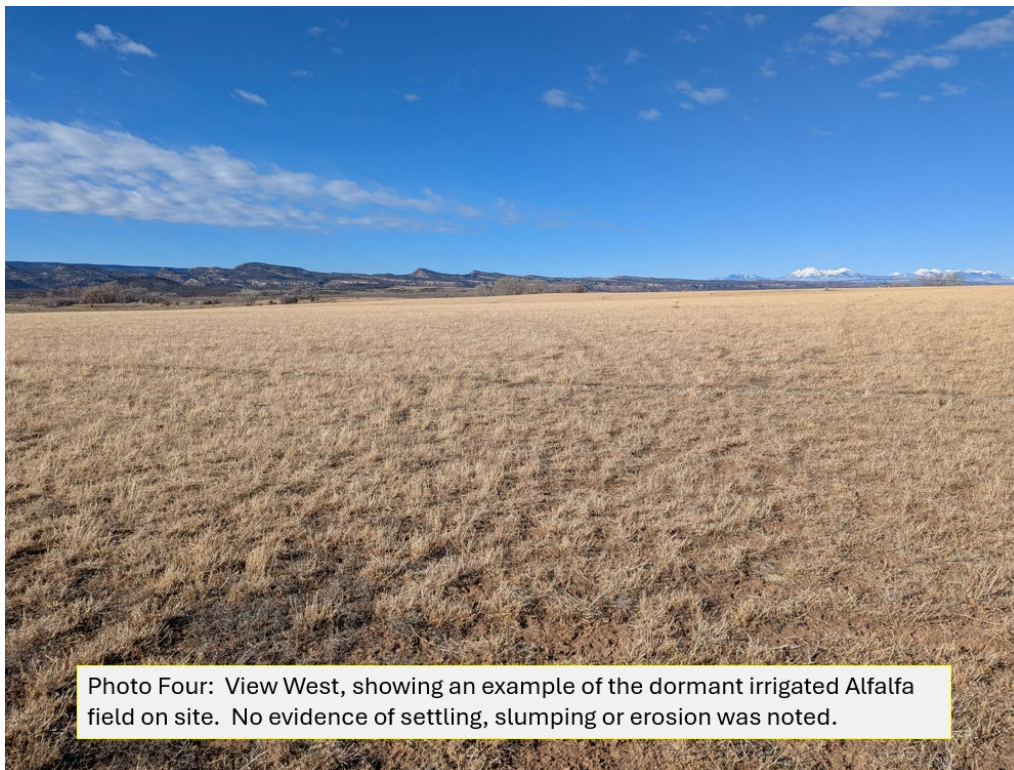
During the course of the inspection, the irrigated alfalfa field was observed to monitor for differential settling or slumping in the reclaimed area. The field was observed from different vantage points, as shown in Photos Four and Five, and no evidence of differential settling, slumping or erosion was noted. The field, dormant

Photo Four: View West, showing an example of the dormant irrigated Alfalfa field on site. No evidence of settling, slumping or erosion was noted.

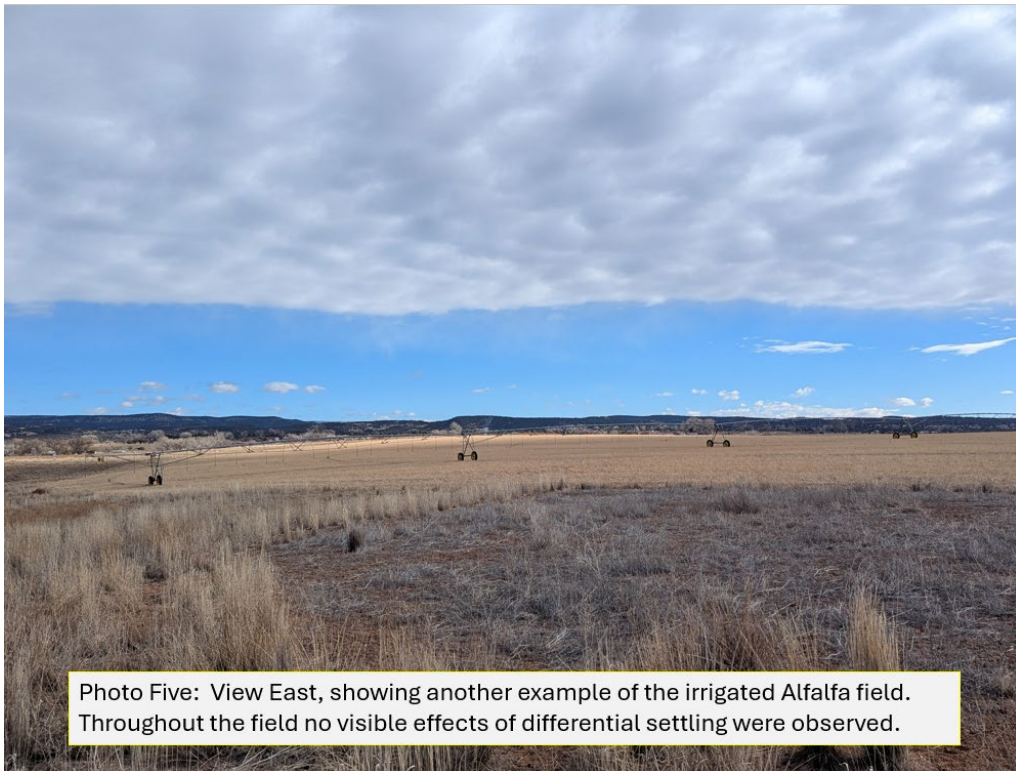
for the winter, is in excellent condition and no issues were noted.
