### MINERALS PROGRAM INSPECTION REPORT

<b>MINE NAME:</b> Biesemeier State Pit	<b>MINE/PROSPECTING ID#:</b> M-2021-029	<b>MINERAL:</b> Gravel and clay (general)	<b>COUNTY:</b> Phillips
<b>INSPECTION TYPE:</b> Monitoring	<b>WEATHER:</b> Cloudy	<b>INSP. DATE:</b> December 17, 2024	<b>INSP. TIME:</b> 11:15
<b>OPERATOR:</b> Phillips County	<b>OPERATOR REPRESENTATIVE:</b> Kevin Scott, Ed Glennemeier, Dave Salyards	<b>TYPE OF OPERATION:</b> 112c - Construction Regular Operation

# Biesemeier State Pit

M2021-029

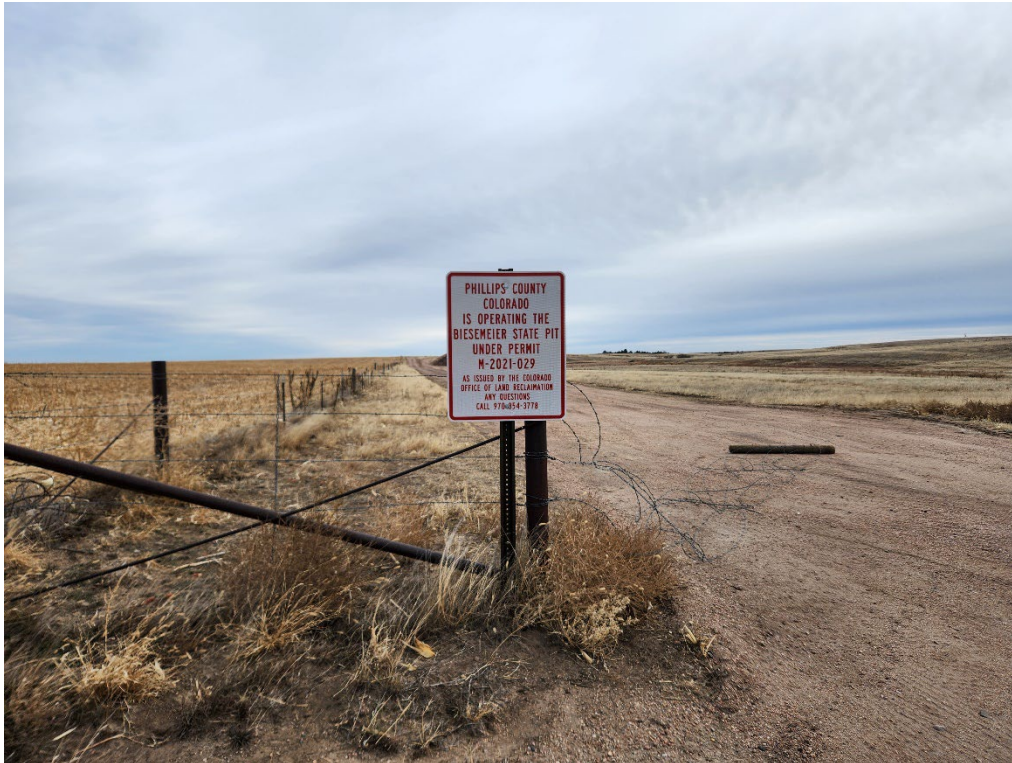
**Photo 1.** Mine entrance sign, looking east.

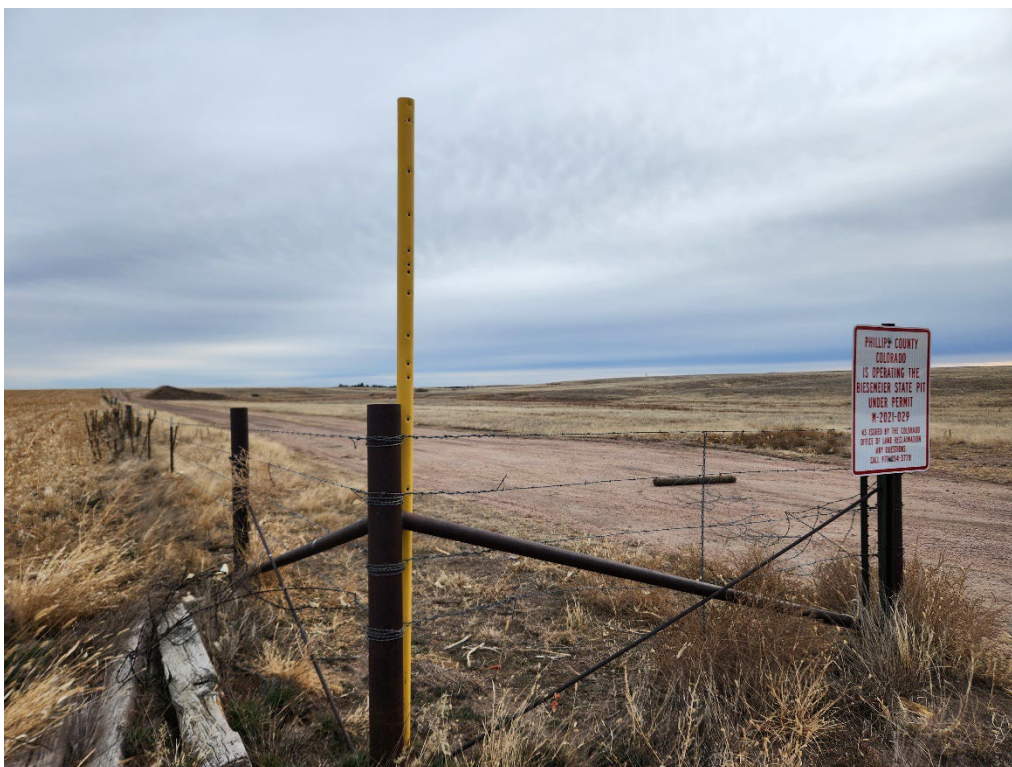
**Photo 2.** Northwest permit boundary marker, looking southeast.

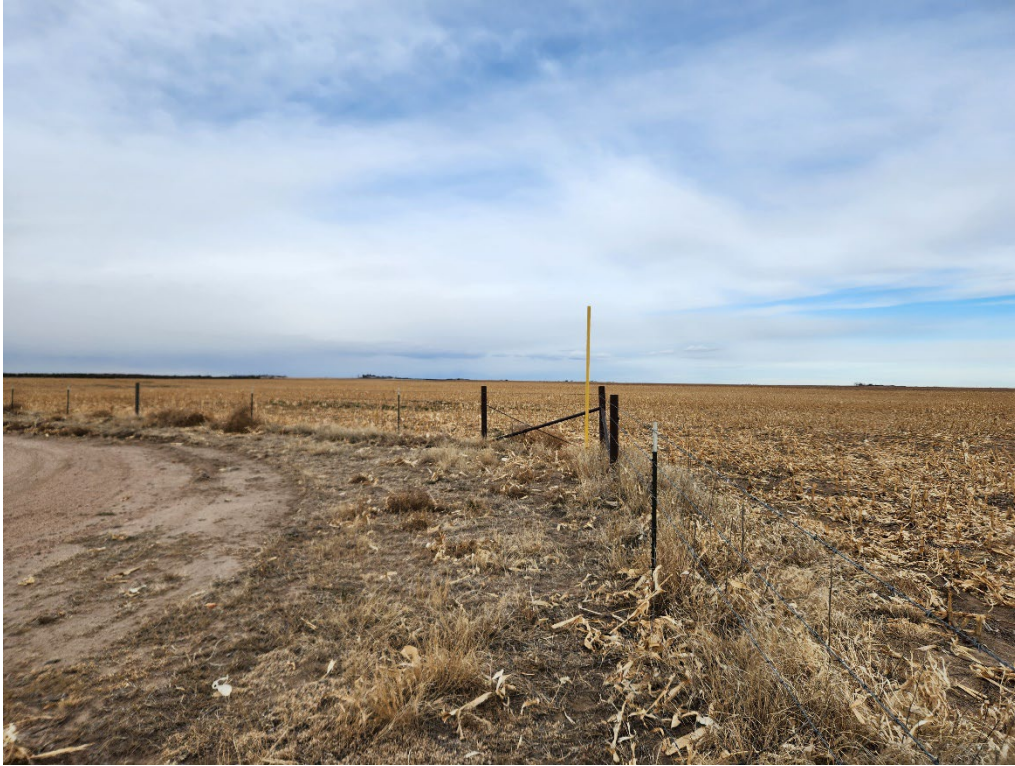
**Photo 3.** Northeastern permit boundary marker, looking north.

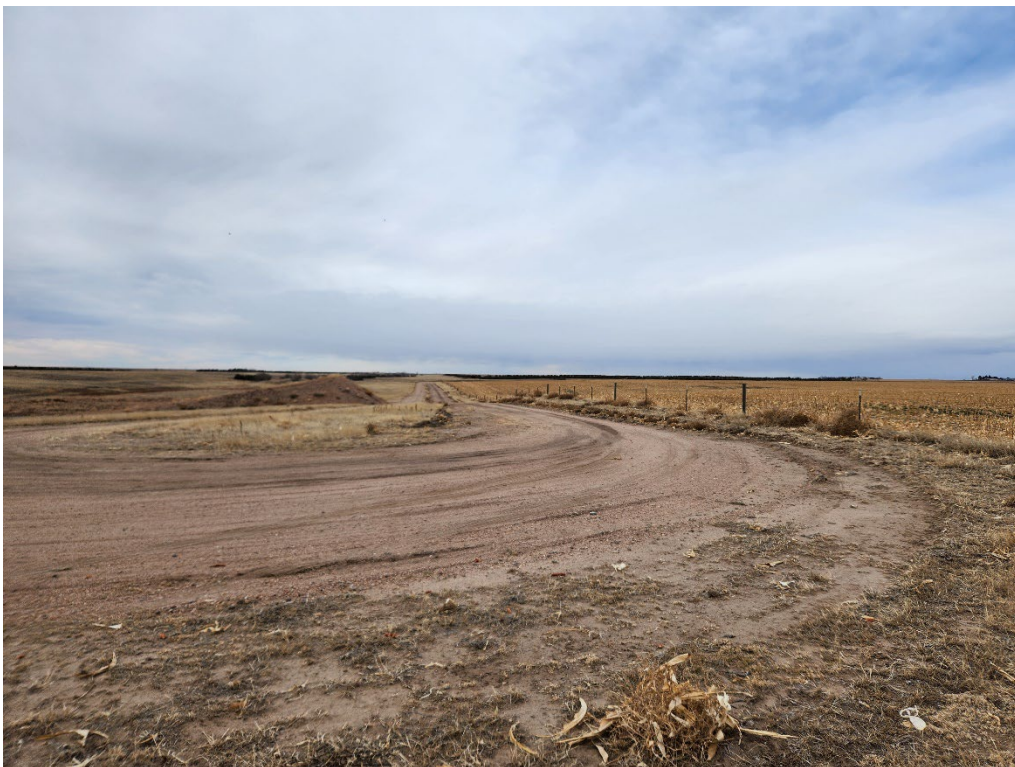
**Photo 4.** Dirt access road to the site, looking west.

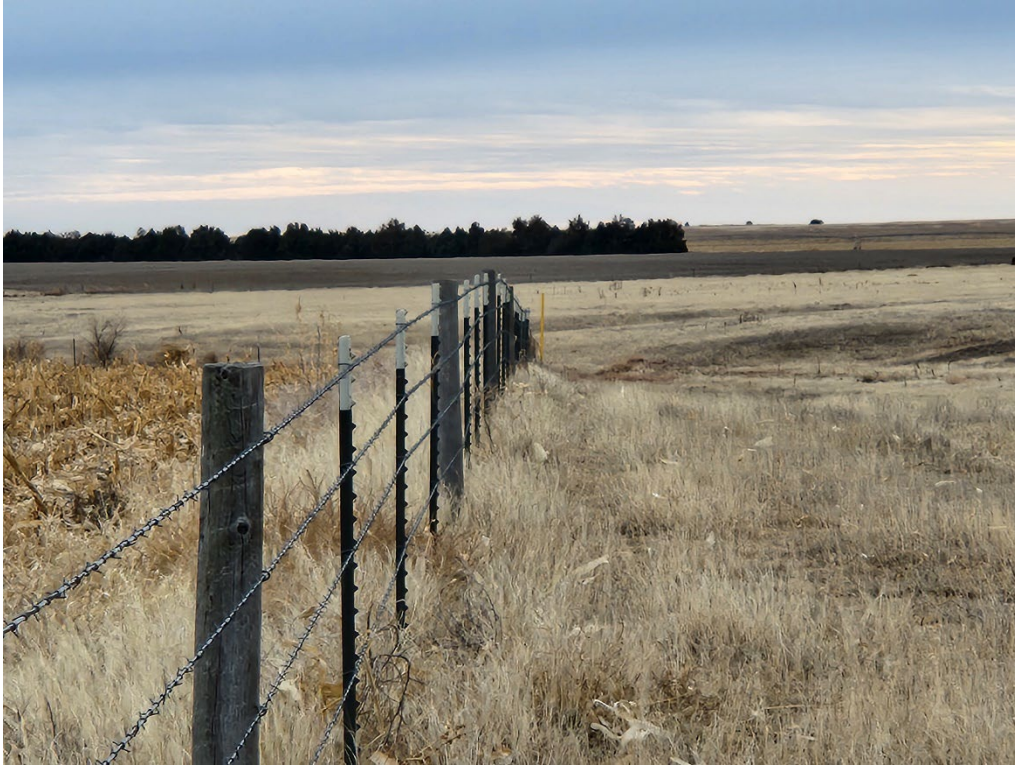
**Photo 5.** Permit boundary fence along the eastern edge of the site, looking south.

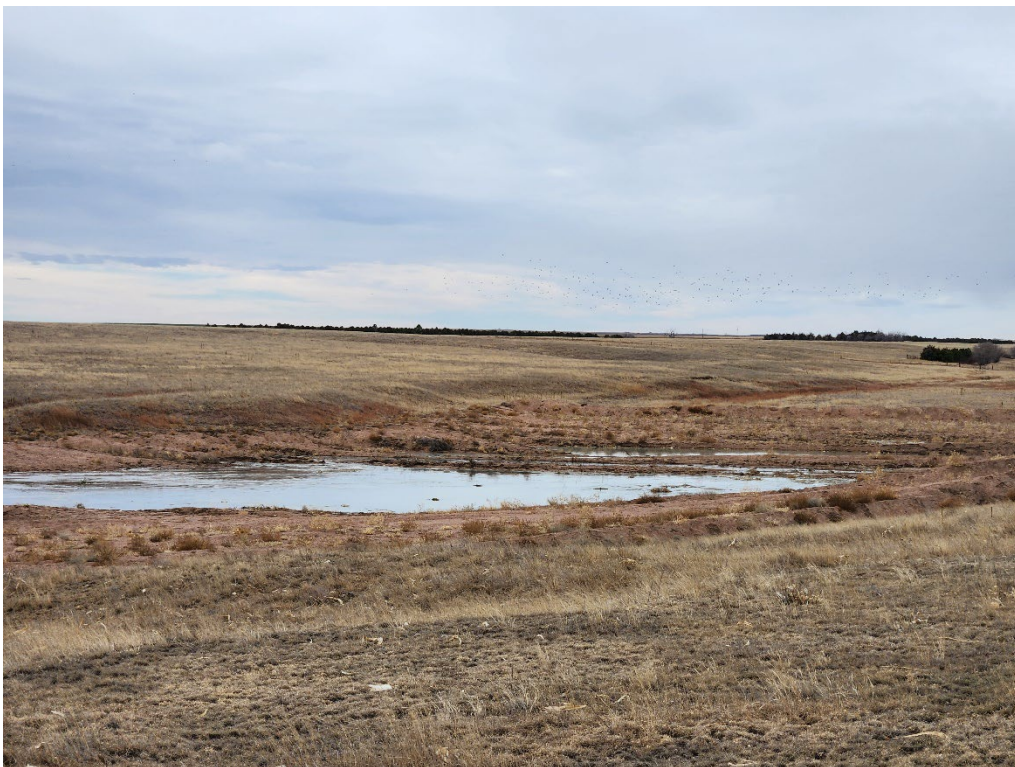
**PROBLEM/POSSIBLE VIOLATION:** Problem: The Division has no evidence that the operator has a valid well permit, substitute water supply plan, or approved water augmentation plan for the exposed groundwater at the site. This is a problem related to C.R.S. 34-32.5-116(4)(h) of the Colorado Revised Statutes and Rule 3.1.6(1)(a) of the Construction Materials Rules and Regulations governing injury to existing water rights.

During the inspection, it was observed that groundwater had been exposed within the active mining pit. Based on observations during the inspection and Google Earth Imagery, it appears that about 1 acre of groundwater has been exposed during the operation, which can be seen in **Photos 6-12** and the attached Google Earth image taken on August 16, 2024. No permits are in place with the Office of the State Engineer (SEO) to allow groundwater exposure. This is a problem related to C.R.S. 34-32.5-116(4)(h) of the Colorado Revised Statutes and Rule 3.1.6(1)(a) of the Construction Materials Rules and Regulations governing injury to existing water rights. **Because of this, the Division is citing it as a problem with a corrective action. By March 17, 2025, please either backfill the exposed groundwater at least 2 feet above the water table and provide photographic evidence of this to the Division or submit evidence to the Division that measures are being taken to be within compliance with SEO. If the operator wishes to continue exposing groundwater and does not want to backfill, then evidence of these measures being taken could be in the form of a copy of the application submittal or copies of email correspondence confirming the motion to work with SEO on obtaining the correct permits.**

**Photo 6.** Mined pit on-site with exposed groundwater, looking southwest.

**CORRECTIVE ACTIONS:** The operator shall demonstrate that the operation is in compliance with the Office of the State Engineer, show evidence that the operator is taking measures to bring the site into compliance with the SEO, or backfill the pits to at least two feet above the groundwater surface by the corrective action date specified.

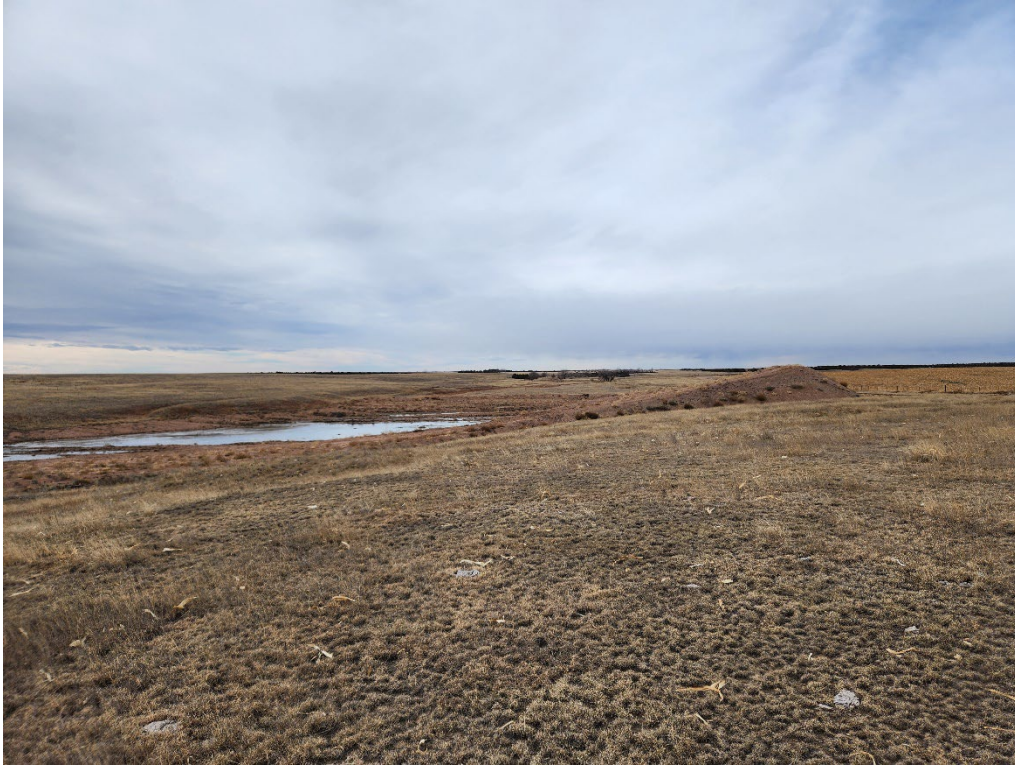
**Photo 7.** Mined it with an overburden stockpile to the right, looking west.

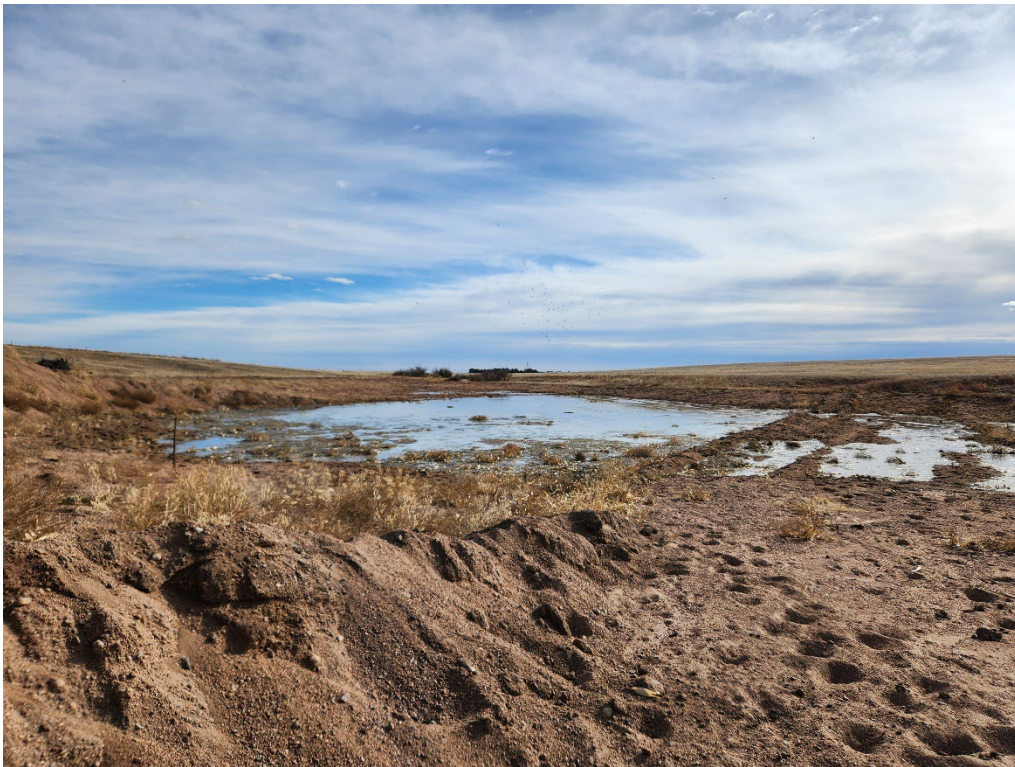
**Photo 8.** Exposed groundwater in the pit, looking southeast.

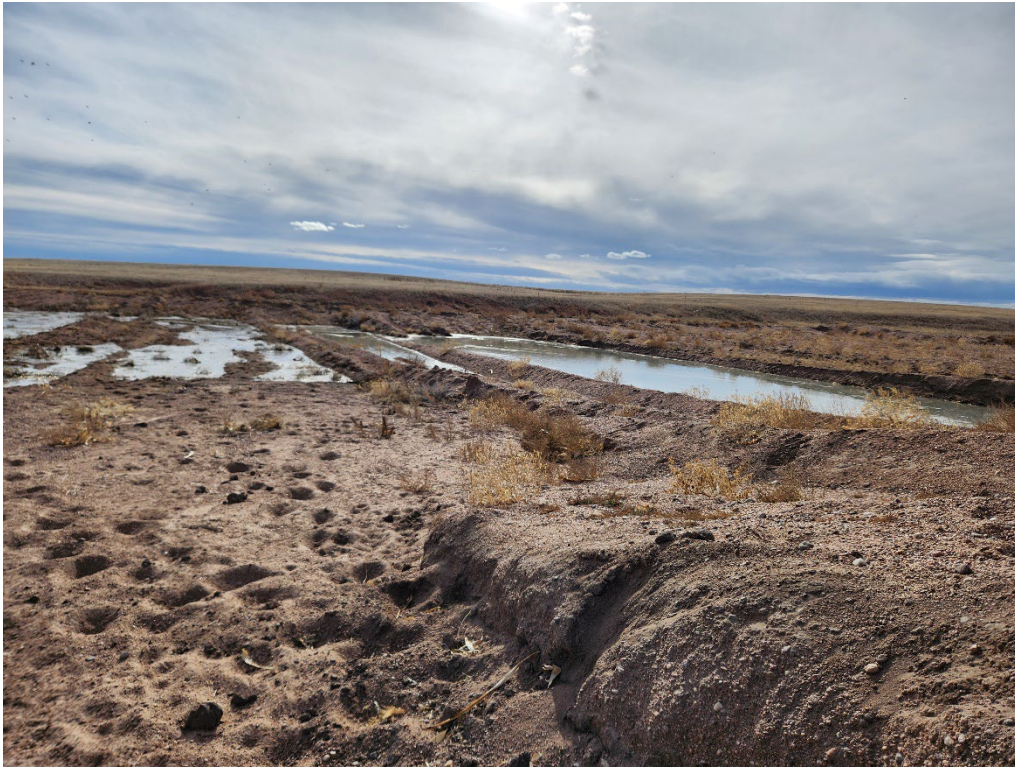
**Photo 9.** Exposed groundwater in the pit, looking south.

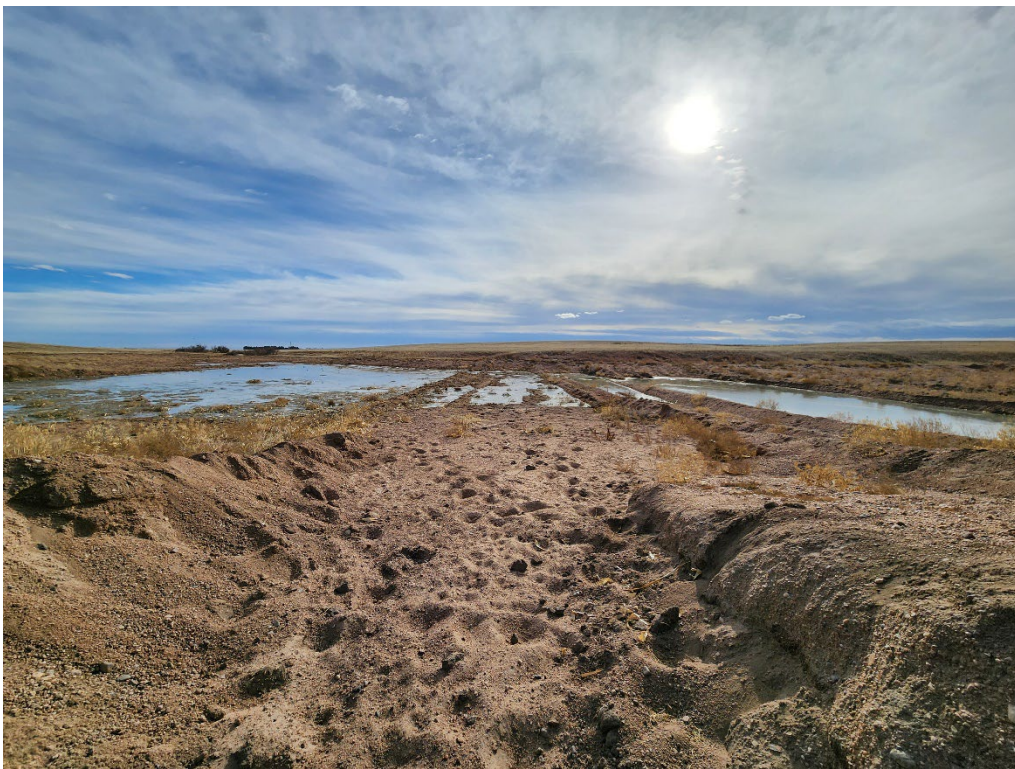
**Photo 10.** Exposed groundwater in the pit, looking south.

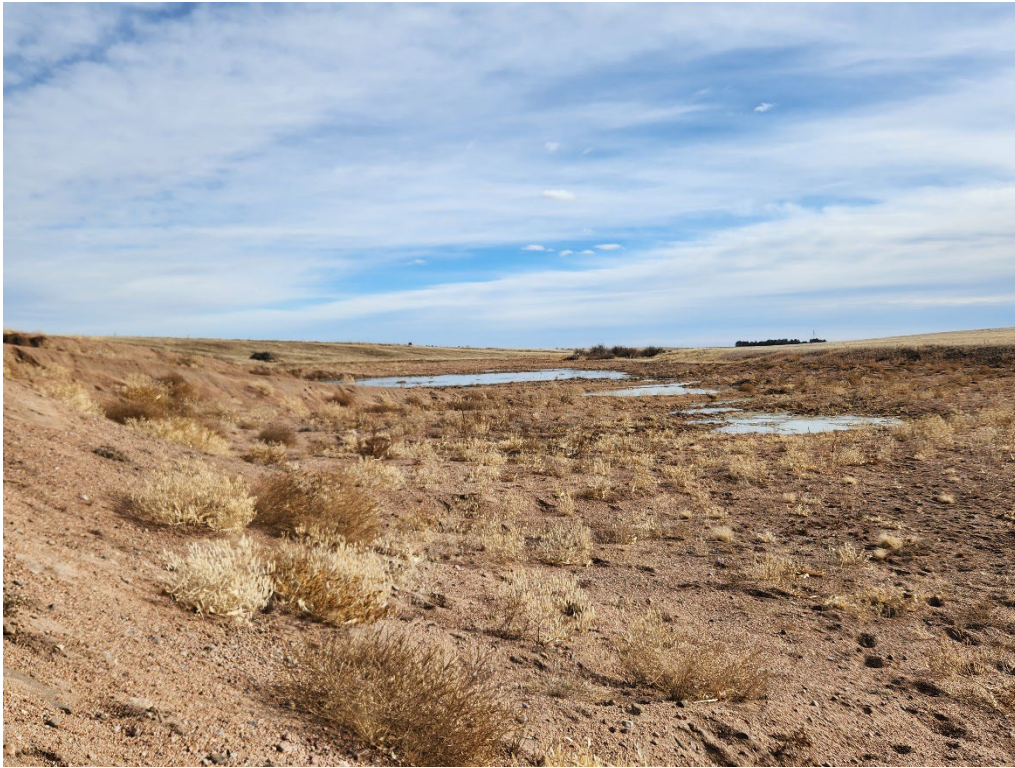
**Photo 11.** Exposed groundwater in the pit, looking east.

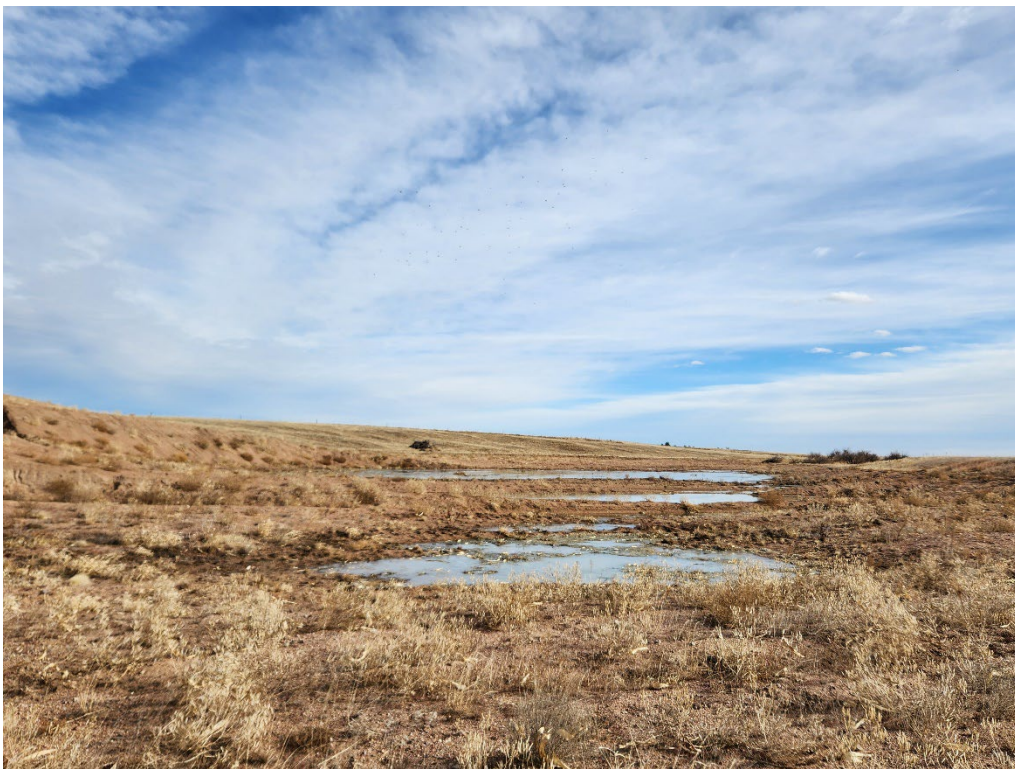
**Photo 12.** Exposed groundwater in the pit, looking east.
