**MINERALS PROGRAM INSPECTION REPORT**  
**PHONE: (303) 866-3567**

| <b>MINE NAME:</b><br>Climax Mine | <b>MINE/PROSPECTING ID#:</b><br>M-1977-493 | <b>MINERAL:</b><br>Molybdenum | <b>COUNTY:</b><br>Lake, Summit |
| <b>INSPECTION TYPE:</b><br>Monitoring | <b>WEATHER:</b> Clear | <b>INSP. DATE:</b><br>January 14, 2025 | <b>INSP. TIME:</b><br>11:30 |

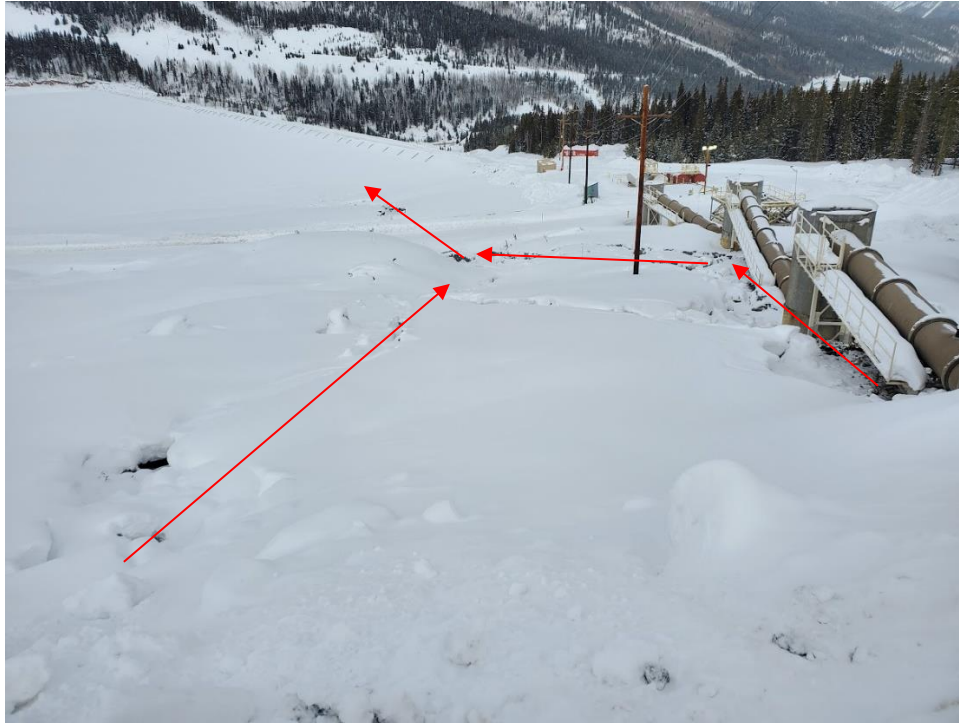
On January 6, 2025, Climax identified a leak of approximately 13,000 gallons per minute (GPM) at Drop Tower 14 on the Tailings Delivery Line (TDL). The leak was observed around 17:30 and deposition of tailings was redirected to an upgradient location by 18:00. The cause of the leak was determined to be a Drop Tower Lid that had fallen into the Drop Tower and blocked the TDL. Some material did report to the Mayflower Tailings Pond as designed. However, snow berms prevented drainage from functioning as designed and a portion of tailings material traveled along the TDL to Drop Tower 16 before controls diverted flow into the Mayflower Tailing Pond (Photo 1). Tailing material that flowed next to the TDL caused erosion that needs to be backfilled to prevent damage to the TDL. Another portion of the tailings material was diverted by snow berms and traveled down the road pooling at the Mayflower Substation (Photo 2), the access road for the base of 5 Dam (Photo 3), and a pullout near Tucker Creek (Photo 4) before stopping on the roadway just before the PDWTP. Residual amounts of tailing material remain in the snow along the roadways after the material was cleaned up, but no more than what would be spread by vehicles that work on the tailings ponds. All material was either contained in the Mayflower Tailings Pond or along the roadway. No material entered waters of the US. Climax conducted outfall sampling the day of the incident to monitor for elevated levels of analytes associated with the leak.

Photo 1 – View to the northwest from Drop Tower 14. Red arrows show the path of leaked tailings material.

1. Lid design – The lids for the TSL Drop Towers were originally very heavy and required rigging to remove for maintenance. To facilitate maintenance the operator experimented with a lighter weight aluminum lid that is easier to remove. It was one of these lightweight lids that failed and fell into the TDL, preventing tailings material from passing. The operator is investigating alternative lids and if lids are even necessary.

2. Backfilling – Areas around the TDL that were eroded by the leak need to be backfilled to prevent further damage to the line. Operation crews are in the process of identifying backfill material before they remove snow and begin backfilling.

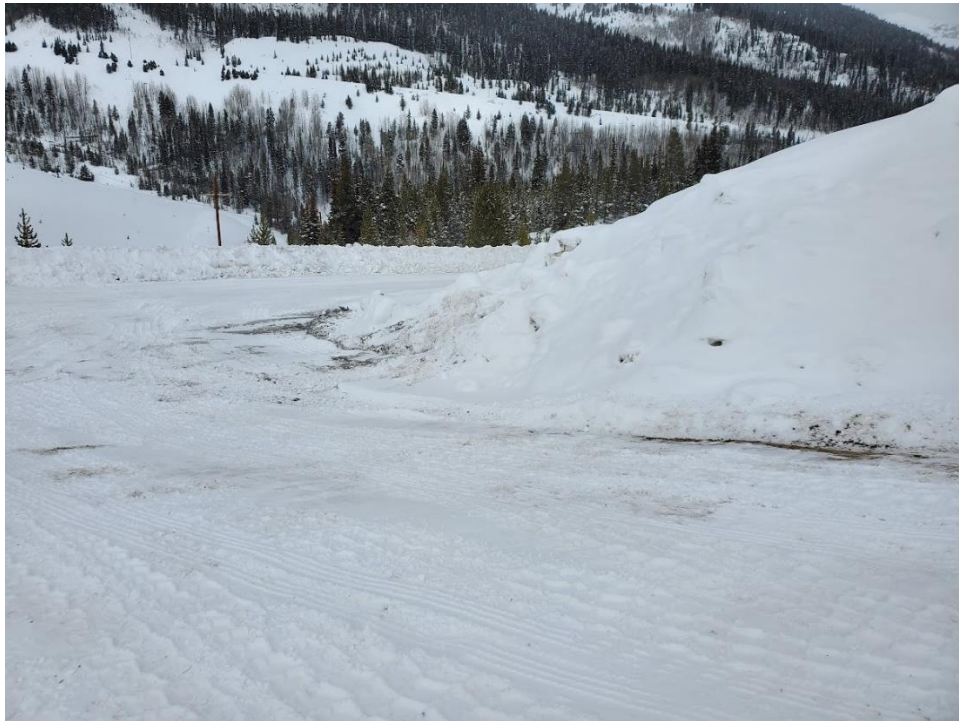
Photo 2 – View to the northwest of area where tailings material was pooled near the Mayflower Substation.

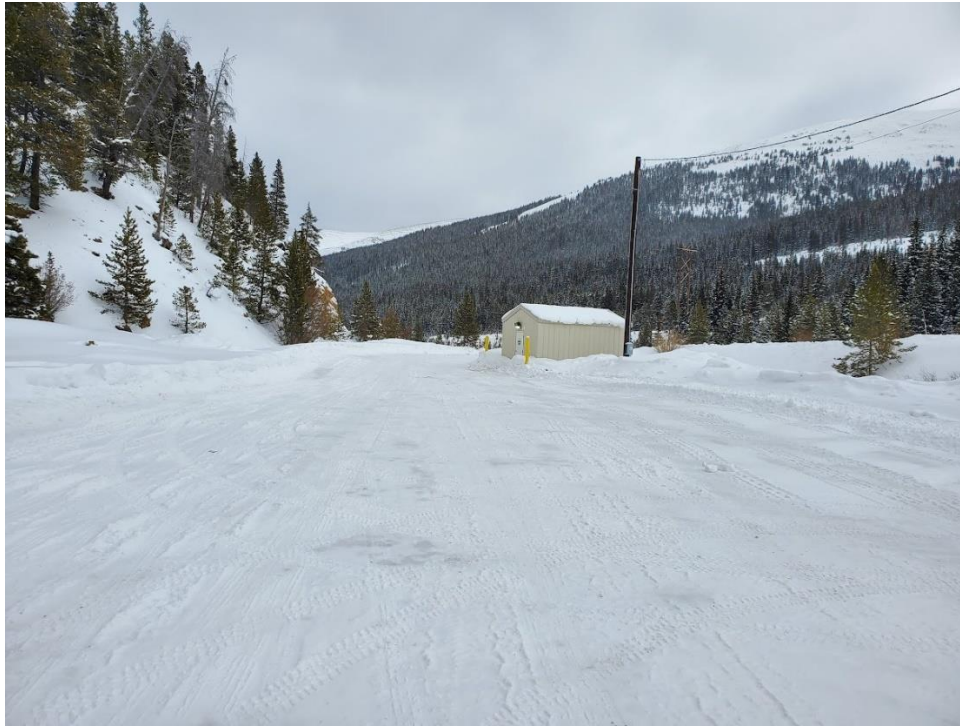
Photo 3 – View to the northeast of area where tailings material was pooled near the access road to the base of 5 Dam.

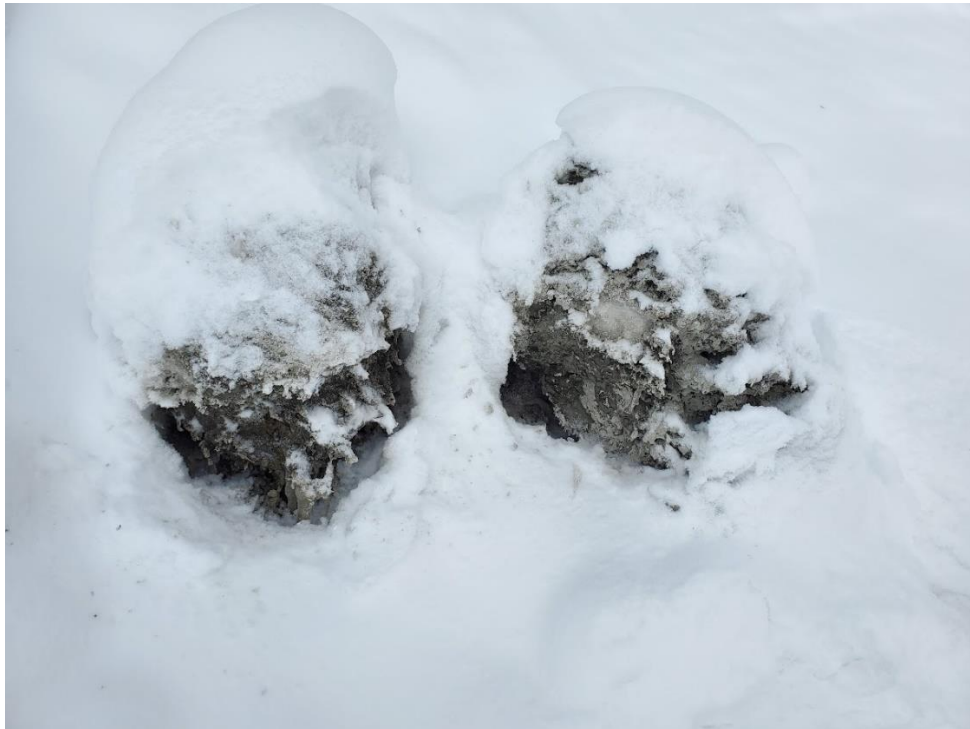
Photo 4 – Image of residual tailings material in the pullout near Tucker Creek where leaked material pooled.

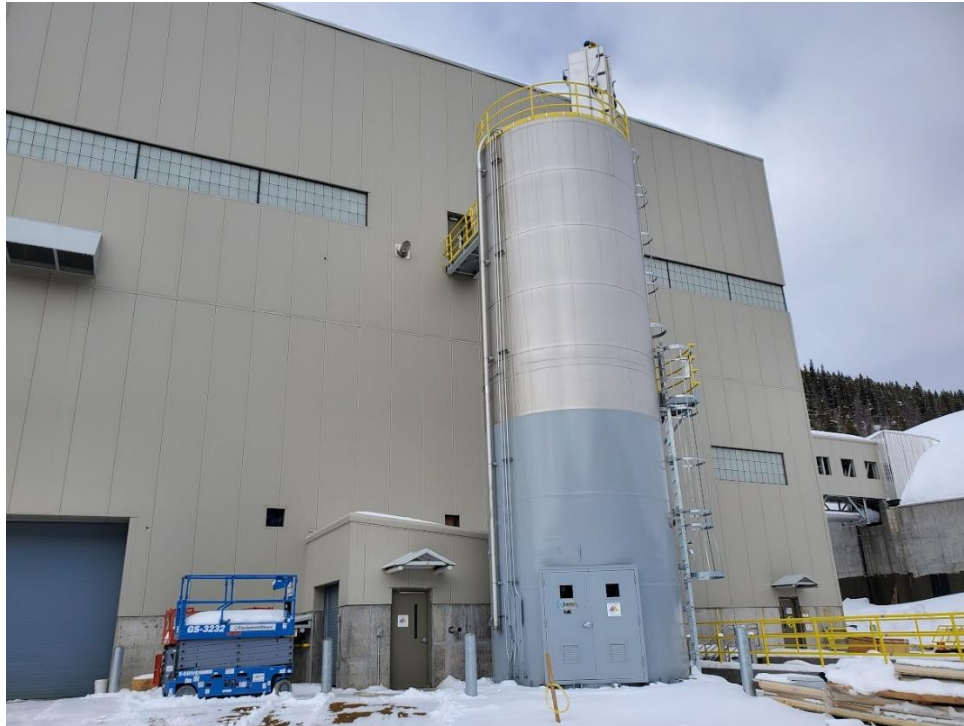
The new MRWTP building approved under TR-34 is nearly complete. This is a supplementary process to Climax's PDWTP. Once online the raw water will first go into the Moly building, then water will go to the existing PDWTP building. The Ferric Sulfide silo was observed during the inspection (Photo 5). Ferric Sulfide is a new chemical, and Climax is working with CDPHE to update their discharge permit to include it. The building is anticipated to be complete in early February 2025.

Photo 5 – View to the west of Ferric Sulfide silo outside the MRWTP.

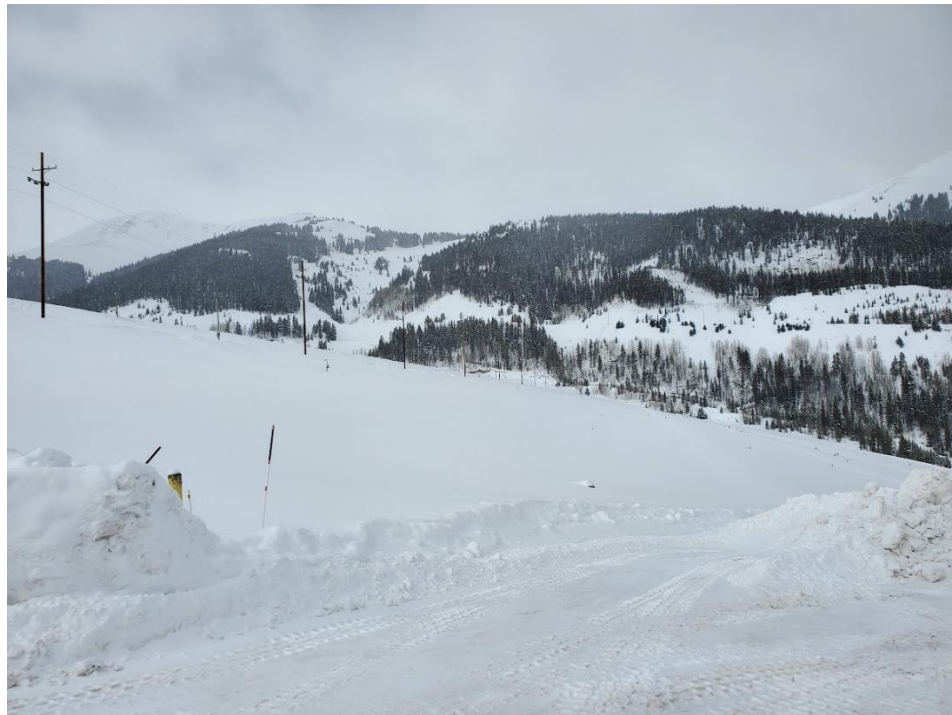
The Tenmile TSF/3 Dam and the Mayflower TSF/ 5 Dam were observed during the inspection. Mayflower TSF is the northernmost tailing storage facility and is contained by 5 Dam. 5 Dam was snow covered at the time of the inspection. No obvious erosion was noted. There were no signs of displacement, wet spots, or slumping observed (Photo 6).

Photo 6 – View to the west across 5 Dam.

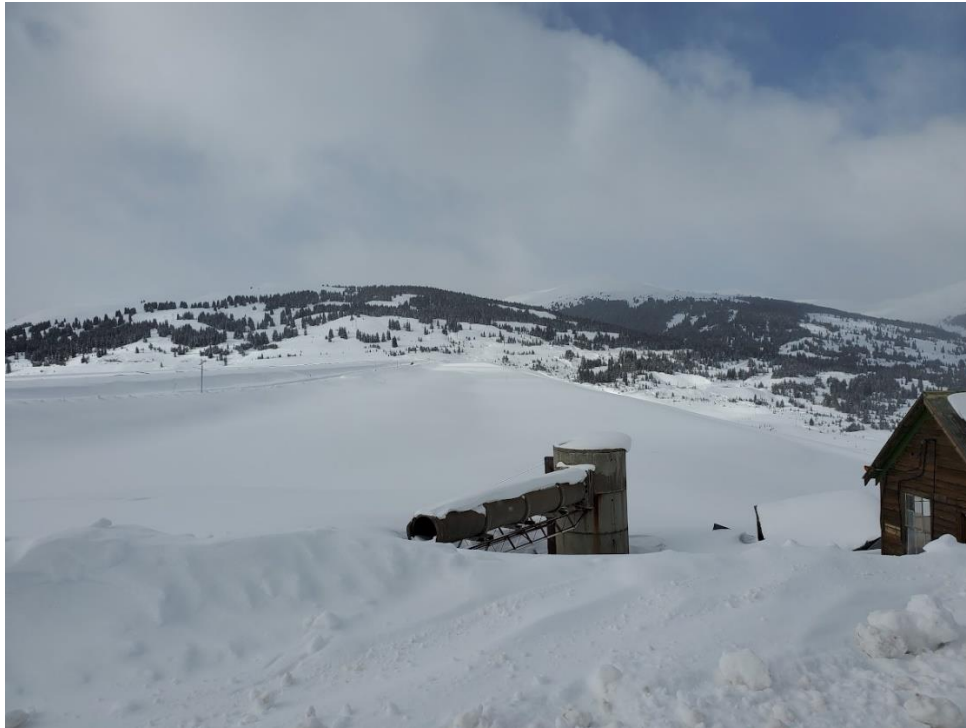
Tenmile TSF is located directly to the south and upgradient of the Mayflower TSF. The Tenmile TSF is contained by 3 Dam. 3 Dam was snow covered at the time of the inspection. No obvious erosion was noted. There were no signs of displacement, wet spots, or slumping observed (Photo 7).

Photo 7 – View to the west across 3 Dam.
