MINERALS PROGRAM INSPECTION REPORT
PHONE: (303) 866-3567

MINE NAME: Seeley Reservoir Stockpiles	MINE/PROSPECTING ID#: M-2023-043	MINERAL: Borrow material for construction	COUNTY: Weld
INSPECTION TYPE: Preoperation Inspection	WEATHER: Windy	INSP. DATE: January 9, 2025	INSP. TIME: 09:30
OPERATOR: Four C Sons, Inc.	OPERATOR REPRESENTATIVE: Scott Cockroft, Tim Naylor, Travis Koch	TYPE OF OPERATION: 112c - Construction Regular Operation	
REASON FOR INSPECTION: Pre-operation Inspection	BOND CALCULATION TYPE: None	BOND AMOUNT: \$0.00	
DATE OF COMPLAINT: NA	POST INSP. CONTACTS: None	JOINT INSP. AGENCY: None	
INSPECTOR(S): Amber Gibson Jared Ebert	INSPECTOR'S SIGNATURE:

An application for the Seeley Reservoir Stockpiles (M-2023-043) has been received by the Division of Reclamation, Mining and Safety (Division/DRMS) and was deemed complete on December 2, 2024. The site was inspected by Amber Gibson and Jared Ebert with the Division as part of a pre-operation inspection. The site was previously inspected by the Division on January 18, 2024 as a possible violation investigation inspection. Scott Cockroft, Tim Naylor, and Travis Koch (representing the Applicant), and Charles and Spencer Keirn

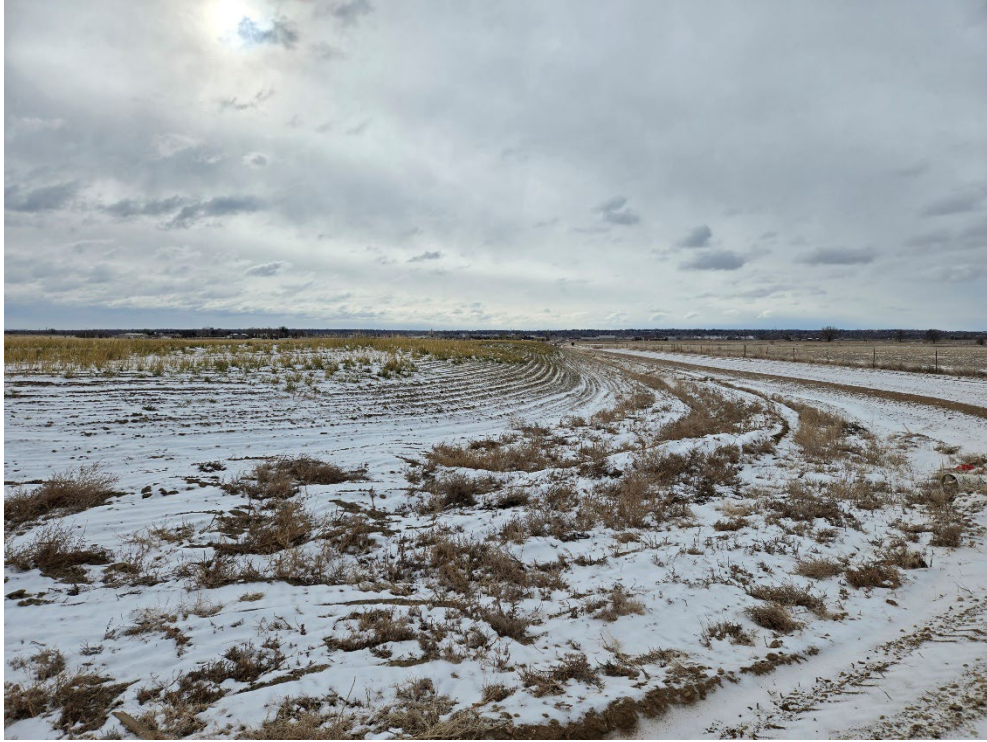
In the Division's previous inspection report, a stormwater diversion ditch was noted in the southern-most stockpile area, located on land owned by PDC Energy Inc. When asked during the inspection if the ditch was created as part of stormwater control measures, the Applicant stated that the ditch was already in place prior to their involvement, and that it was a diversion ditch that kept the cropland irrigation separate from the energy utility areas (Photos 1-2).

Photo 1: Looking at the northwest corner of the stockpile area in the southern portion of the permit. A stormwater diversion ditch is shown between the stockpile and the road.

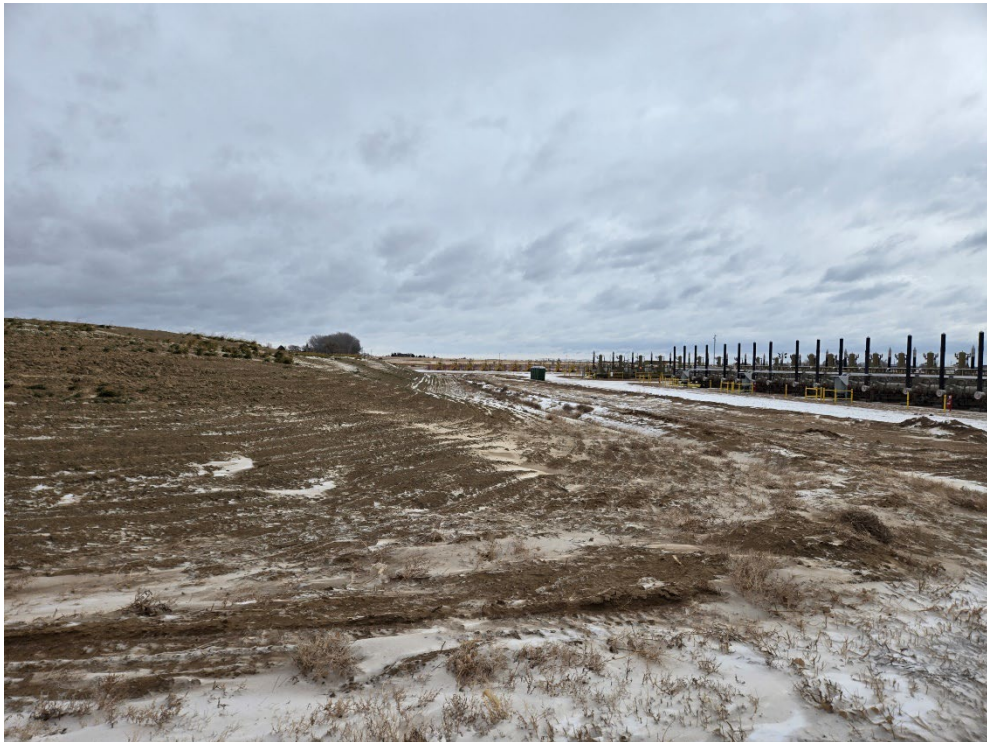
Photo 2: Looking at the southwest corner of the stockpile area in the southern portion of the permit. A stormwater diversion ditch is shown between the stockpile and the road. The right side of the photo shows some of the utilities belonging to PDC Energy, Inc.

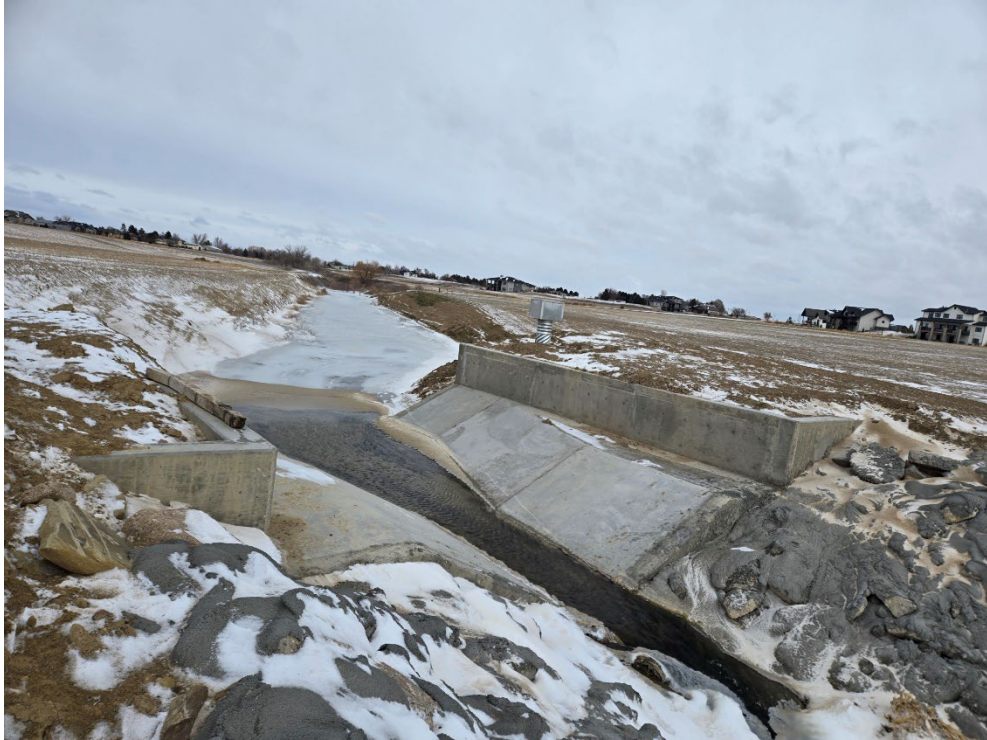
Some of the comments provided by the landowners of the northern portions of the permit were concerned with structures within the Ogilvy ditch and the configuration of the ditch side-slopes. This area was observed during the inspection (Photo 3). The Applicant explained that the failed structure noted in the landowner's comments has been replaced with a structure equipped to handle flows with a much higher CFS than previously anticipated. The Applicant stated that the new structure has been examined by a Dam Safety engineer and is expected to now be adequately equipped to handle any large flows the ditch may experience in the future. The Applicant will be required to provide the engineering specifications and justification as to why this structure and the side-slope configuration is and will be stable, as part of their responses to the Division's adequacy review.

Photo 3: Looking north at the Ogilvy ditch and the new flow regulating structure.

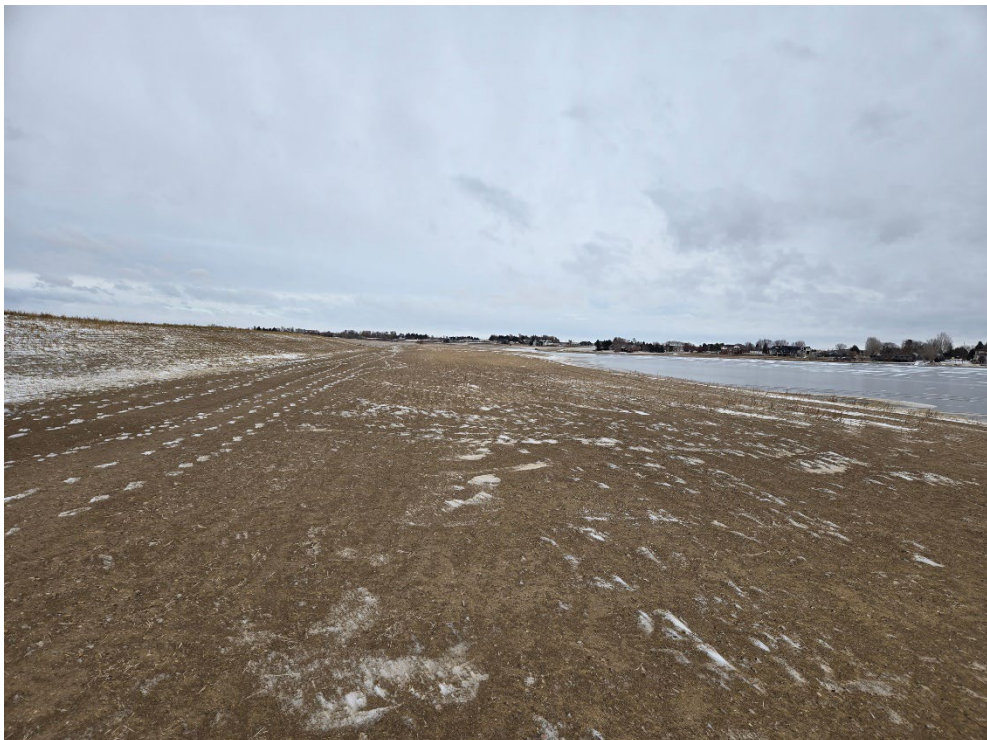
During the inspection, the Division asked the Applicant for clarification as to whether the haul road will be removed, need to be reclaimed, or stay in place after reclamation, to which the Applicant stated that it will

remain (Photo 4). The Applicant will provide an updated reclamation plan exhibit that will address this in the narrative.

Photo 4: Looking north along the haul road located to the west of Seeley Lake.

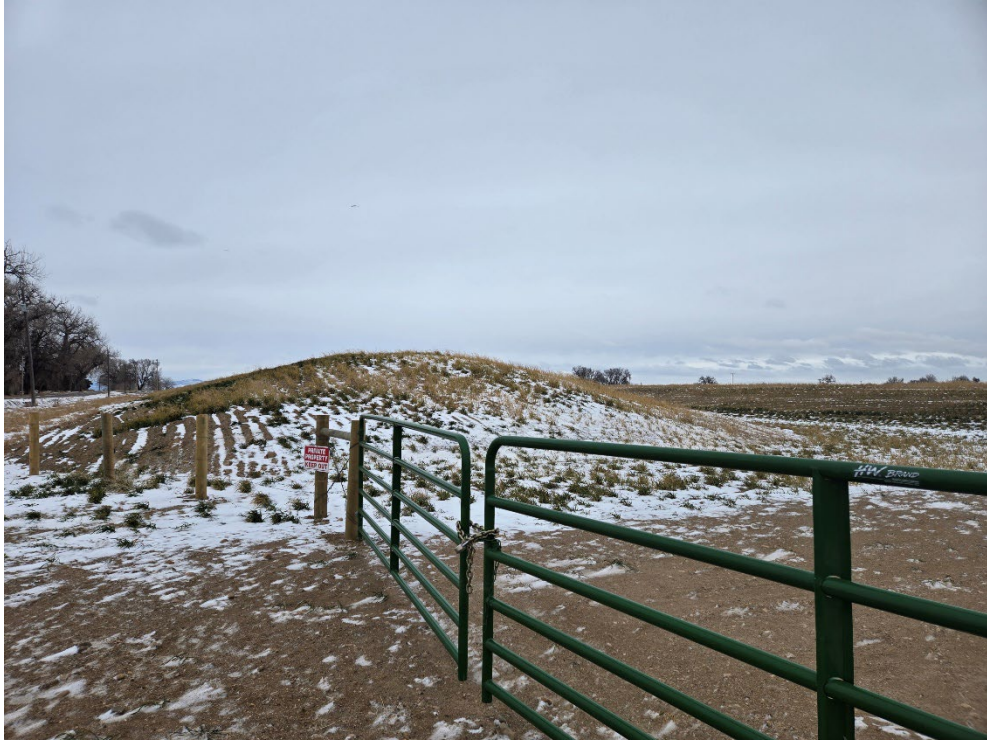
The stabilized stockpiles have been graded and shaped with gentle 3H:1V side-slopes and were seeded in the fall of 2024 to aid in stabilization. At the time of the inspection, the Division observed that vegetation is beginning to establish (Photo 5-12). The Applicant stated that the piles were seeded with the pastureland/dryland mix as proposed in the permit application. Prior to the permit's eligibility for release, the Division will need to make the determination as to whether vegetation has established per the requirements of Rule 3.1.10.

Photo 5: Looking west at one of the stockpiles to remain as a perimeter berm on the northside of AA street.

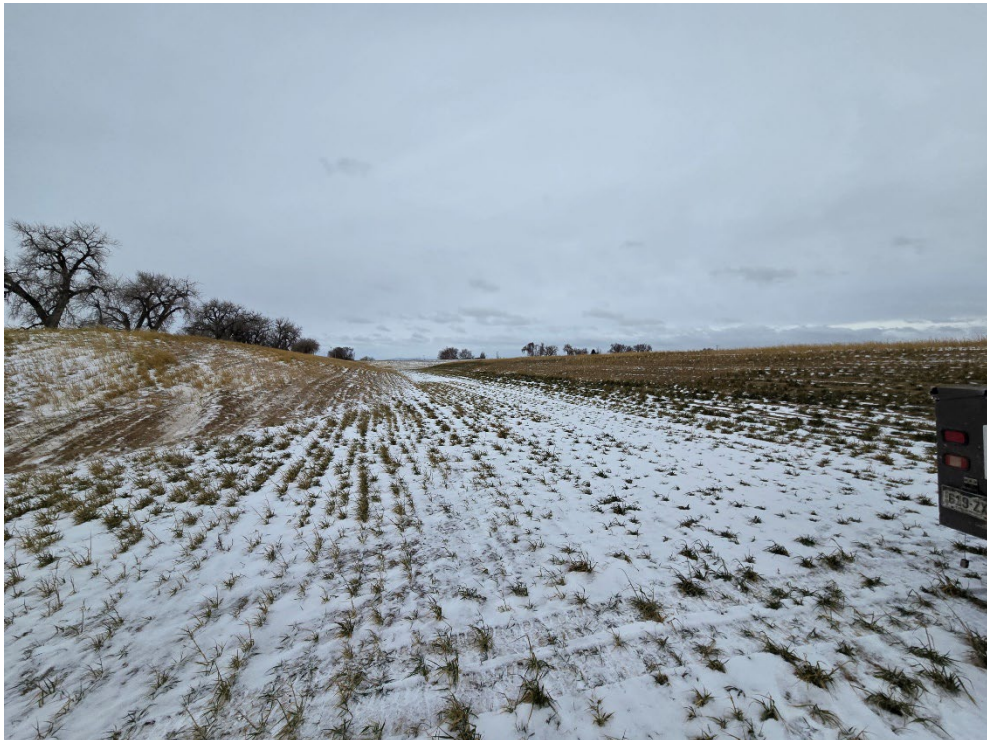
Photo 6: Pictured on the left is the perimeter stockpile berm shown in Photo 5. Pictured on the right is the stockpile that will be removed via reclamation option 1, or will be graded out and seeded via reclamation option 2.

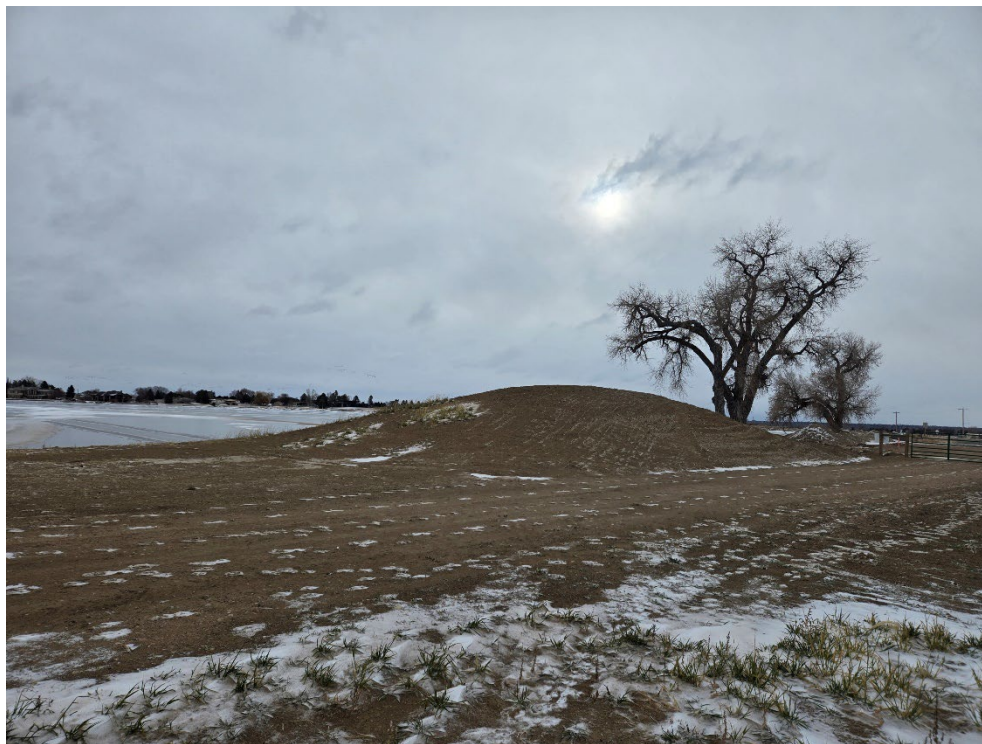
Photo 7: Looking east at a small stockpile located on the west side of Seeley Lake that will be removed via reclamation option 1, or will remain via reclamation option 2.

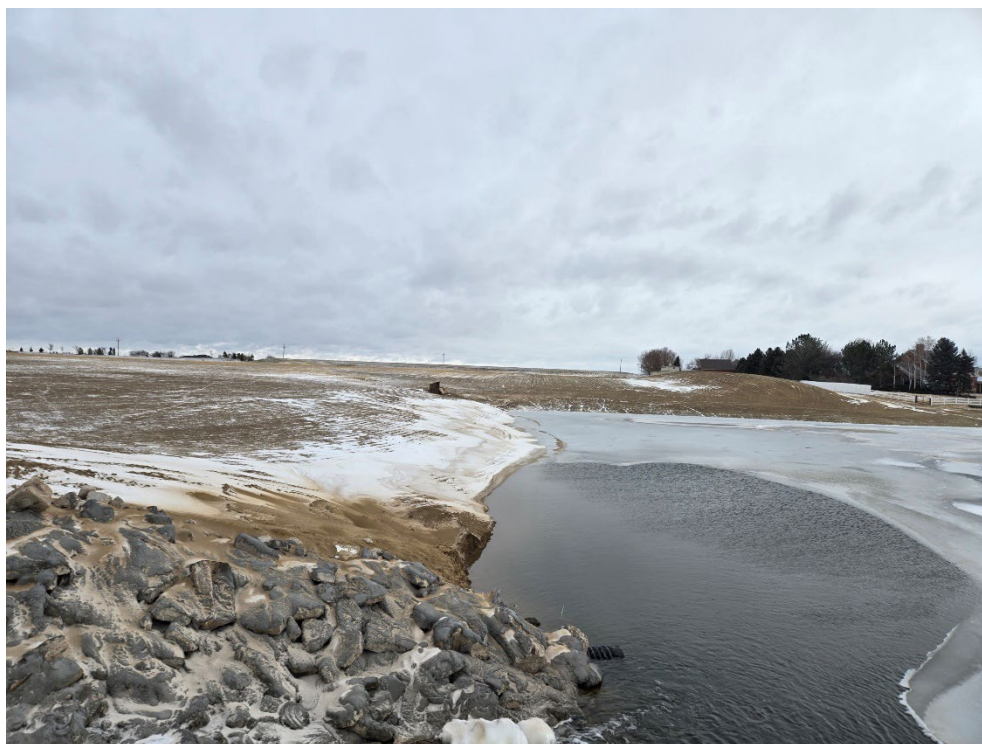
Photo 8: Looking north from the flow structure in Photo 3 towards the northeastern-most stockpile area. The only materials remaining, and which is planned to stay regardless of which option is chosen, are the permitter berms located on the east and south sides.

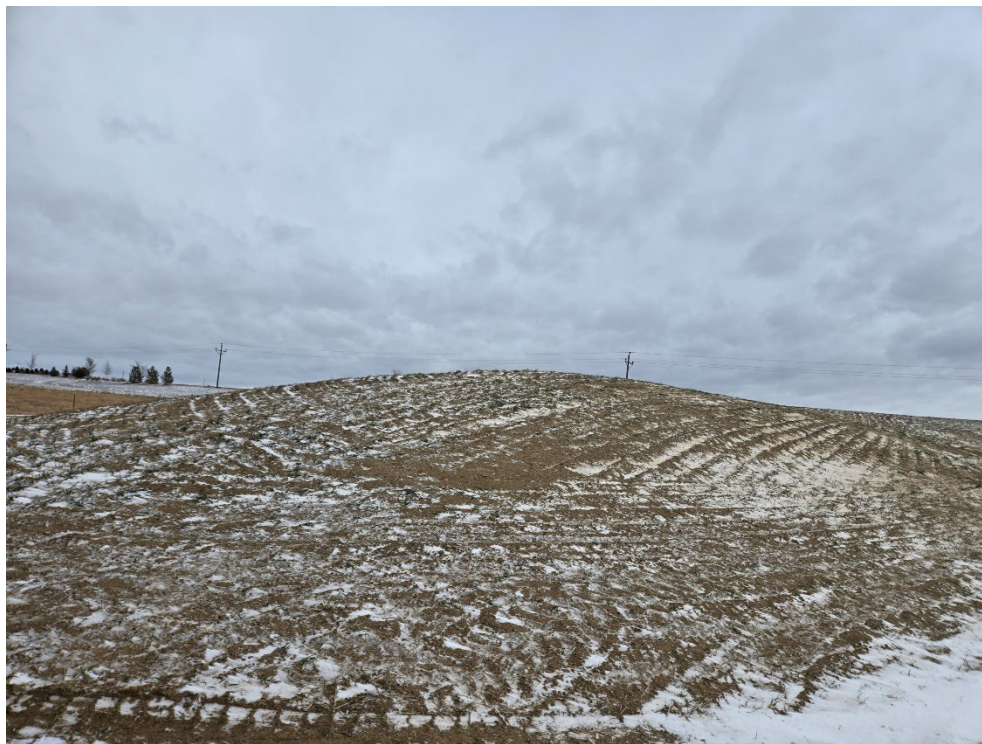
Photo 9: Looking east at the western most portion of the eastern berm in the area mentioned in Photo 8.

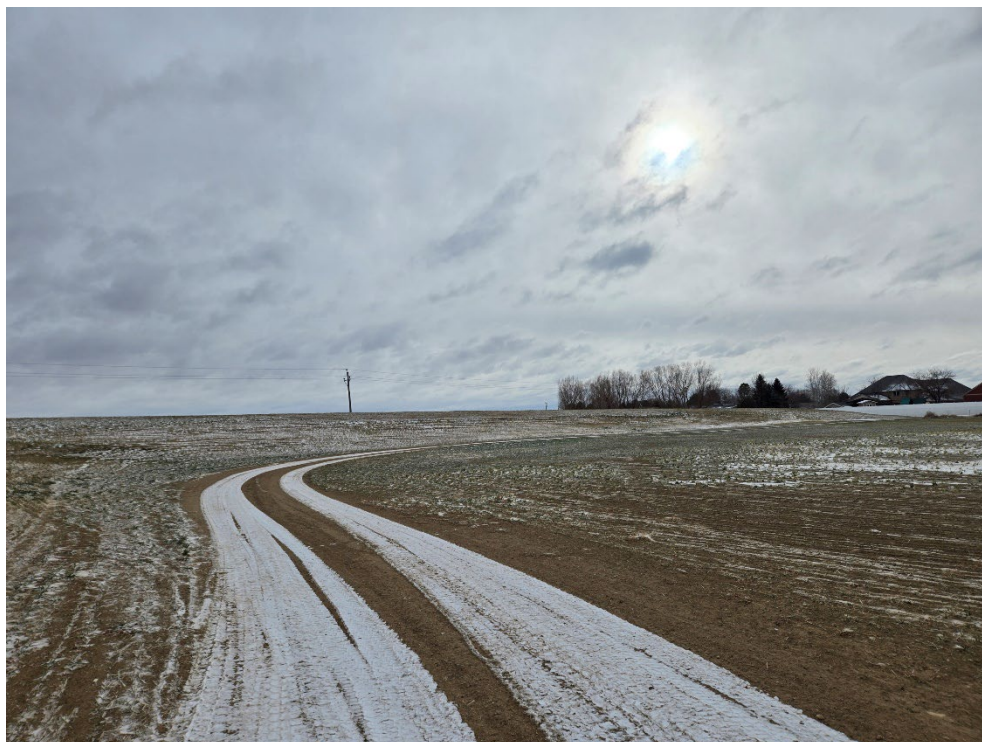
Photo 10: Looking at the east side of the eastern berm in the area mentioned in Photo 8.

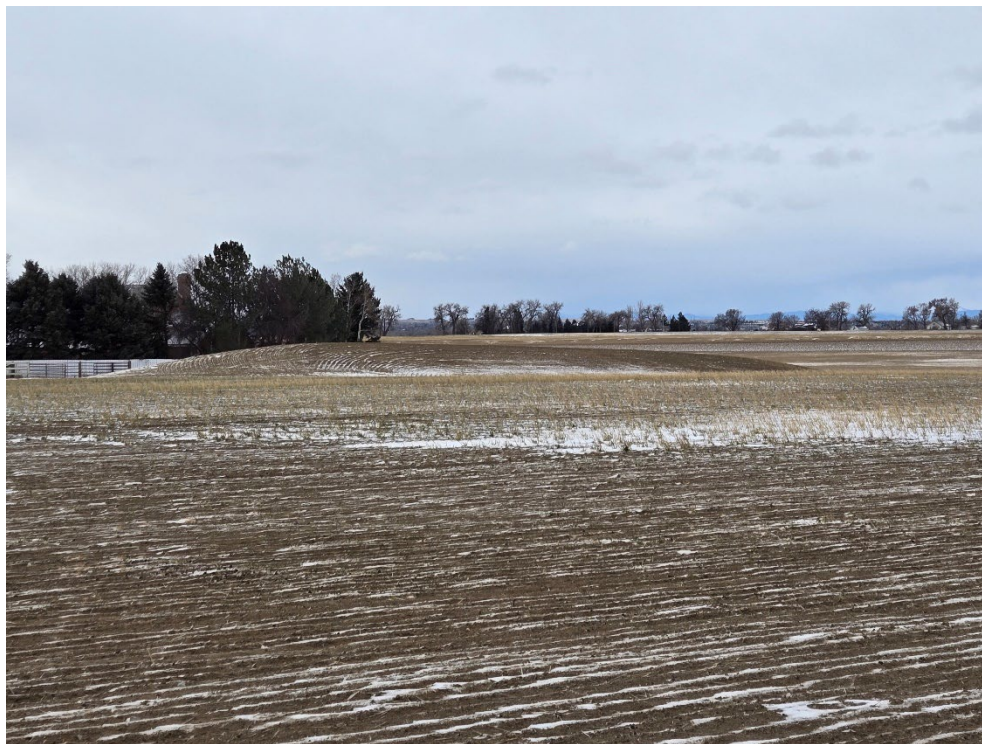
Photo 11: Looking south at the southern berm in the area mentioned in Photo 8.

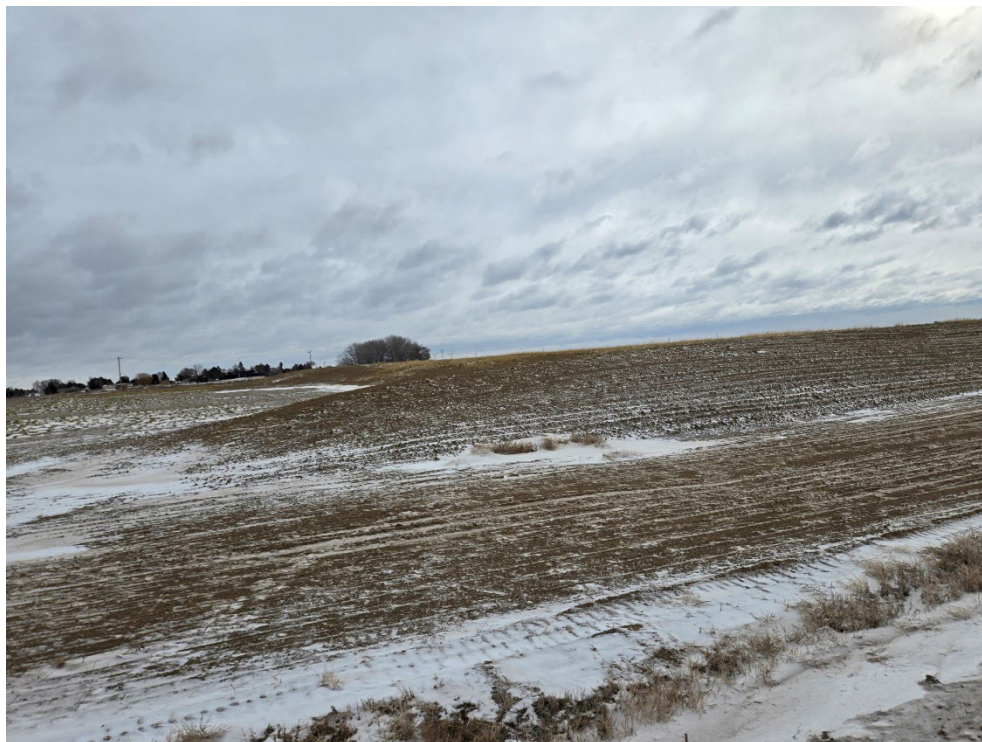
Photo 12: Looking east at the eastern stockpile area in the southern portion of the permit (PDC Energy area). All the stockpiled material within this parcel is planned to be removed upon the permit's issuance.

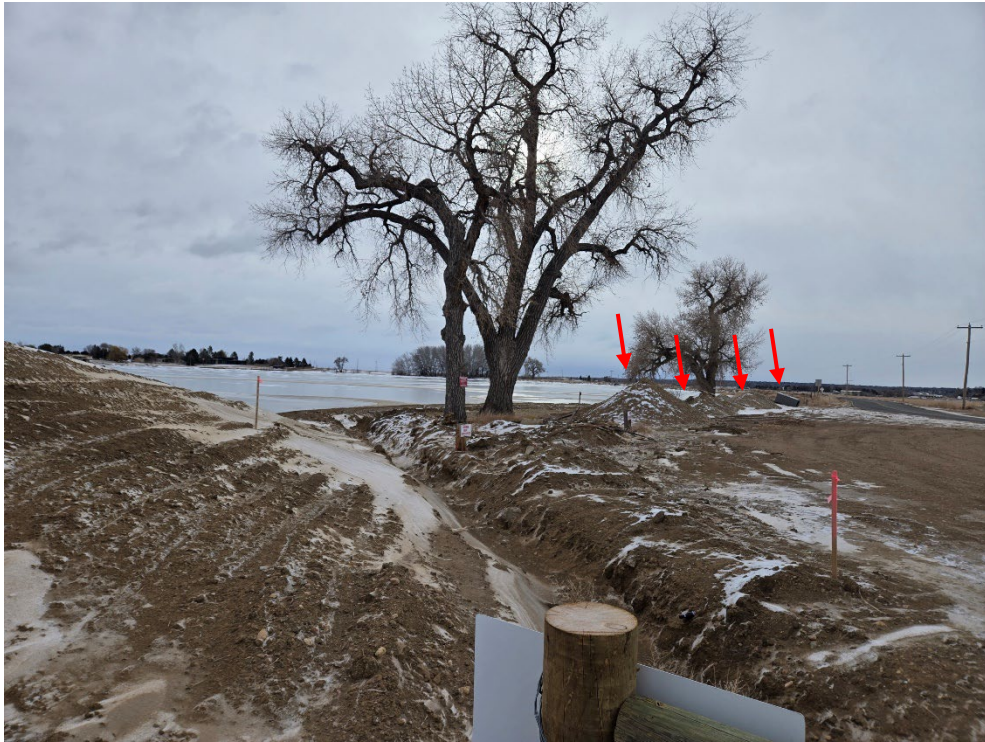
During the inspection, the landowners brought the inspectors and the Applicant to the location where they believed remaining materials needed to be reclaimed and included in the affected area of the permit boundary (Map 1; Figure 1; Photo 13). At the time of the inspection, the Applicant's stated that that material was on Ogilvy's property and was not included as part of the operation. However, following the inspection the Division discovered that this area is already included in the Applicant's affected area boundary (Figure 1). The reclamation of this portion of the permit will need to be further addressed and accounted for in the Applicant's adequacy responses.

Photo 13: Looking southeast at the area mentioned in the landowner's complaint. The survey sticks in the photo indicate the end of the landowner's property. The remaining material (arrows) is located on Ogilvy's property.

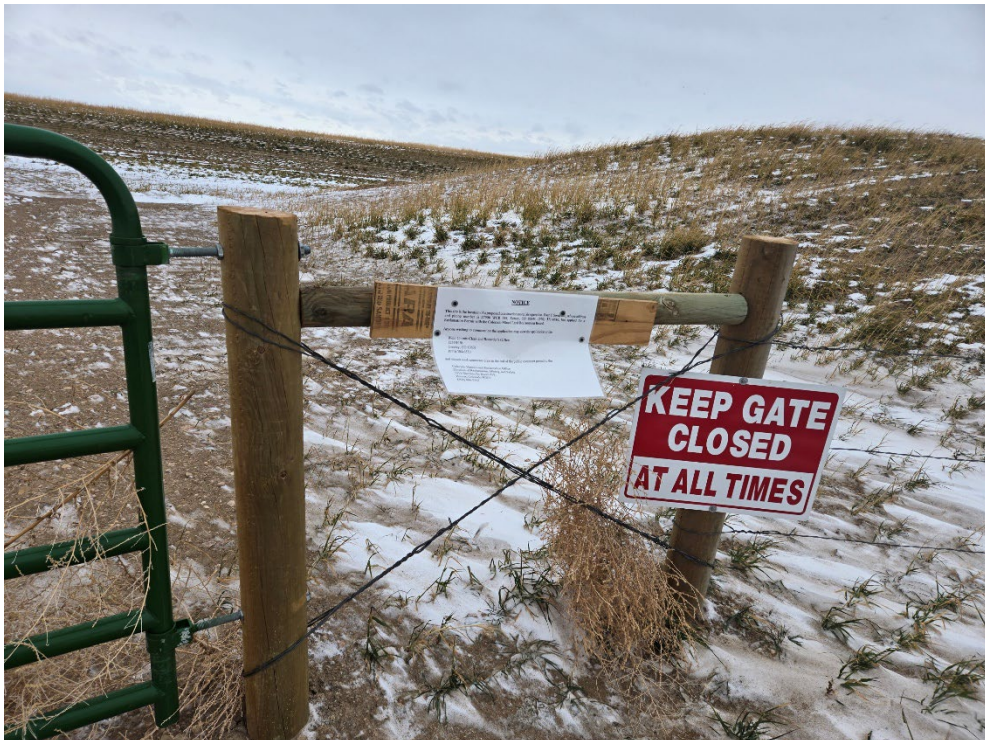
A notice sign was posted at the entrance to the site in compliance with Rule 1.6.2 (Photo 14).

Photo 14: Looking northeast from the entrance gate at the notice sign posted in compliance with Rule 1.6.2.

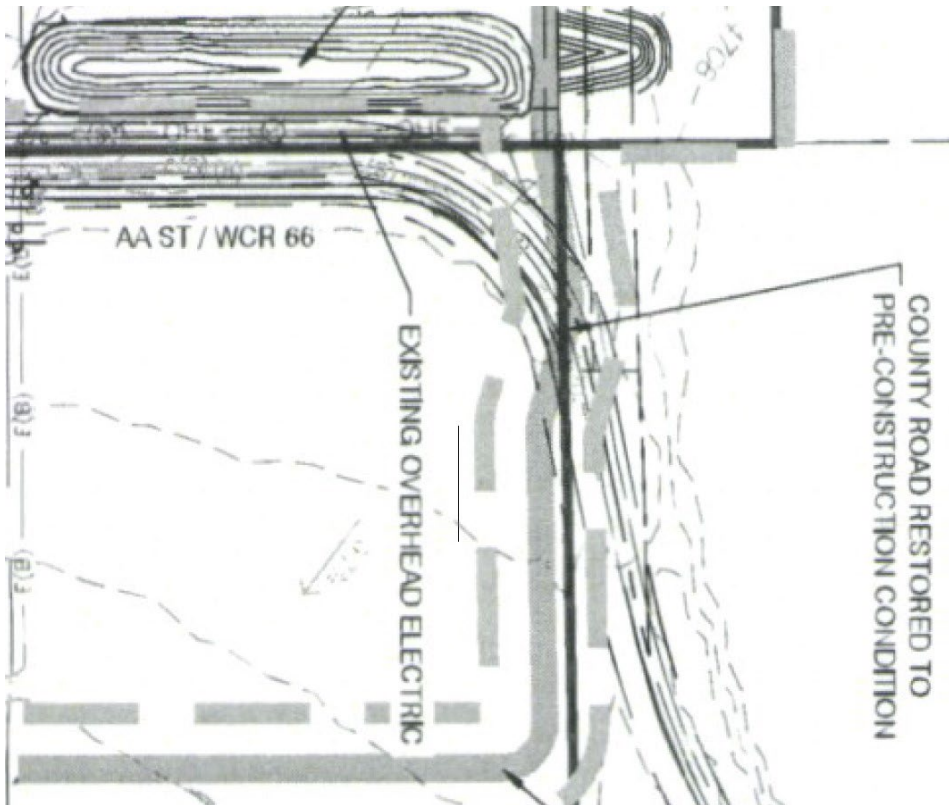
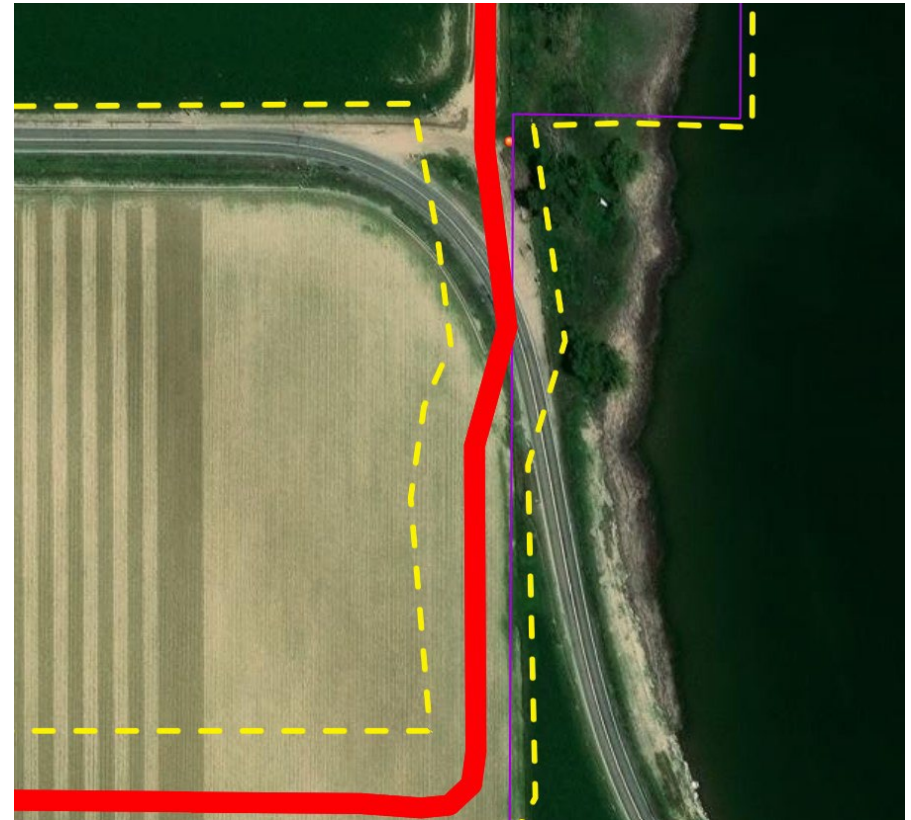
Figure 1: (Right) Excerpt from the Applicant's Reclamation Plan Map Option 2. The dashed lines indicate the Applicant's affected area boundary. (Left) Approximate location of the Applicant's affected area boundary (yellow dashed line), haul road (red line), property/parcel boundary included on the maps (purple line), overlain on aerial imagery that pre-dates the dredging operation in ArcOnline. The red dot indicates the location where inspection Photo #13 was taken. In comparison with the Applicant's maps, the location where excess material was stored on Ogilvy's land during the dredging project is included in the affected area boundary. The reclamation plan for this area will need to be addressed via the Applicant's response to the Division's adequacy review of the permit application.
