Huddleston-Berry
Engineering & Testing, LLC

Subject: Summary of Instrumentation Monitoring
4th Quarter 2024
Bowie Coal Waste Disposal Area No. 2
Paonia, Colorado

SUBJECT: Summary Report, 4th Quarter 2024, Inclinator and Active Vibrating Wire Piezometer Data October – December 2024, Bowie Mine #2 Coal Waste Disposal Area (CWDA) #2

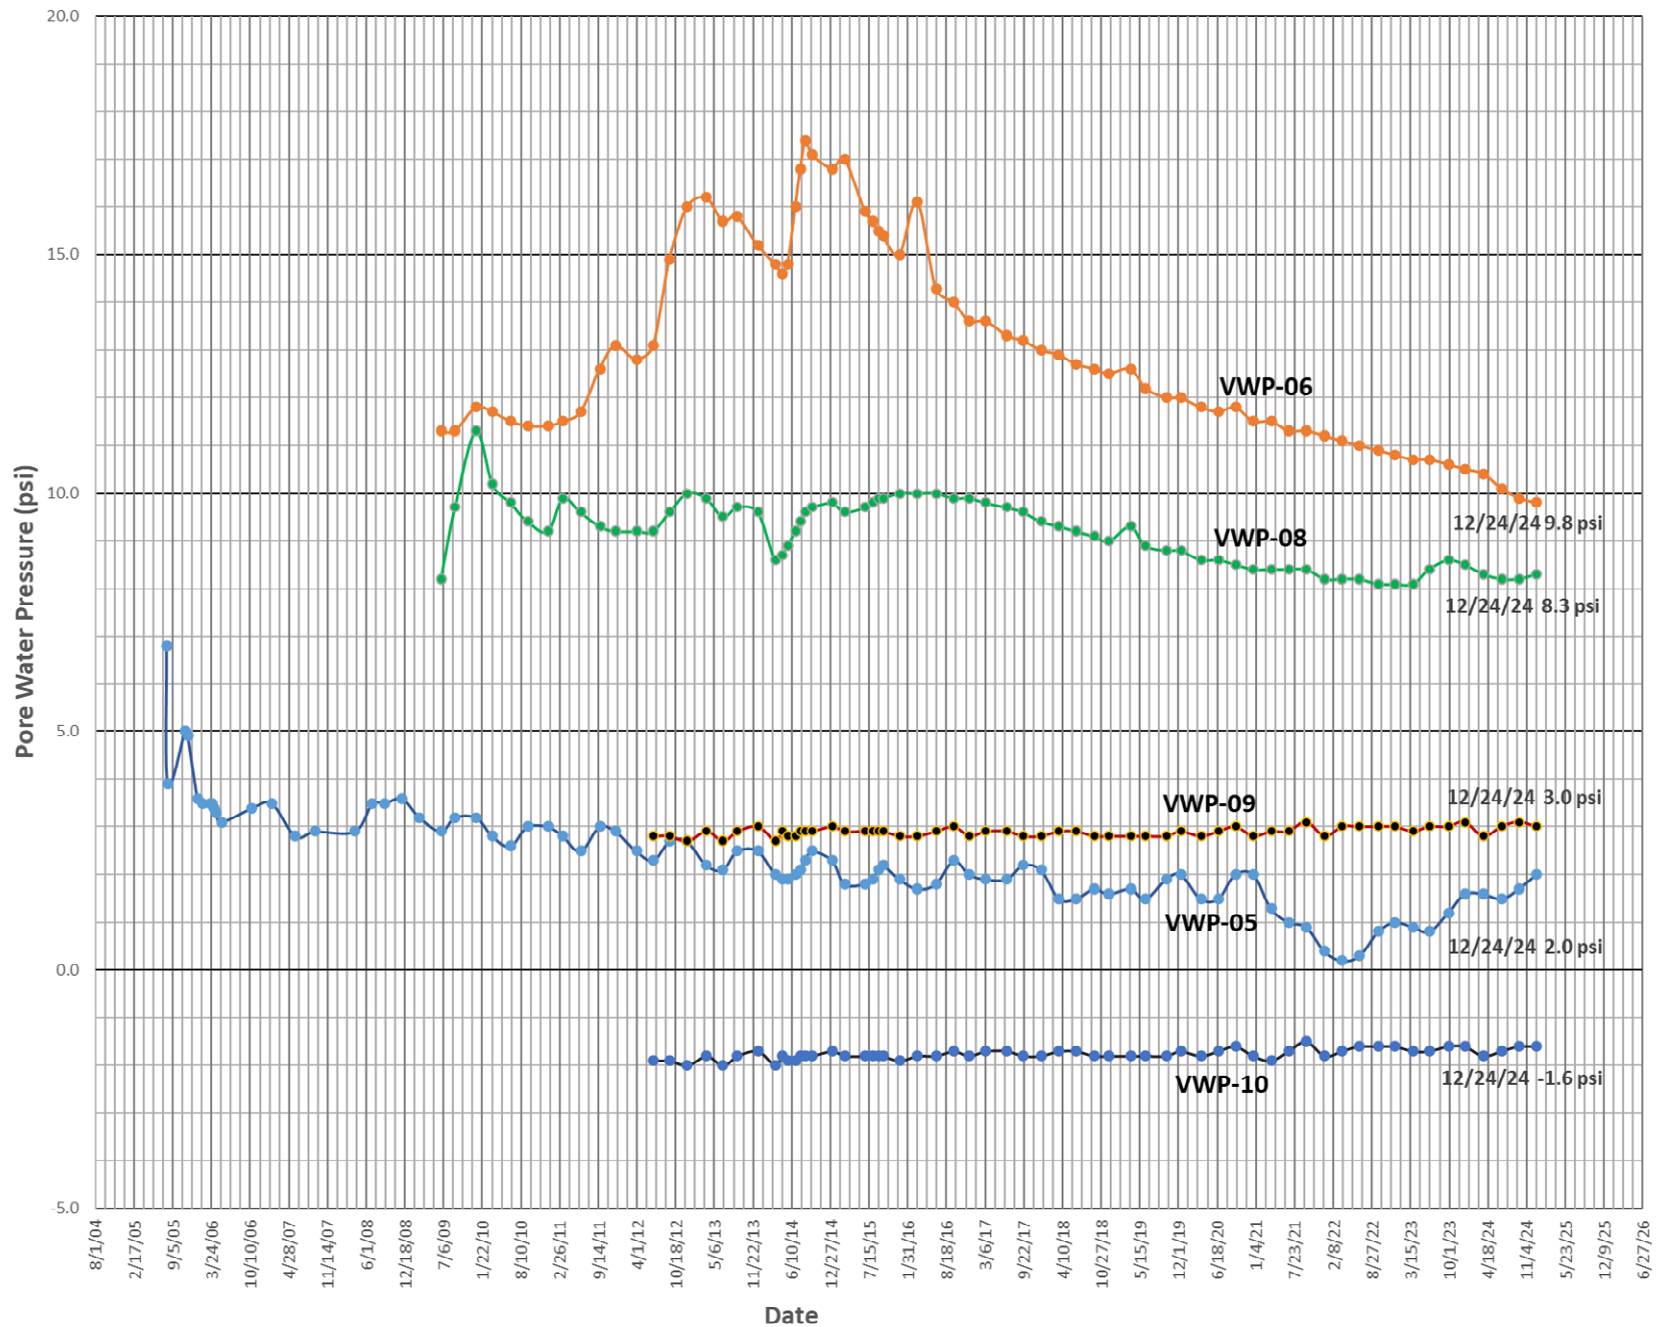
Figure 2 - Bowie Mine #2 - CWDA #2
Active Vibrating Wire Piezometer Data

As seen on Table 1 and Figure 2, the VWP readings and trends are consistent with recent and historic readings. When compared to a year ago (Q4 2023), pore pressure readings in three of the VWP's changed by small amounts (-0.7 to +0.4 psi), and one had no change (VWP-10). When compared with last quarter (Q3 2024), pore pressures also changed by relatively small amounts (-0.1 to 0.3 psi) for four of the VWP's, with VWP-10 showing no change since last quarter. Although four of the five VWP's remain steady or have general declining trends in pore pressure over the life of the VWP's, one of the piezometers (VWP-05) has exhibited pronounced seasonal cyclical behavior for its lifespan, except from mid-2021 to mid-2022 where there was a steady decline in pore pressures. This piezometer generally (but not always) shows low pore pressures for Q1 and Q2 and higher pressures for Q3 and Q4, with a net loss of -4.8 psi over the lifetime of that VWP. The other four VWP's have experienced net changes of -1.5 to 0.3 psi since installation, meaning current readings are very similar to initial readings. For VWP-09 and VWP-10, pressures have been consistent throughout the lifetime of the piezometers; however, for VWP-06 and VWP-08, they experienced wild fluctuations in pore water pressure in the first half of their lifetimes but have settled to pressures similar to the installation pressures.

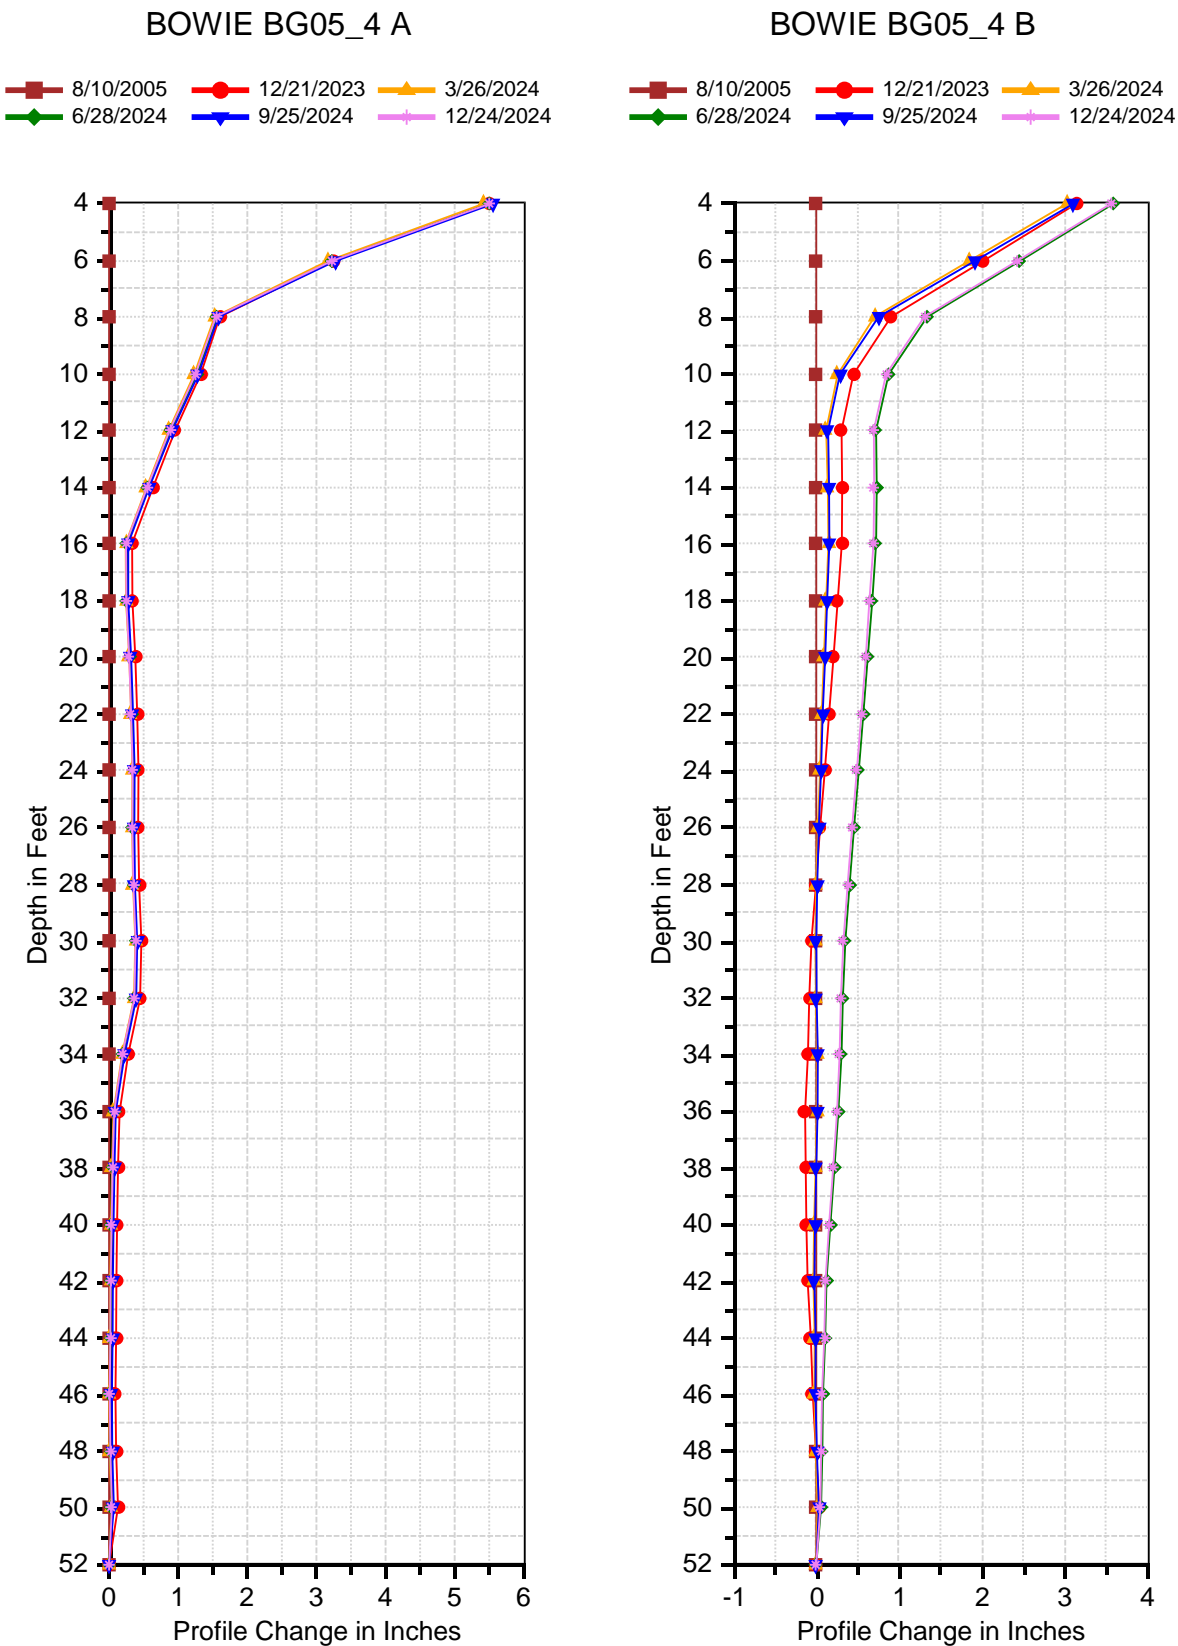
Figure 3 - Inclinometer Displacement Curves

As described in previous reports, historic downslope displacements indicated on the plots for the approximate upper 14-16 feet of the inclinometers since installation in 2005 are due to placement of cover soil on the face of the waste pile during revegetation/regrading operations in late 2006 and early 2007. This man-caused displacement is documented in a report by Buckhorn Geotech dated December 22, 2008, to Bowie Resources called *Revised Stability Evaluations for Coal Mine Waste Disposal Area No. 2, Bowie No. 2 Mine*.

Based on the current inclinometer readings, BG05_7 shows near perfect alignment (essentially identical readings for the past 19 years) with the initial reading in 2005 for the downslope direction (Axis A). Inclinometers BG05_4 and BG05_5, however, show a bulge of less than 1/2-inch in the inclinometer pipes below the surface regrading. Based on our records, this bulge developed slowly from 2005 to 2010, but no movement has been recorded since then. This suggests there had been some gob pile settlement early in the lifetime of the inclinometers, but no recent or additional movement has occurred. Some "noise" which is understood to be

relatively common in orthogonal direction (Axis B) readings, was observed over the past few years for all three inclinometers. All readings were consistent with previous readings and the "displacement" error was within equipment tolerances and not deemed to be due to slope movement.
