Keenesburg No. 2 Mine- October 2024 Inspection Report and Updated Bond

MINERALS PROGRAM INSPECTION REPORT
PHONE: (303) 866-3567

MINE NAME: Keenesburg No. 2 Mine	MINE/PROSPECTING ID#: M-2019-058	MINERAL: Sand	COUNTY: Weld
INSPECTION TYPE: Monitoring	WEATHER: Clear	INSP. DATE: October 2, 2024	INSP. TIME: 10:00am
OPERATOR: Colorado Sand Company LLC	OPERATOR REPRESENTATIVE: Brady Reece	TYPE OF OPERATION: 112c - Construction Regular Operation	
REASON FOR INSPECTION: Normal I&E Program	BOND CALCULATION TYPE: Complete	BOND AMOUNT: \$6,981,069	
DATE OF COMPLAINT: NA	POST INSP. CONTACTS: None	JOINT INSP. AGENCY: None	
INSPECTOR(S): Chris Girardi Jared Ebert	INSPECTOR'S SIGNATURE:

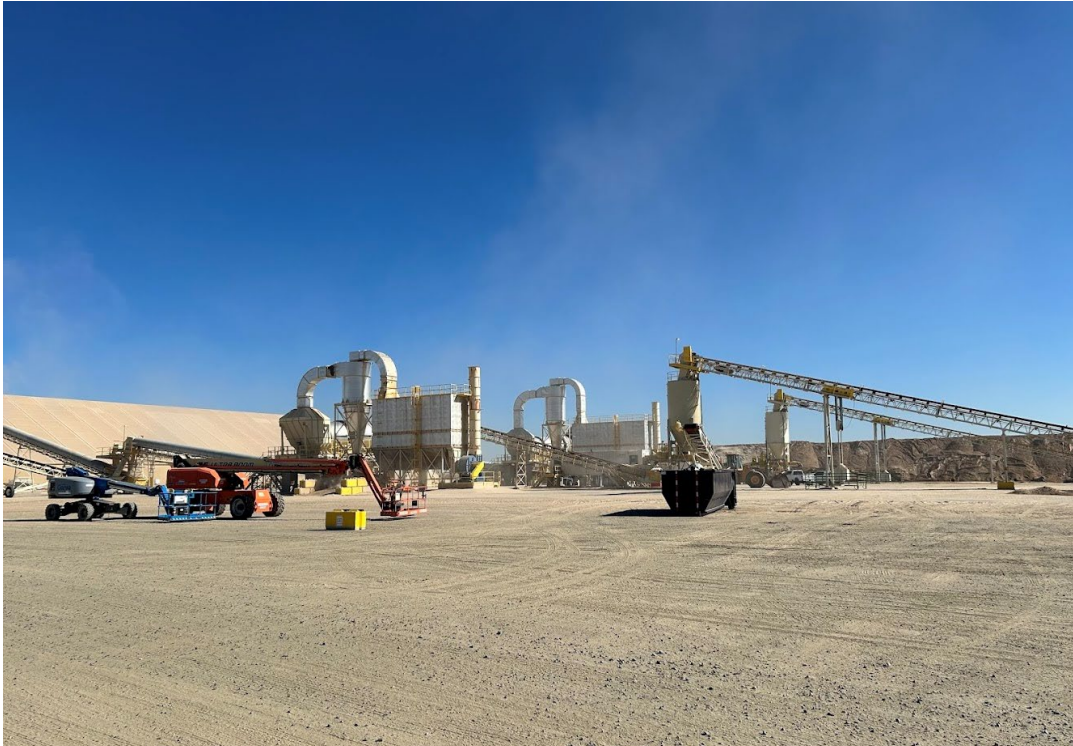
Photo 1: View of Processing Area, including the Dryer Units, facing northeast.

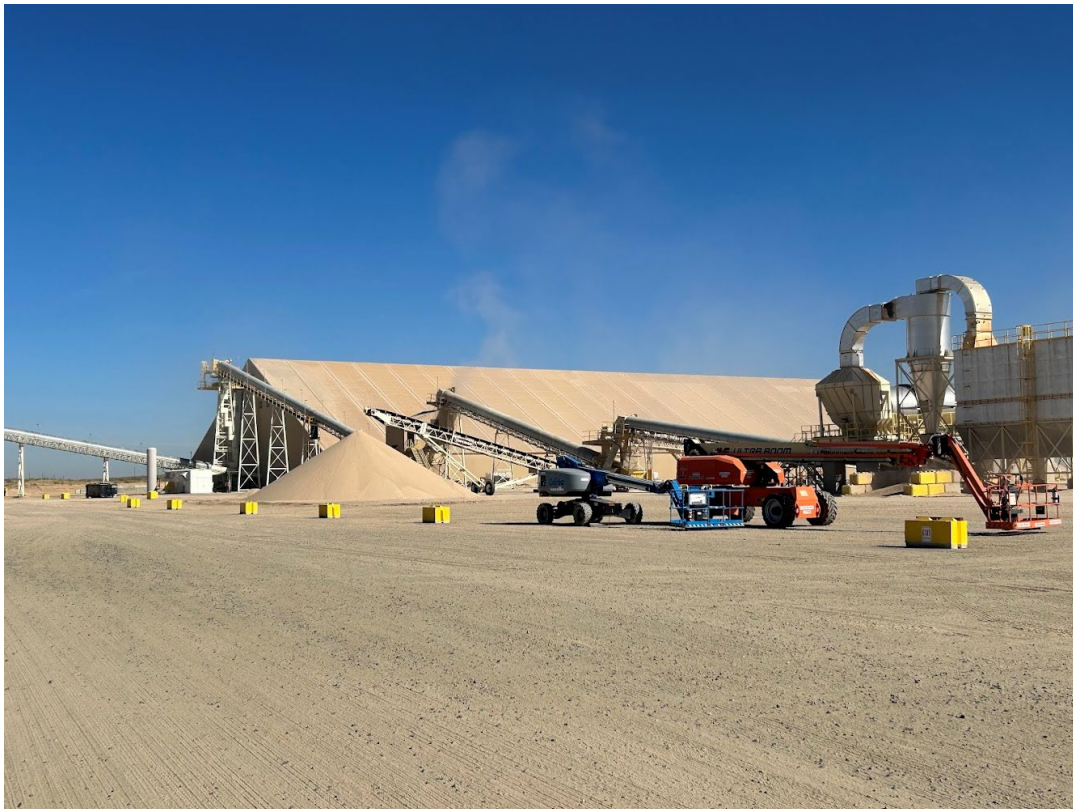
Photo 2: View of the Processing Area, including the Dry Sand Storage Building, Dryer Units, and Air Compressor, facing.

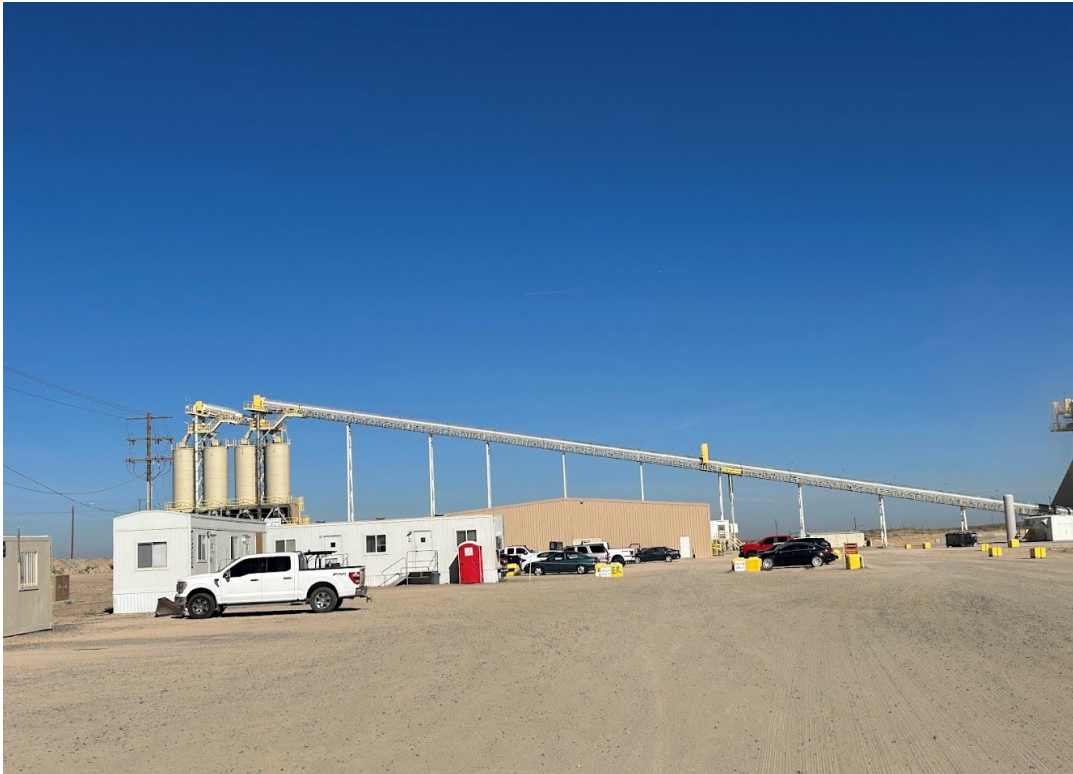
Photo 3: Mine Office within Processing Area, facing north.

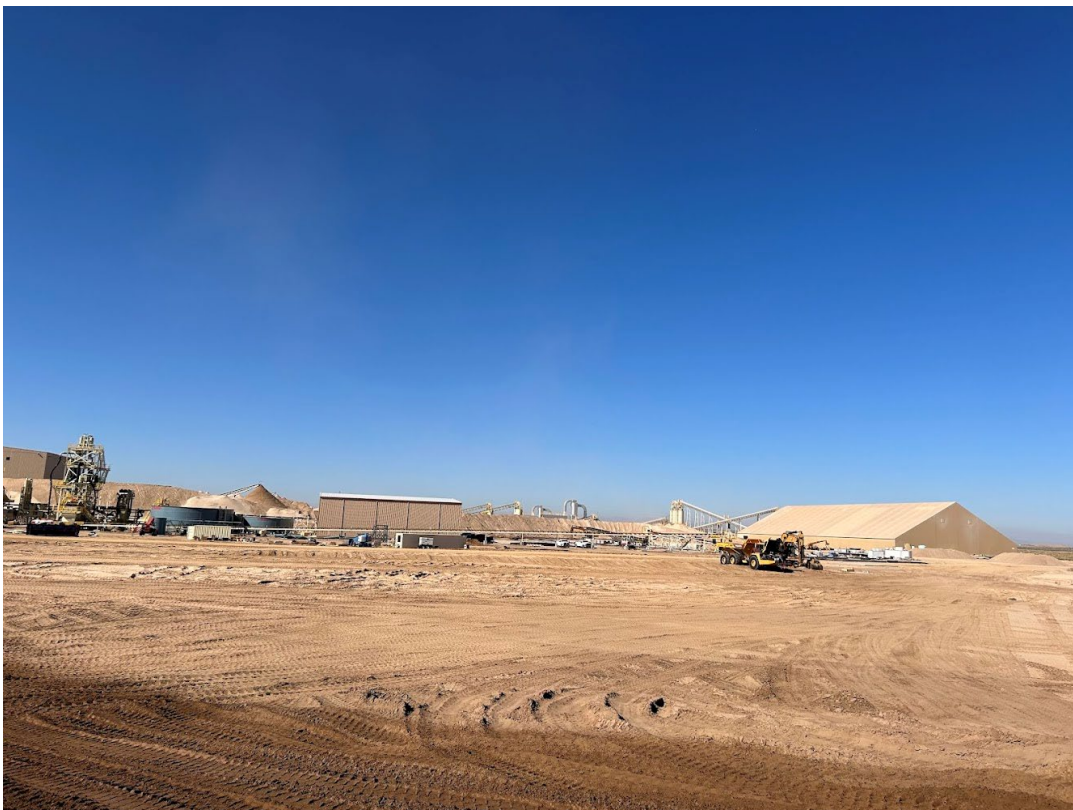
Photo 4: View of Processing Area from the east, facing west.

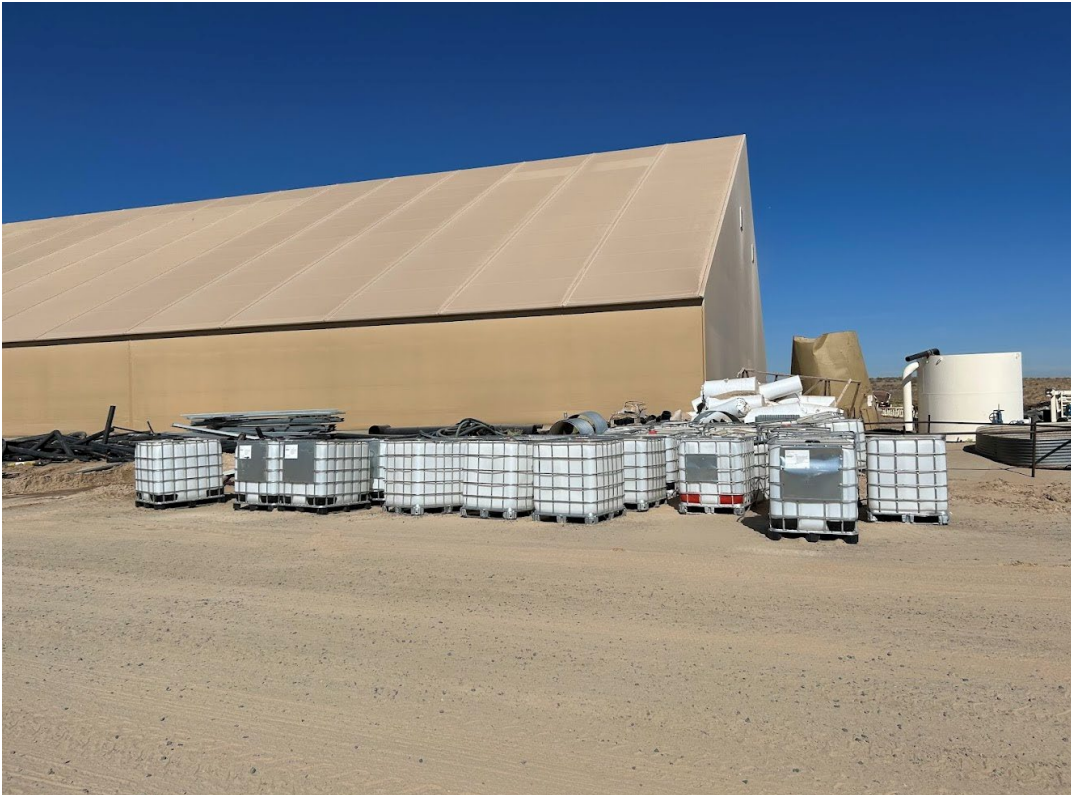
Photo 5: Several totes within the Processing Area.

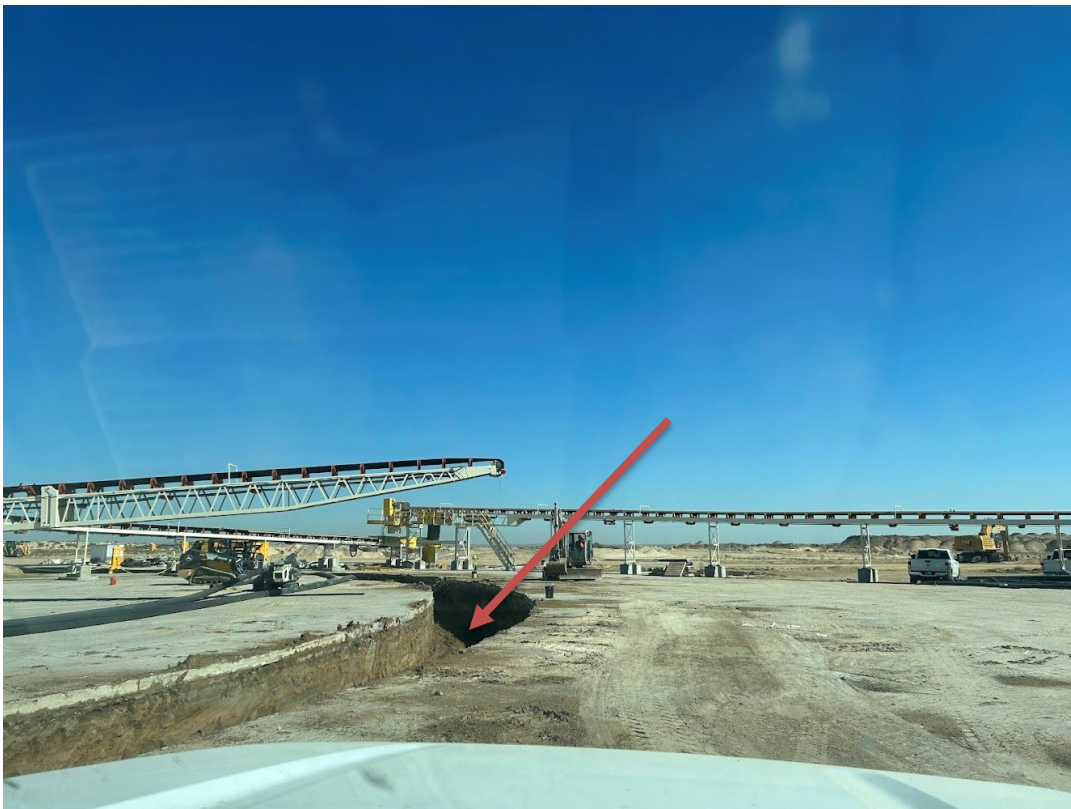
Photo 6: French drain within the processing area.

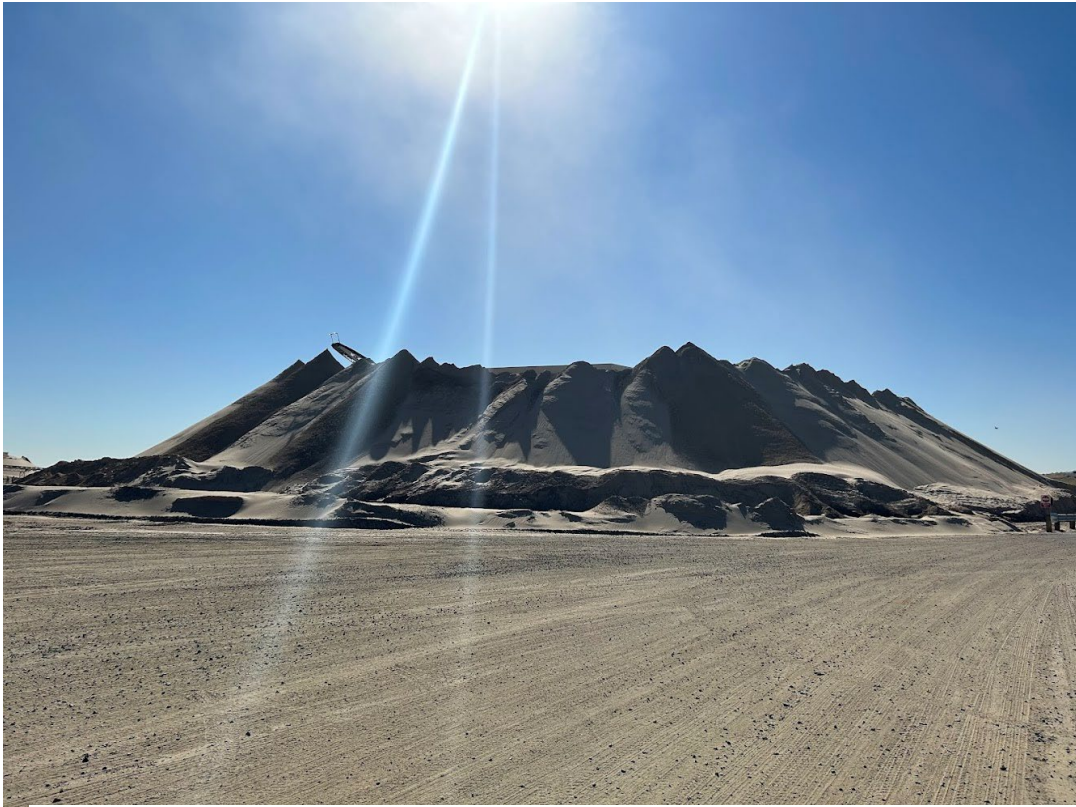
Photo 7: The ROM stockpile located to the south of the Processing Area.

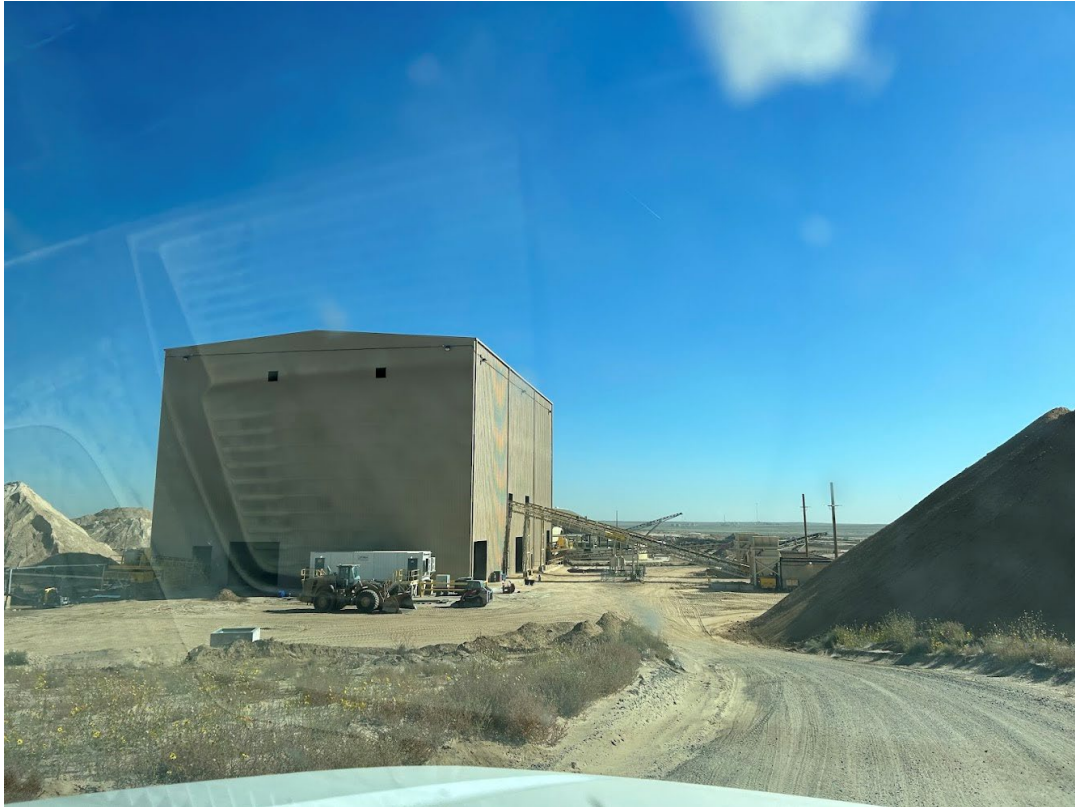
Photo 8: Wash processing building adjacent to the southeast of the ROM stockpile, facing west.

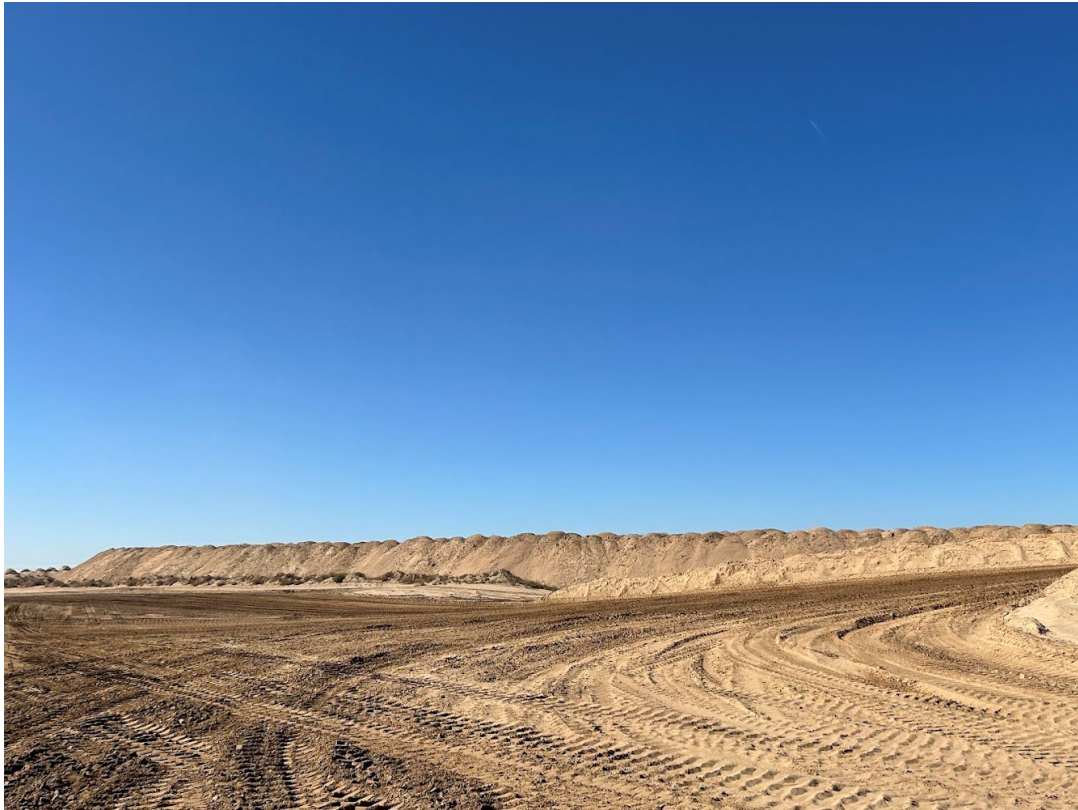
Photo 9: Stockpile in the Year 1 Area.

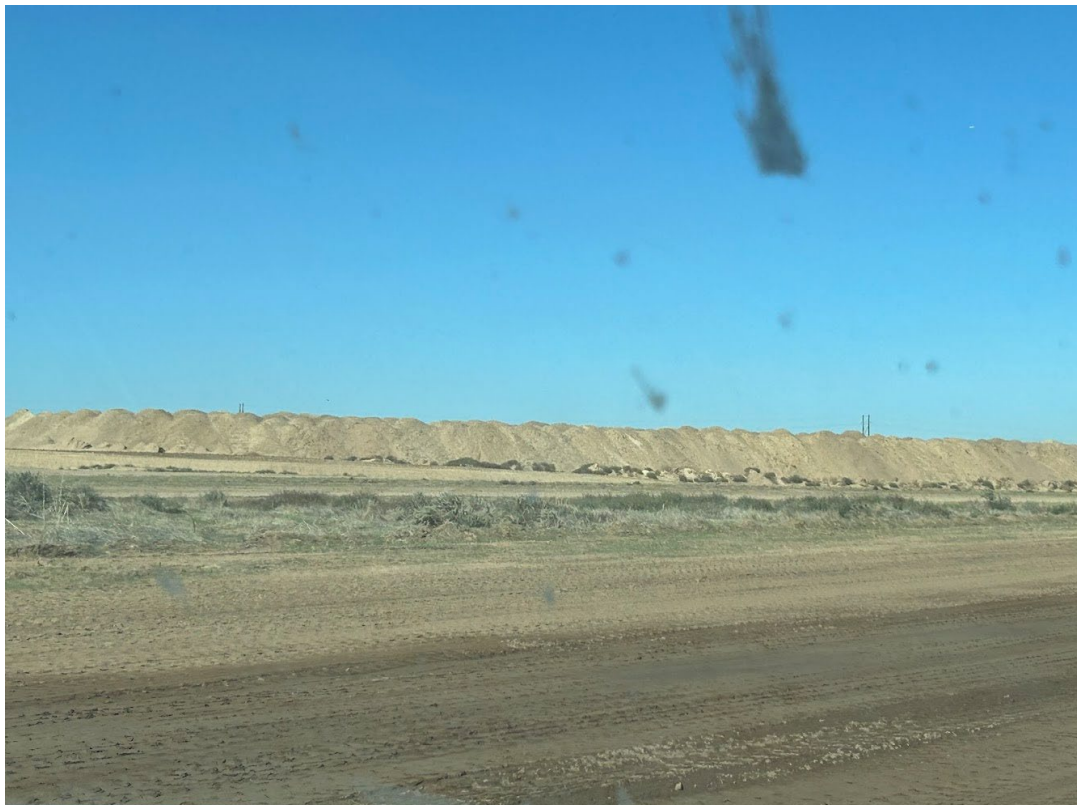
Photo 10: Topsoil stockpile in the Year 1 Area.

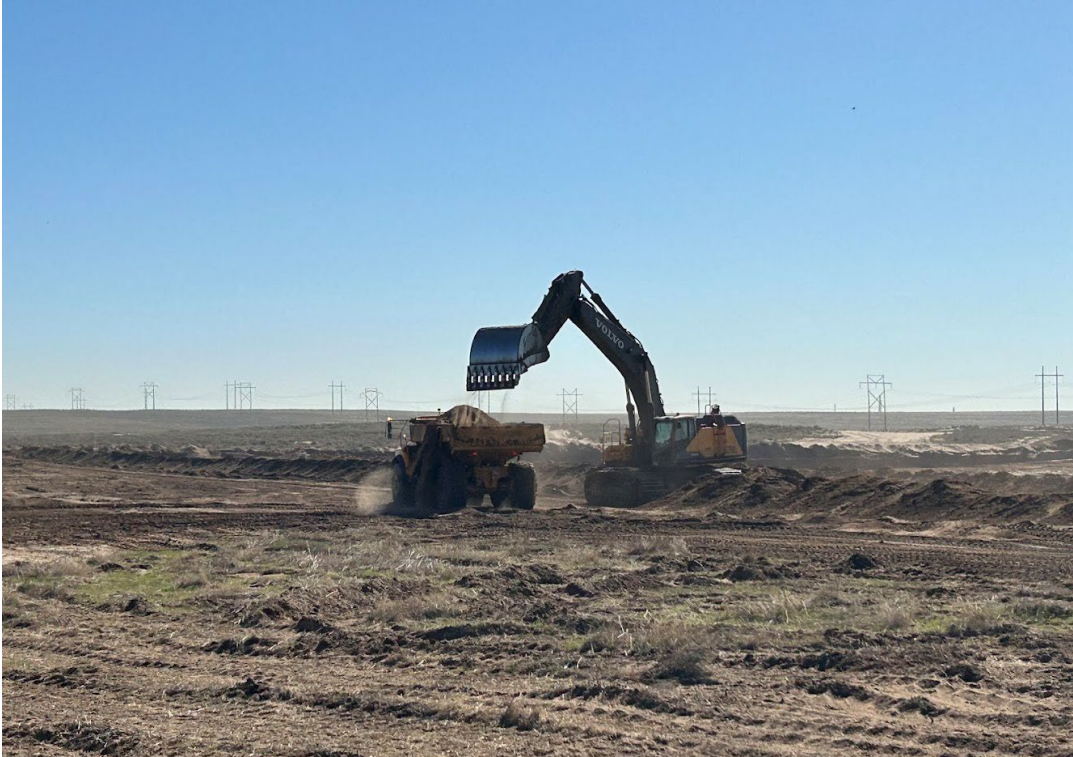
Photo 11: Excavator and Haul Truck mining in the Year 2 Area, facing south.

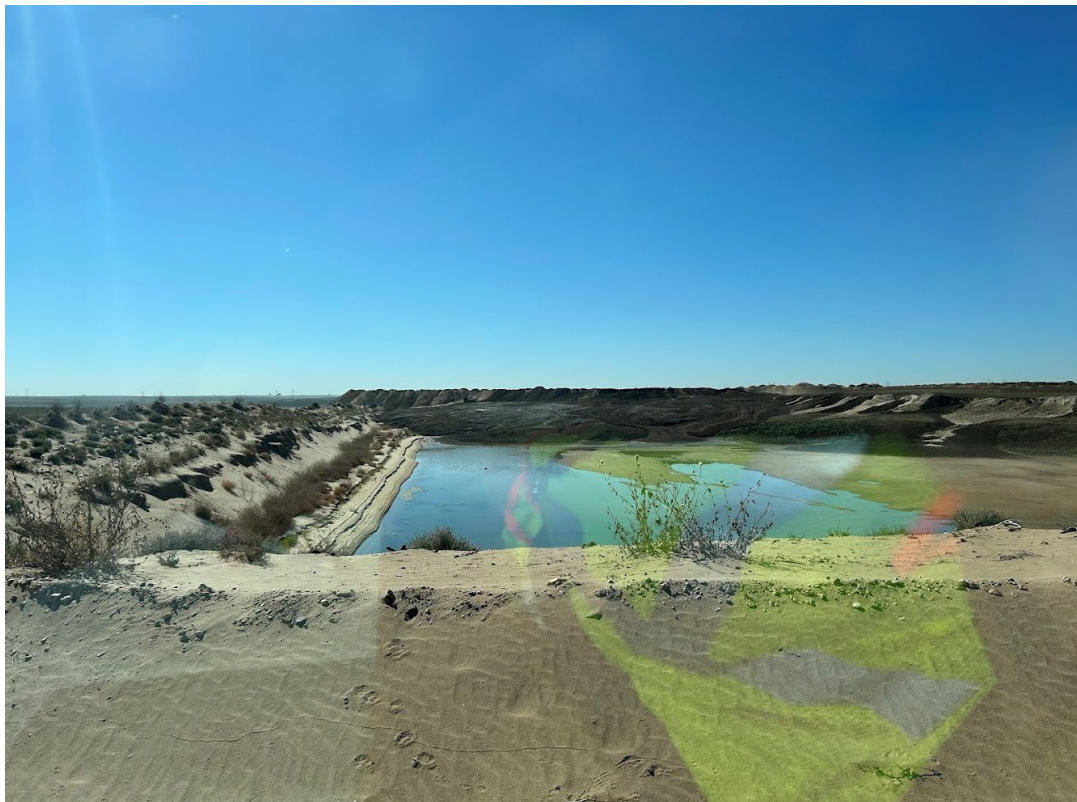
Photo 12: Settling pond in the northern portion of the Year 1 area.
