## C-1981-035 Jan 2025 Partial Inspection Report

<b>Permit Number:</b> C-1981-035 <b>Mine Name:</b> King Coal Mine <b>Operator:</b> GCC Energy, LLC <b>Operator Address:</b> Mr Jordan McCourt 6473 County Road 120 Hesperus, CO 81326	<b>County:</b> La Plata <b>Operation Type:</b> Underground <b>Permit Status:</b> Active <b>Ownership:</b> Private  <b>Operator Representative Present:</b>  Wade Wymore
<b>Operator Representative Signature: (Field Issuance Only)</b>

<b>Inspection Start Date:</b> January 14, 2025 <b>Inspection Start Time:</b> 14:20 <b>Inspection End Date:</b> January 14, 2025 <b>Inspection End Time:</b> 15:30	<b>Inspection Type:</b> Coal Partial Inspection <b>Inspection Reason:</b> Normal I&E Program <b>Weather:</b> Clear
<b>Joint Inspection Agency:</b>  None	<b>Joint Inspection Contacts:</b>
<b>Post Inspection Agency:</b>  None	<b>Post Inspection Contacts:</b>
<b>Inspector(s):</b>  Lucas West	<b>Inspector's Signature:</b>

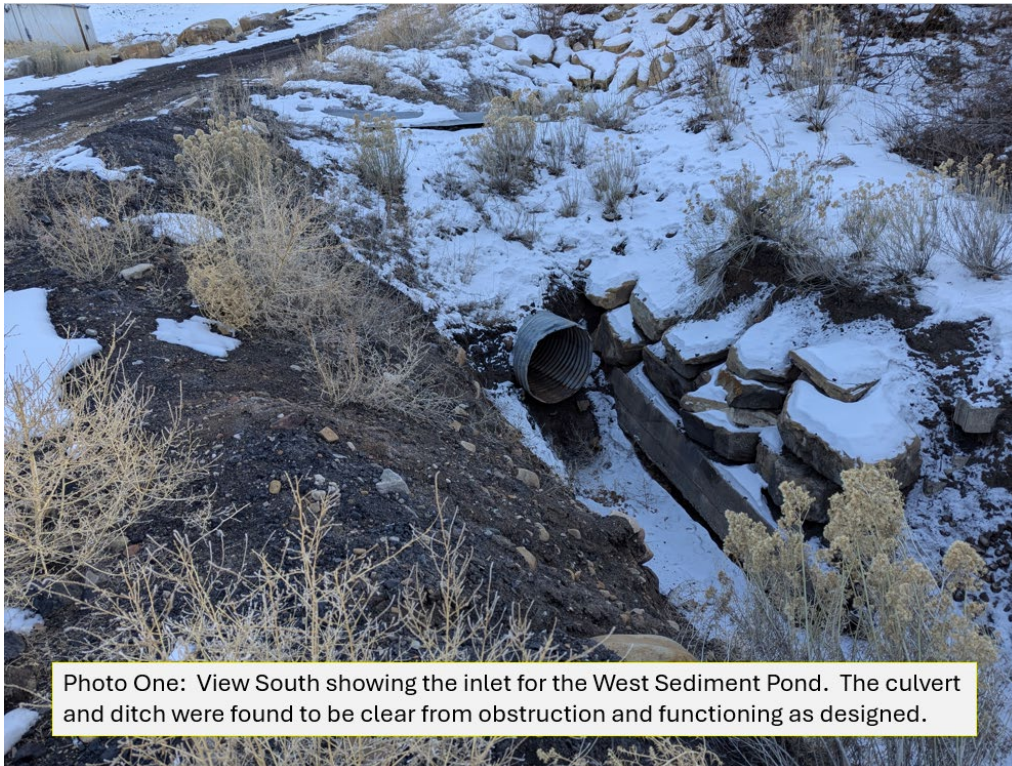
The inlets to both the East and West Sediment Ponds at the King I Facility were observed as well as the sediment levels in the ponds. At the West Pond the inlet was found to be free from obstruction and able to function as designed as seen in Photo One. The pond contained minimal frozen water as seen in Photo Two. The water, including sediment load, was well below both the discharge and cleanout elevation. The East Pond contained no water nor showed any evidence of recent impoundment. The sediment load was well below the cleanout witness line on the pond marker.

Photo One: View South showing the inlet for the West Sediment Pond. The culvert and ditch were found to be clear from obstruction and functioning as designed.

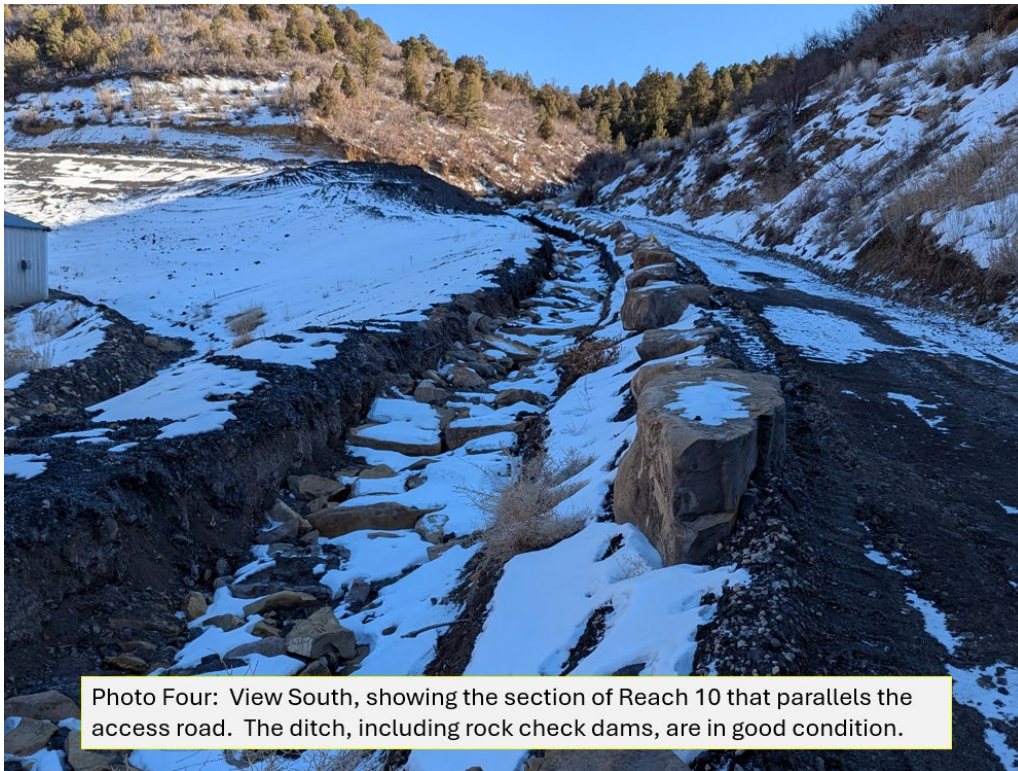
Additionally, at the King I facility, Reaches 10 and 13 of the internal drainage system around the Lower Refuse Pile were observed. Reach 10 follows along the South and West sides of the LRP, paralleling the access road towards the sump. The culvert flowing into Reach 10 was found to be in good working order and free from obstruction. As the ditch flows along the South and West sides of the LRP it was found to be free from obstruction and able to function as designed. An example can be seen in Photo Three. As the ditch parallels the access road, the rock check dams were found to be in good condition and appeared to be functioning as designed.

This section of the ditch can be seen in Photo Four. Similarly, Reach 13 that flows along the North side of the LRP before terminating in the sump near the toe of the slope, was also in good condition, free from obstruction and appears to be functioning as designed. Photo Five shows an example of Reach 13.

Photo Four: View South, showing the section of Reach 10 that parallels the access road. The ditch, including rock check dams, are in good condition.

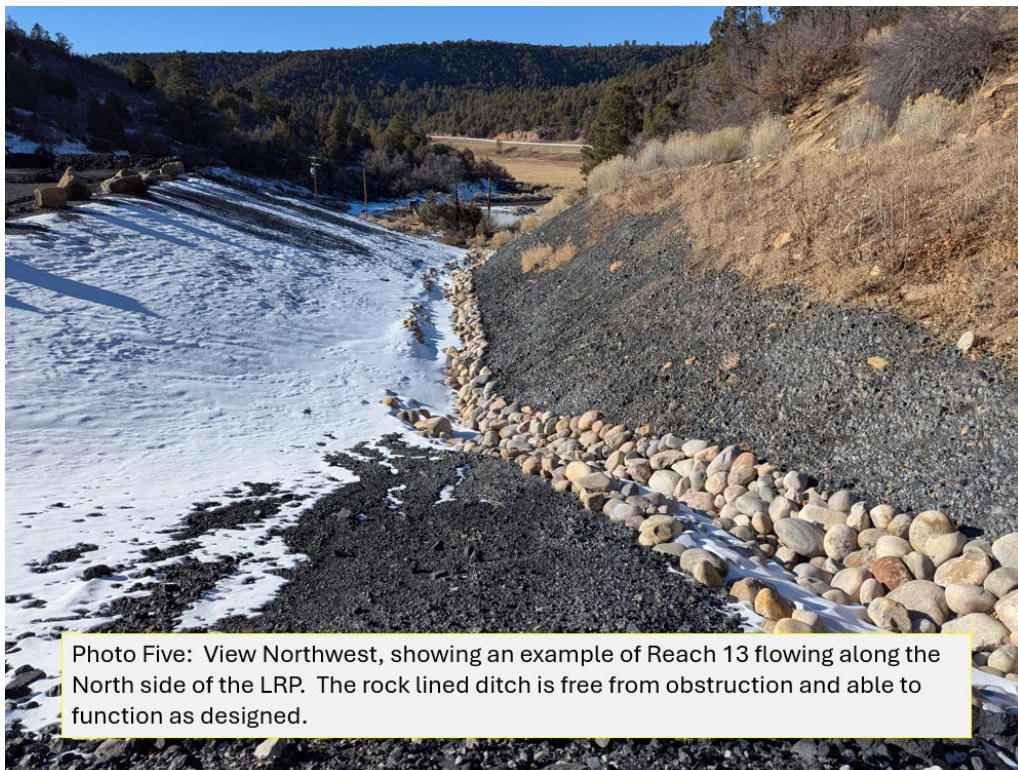
Photo Five: View Northwest, showing an example of Reach 13 flowing along the North side of the LRP. The rock lined ditch is free from obstruction and able to function as designed.

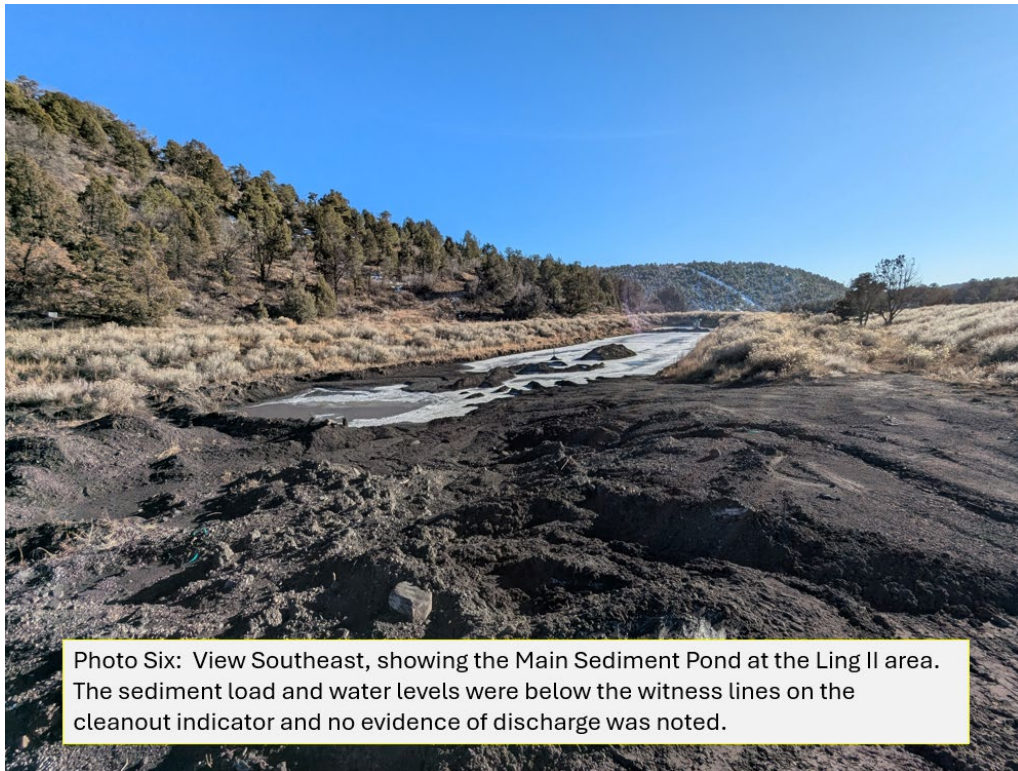
At the King II facility, the main sediment pond was observed and can be seen in Photo Six. The pond contained minimal standing water that was frozen at the time of the inspection. The sediment levels vary across the pond as the cleanout efforts conducted during the summer months are ongoing. Both the water and the sediment levels were well below the witness lines on the indicator found in the pond. Additionally, the water level was well below the discharge elevation and no evidence of discharge was noted.

Photo Six: View Southeast, showing the Main Sediment Pond at the Ling II area. The sediment load and water levels were below the witness lines on the cleanout indicator and no evidence of discharge was noted.

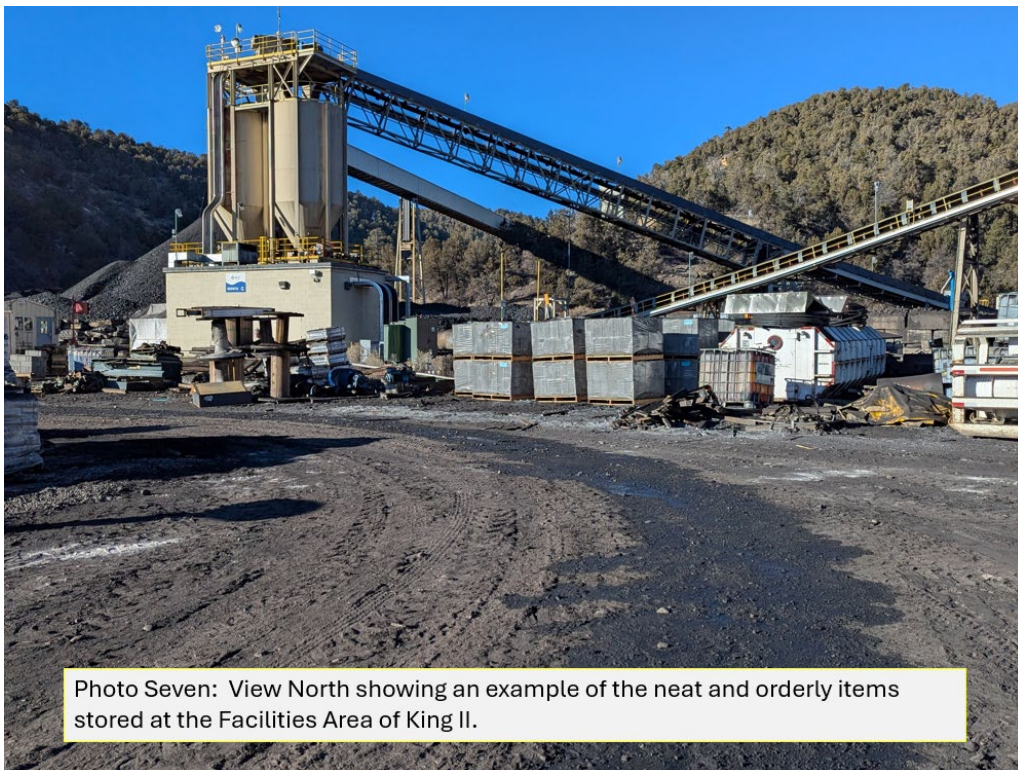
Near the main sediment pond at King II a large yard is used for storage and facilities. Miscellaneous mining and surface support related items and equipment are utilized and stored in the area. Of all of the items found in the area, they were all stored in a neat and orderly fashion and no excessive trash or debris was noted. All areas are extremely well kept, with all trash and deleterious items being stored in roll off dumpsters or bins. Photos Seven and Eight show examples of the Facilities Area.

Photo Seven: View North showing an example of the neat and orderly items stored at the Facilities Area of King II.
