Inouye Gravel Mine Inspection Report

MINERALS PROGRAM INSPECTION REPORT
PHONE: (303) 866-3567

MINE NAME: Inouye Gravel Mine	MINE/PROSPECTING ID#: M-2018-037	MINERAL: Overburden and sand	COUNTY: Weld
INSPECTION TYPE: Monitoring	WEATHER: Clear	INSP. DATE: November 20, 2024	INSP. TIME: 13:00
OPERATOR: BURNCO Colorado, LLC	OPERATOR REPRESENTATIVE: Joel Bolduc	TYPE OF OPERATION: 112c - Construction Regular Operation	
REASON FOR INSPECTION: Normal I&E Program	BOND CALCULATION TYPE: Complete Bond	BOND AMOUNT: \$4,446,424.00	
DATE OF COMPLAINT: NA	POST INSP. CONTACTS: None	JOINT INSP. AGENCY: None	
INSPECTOR(S): Nikie Gagnon	INSPECTOR'S SIGNATURE:

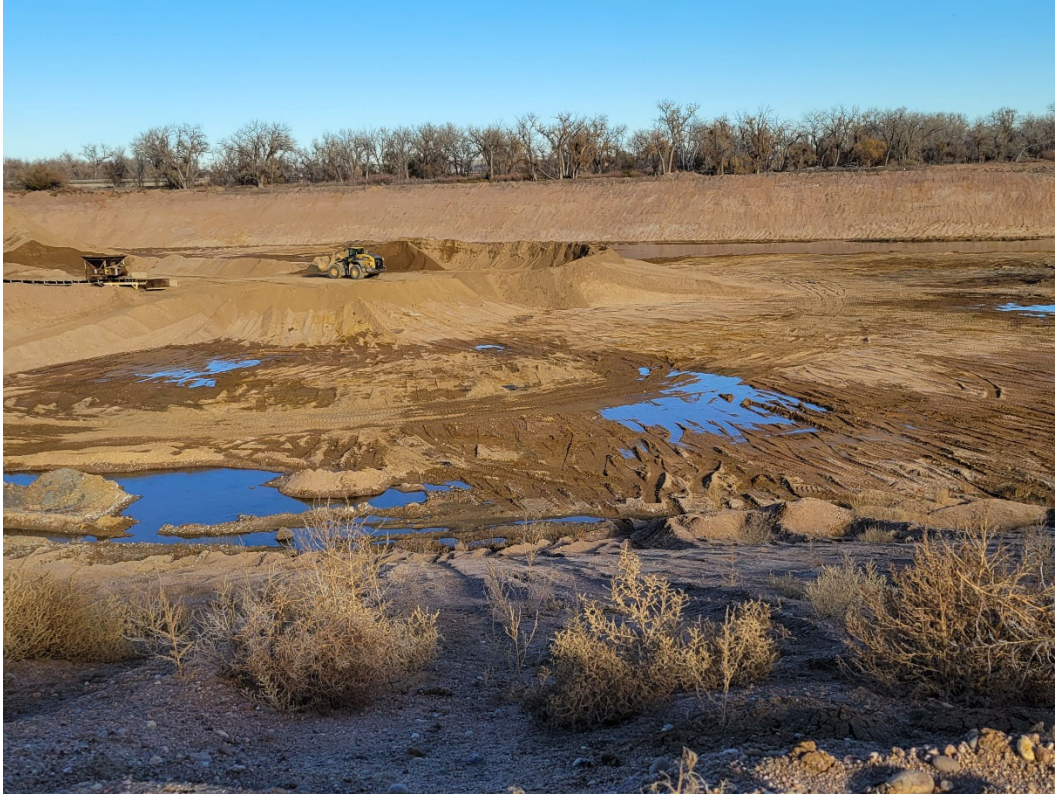
Mining at the site is occurring within the approved liner of a slurry wall. The slurry wall for the northeast cell was provisionally approved by the State Engineer on January 13, 2023. The slurry wall for the northwest cell was completed as of April 2024. During the inspection, the Division observed active mining in the northeast cell. The slopes around the perimeter have been graded to 3H:1V in accordance with the approved reclamation plan. An operating conveyor was observed in the center of the mine site. The conveyor was moving material from the northeast cell to the processing area in the northwest.

Photo 1: Looking south at active mining in the northeast cell.

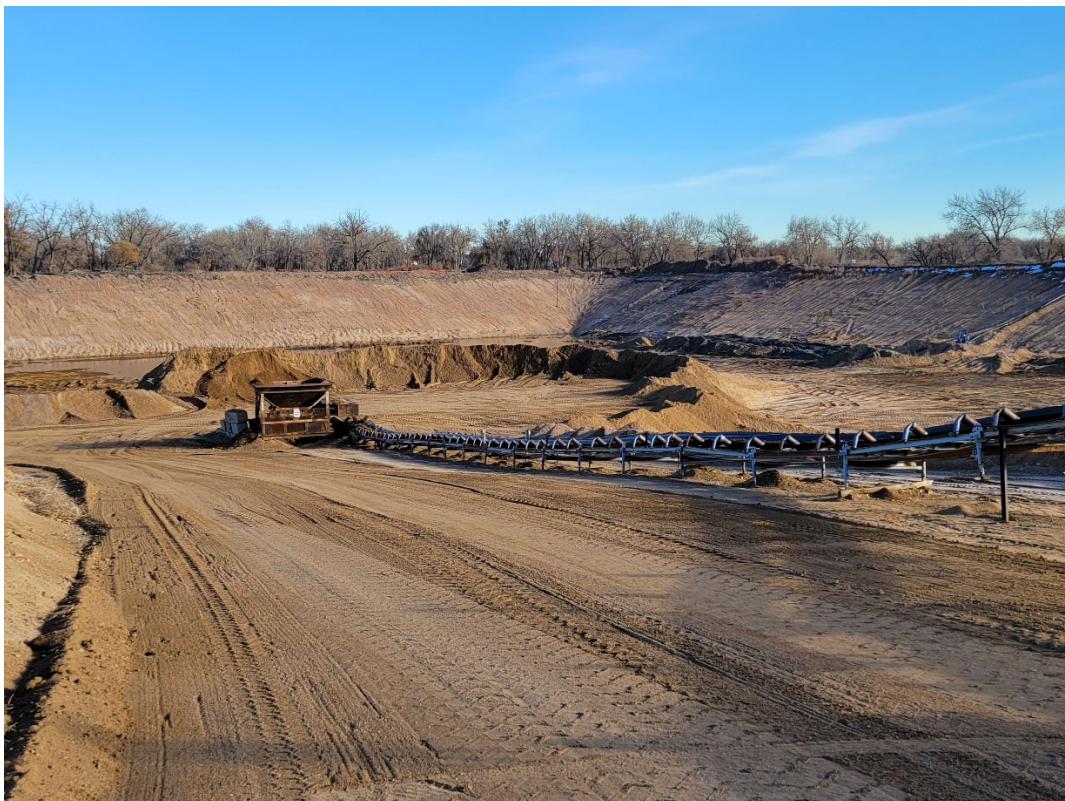
Photo 2: Looking southeast at the conveyor in the northeast cell.

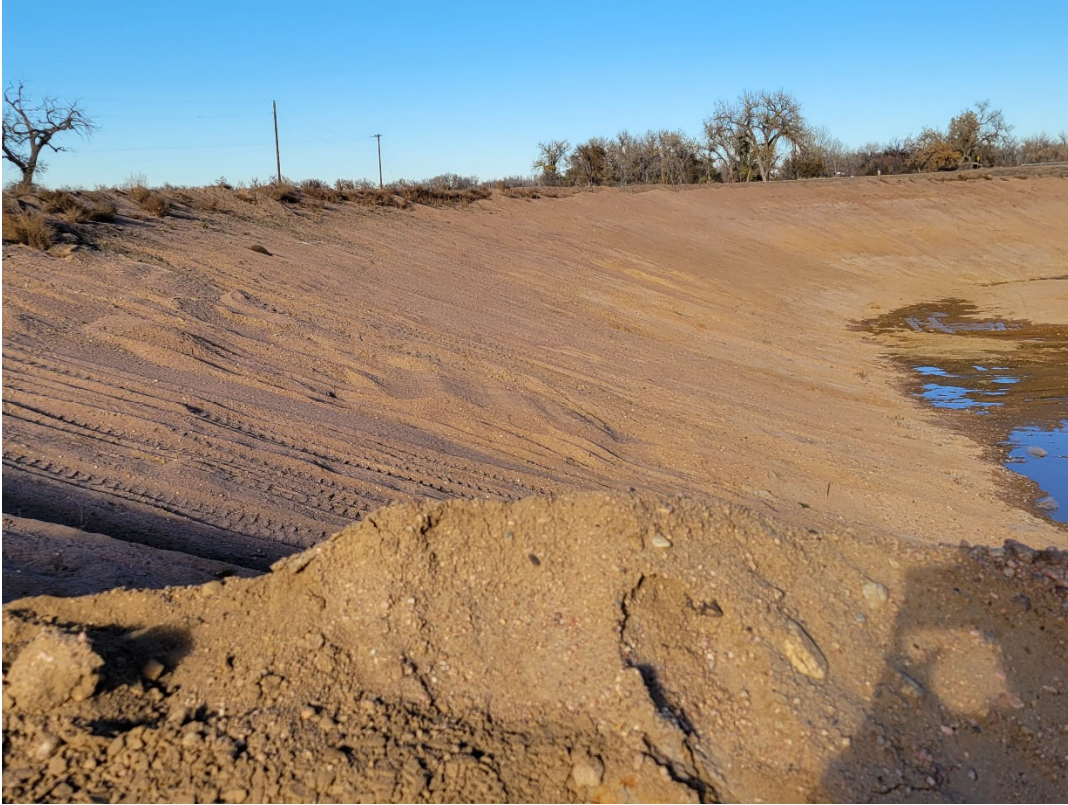
Photo 3: Looking at the graded slopes on the north side of the northeast cell.

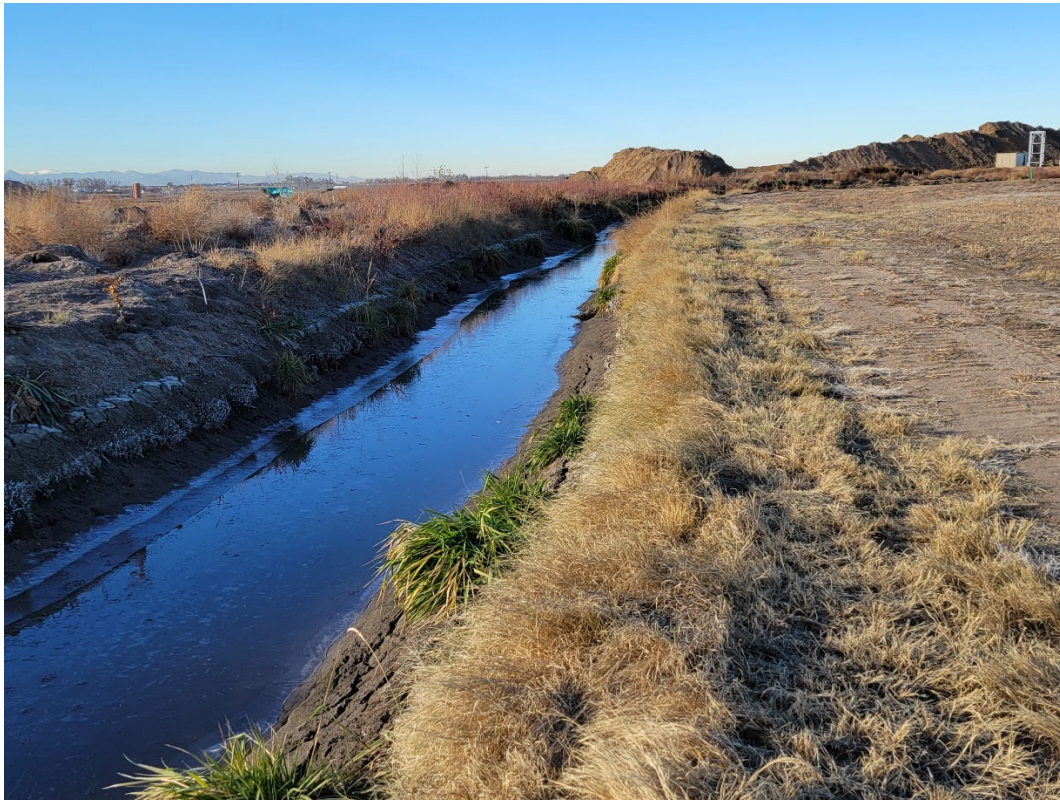
The Lupton Bottom Ditch separates the northwest and the northeast cells. The Division observed water flowing in the ditch during this inspection. In compliance with the Division of Water Resources requirements, the site has an approved Substitute Water Supply Plan (WDID 0202668) to replace depletions resulting from the mining including evaporation from exposed groundwater, dust suppression, past dewatering, water lost with the mined product, and water used for slurry construction. The current SWSP is effective from of April 1, 2024 through March 31, 2025.

Photo 4: Looking down the Lupton Bottom Ditch separates the northwest and the northeast cells

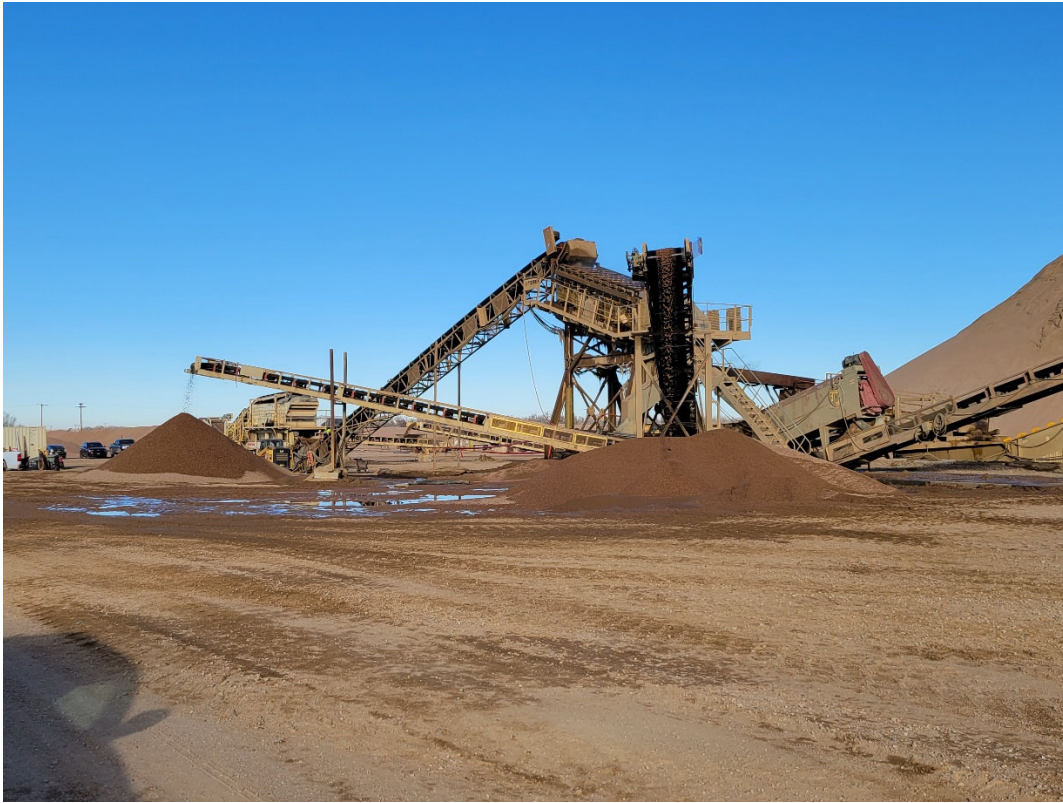
Photo 5: Looking at processing facility in the northwest cell.

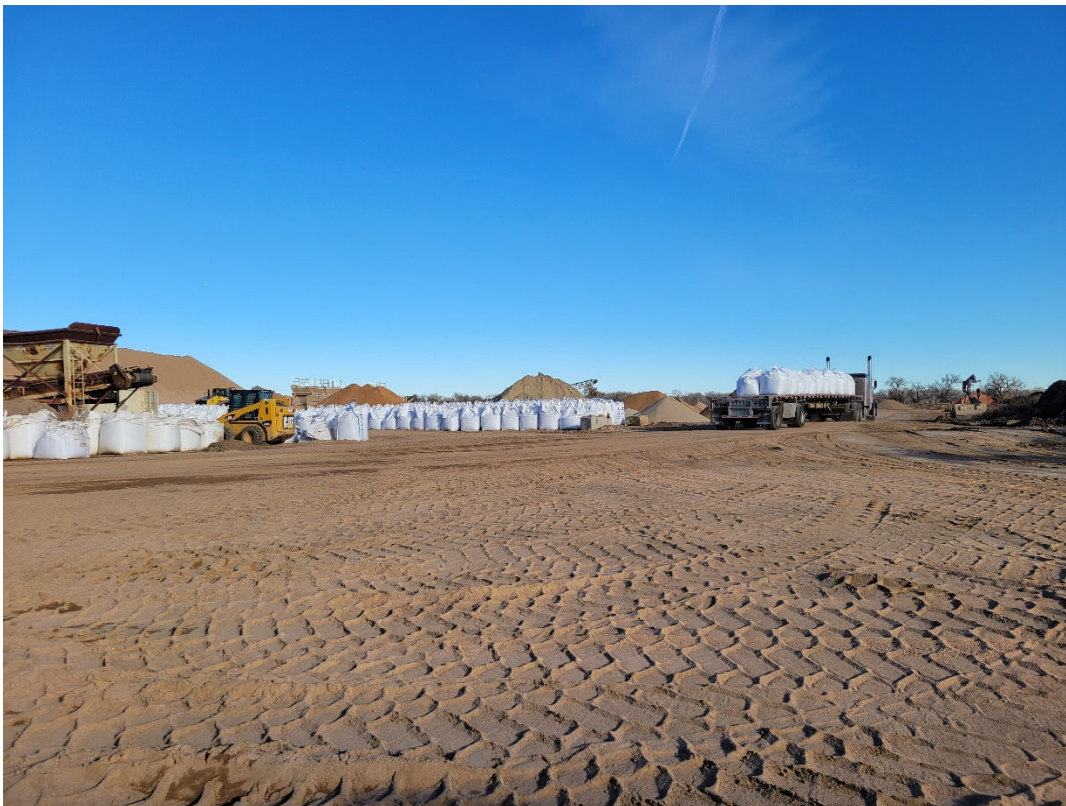
Photo 6: Looking at product stored bags in the northeast cell.

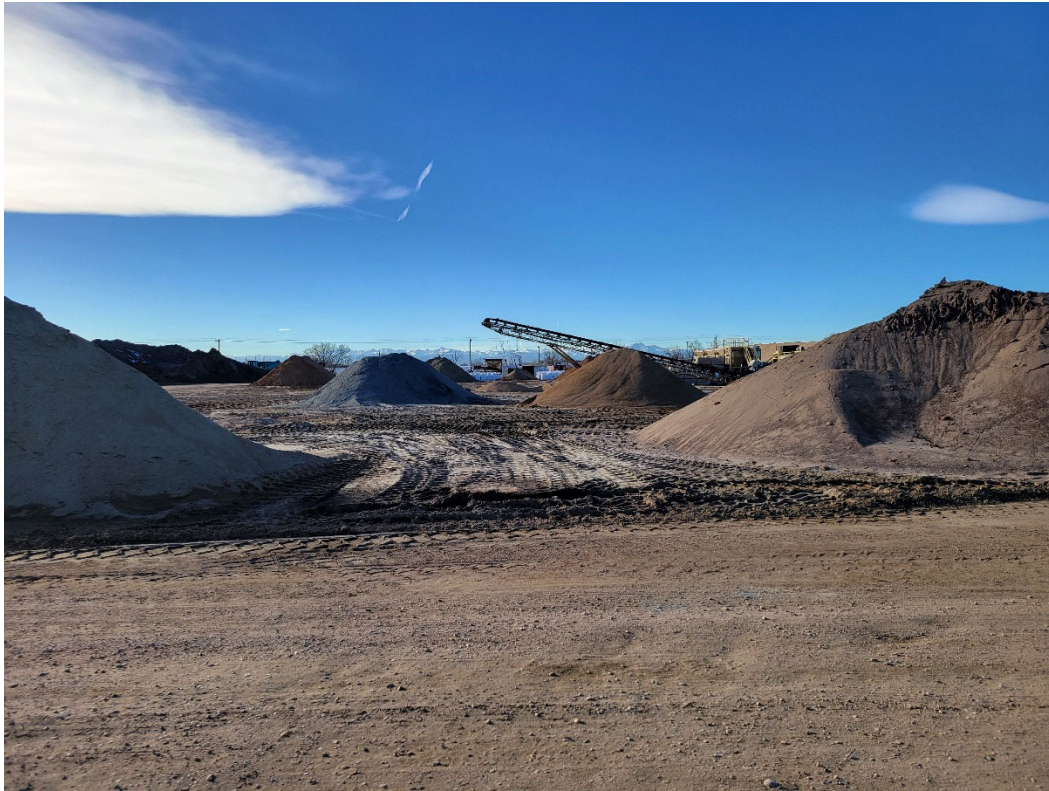
Photo 7: Stockpiles of material adjacent to the processing area in the northeast cell.

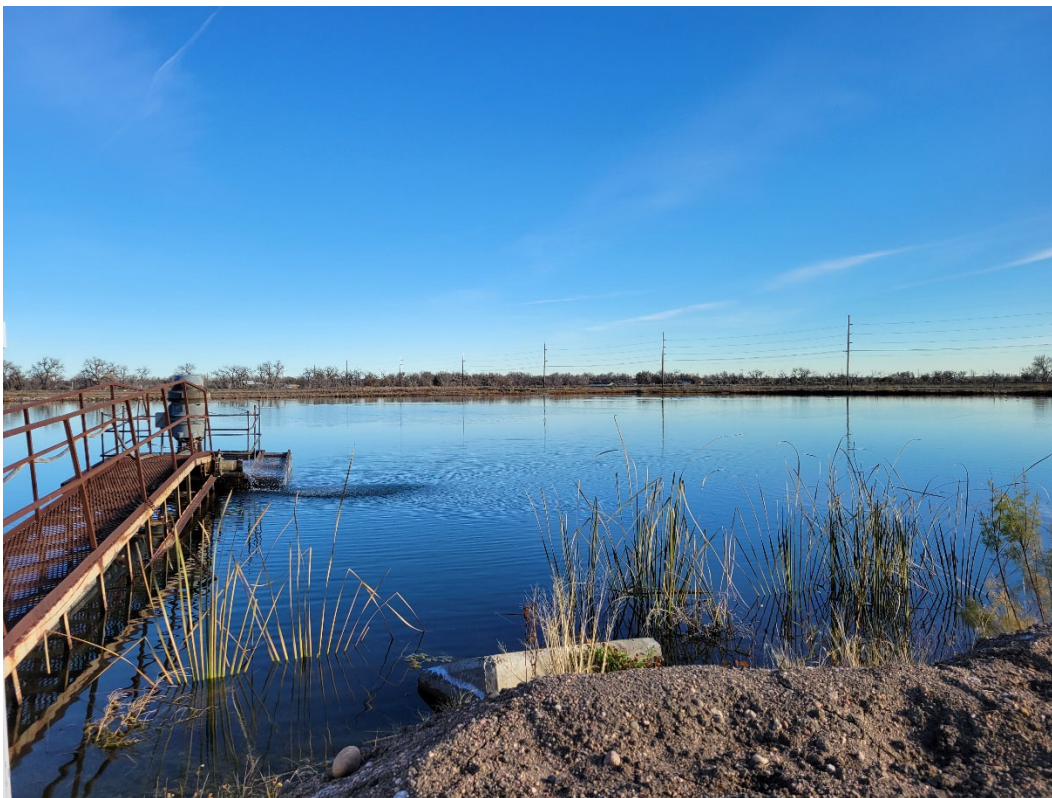
The Division observed water in two ponds in the southwest cell. The ponds receive fines and process water. The water is recycled for the processing operation and dust suppression. Once mining is complete, the ponds will be backfilled and reclaimed.

Photo 8: Looking across the west pond in the southwest cell. A pump in the pond recycles the water through the operation.

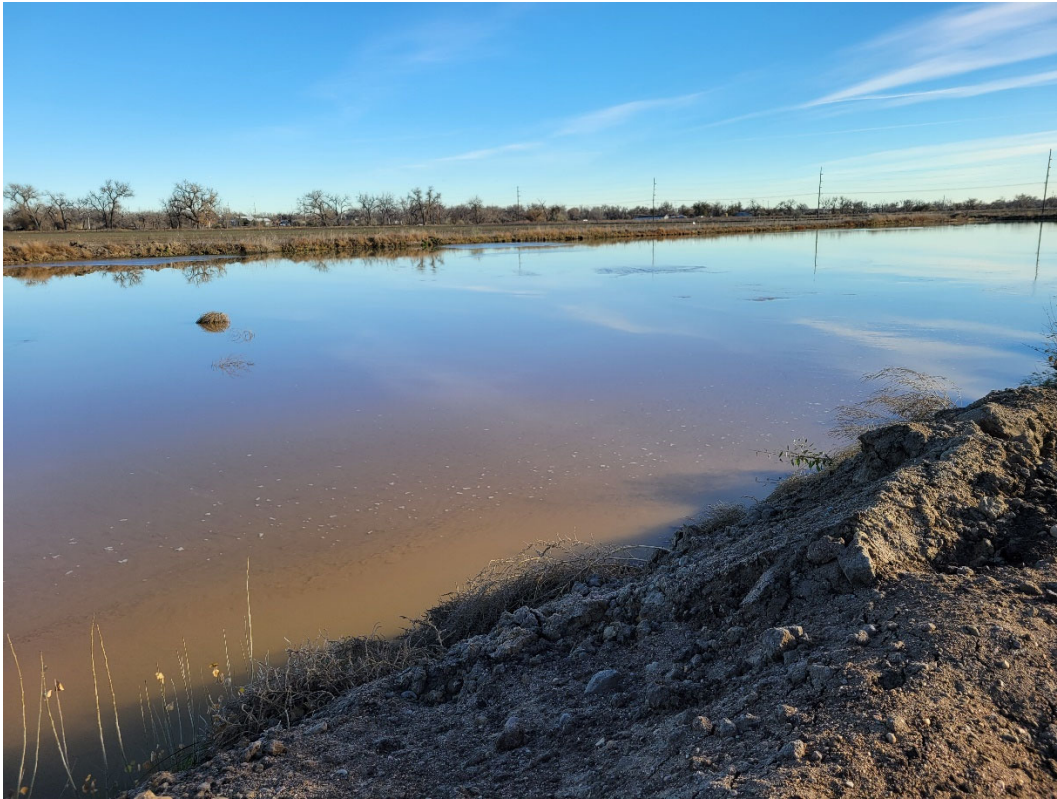
Photo 9: Looking across the east pond in the southwest cell which receives wash fines from the processing facility.

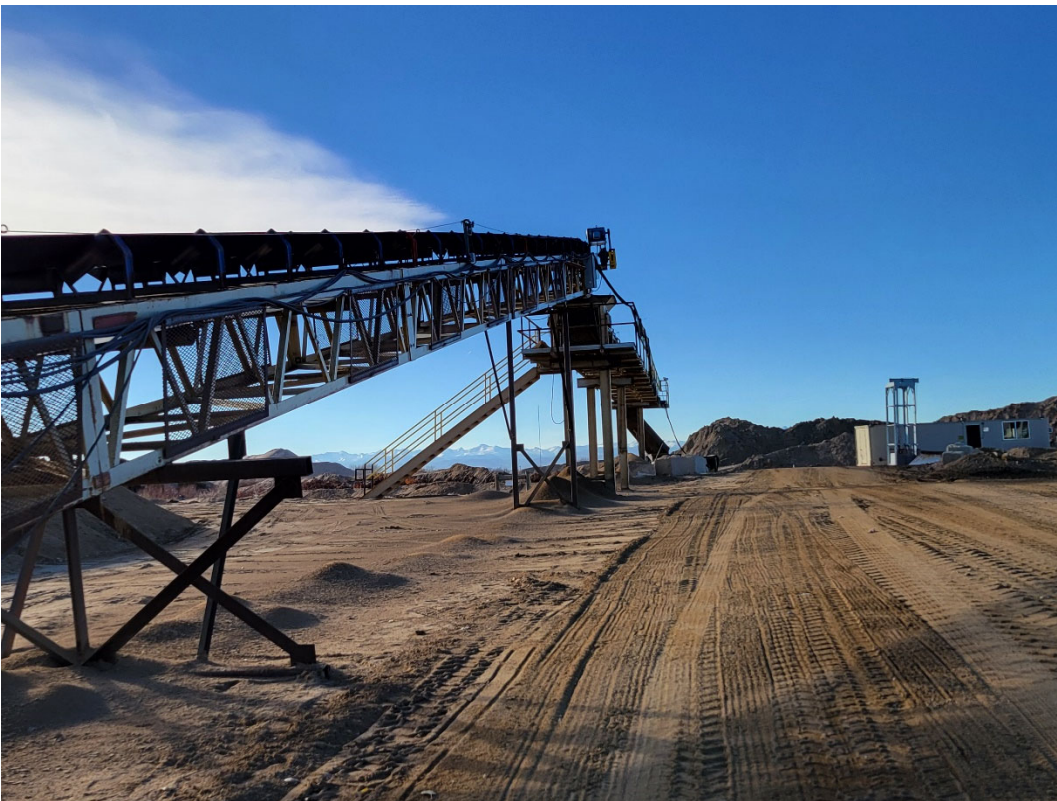
Photo 10: Conveyor running east/west from the northwest cell to the processing facility.

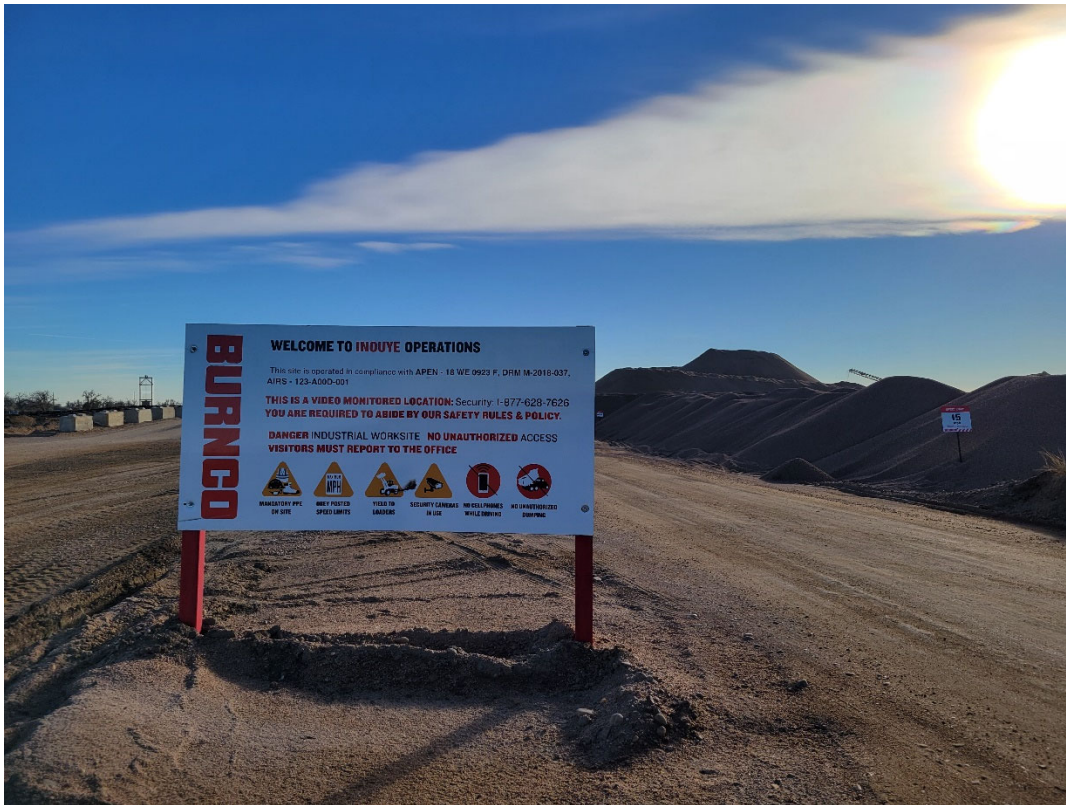
A mine sign was posted at the entrance in the northwest corner, as required by Rule 3.1.12(1). A barbed wire fence was installed around site. White plastic posts were observed marking the edge of the slurry wall around the northeast and northwest cells.

Photo 11: Mine sign posted at the entrance in the northwest corner of the permit area.

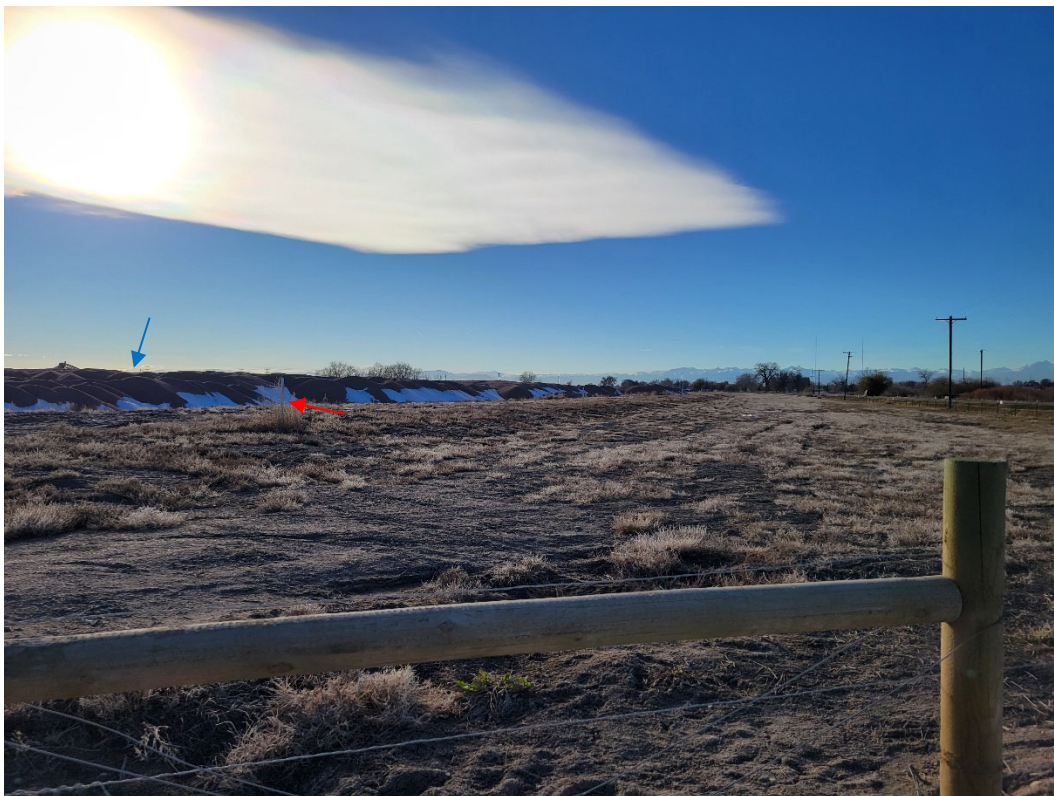
Photo 12: Topsoil placed in a berm along the northern boundary (blue arrow). A fence is installed around the perimeter of the site, and white plastic markers note the edge of the slurry wall (red arrow).

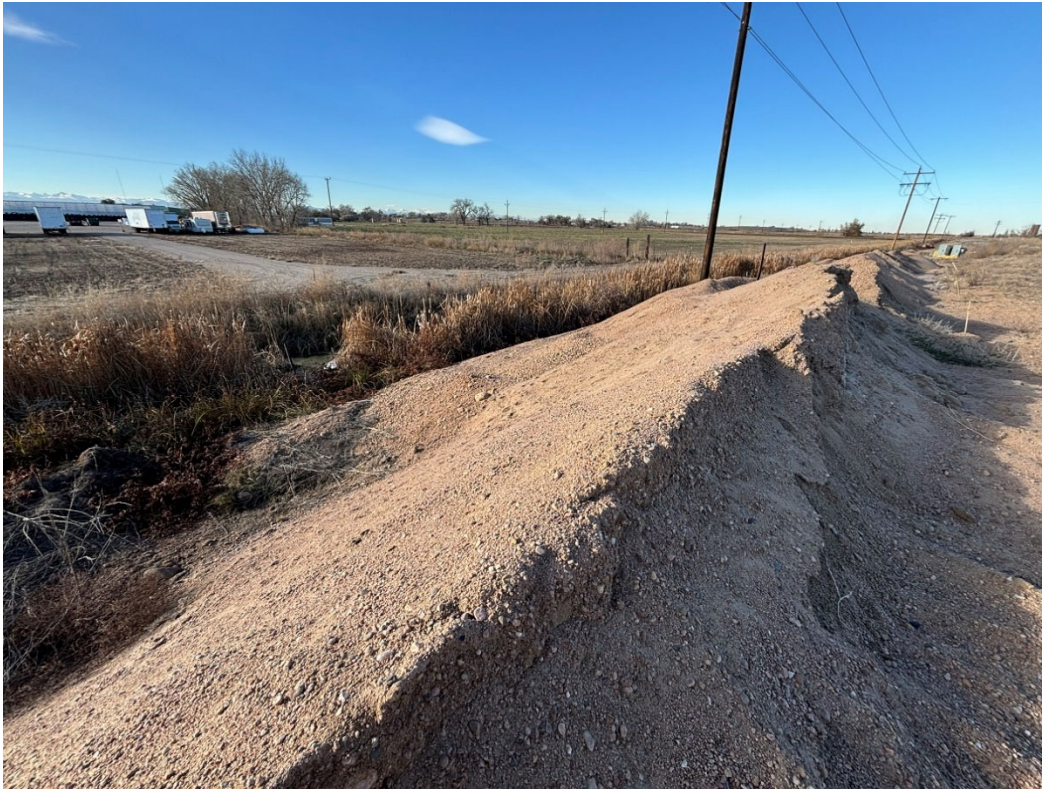
The Division observed the aggregate processing area in the northwest cell. Stockpiles of material were observed adjacent to the processing area. An equipment storage area was observed along the western side of the permit area. The Division observed a sand berm along the western boundary. The Division discussed moving the berm further away from the permit boundary since the sand was slumping into the fence line and could potentially impact the adjacent land. After the inspection, the operator provided a photo showing the berm was removed and the area was regraded level.

Photo 13: Sand berm adjacent to the western permit bounday observed during the inspection.

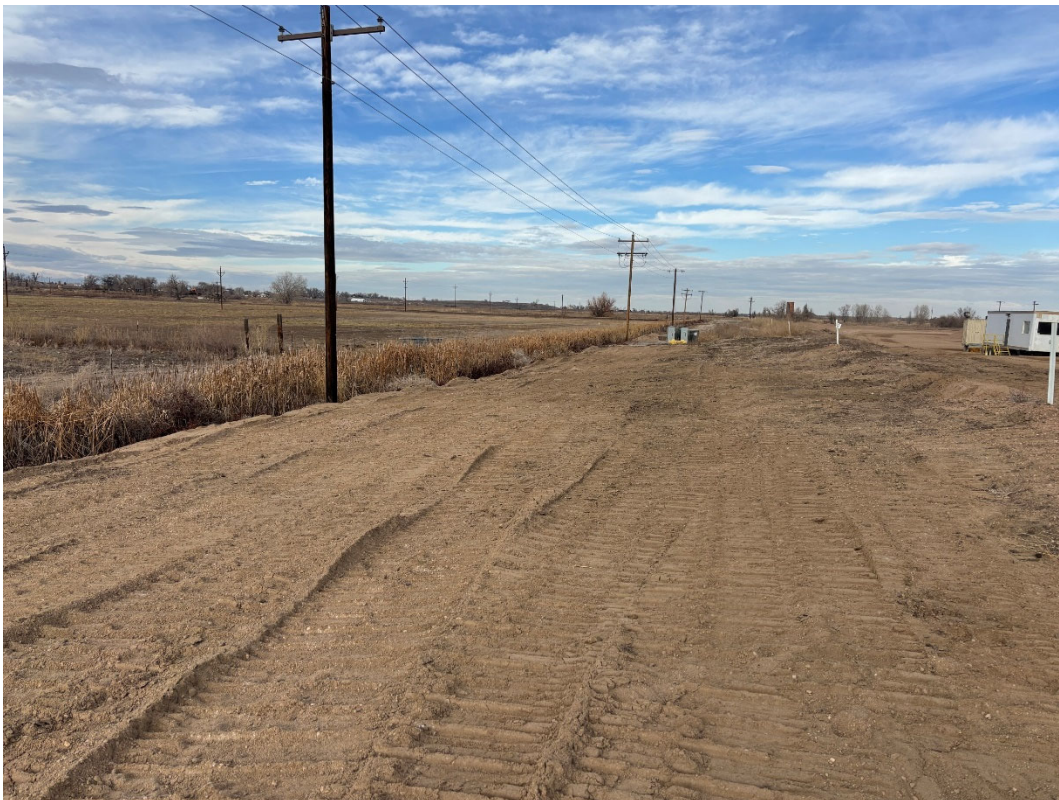
Photo 14: Photo provided by the Operator on 1/6/2025 showing the berm has been removed to prevent sand from flowing onto the adjacent property and the area has been graded level.

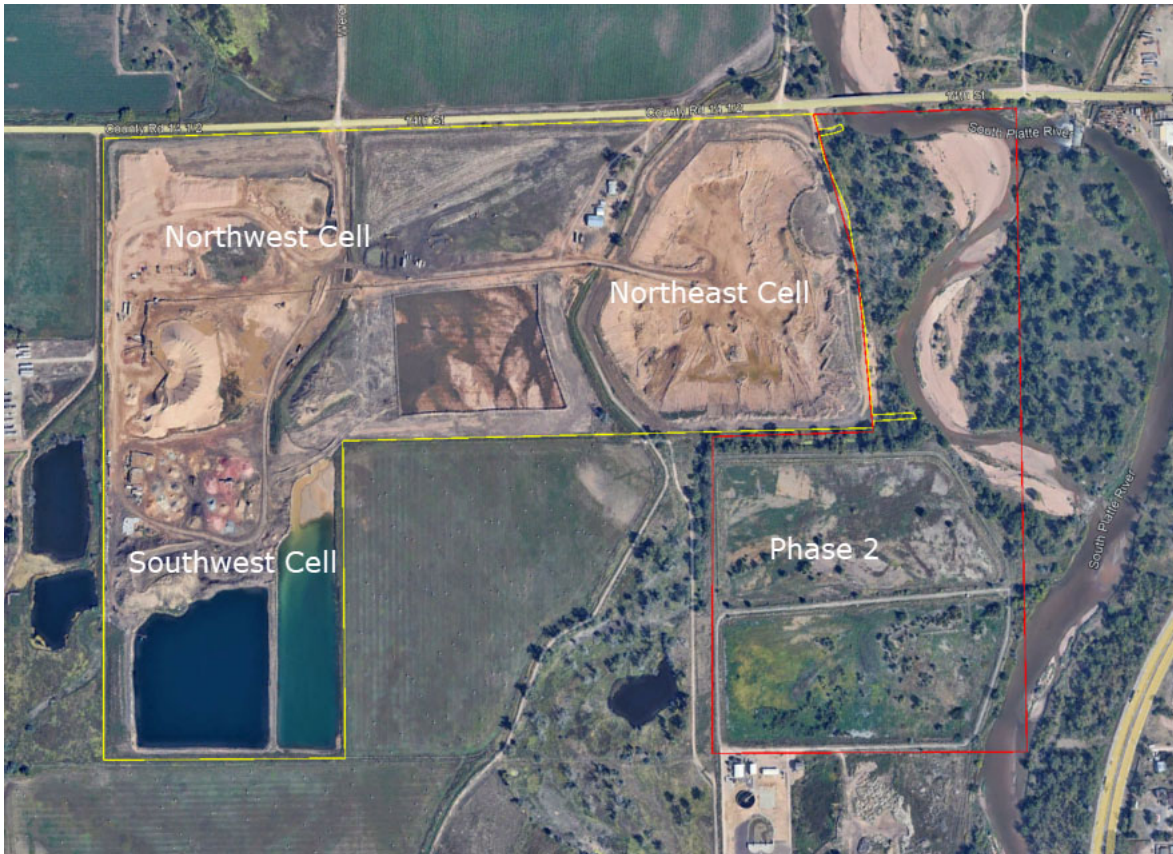
Figure 1: Inouye Gravel Mine – Current affected area represented by the yellow line.
Google imagery dated 9/4/2023.
