Nix Sand and Gravel November Inspection Report M2001046

MINERALS PROGRAM INSPECTION REPORT
PHONE: (303) 866-3567

MINE NAME: Nix Sand & Gravel Mine	MINE/PROSPECTING ID#: M-2001-046	MINERAL: Sand and gravel	COUNTY: Weld
INSPECTION TYPE: Monitoring	WEATHER: Clear	INSP. DATE: November 20, 2024	INSP. TIME: 09:00
OPERATOR: Ready Mixed Concrete Company, LLC	OPERATOR REPRESENTATIVE: Steve Kelton, Stuartt Erns, Scott Legg	TYPE OF OPERATION: 112c - Construction Regular Operation	
REASON FOR INSPECTION: Normal I&E Program	BOND CALCULATION TYPE: Complete Bond	BOND AMOUNT: \$6,964,000.00	
DATE OF COMPLAINT: NA	POST INSP. CONTACTS: None	JOINT INSP. AGENCY: None	
INSPECTOR(S): Nikie Gagnon Jared Ebert Chris Girardi	INSPECTOR'S SIGNATURE:

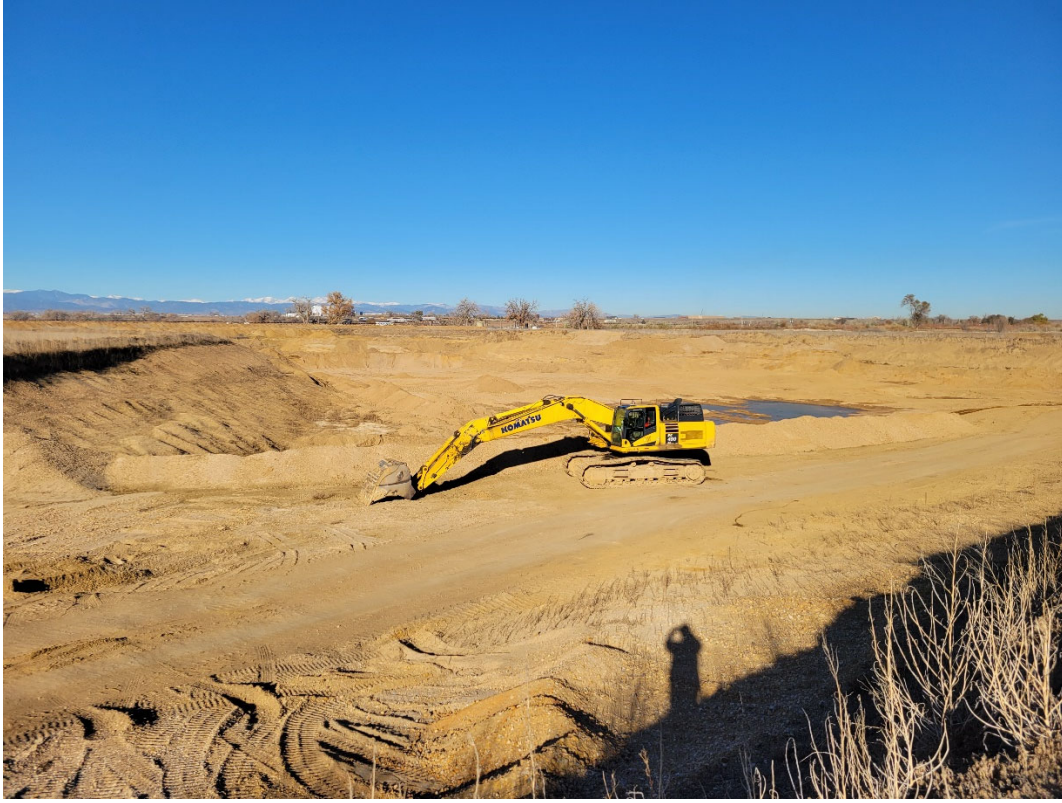
The operation is permitted to affect 307.20 acres. Mining will occur in four stages across 7 cells. Post mining land use will leave three slurry wall lined reservoirs surrounded by pasture. The Stage 1 area (Cells 1 & 2) will be mined to construct two unlined cells, a freshwater pond and a siltation pond which receives wash fines from the processing facility. Post mining, a slurry wall is proposed to be installed around the two ponds to create a reservoir. During this inspection, the Division observed active mining in Pond 2 in the southwest corner of the permit area (Photo 1). The adjacent siltation pond has been mined and was holding water (Photo 2).

Photo 1: Looking northwest across Pond 2 - Freshwater Pond in the Stage 1 area.

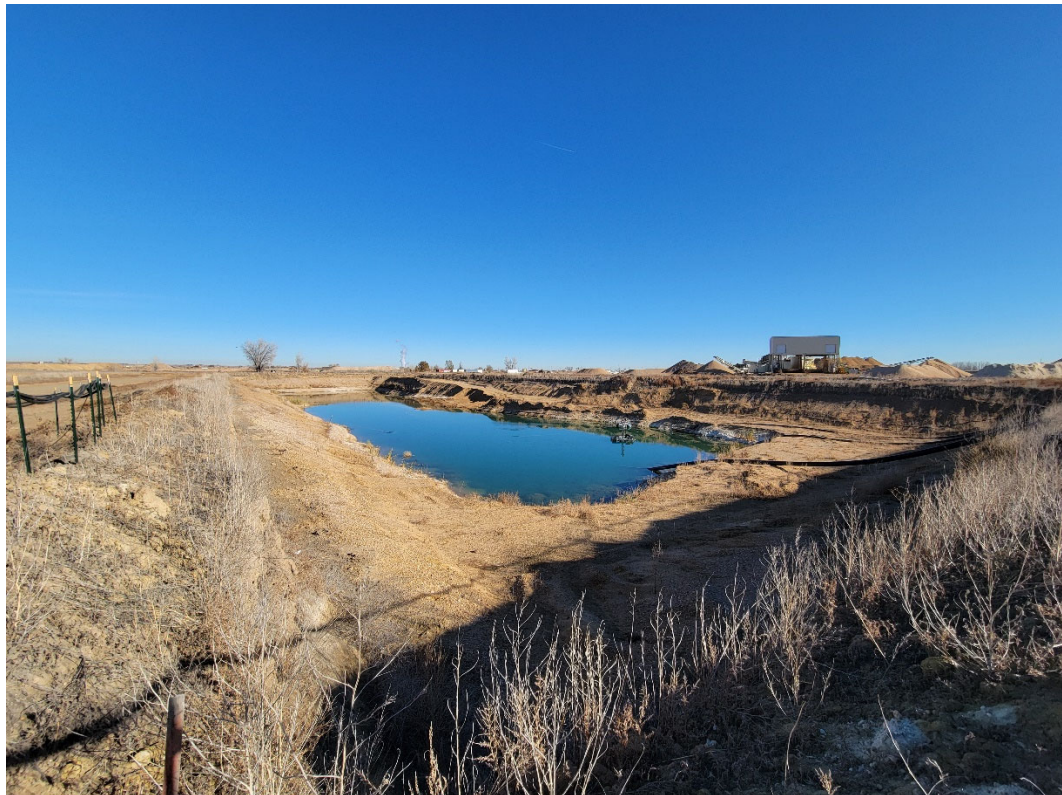
Photo 2: Looking northwest across Pond 1 - Siltation Pond constructed in the Stage 1 area.

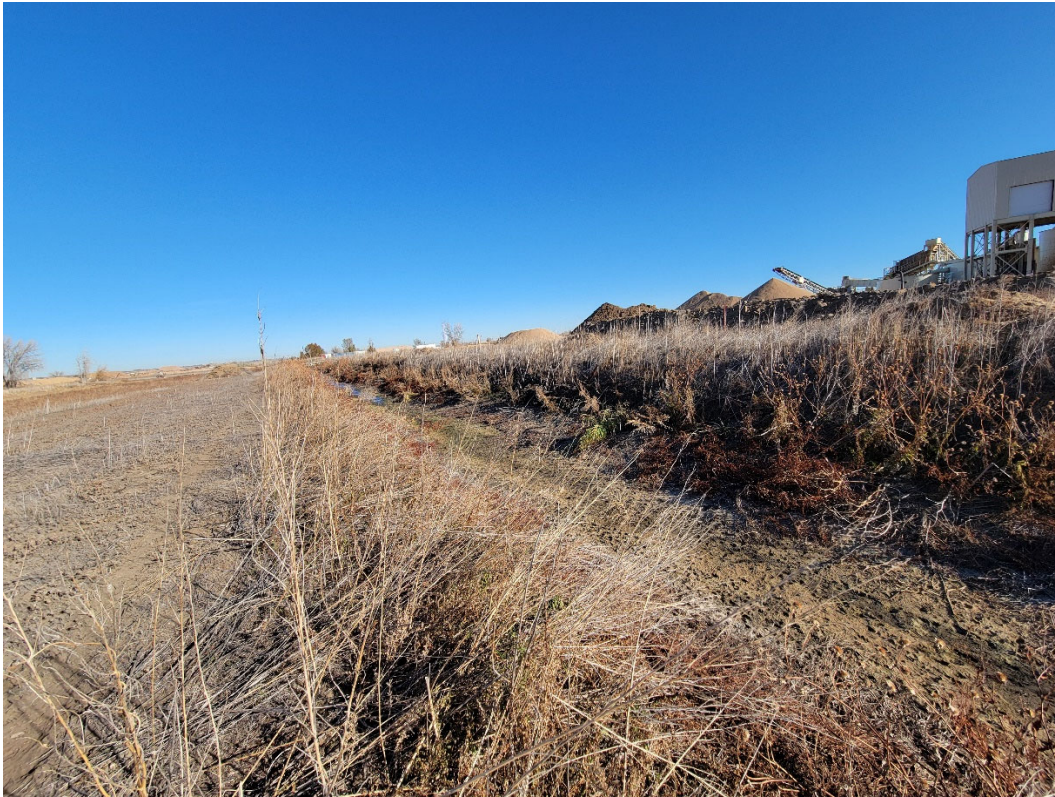
Photo 3: Looking northeast at the Last Chance Ditch below the processing plant.

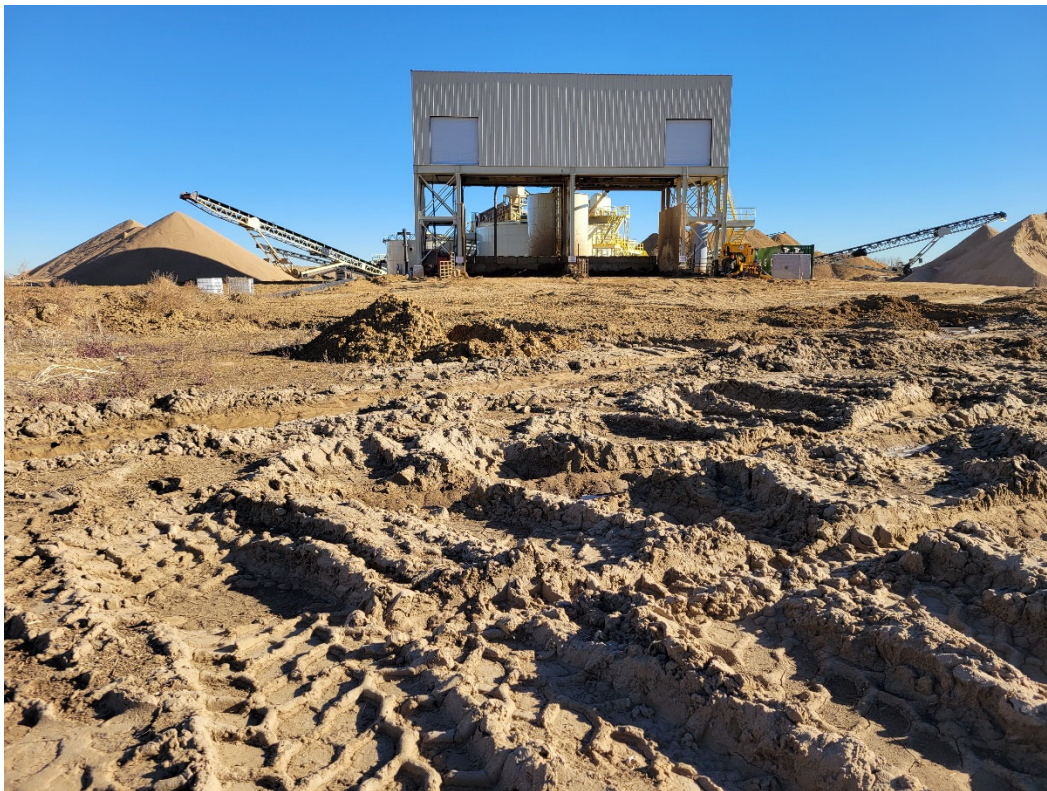
Adjacent to the Stage 1 area, the Division observed a processing plant in Cell 7 (Photo 4). The operation uses a filter press process to separate the material, which uses less water through recycling over conventional methods. The resulting filter cake material is stockpiled on site in Cell 6 for a future use (Photo 5)

Photo 4: Looking at the processing plant and material stockpiles in Cell 6. The operator installed a filter press process.

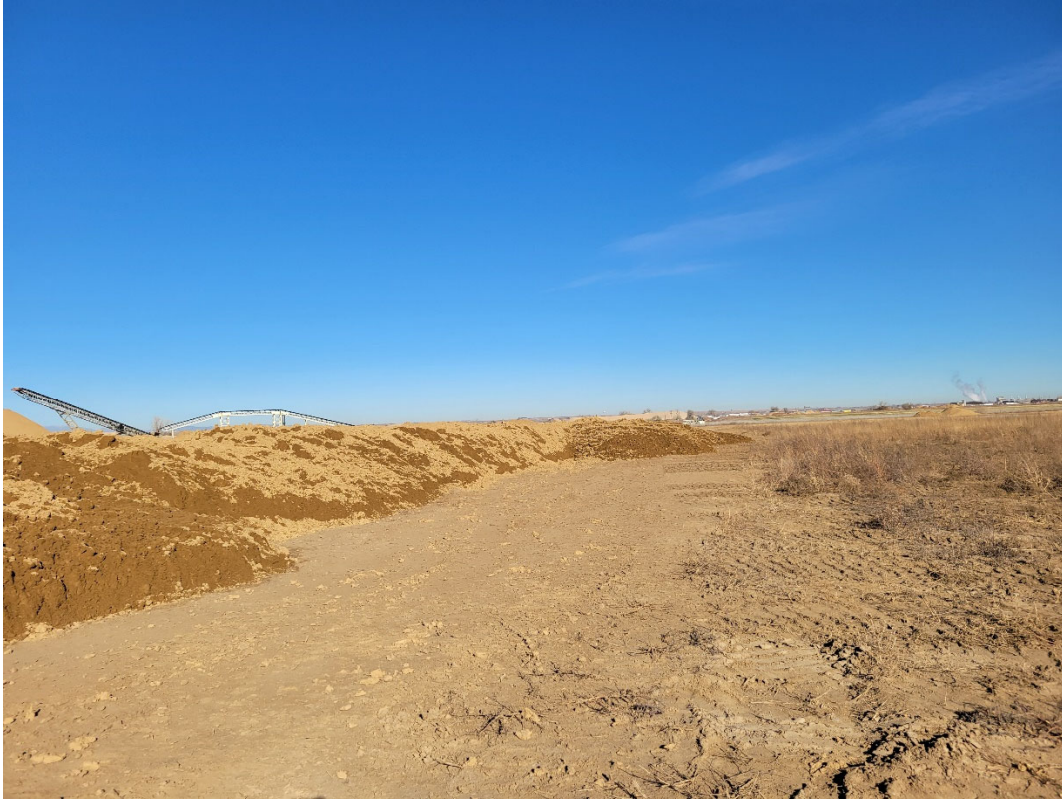
Photo 5: Looking at stockpiled filter cake clay material from the filter press process.

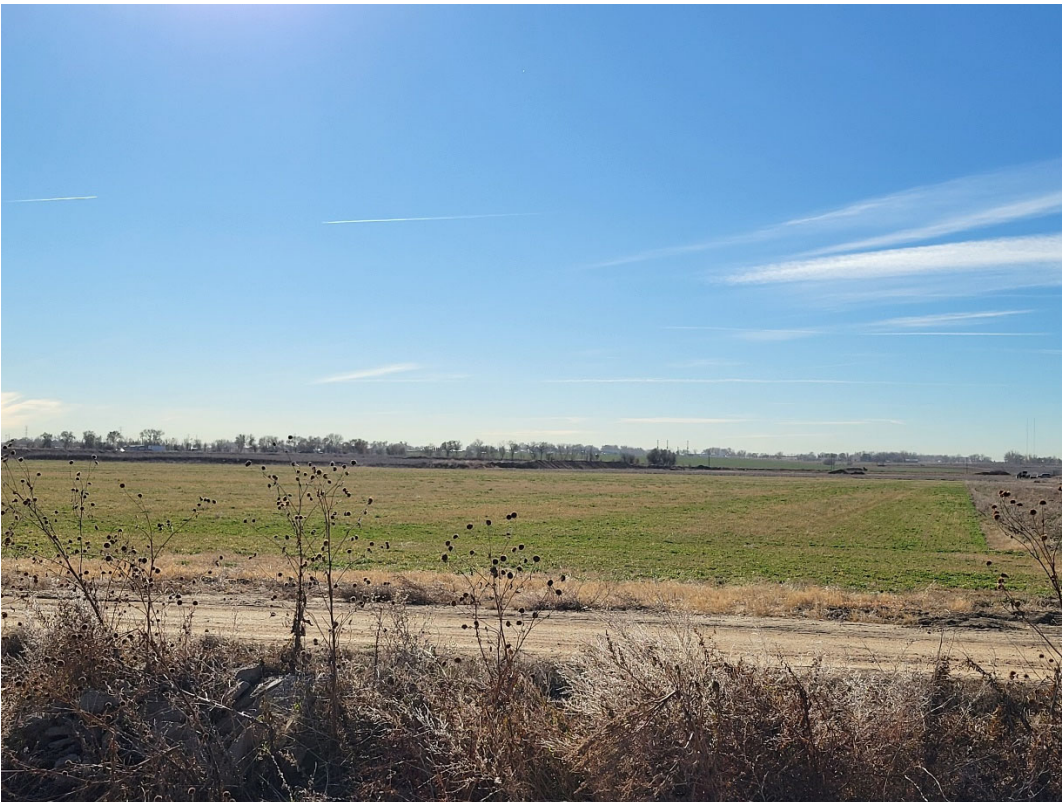
The Division observed the Stage 3 area (Cells 5 and 6) which has not been mined. Cell 5 is a producing cropland (Photo 6). A slurry wall will be installed and tested prior to the initiation mining in this area and the bond will be adjusted at that time.

Photo 6: Looking south across an agriculture field in Cell 5.

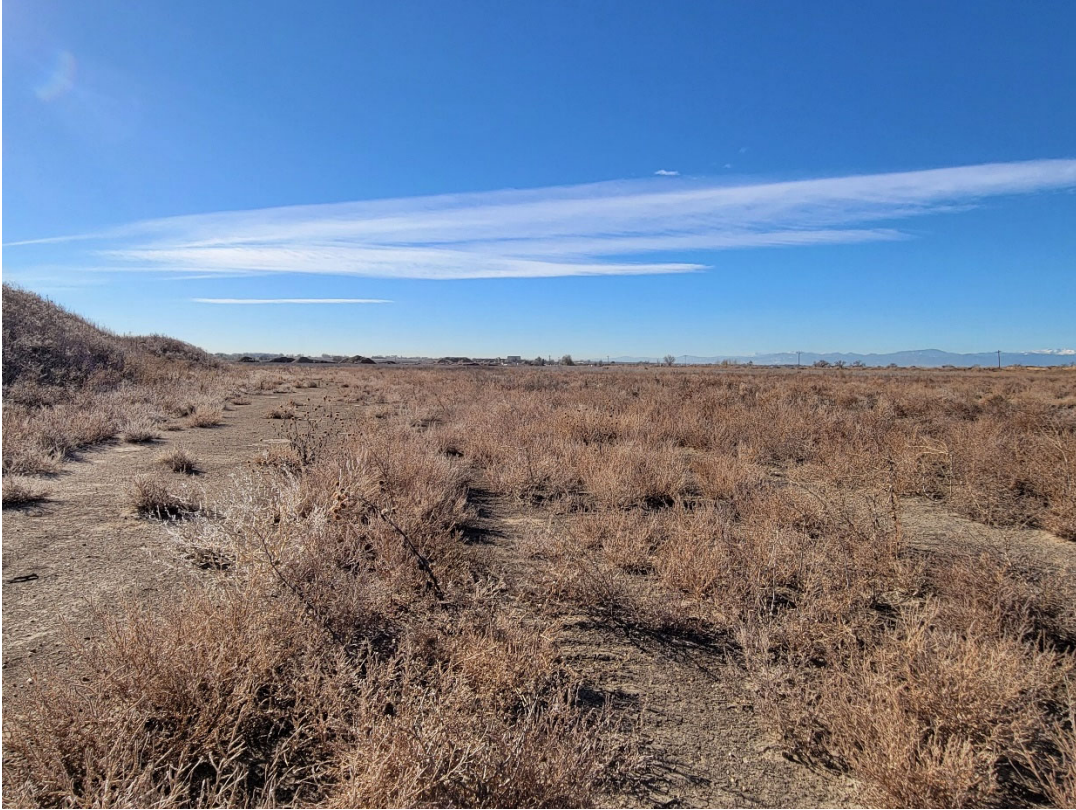
Photo 7: Looking southwest from the north end of Cell 4.

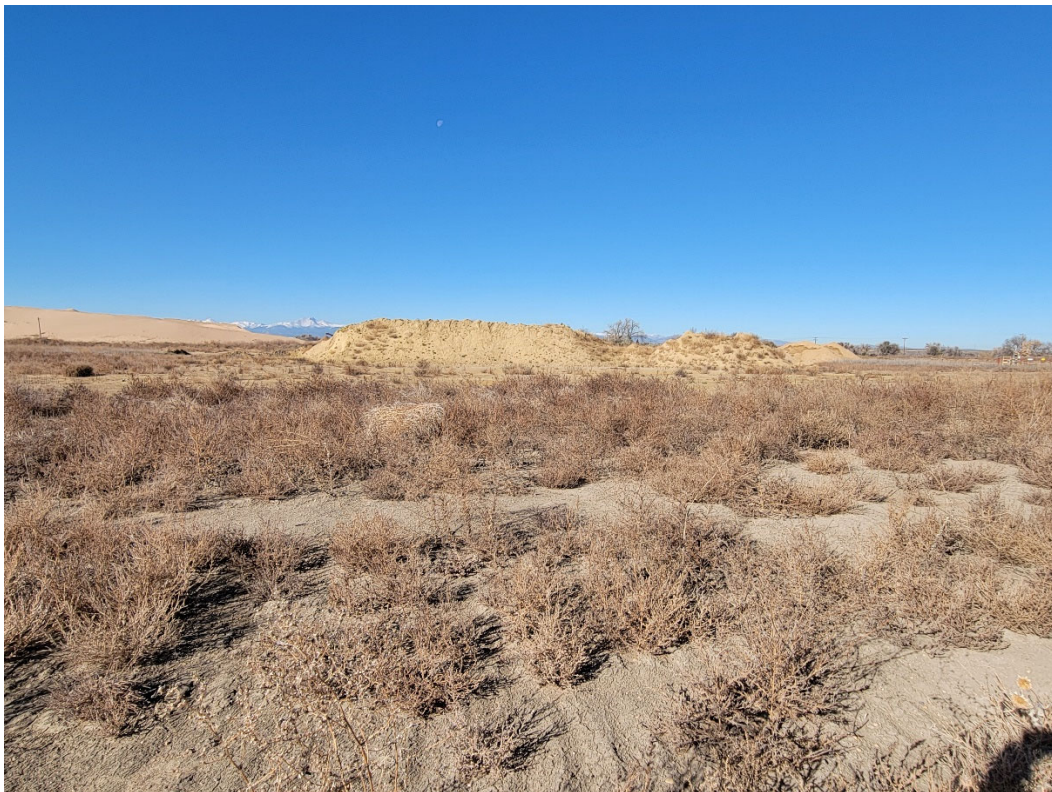
Photo 8: Looking northwest across Cell 3. Stockpiles of material left over from previous mining operation at the site.

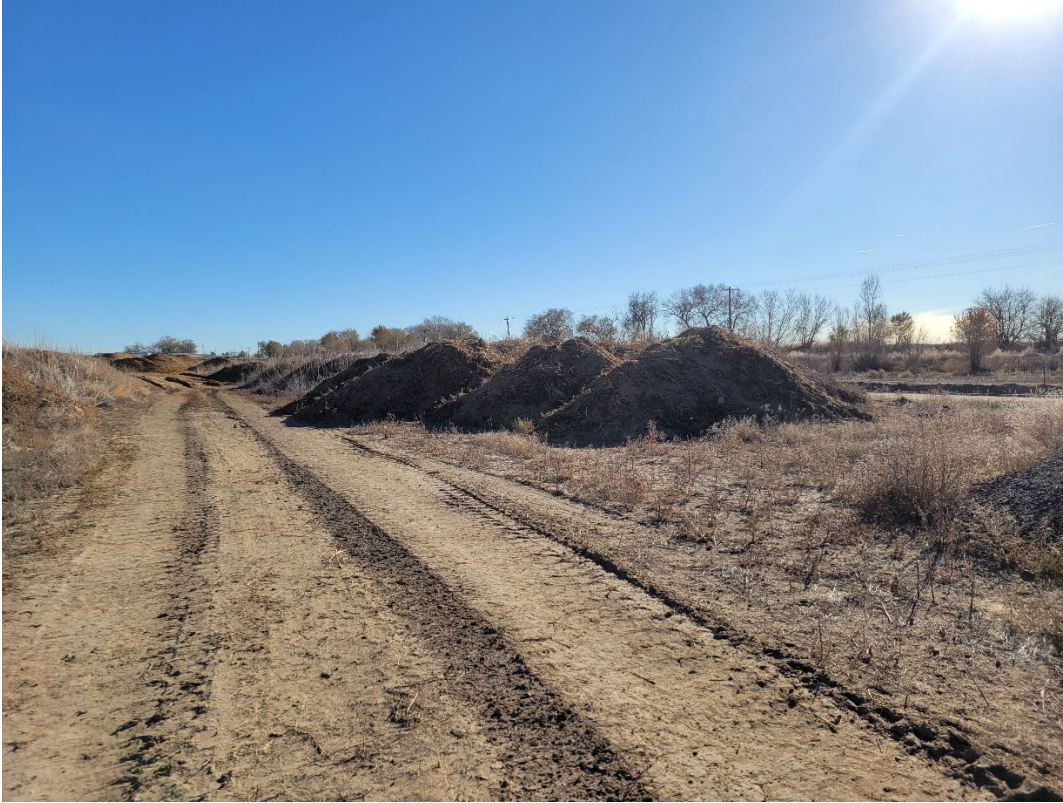
The Division observed topsoil stockpiles on the south end of Cell 6 (Photo 9). The Operator stated the material was placed there recently from clearing the Pond 2 area. The Division discussed with the Operator the requirements in Rule 3.1.9 to seed and stabilize the topsoil that will be used for reclamation. Since the final reclamation calls for 3 large reservoirs, Excess topsoil material not needed from reclamation may be sold or hauled off site during the life of the mine.

Photo 9: Looking at topsoil placed in stockpiles in Cell 6.

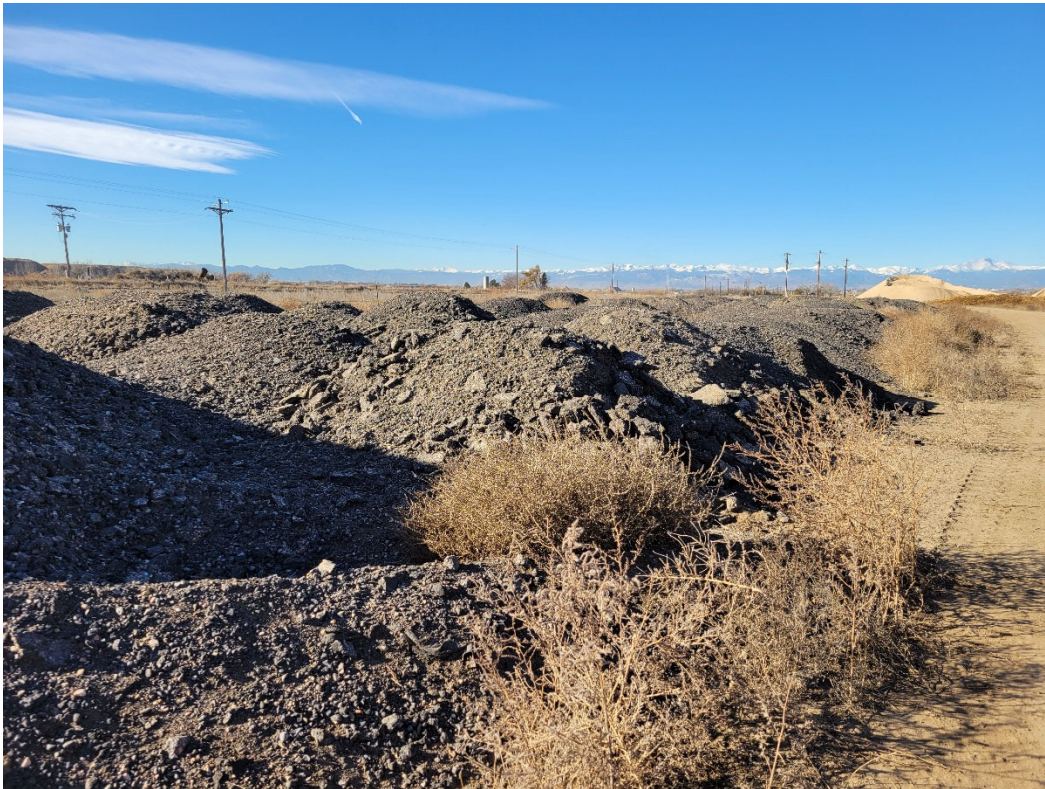
Photo 10: Looking at stockpiled material to be used for road base.
