Tucson South Inspection Report with Problem Cited

MINERALS PROGRAM INSPECTION REPORT

MINE NAME: Tucson South Resource	MINE/PROSPECTING ID#: M-2004-044	MINERAL: Sand and gravel	COUNTY: Adams
INSPECTION TYPE: Monitoring	WEATHER: Clear	INSP. DATE: December 26, 2024	INSP. TIME: 10:00
OPERATOR: Holcim - WCR, Inc.	OPERATOR REPRESENTATIVE: Tom Clay and Dustin Callier	TYPE OF OPERATION: 112c - Construction Regular Operation

INSPECTION TOPIC: Hydrologic Balance/Sediment Control

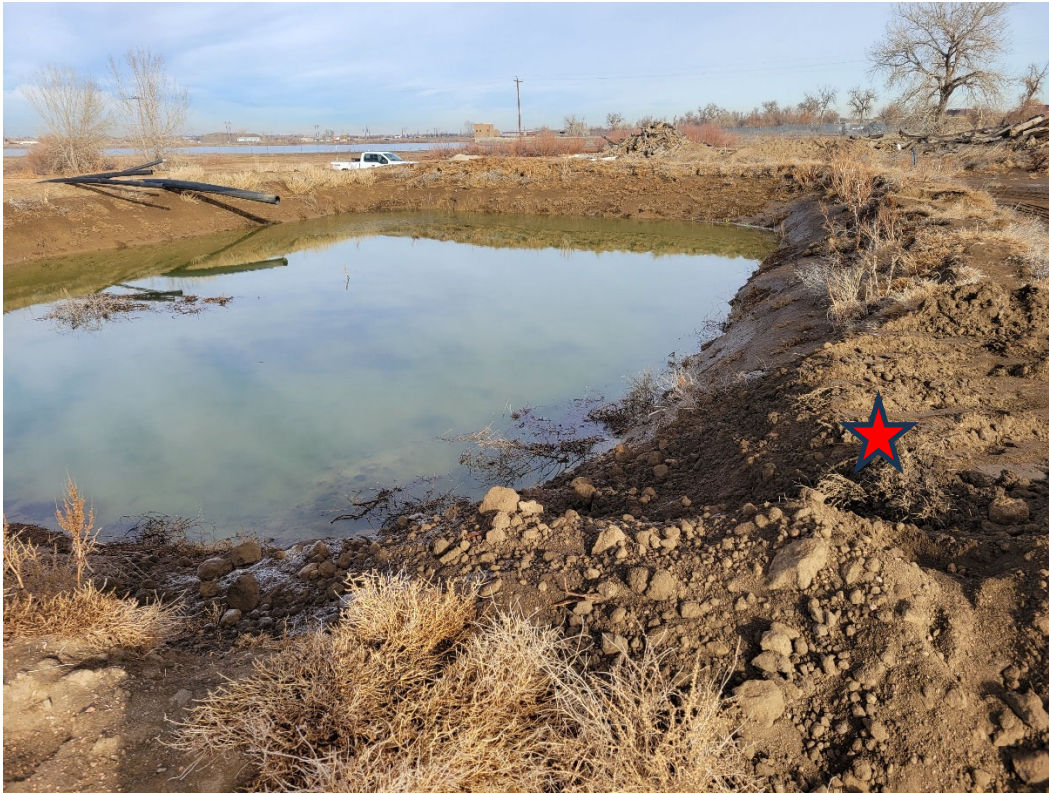
PROBLEM: Holcim recently started dewatering the mining pit on the east side of the permit area. A sediment basin in the northeast corner of the permit area failed and water drained into the surrounding area. The failure was caused by prairie dogs burrowing into the sides of the basin when it was dry. Rule 3.1.6(1) states, "Disturbances to the prevailing hydrologic balance of the affected land and of the surrounding area and to the quantity or quality of water in surface and groundwater systems both during and after the mining operation and during reclamation shall be minimized." Additionally, per Rule 3.1.6(2) earth dams may be constructed if the formation of such impoundments will not damage adjoining property or conflict with water pollution laws.

The Division observed two sediment basins in the northeast corner of the permit area, adjacent to the South Platte River (Photos 1 and 2). The basins were less than half full. A berm on the east side of the north basin appeared to be recently repaired (Photo 4). A small excavator with a compactor attachment was observed in a containment area between the sediment basins and the river (Photo 5). The Division observed a few prairie dog burrows in the berms around the basin (Photos 10-11). According to the site manager, when they were notified of the leak, water was flowing out of a burrow on the east side and while they were getting the equipment ready to repair the berm, a section of the berm failed, and water flowed into a containment area adjacent to the basin (Photos 5-6). During the inspection, the Operator estimated approximately 15,000 gallons leaked from the north basin. The adjacent south basin did not fail. The operator stated that they plan to bring equipment over to rebuild the sediment basins before pumping more water from the mining pit.

Photo 1: Looking at the north sediment basin in the northeast corner of the permit area. Area of berm failure marked by red star.

1. Provide evidence to the Division that the sediment basin has been repaired.
2. Submit a Technical Revision to the Division updating the mining plan to discuss how the sediment basin is constructed to stay compliance with Rule 3.1.6 and monitored during dewatering to avoid future impacts to the surrounding area and prevent sediment from reaching the South Platte River.

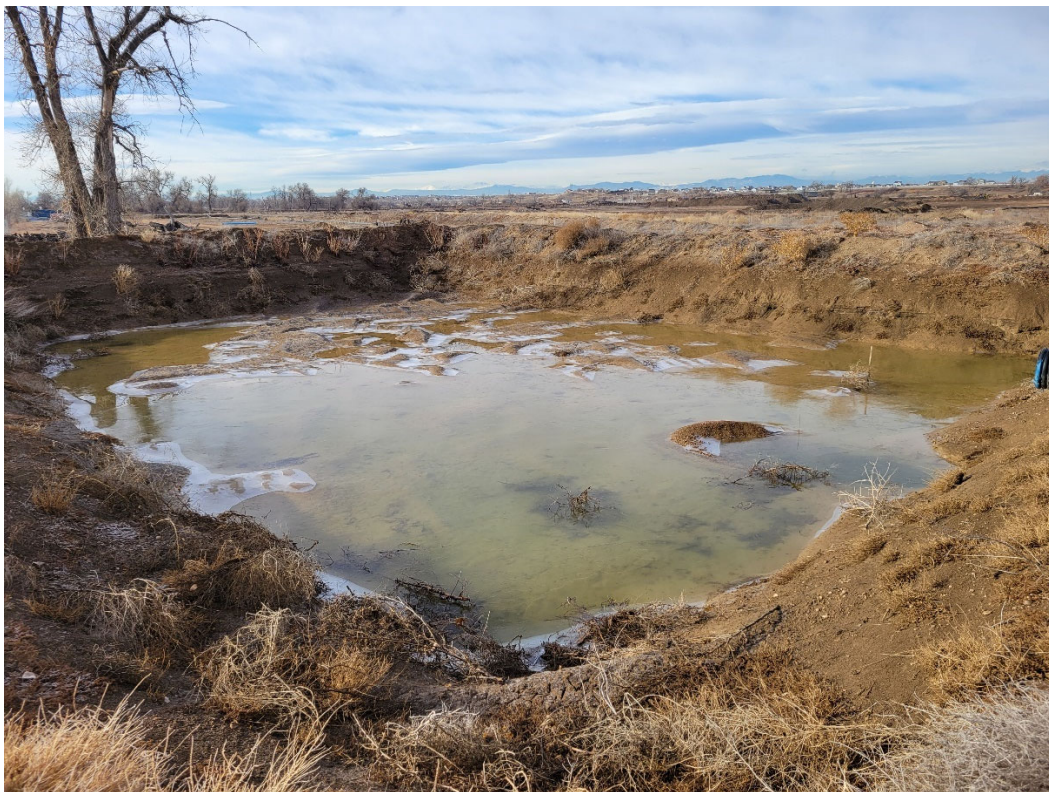
Photo 2: Looking at the south sediment basin. This basin did not fail.

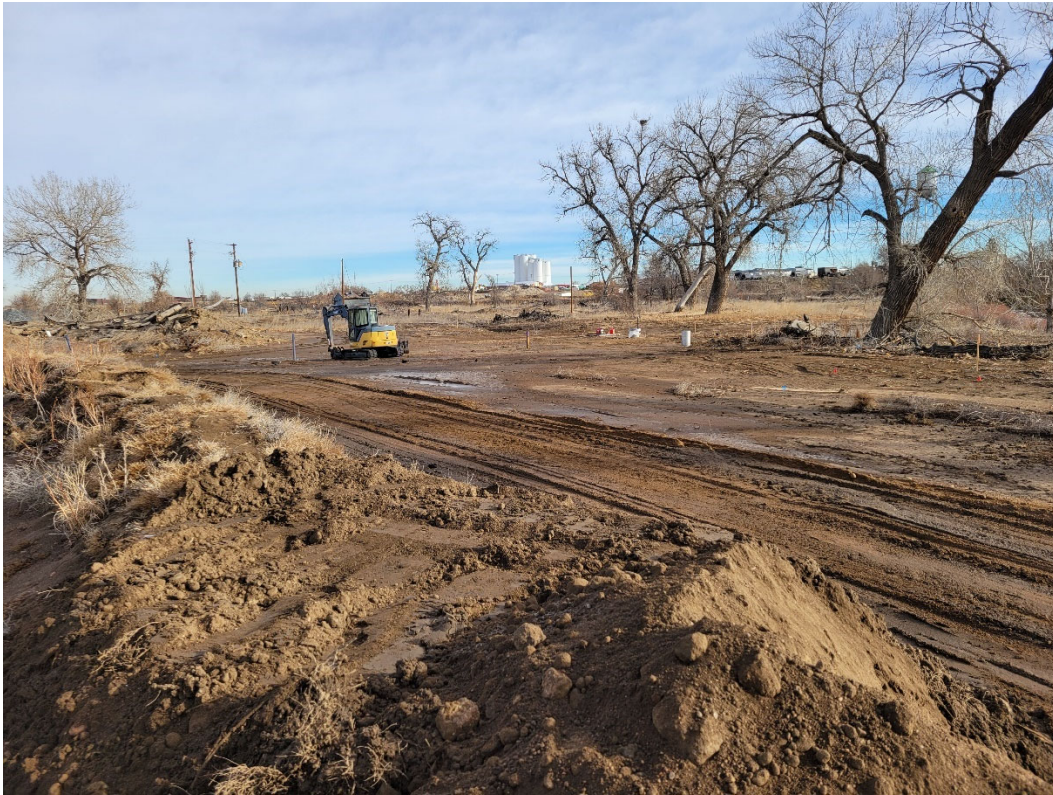
Photo 3: Looking northeast at the saturated containment area outside the north sediment basin.

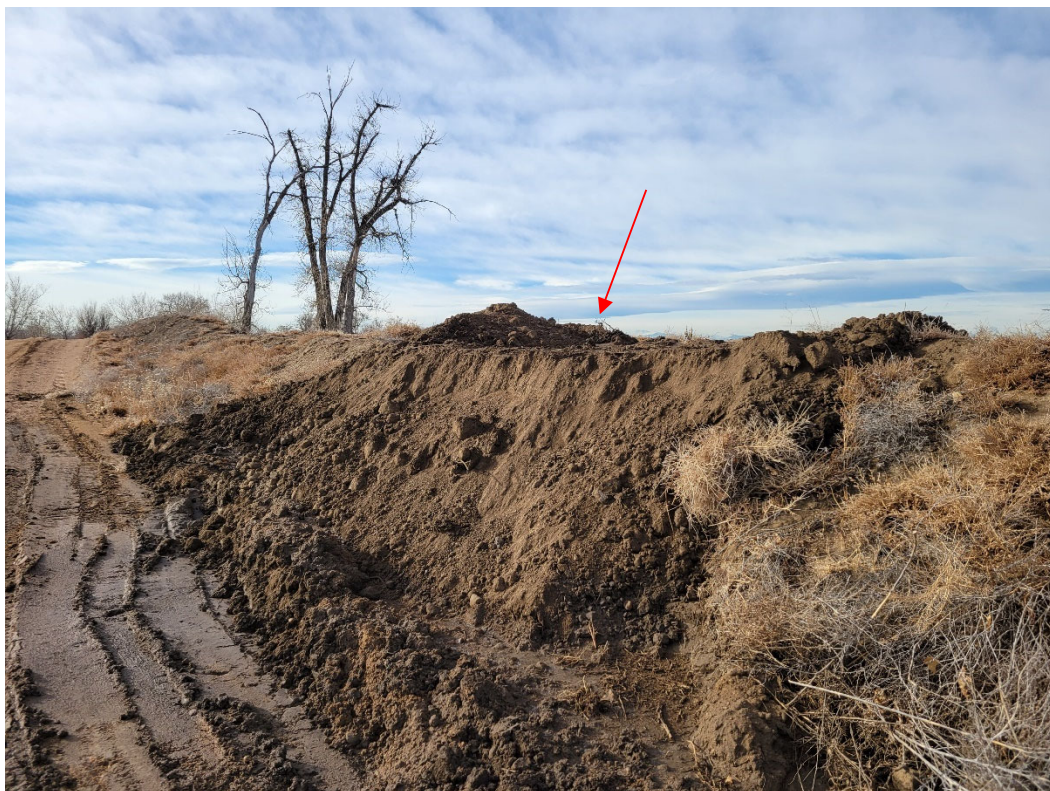
Photo 4: Looking at the repaired berm on the east side of the sediment basin.

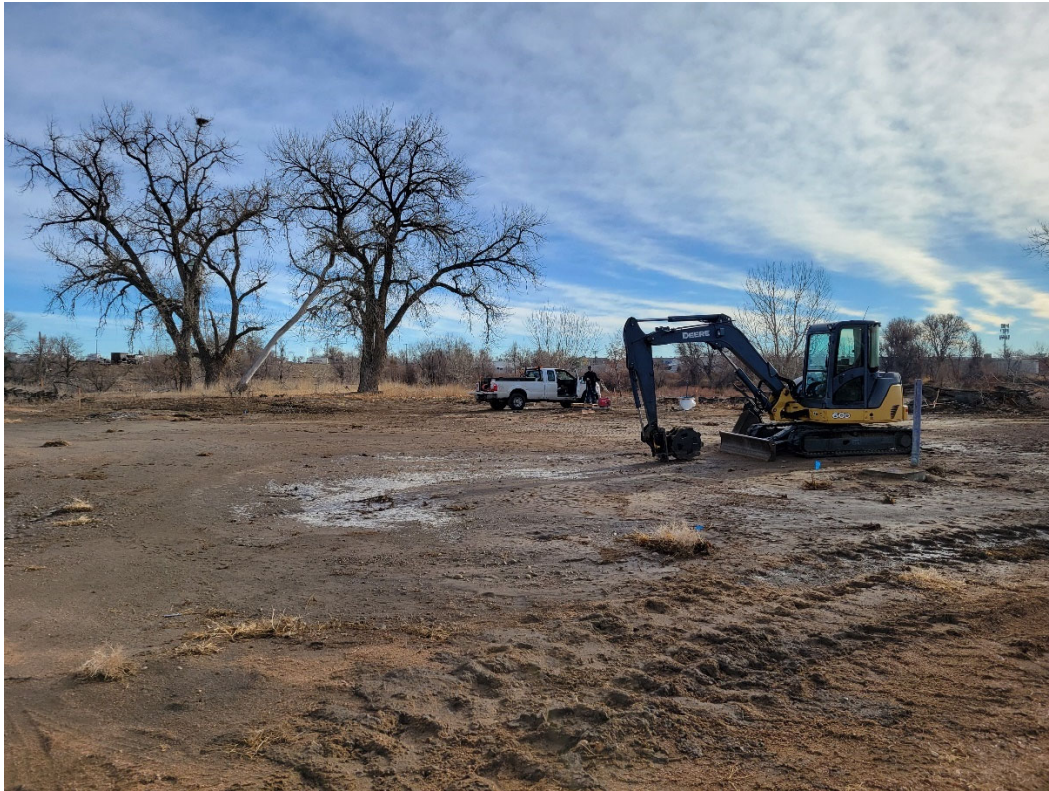
During this inspection, the Division did not observe any standing water, however the soil was saturated on the east side of the sediment basin in an area estimated at 100 wide x 200 feet long (Photos 5-6). A thin layer of sediment settled out on top of the gravel in this area within the permit boundary. Additionally, it appeared that water drained to the north, down an existing drainage in the northeast corner of the permit area, and onto the adjoining property. Water flowed for approximately 300 feet in the drainage and fanned out in a wide low spot where it infiltrated into the ground. No evidence of water from the basin reaching the South Platte was observed during this inspection. Following the incident, the Operator submitted a 5-day report to CDPHE and provided a copy to the Division (enclosed).

Photo 5: Looking east at across the containment area below the sediment basin. A small excavator with compactor was observed here.

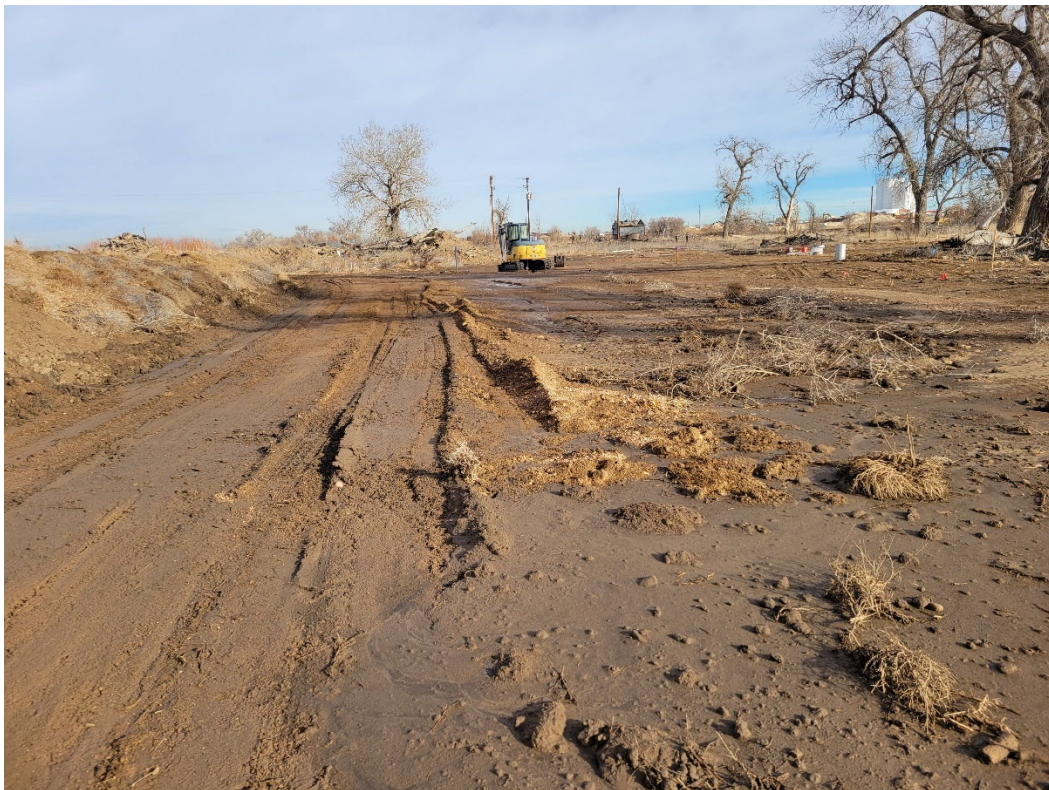
Photo 6: Looking north from the south end of the containment area. Berm surrounding the sediment basin is on the left.

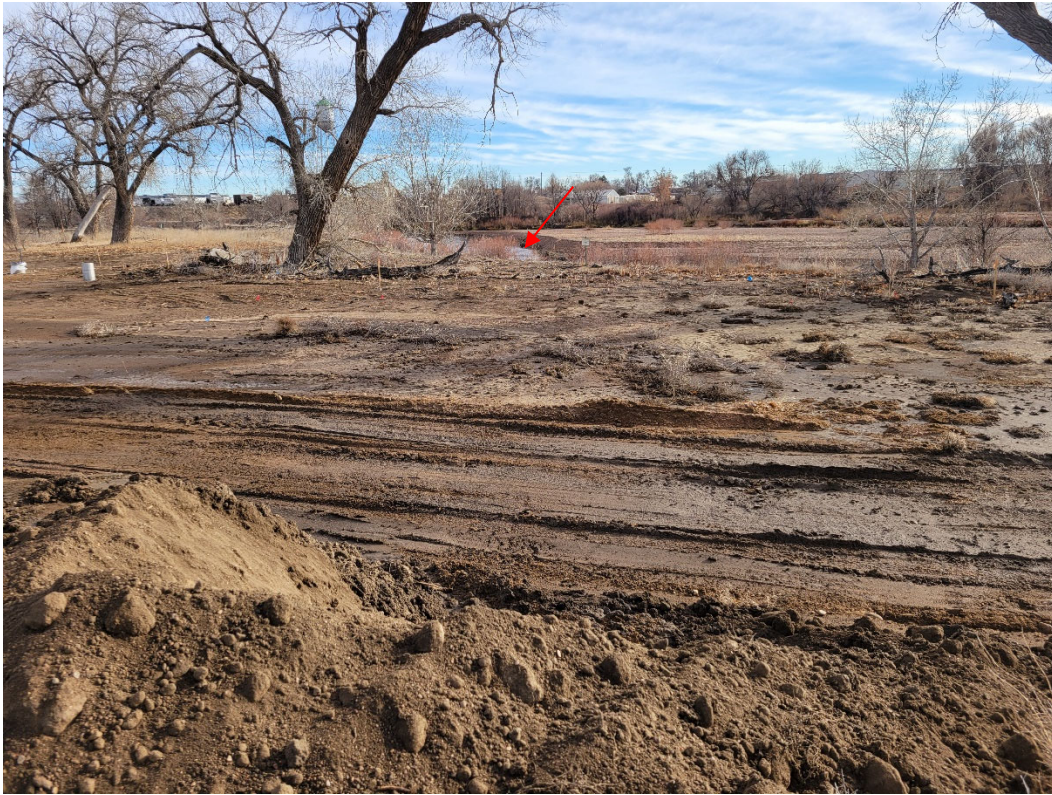
Photo 7: Looking towards the South Platte River (red arrow) from the western edge of the sediment basin.

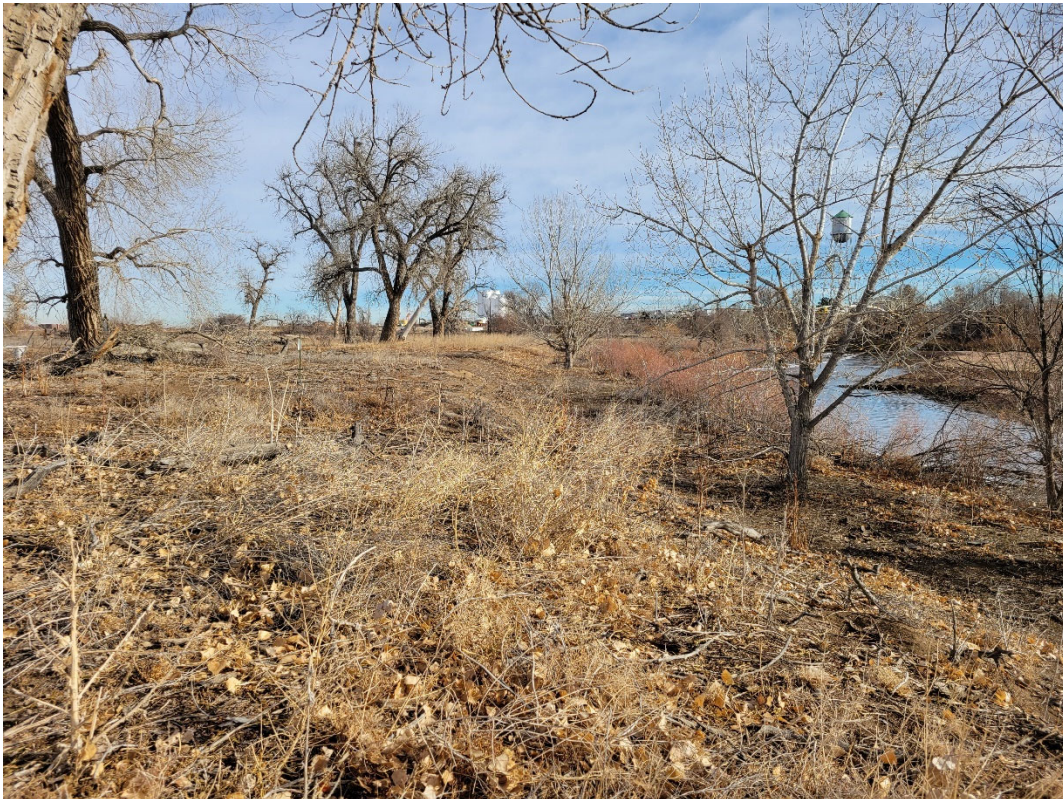
Photo 8: Looking north from the south end of the containment area at the bank of the South Platte River. No evidence of flooding or saturated soils here.

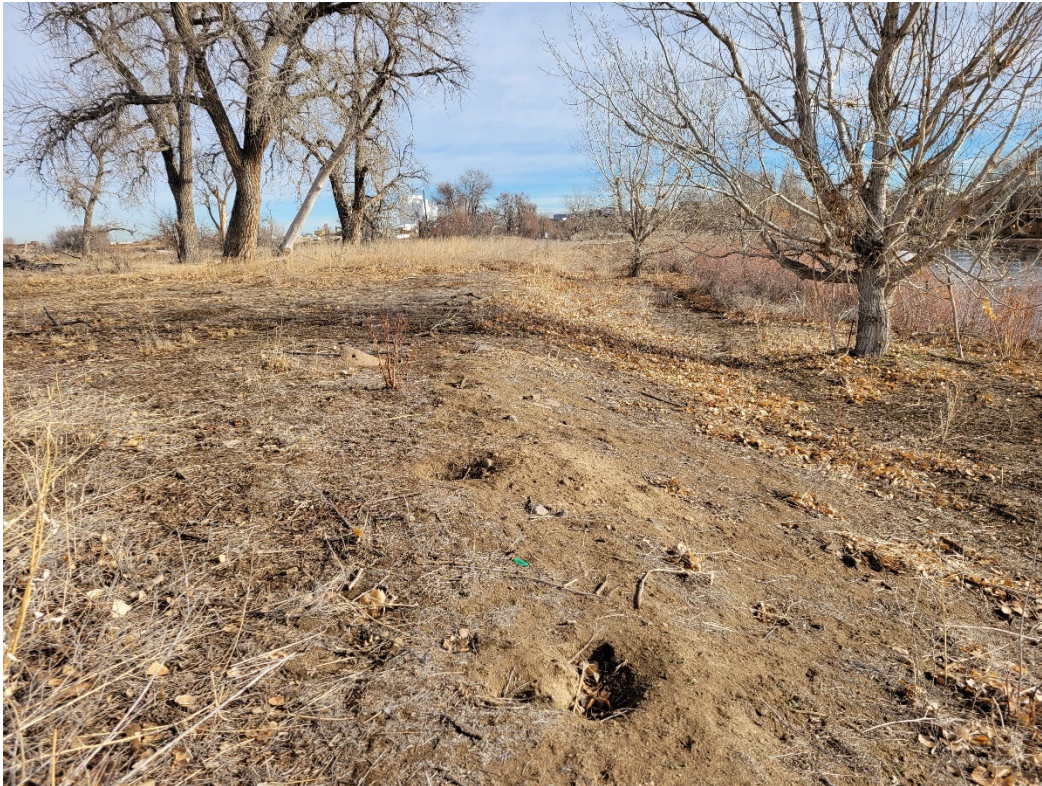
Photo 9: Looking towards the northeast corner of the permit area, along the bank of the South Platte River. No evidence of flooding or soil saturation here.

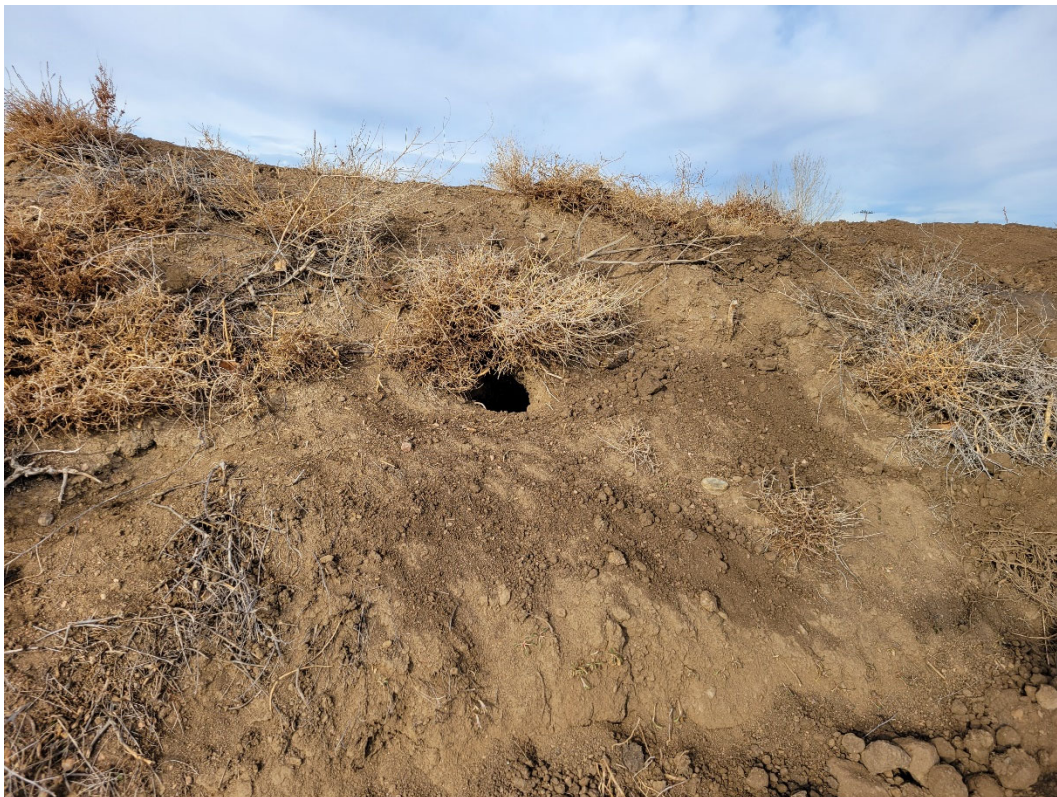
Photo 10: Looking at prairie dog burrow on the east side of the sediment basin.

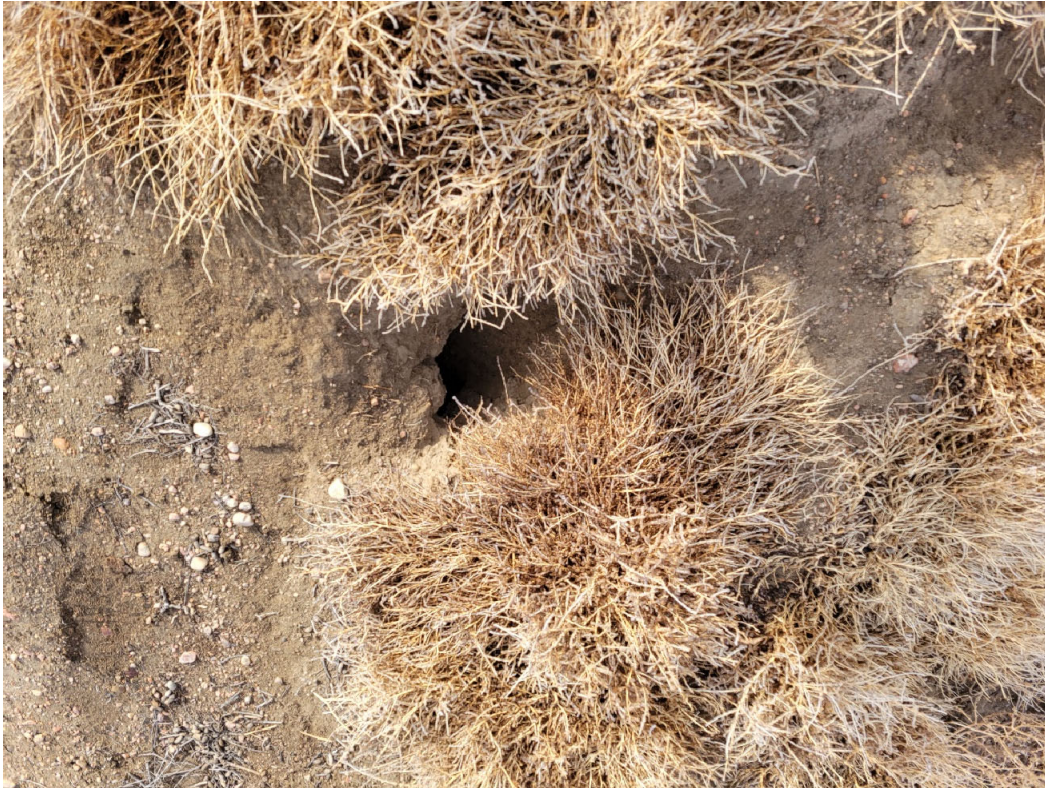
Photo 11: Looking at prairie dog burrow on the west side of the sediment basin.

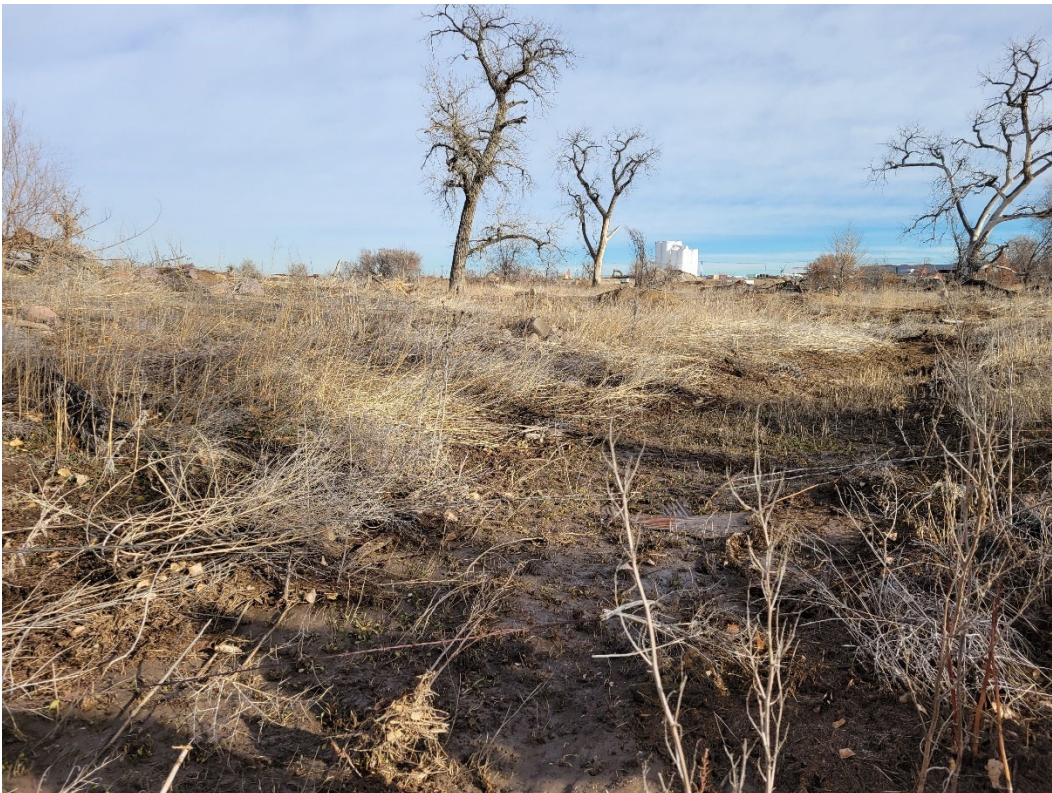
Photo 12: Looking at existing drainage that begins in the northeast corner of the permit area and flows to the adjacent property. Soil saturated here indicating water flowed through the drainage recently.

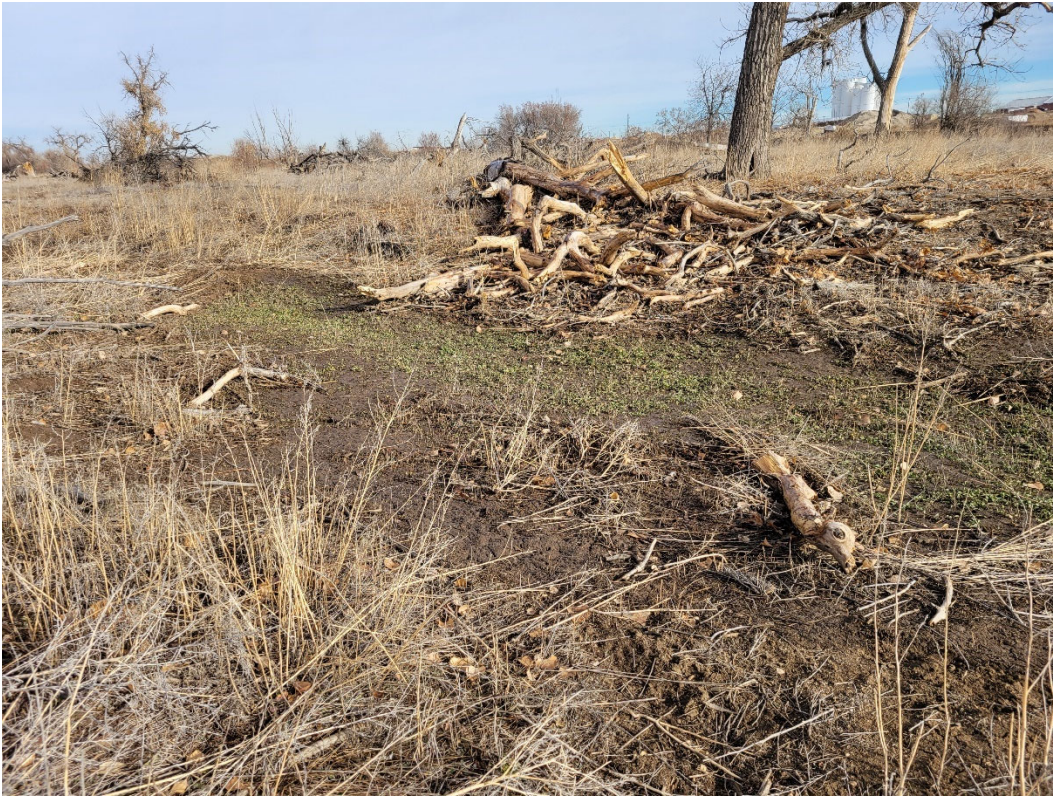
Photo 13: Looking north at extent of drainage/soil saturation on adjacent property

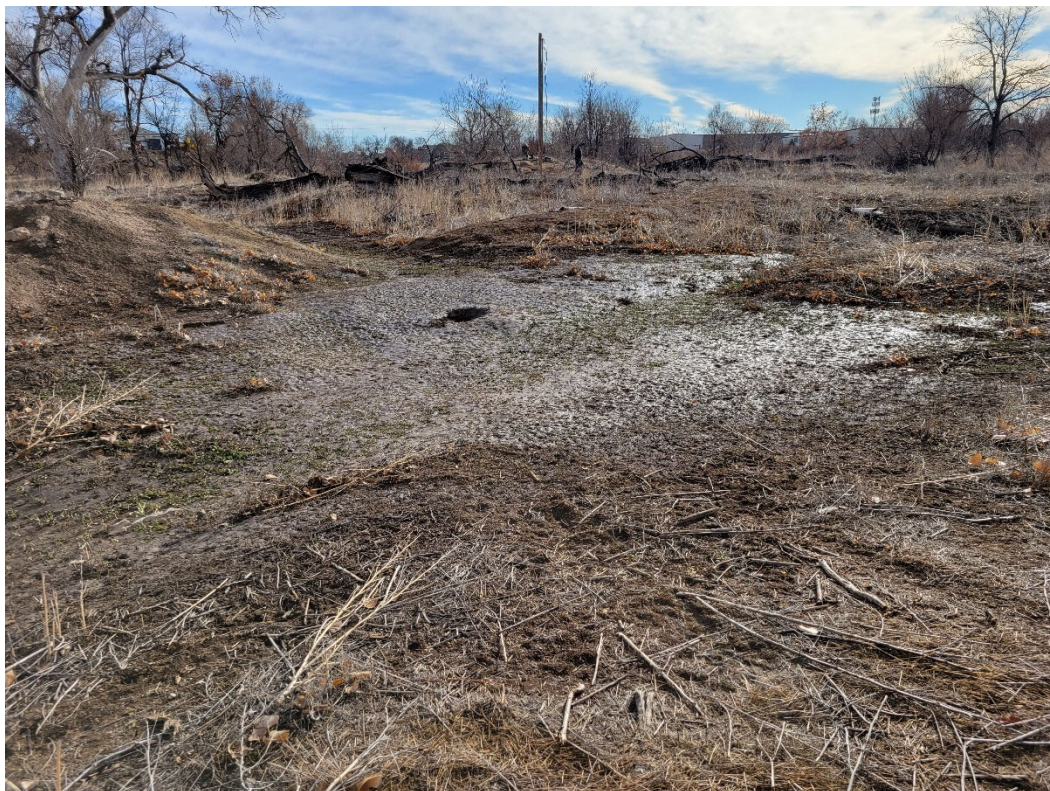
Photo 14: Looking east at northern extent of soil saturation on adjacent property.
Berms surround this low area.

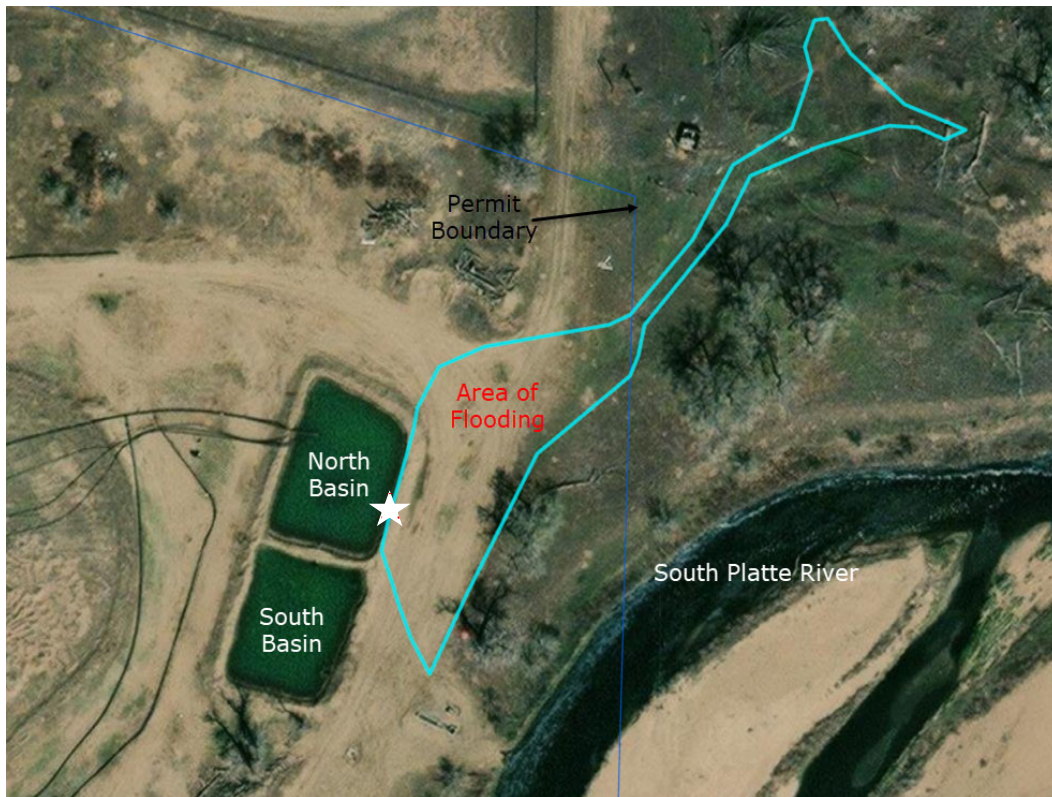
Figure 1: Aerial image showing the northeast corner of the Tucson South permit area. Highlighted area depicts the area where the soil was saturated during the inspection. Star notes the approximate location of the berm failure.
