MINERALS PROGRAM INSPECTION REPORT
PHONE: (303) 866-3567

MINE NAME: Ordway Pit	MINE/PROSPECTING ID#: M-2006-054	MINERAL: Sand and gravel	COUNTY: Crowley
INSPECTION TYPE: Surety-Related Inspection	WEATHER: Clear	INSP. DATE: December 12, 2024	INSP. TIME: 10:40
OPERATOR: Mid-States Materials, LLC	OPERATOR REPRESENTATIVE: Philip Porter	TYPE OF OPERATION: 112c - Construction Regular Operation	
REASON FOR INSPECTION: Surety Related	BOND CALCULATION TYPE: Complete	BOND AMOUNT: \$68,828.00	
DATE OF COMPLAINT: NA	POST INSP. CONTACTS: None	JOINT INSP. AGENCY: None	
INSPECTOR(S): Ursula Armstrong	INSPECTOR'S SIGNATURE:

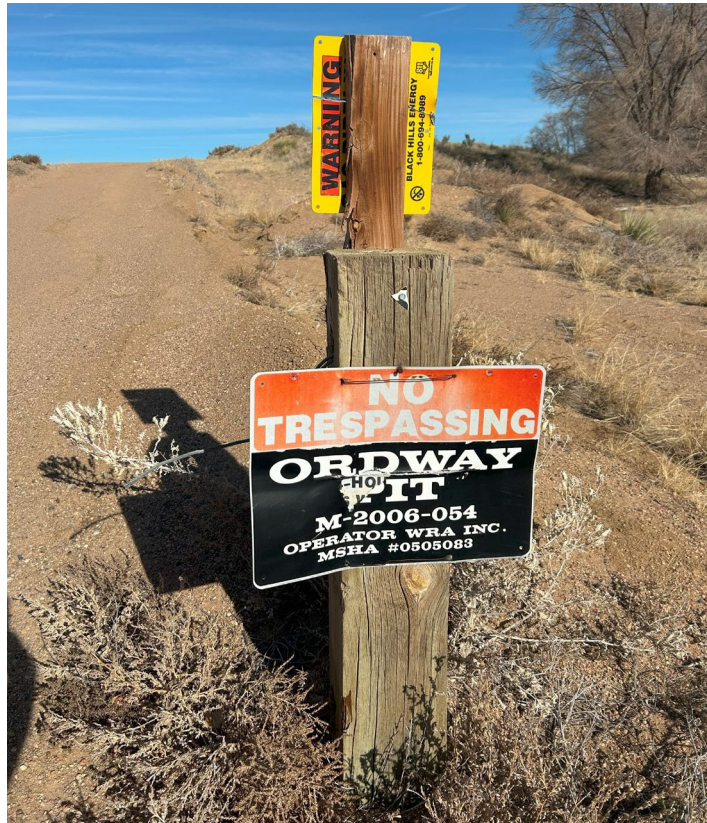
PROBLEM #1: A proper mine identification sign was not posted at the entrance of the mine site. This is a problem for failure to post a mine identification sign in accordance with Rule 3.1.12(1).

At the time of the inspection, the weather was mild and sunny. A mine permit sign was posted at the southeast entrance to the site. The permit sign has the name of the previous operator, the operation name, and the permit number. It does not include a statement that a reclamation permit for the operation has been issued by the Colorado Mined Land Reclamation Board, as required by Rule 3.1.12(1) and the operator needs to be updated. A problem is cited for this issue; see Problem #1 in this report for the required corrective actions.

Photo 1. Looking north at the mine identification sign posted at the southeast entrance to the mine.

CORRECTIVE ACTIONS: The Operator shall, at the entrance of the mine site post a sign, which shall be clearly visible from the access road, with a minimum size equaling one hundred and eighty-seven (187) square inches, such as eleven (11) inches in height and seventeen (17) inches in width, with appropriate font size, with the following: the name of the Operator, the operation name, a statement that a reclamation permit for the operation has been issued by the Colorado Mined Land Reclamation Board, and the permit number. The operator shall submit photo documentation that a proper sign has been posted by the corrective action date.

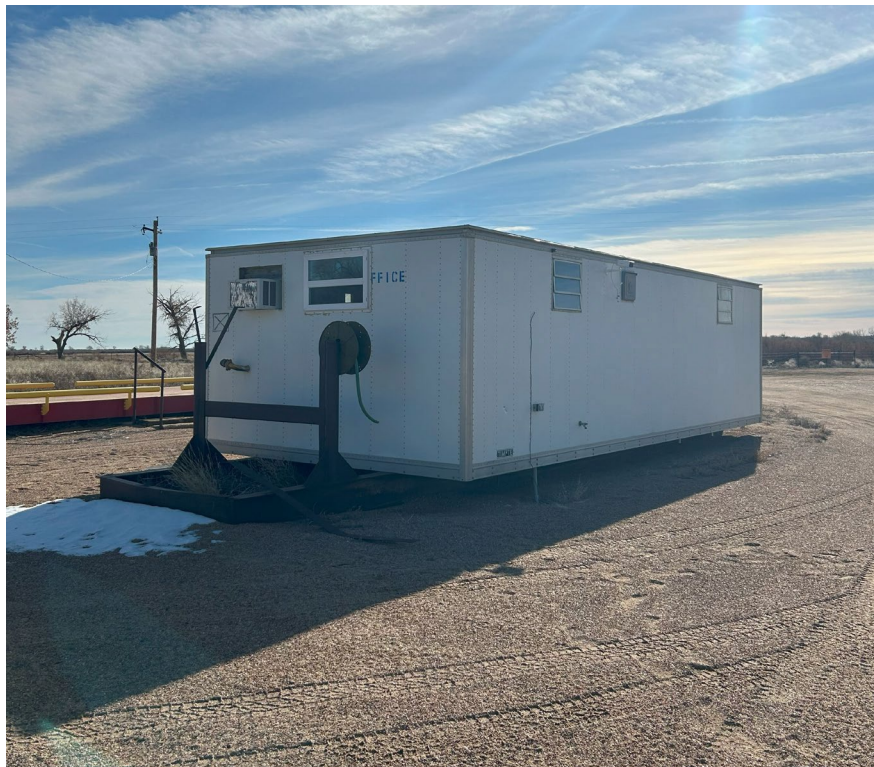
Photo 2. Looking southeast at the mobile office trailer near the scale at the southeastern corner of the site.

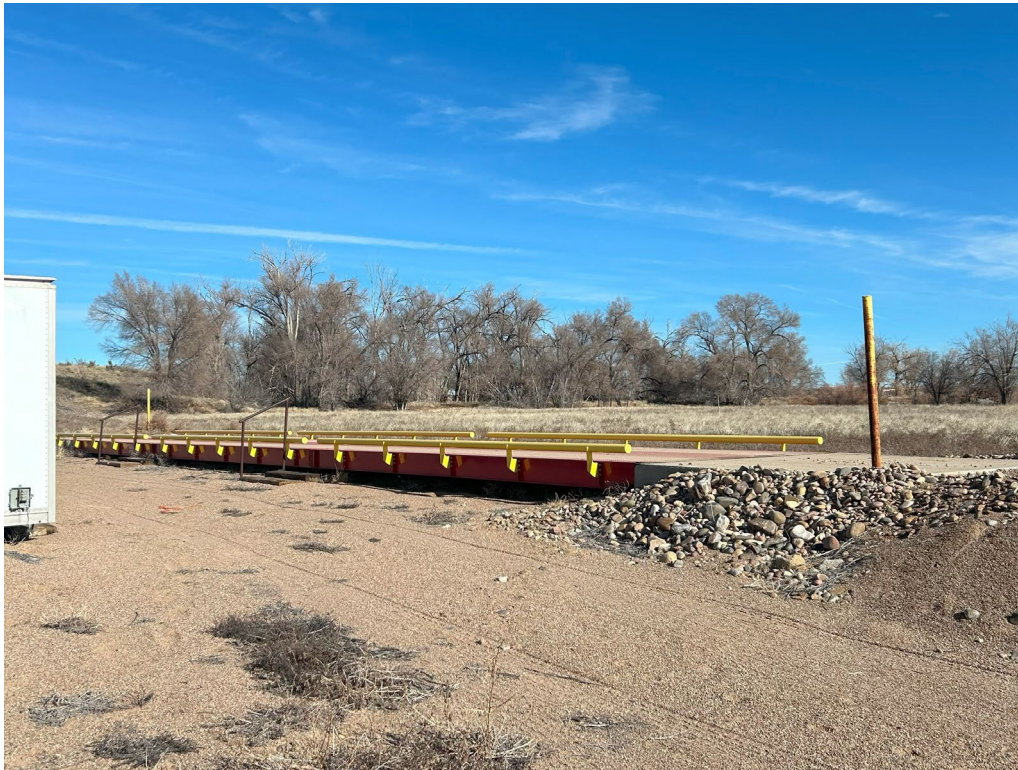
Photo 3. Looking north at the scale in the southeastern corner of the site.

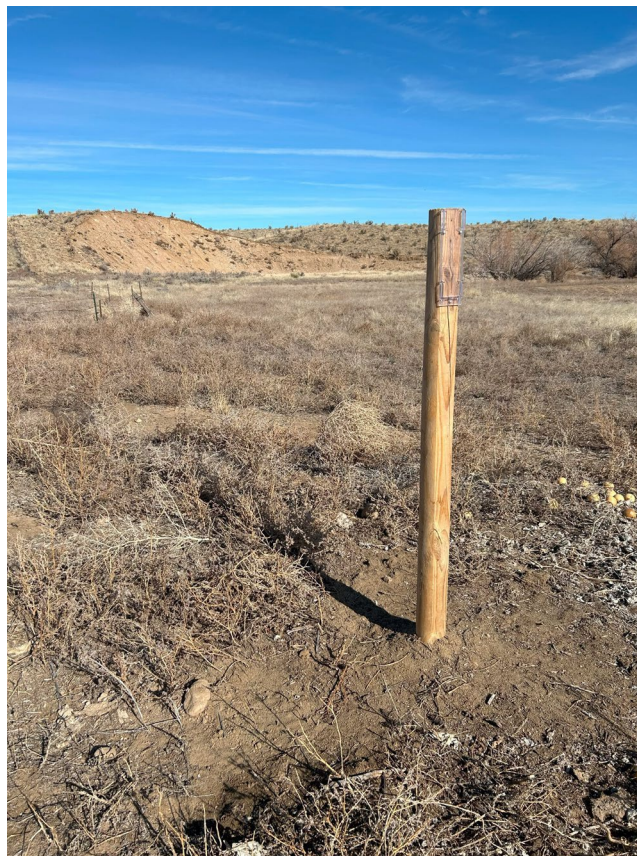
Photo 4. The southwestern corner of the permit boundary delineated with a large wooden pole, looking north.

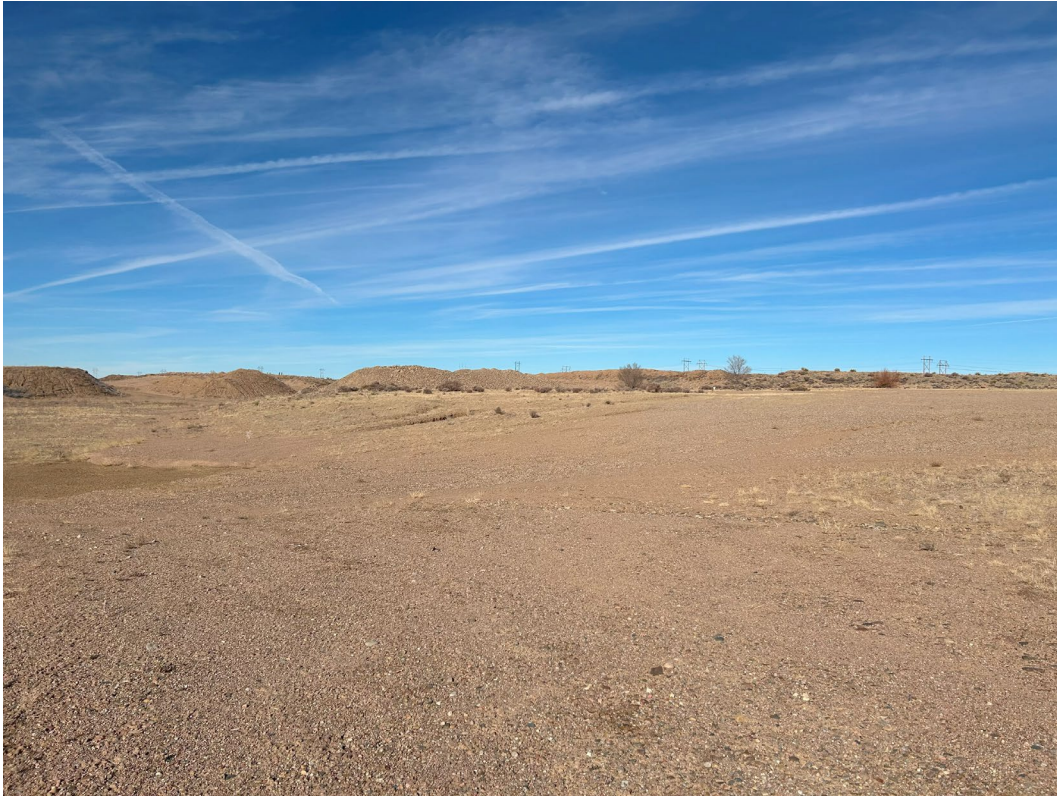
Photo 5. Looking northwest toward the most recent processing area (off to the left). The photo was taken from the area that has been graded and re-topsoiled (off to the right).

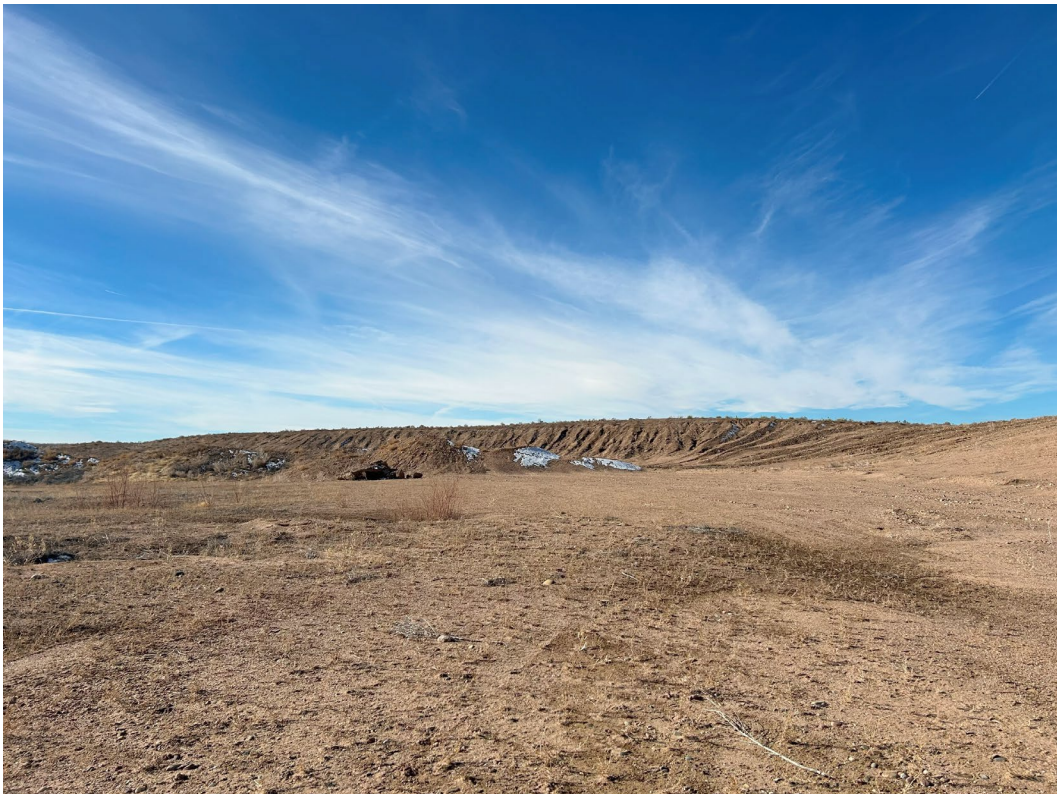
Photo 6. Looking toward the furthest mined highwall to the west. Photo was taken standing in the recent processing area.

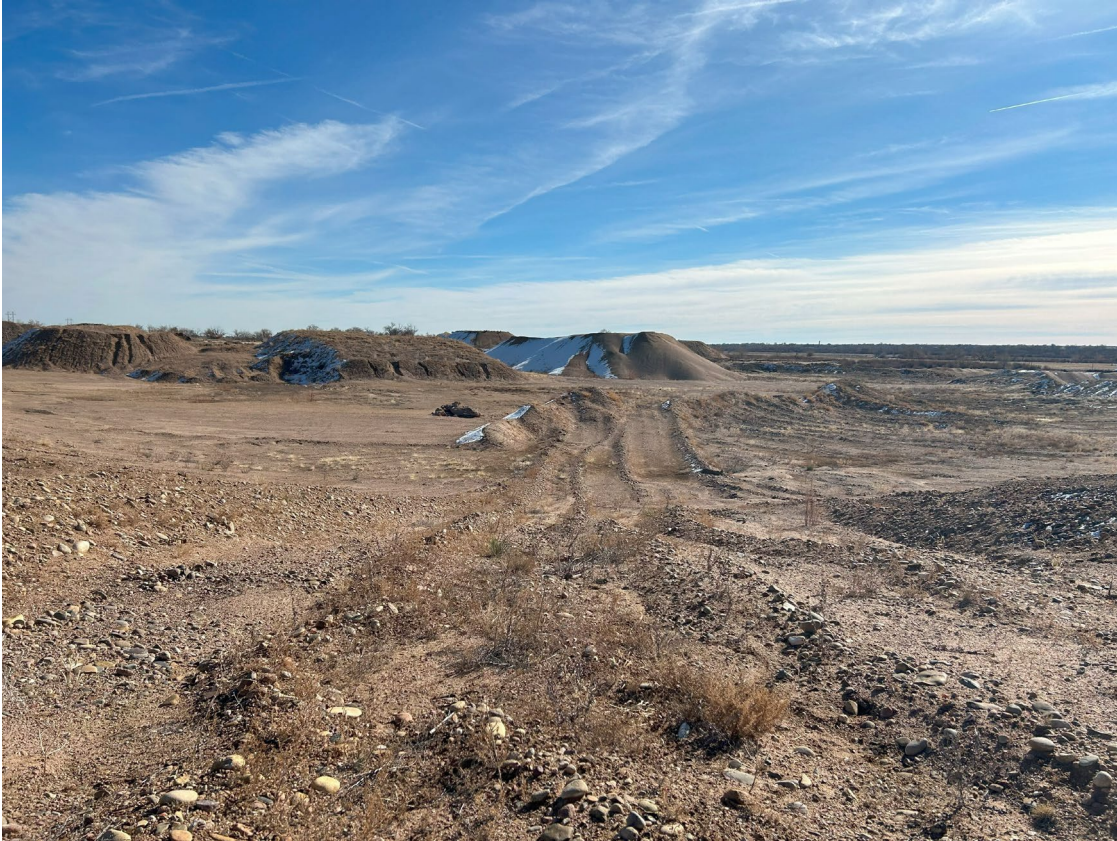
Photo 7. View looking east over the recent processing area, taken from the top of the western-most mined slope. Material stockpiles seen in the background.

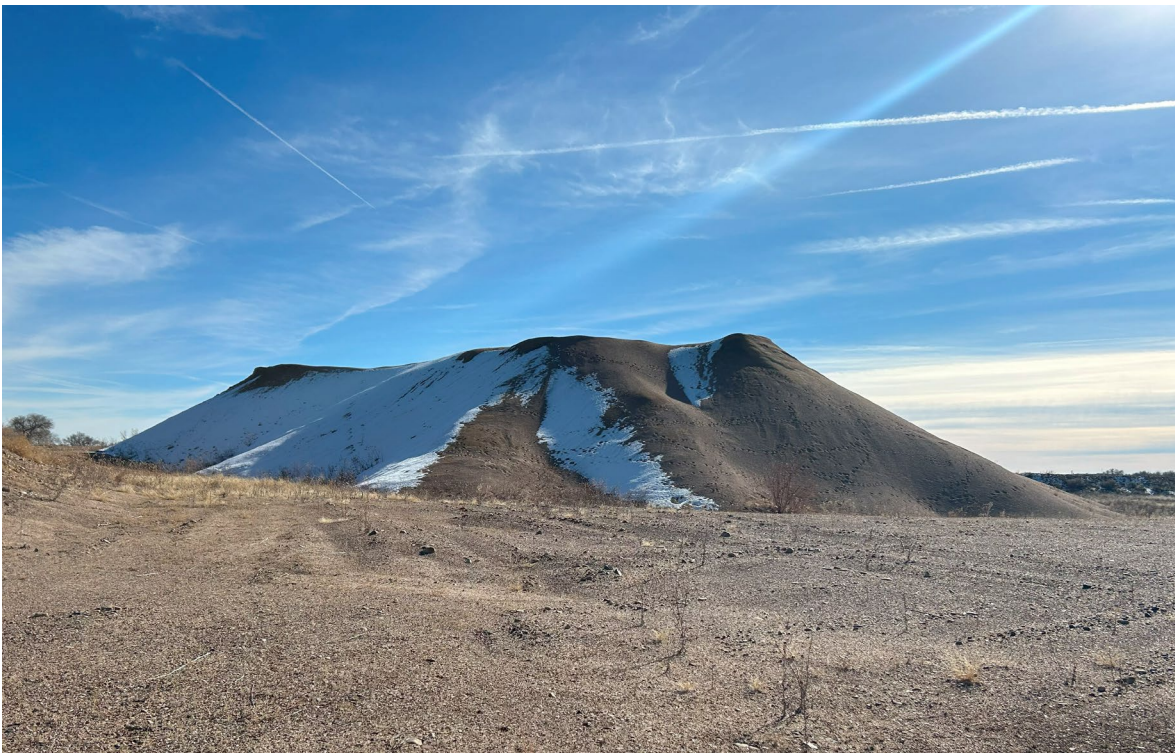
Photo 8. One of the material stockpiles remaining near the recent processing area, looking east.

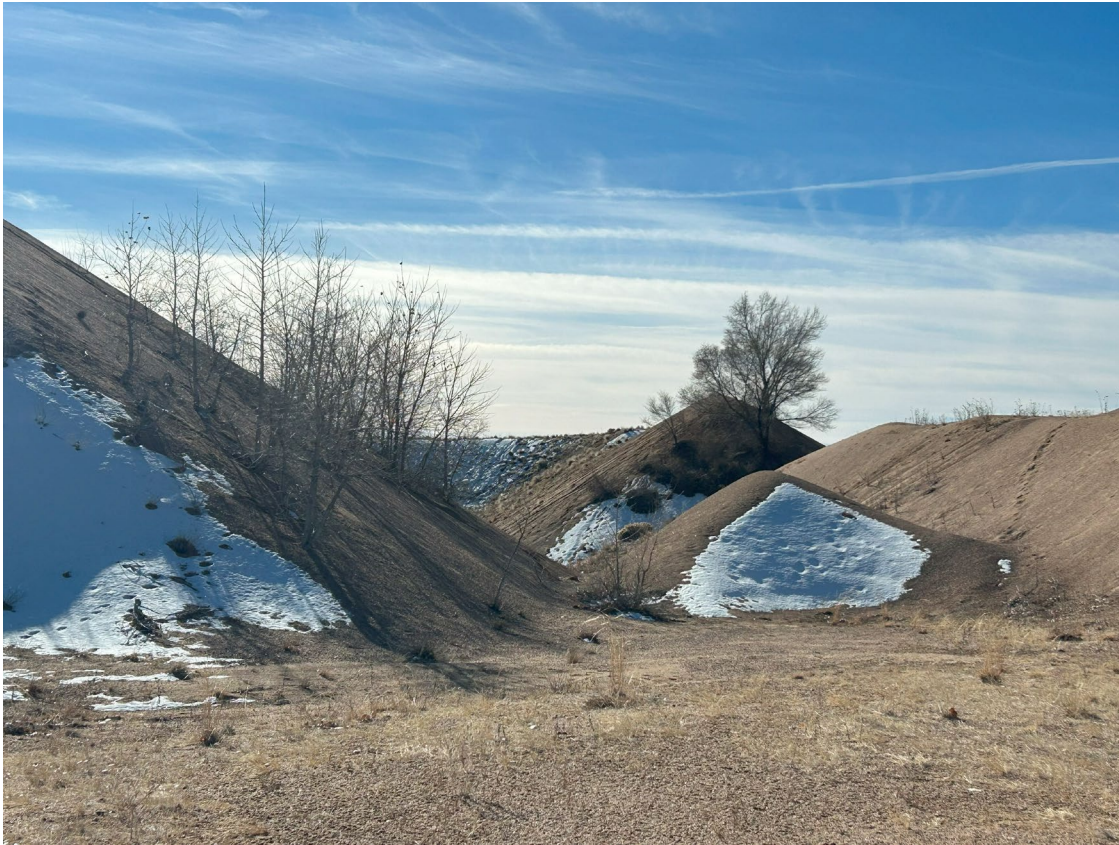
The large sand and gravel stockpiles located in the southeastern portion of the site are approximately 20-25 feet in height and have a significant amount of vegetation growth indicating they have not been utilized in several years. The three ponds previously observed at the site were likely filled with sediment, but the Division is assuming they are still there based on the approved mining plan. According to the approved plan, two of the ponds are lined and used to recirculate water from the material wash plant. Approximately 12.2 acres in the northeastern portion of the site have been graded to 3H:1V or flatter and appear to have had topsoil replaced. The western portion of the current disturbed area of the site includes several sand and gravel stockpiles leftover from the mobile processing equipment.

Photo 9. Looking south at the material stockpiles in the southeastern corner. Note the large amount of vegetation.

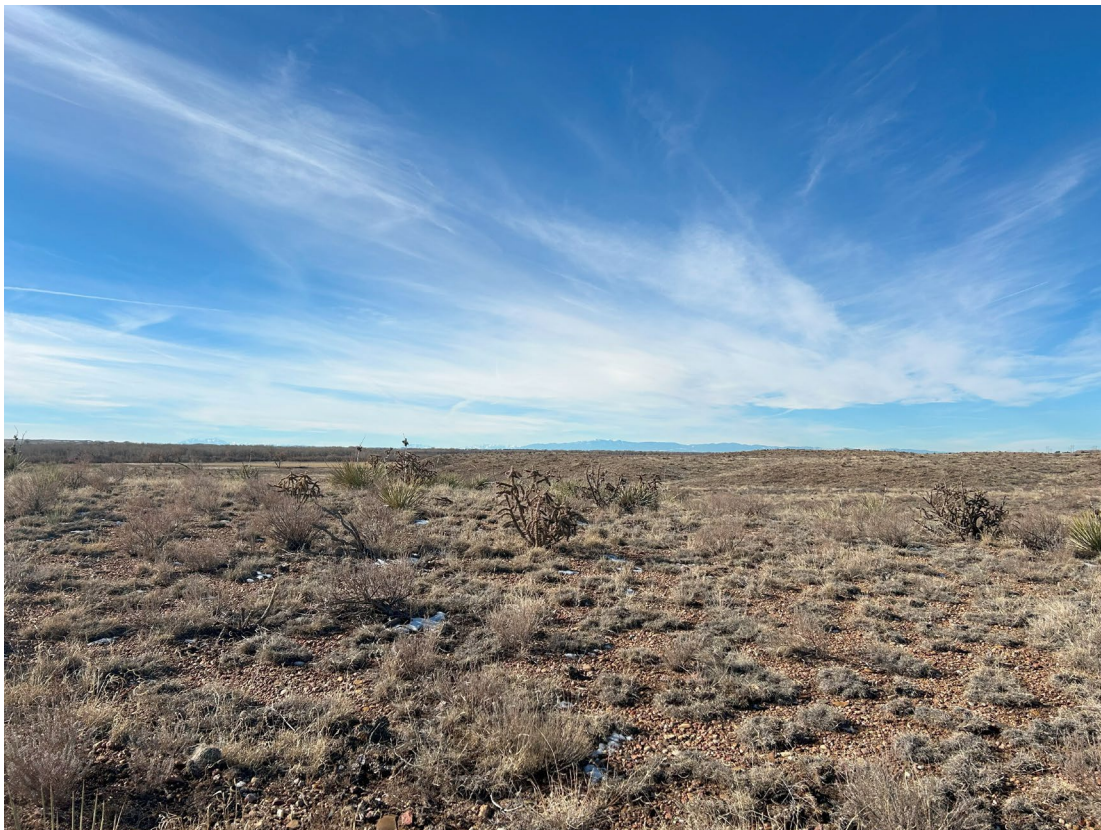
Photo 10. Typical conditions of the surrounding land ahead of mining activities, looking west.
