Inspection Report, Colowyo, C-1981-019

Permit Number: C-1981-019 Mine Name: Colowyo Coal Mine Operator: Colowyo Coal Company L.P. Operator Address: Mr Tony Tennyson 5731 State Highway 13 Meeker, CO 81641	County: Moffat, Rio Blanco Operation Type: Surface Permit Status: Active Ownership: Private
	Operator Representative Present: Tony Tennyson
Operator Representative Signature: (Field Issuance Only)

Inspection Start Date: January 14, 2025 Inspection Start Time: 07:30 Inspection End Date: January 14, 2025 Inspection End Time: 12:00		Inspection Type: Coal Partial Inspection Inspection Reason: Normal I&E Program Weather: Clear	
Joint Inspection Agency: None		Joint Inspection Contacts: 	
Post Inspection Agency: None		Post Inspection Contacts: 	
Inspector(s): Hunter Ridley	Inspector's Signature: <i>Hunter Ridley</i>		Signature Date: January 22, 2025

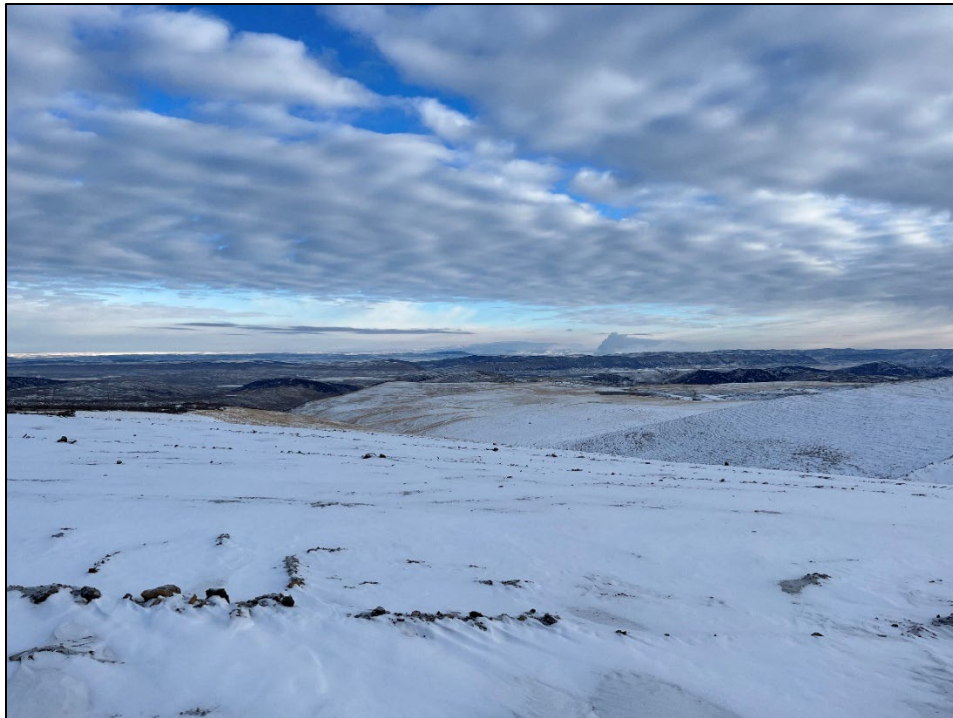
West Pit reclamation was observed from atop the spoil pile south of West Pit (Photo 1). West Pit is near completion in terms of backfill operations. Vegetation in this area is partially established, with some areas waiting out the 10-year liability period and others awaiting reseeding efforts.

Photo 1: View north of West Pit reclamation.

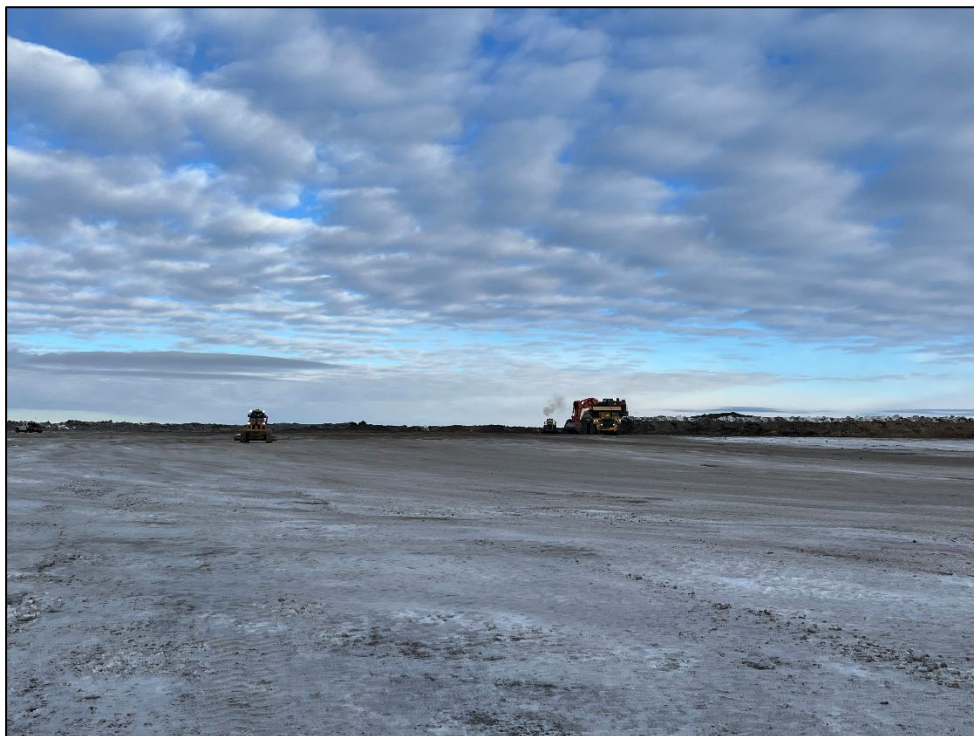
Active backfill operations were observed in the South Taylor Pit during the inspection. Spoil material was being hauled from the eastern side of the South Taylor Pit (Photo 2) and was being deposited towards the southeast corner of the South Taylor pit (Photo 5). A highwall of product remains to the west for possible future use.

Photo 2: Material is being hauled from the temporary spoil pile in the South Taylor area for use in backfill operations.

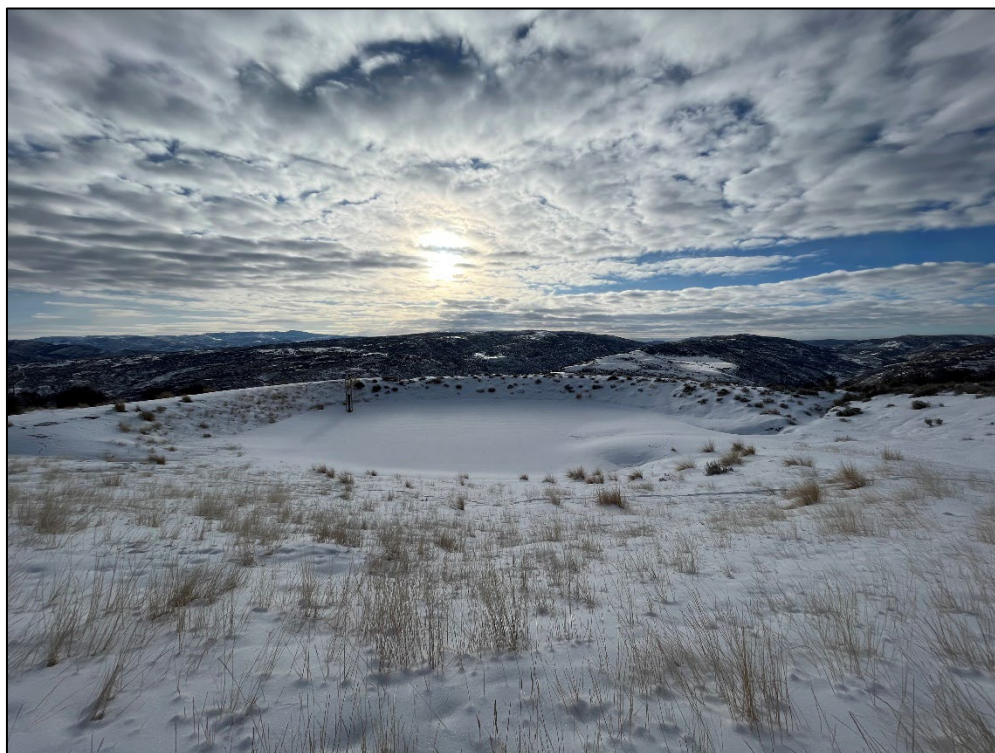
Section 15 (Photo 6) and Section 16 (Photo 3) Ponds and Ditches were accessible with the use of a small off-road vehicle. Both ponds were frozen over, snow covered and had no issues.

Photo 3: View east of Section 16 Pond.

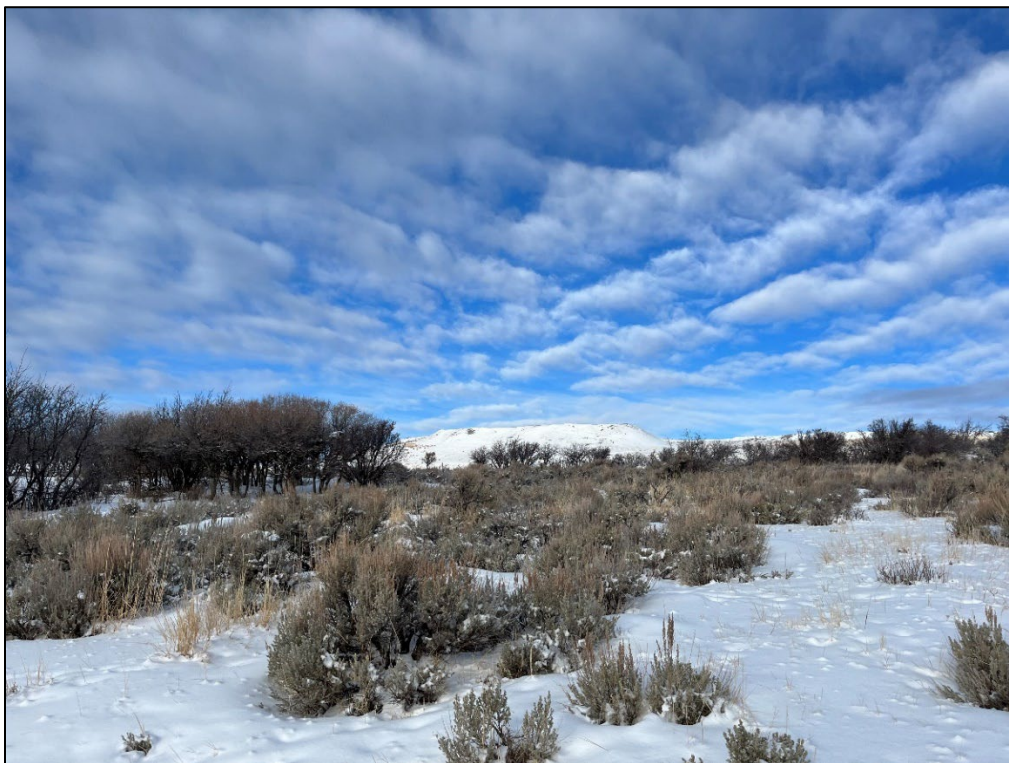
Topsoil piles across the site contained appropriate markers. Markers have been maintained throughout the winter season thus far, with signs being present for even remote topsoil areas in East and South Taylor Pit (Photo 4).

Photo 4: Topsoil pile located to the west of Section 16 Pond.

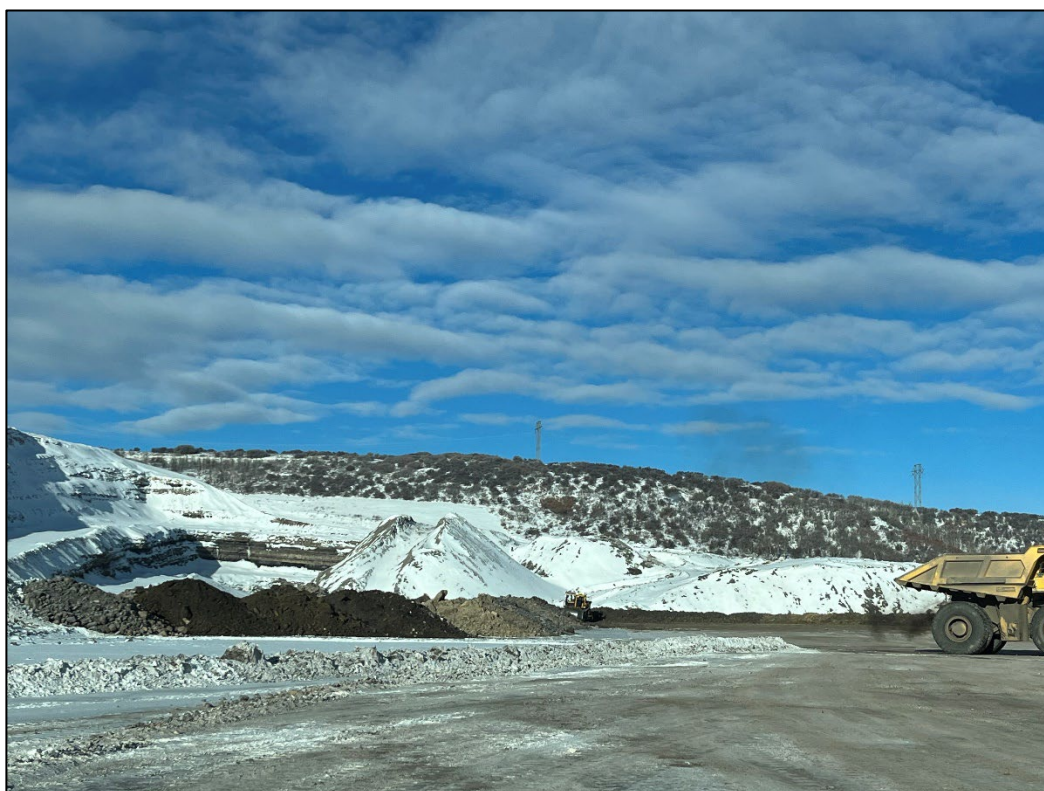
Photo 5: Active backfill operations in the South Taylor Pit.

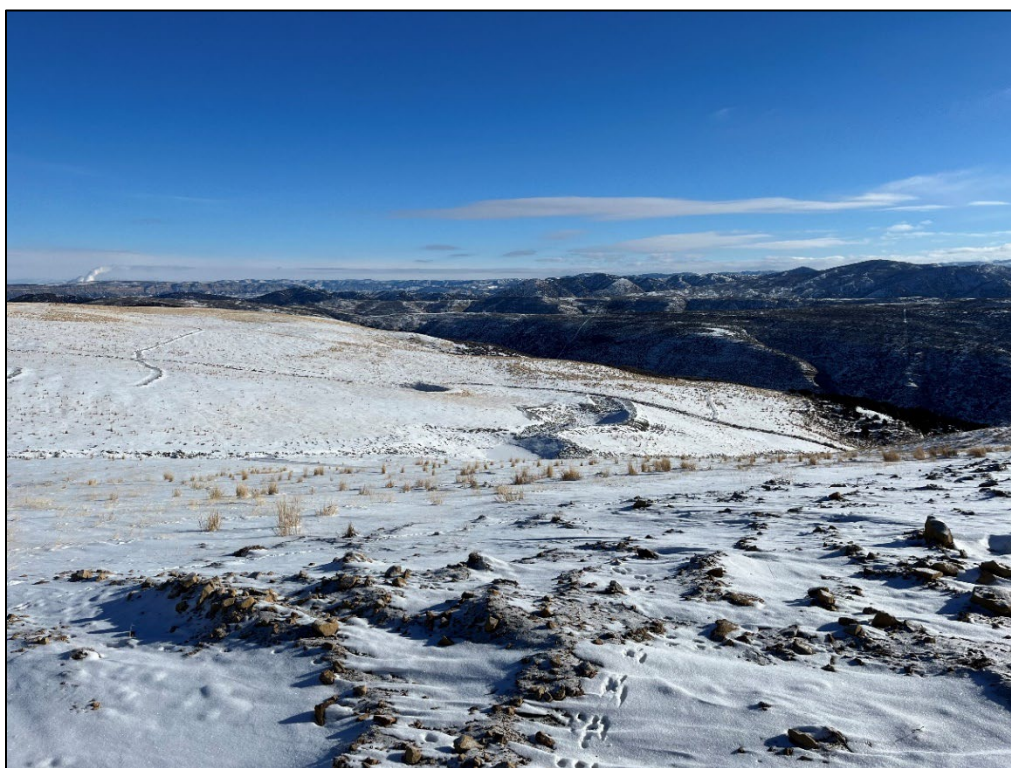
Ditches in the East Pit area were not visited directly due to steep and snowy conditions. However, the southern end of these pits was observed from along the slope adjacent to Section 15 Ditch. Final East Pit Ditch and EP1 (Photo 7), EP2 (Photo 8), and EP3 (Photo 7) were visible from this vantage point. All ditches were partially snow covered but looked to be stable. EP2 and EP1 were holding water but frozen over.

Photo 7: View east of Final East Pit Ditch and EP1 & EP3.

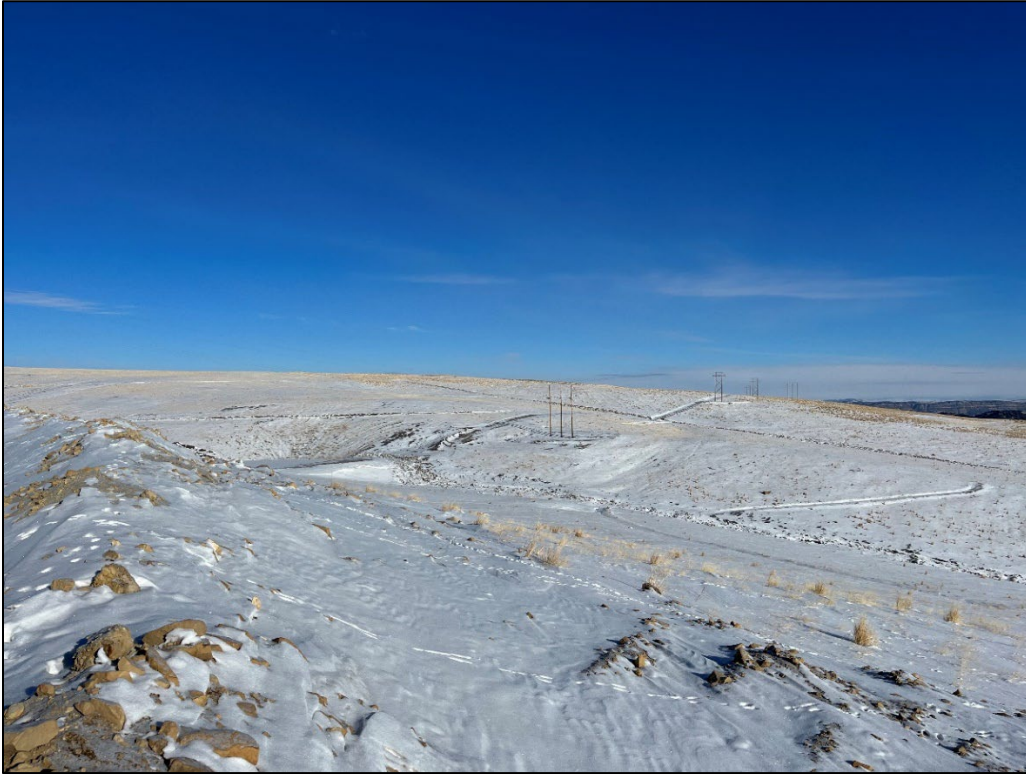
Photo 8: View north of EP2 in the Final East Pit Ditch.

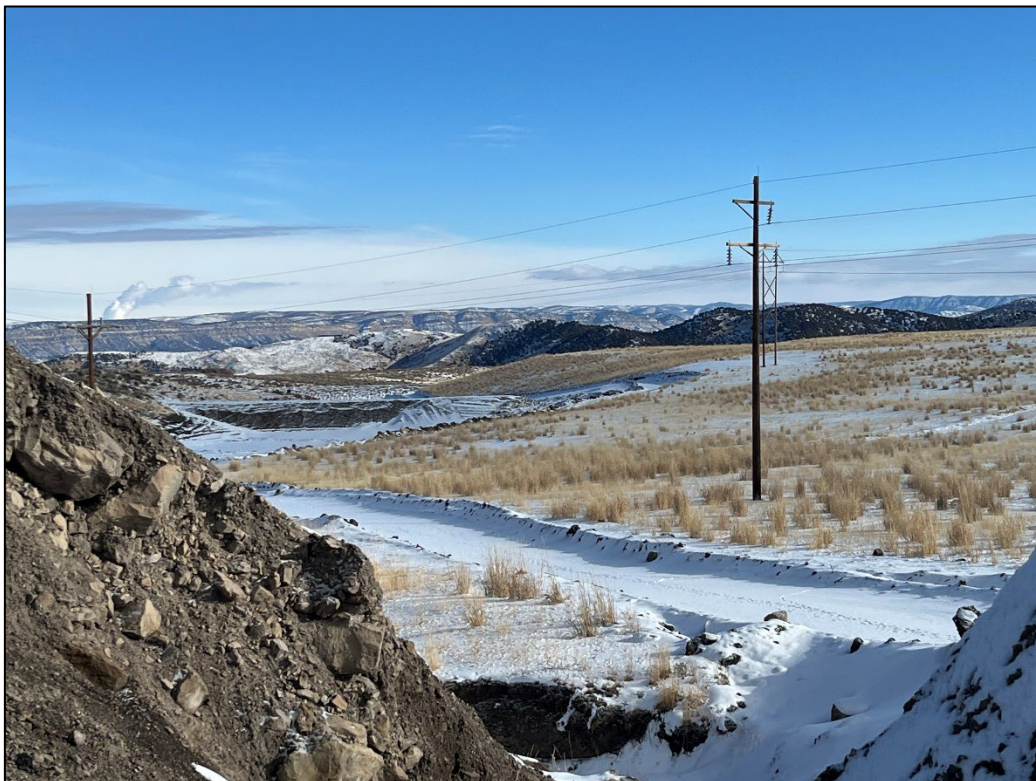
Upper and Lower Section 3 Ponds in the East Pit are complete. These sediment ponds function in series, with the Lower Section 3 Pond being a non-discharging structure. Due to snow and berms, the Division was unable to drive directly to the ponds during this inspection. However, the ponds were visible through a small cut in the road berm and were observed to be stable (Photo 9). Spring melt will test the ponds' full functionality later in the year.

Photo 9: View of Section 3 Ponds from the eastern side of the haul road.

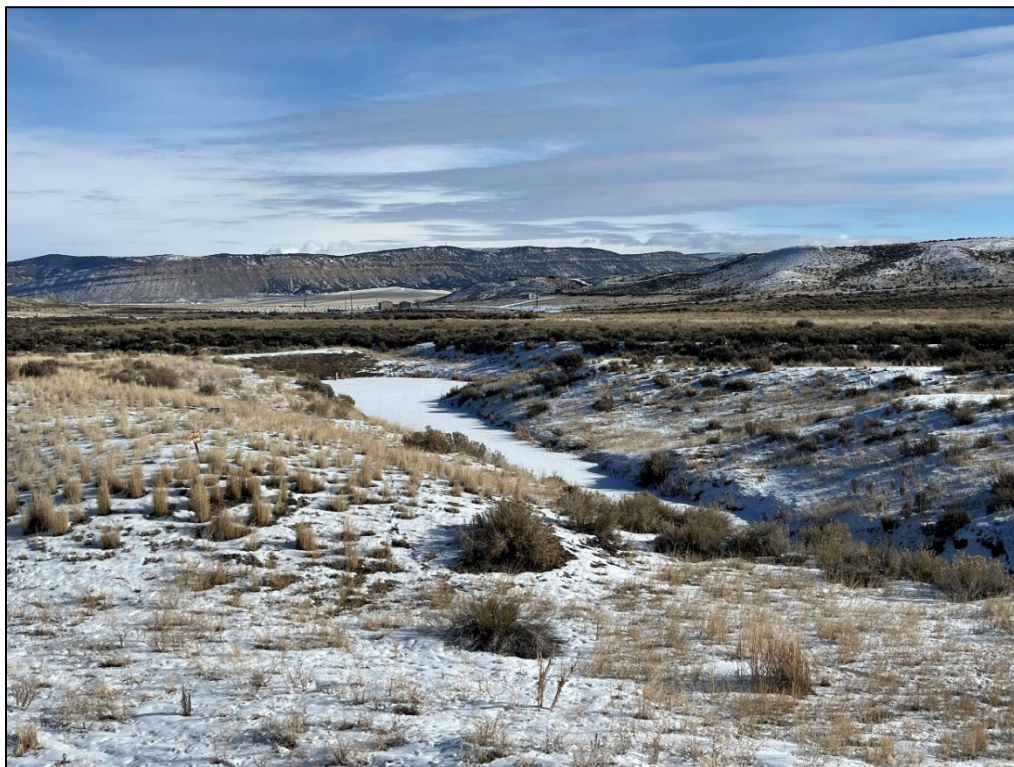
The following ponds in the Loadout Area were inspection this month: Gossard Pond (Photo 12), Stoker Siding Pond (Photo 10) and Rail Loop Pond (Photo 11). No problems or erosional concerns were noted. All inspected ponds were noted to be holding water, but frozen over. The Rail Loop and Gossard Ponds are both designed for containment rather than discharge.

Photo 10: View north of the Stroker Siding Pond.

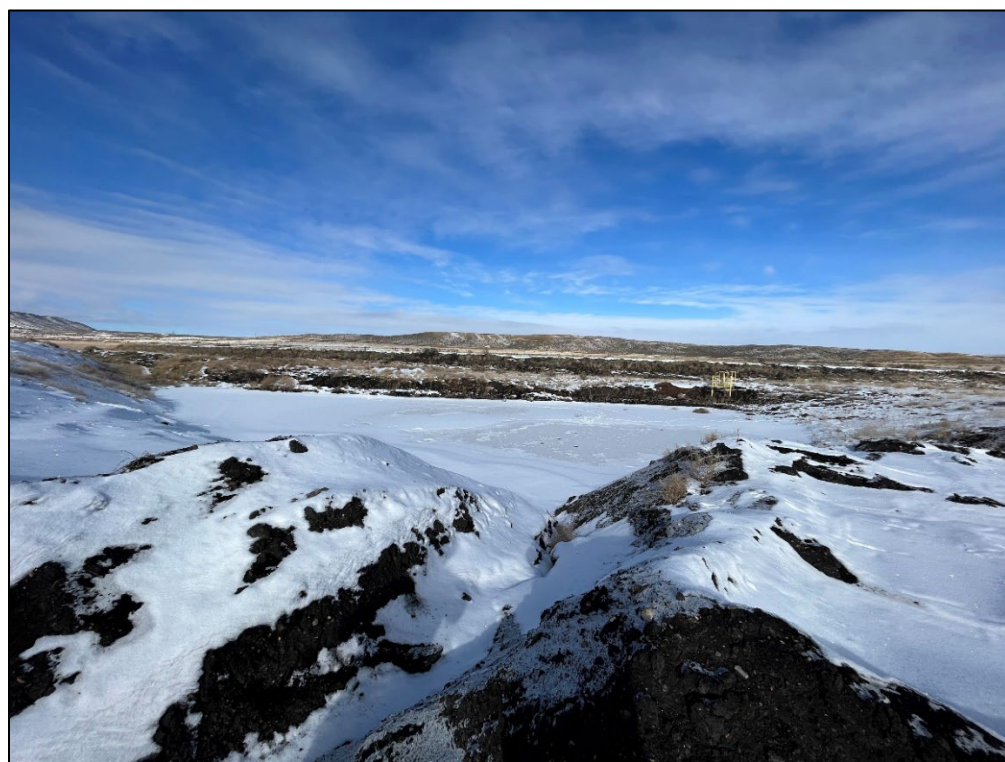
Photo 11: View northwest of the Rail Loop Pond.

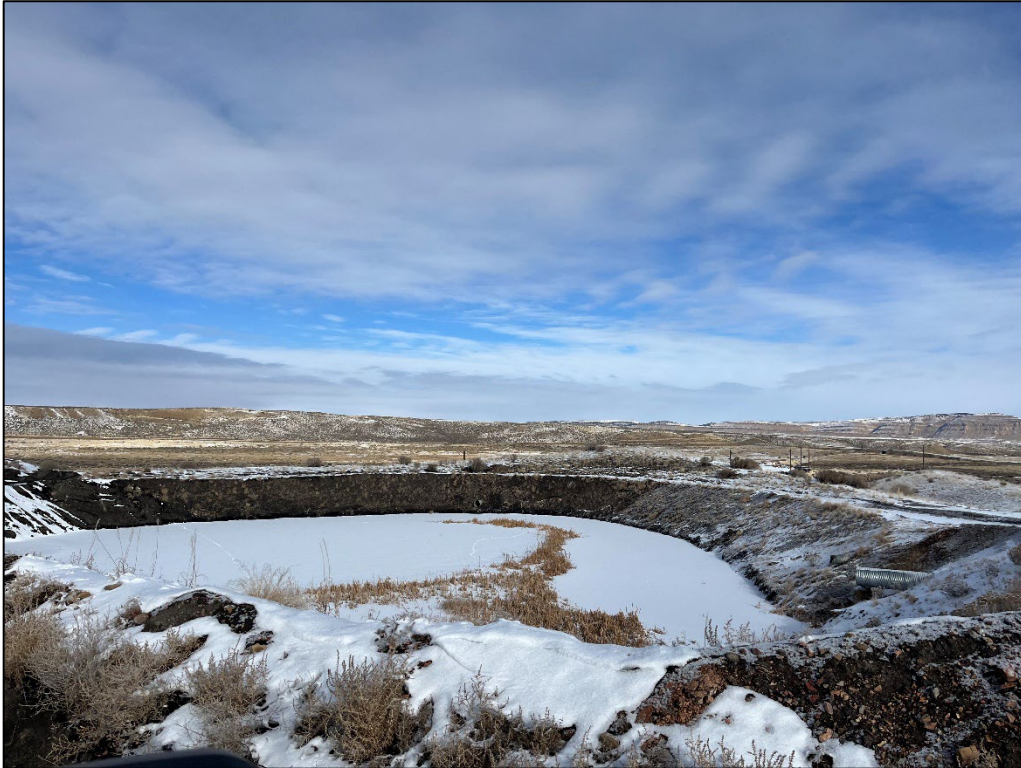
Photo 12: View of Gossard Pond located in the rail loop area.

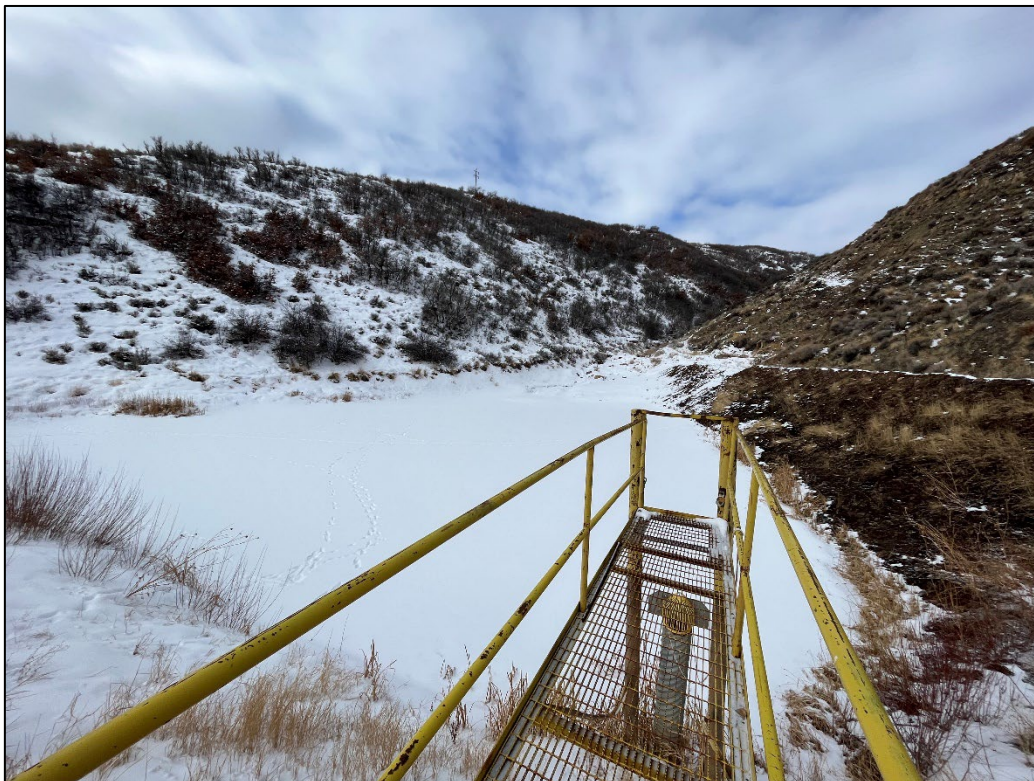
The Prospect Pond and Section 28 Pond, accessible via Hwy 13, were inspected. Section 28 (Photo 14) and Prospect (Photo 13) Ponds held water at the time of inspection but were entirely frozen over. All embankments appeared stable and vegetated under snow cover. No issues were noted.

Photo 13: View west of Prospect Pond.

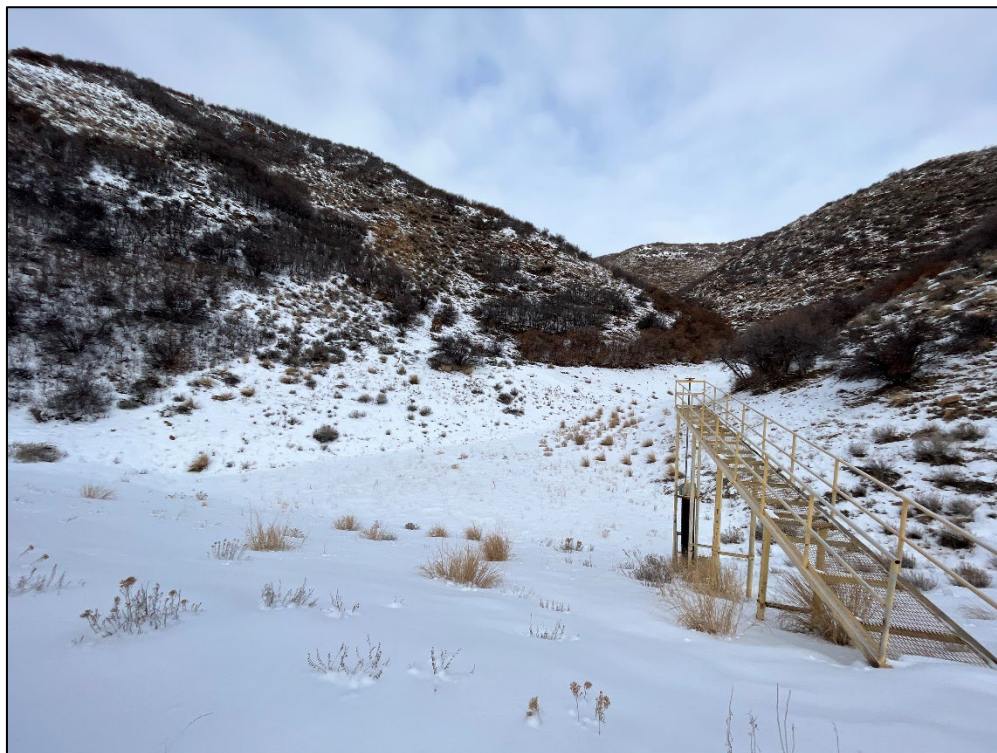
Photo 14: View north of Section 28 Pond.
