**MINERALS PROGRAM INSPECTION REPORT**  
**PHONE: (303) 866-3567**

<b>MINE NAME:</b> LTS Topsoil Mine	<b>MINE/PROSPECTING ID#:</b> M-2024-055	<b>MINERAL:</b> Borrow material for	<b>COUNTY:</b> Weld
<b>INSPECTION TYPE:</b> Preoperation Inspection	<b>WEATHER:</b> Cloudy	<b>INSP. DATE:</b> January 17, 2025	<b>INSP. TIME:</b> 09:00
<b>OPERATOR:</b> LTS Performance Horses LLC	<b>OPERATOR REPRESENTATIVE:</b> Kelesy Bruxvoort	<b>TYPE OF OPERATION:</b> 112c - Construction Regular Operation	
<b>REASON FOR INSPECTION:</b> Preoperation Inspection	<b>BOND CALCULATION TYPE:</b> None	<b>BOND AMOUNT:</b> \$0.00	
<b>DATE OF COMPLAINT:</b> NA	<b>POST INSP. CONTACTS:</b> None	<b>JOINT INSP. AGENCY:</b> None	
<b>INSPECTOR(S):</b> Patrick Lennberg	<b>INSPECTOR'S SIGNATURE:</b>

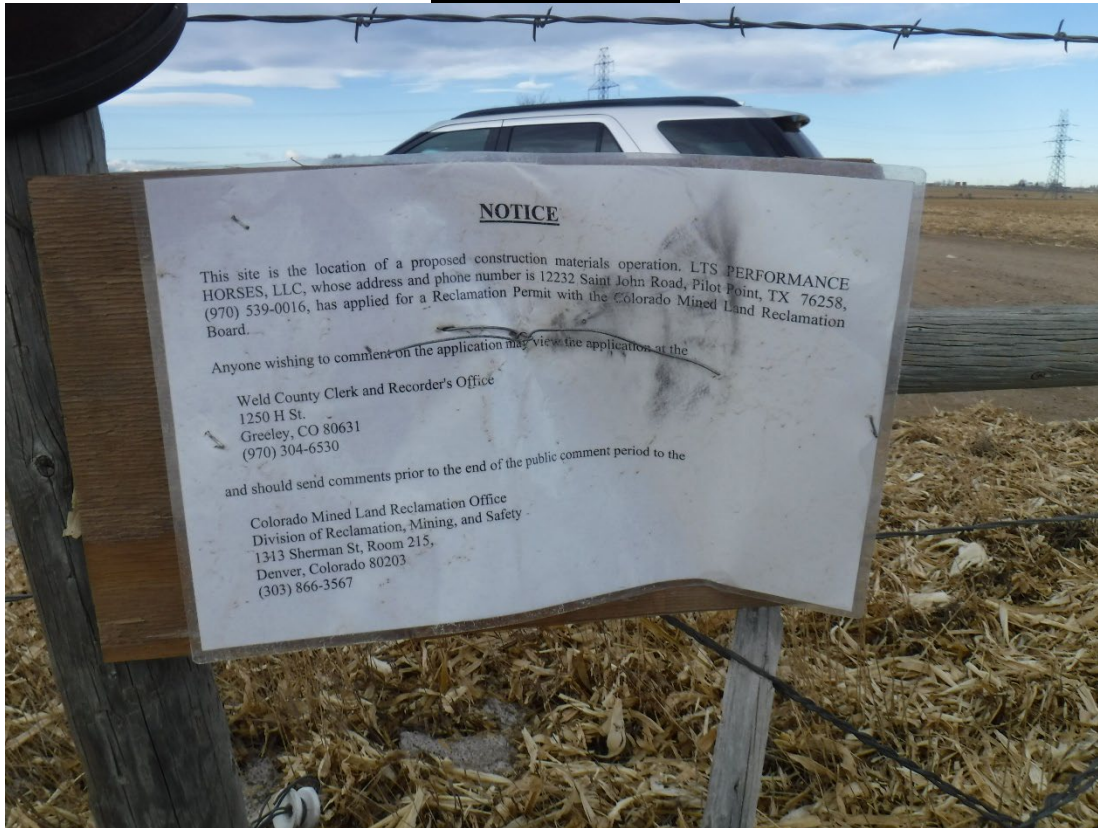
**Photo 1:** Notice sign posted at or near the proposed mine entrance

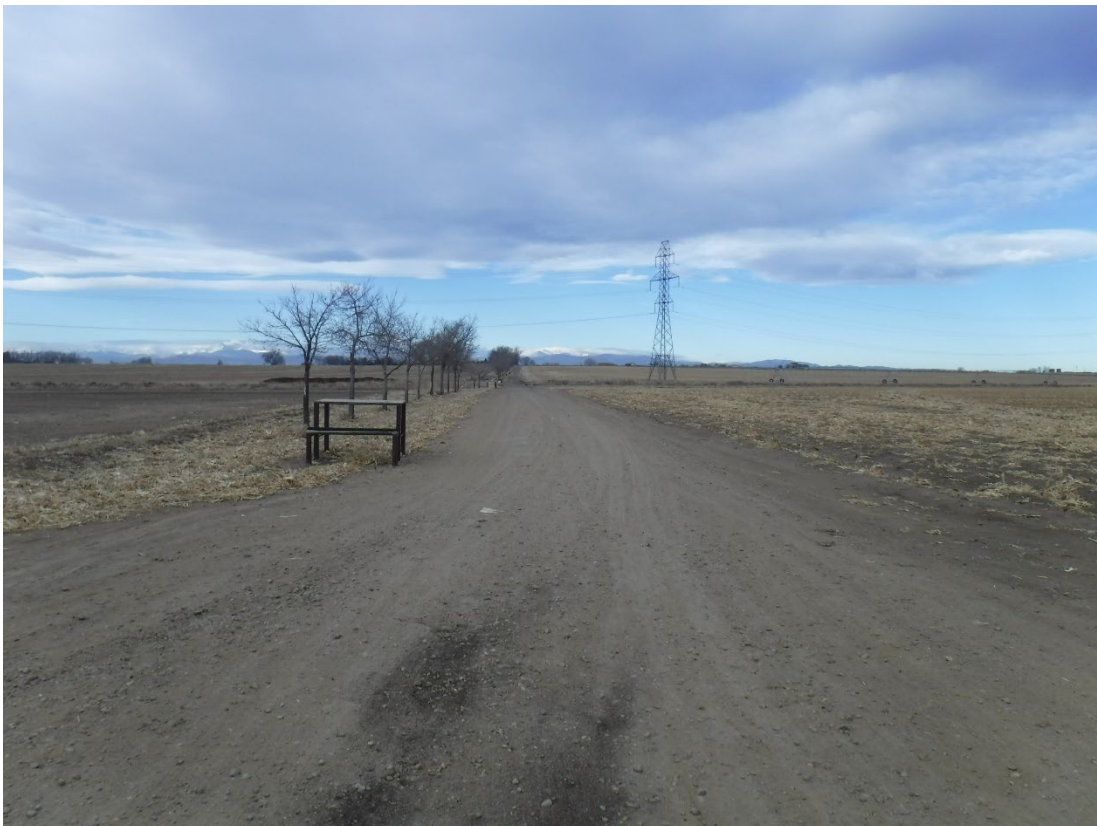
**Photo 2:** Primary access road to proposed mine site with an easement to Bartmann residence

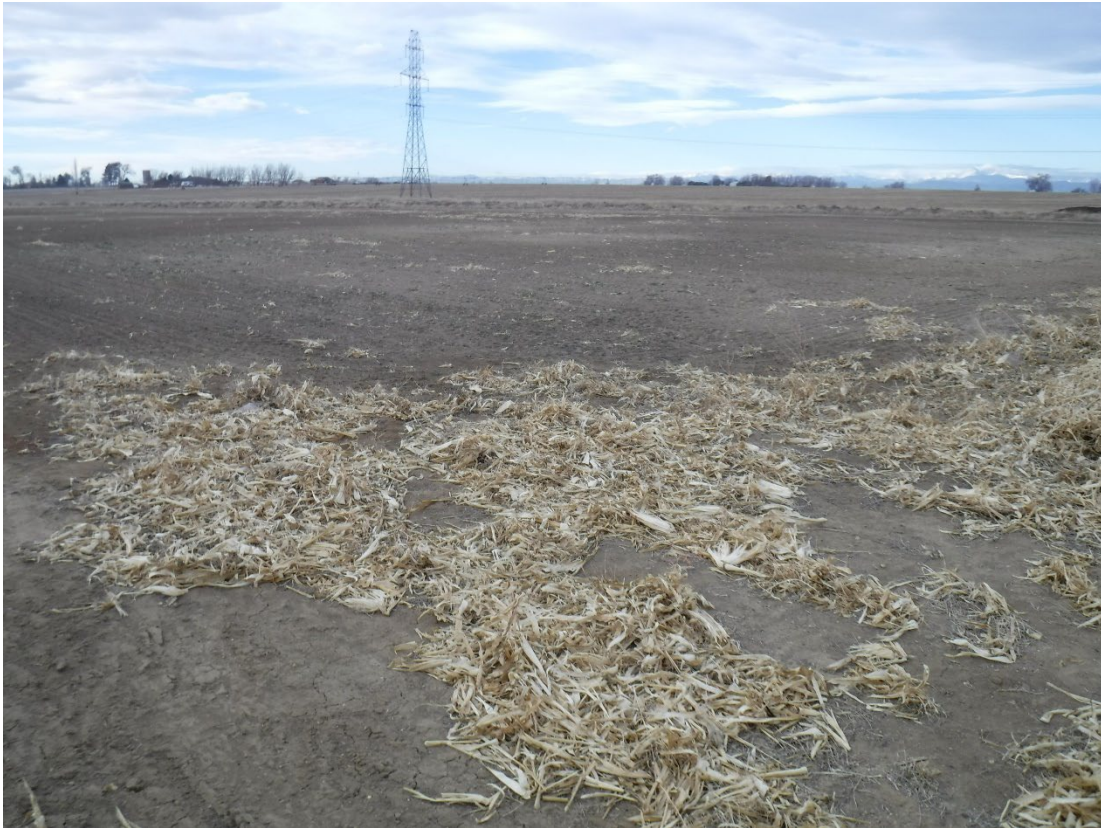
All structures observed during the inspection were accurately depicted on the maps within the permit application. It was noted that the area of the proposed Staging Area (5.05-acres) appears to have been cultivated earlier this year. Currently, the application has this area being reclaimed with a native grass seed mix. The Division discussed that it might be more appropriate to have this area reclaimed to cropland like other areas of the permit. This change would benefit the Operator in getting the area ready sooner for potential final release. Otherwise, the native grasses would take years to get established before becoming eligible for final release.

**Photo 3:** Proposed Staging Area location, the area has recently been cultivated, looking southwest

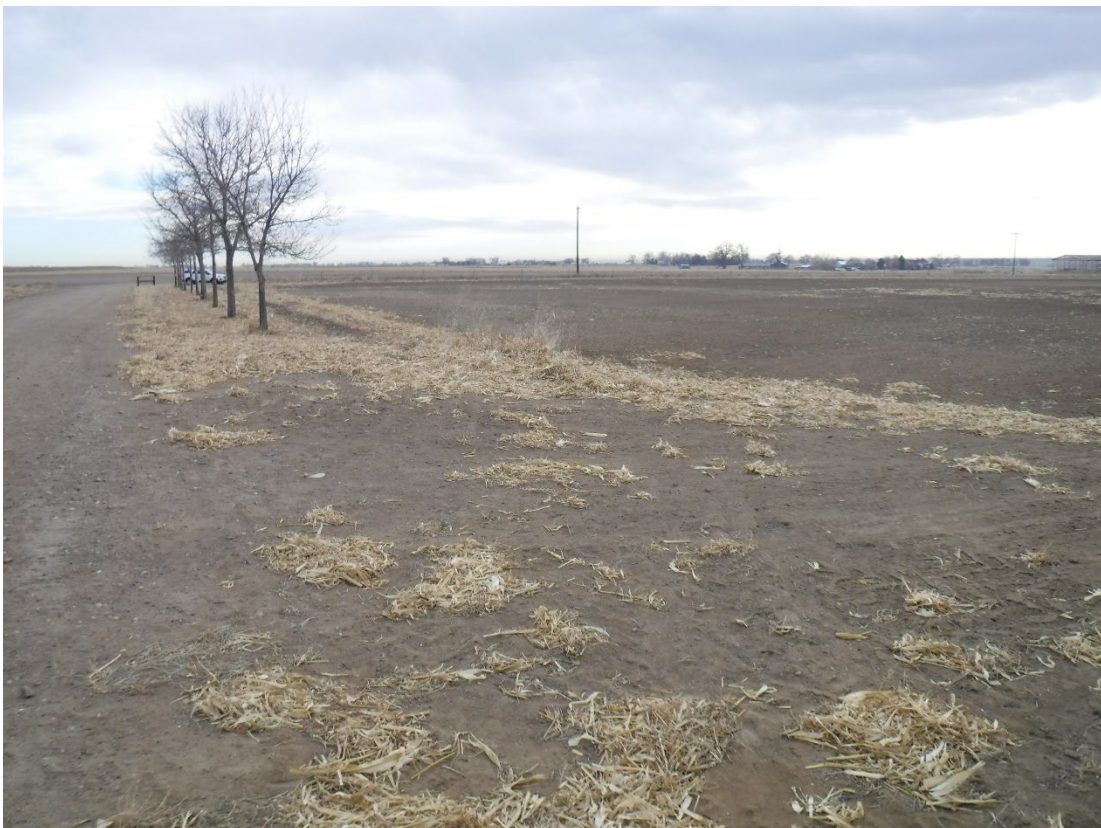
**Photo 4:** Proposed Staging Area location, looking southeast

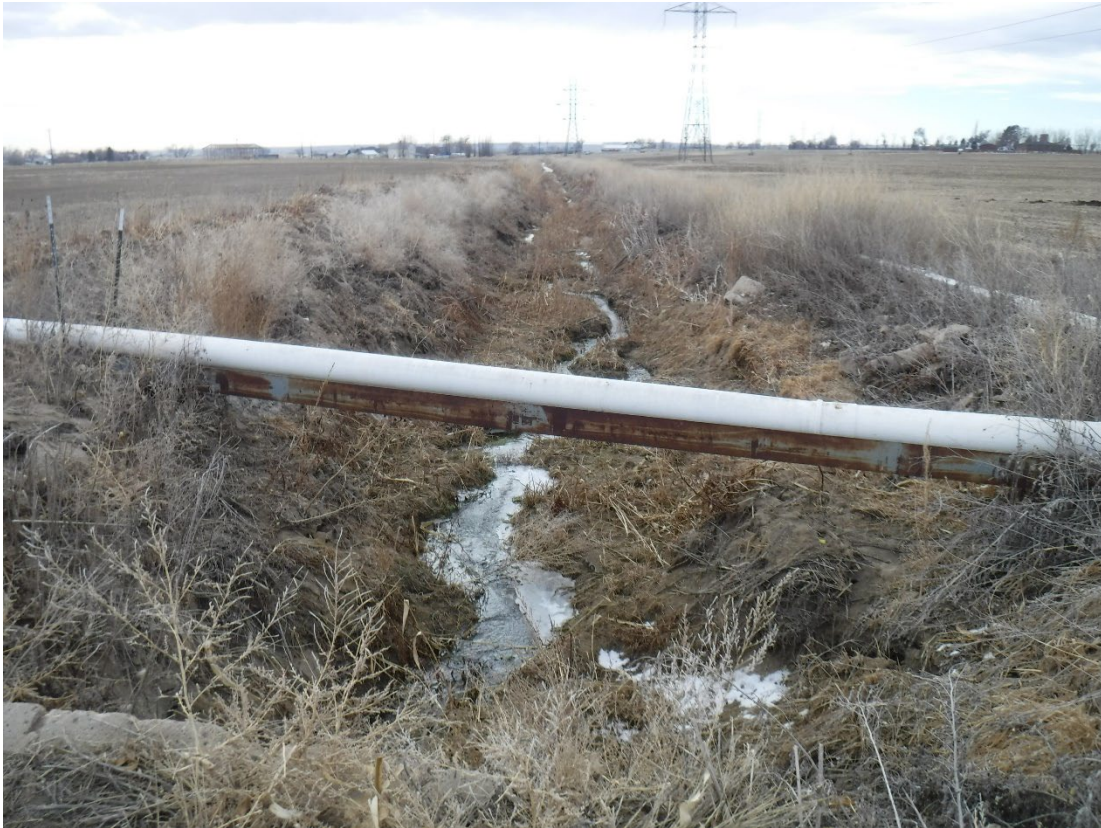
**Photo 5:** Irrigation ditch and overhead powerlines mining will be 200' away from these structures

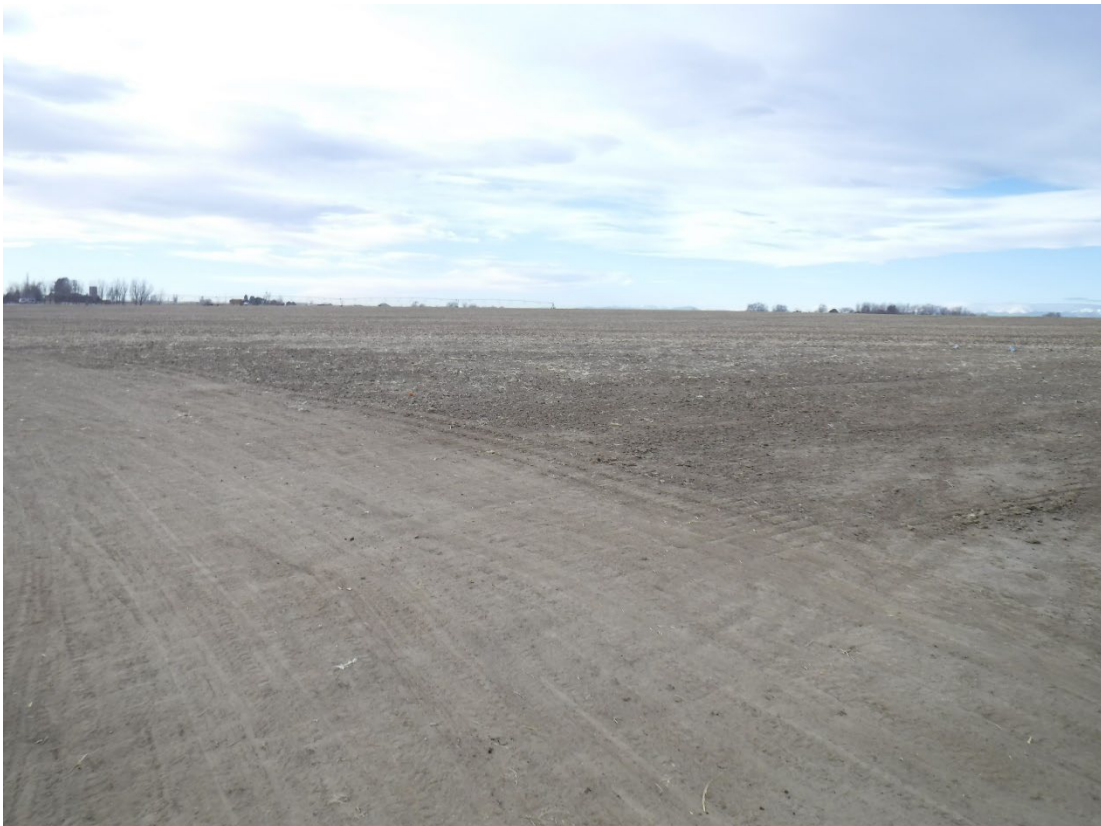
**Photo 6:** Looking south across the Phase I Mining Area

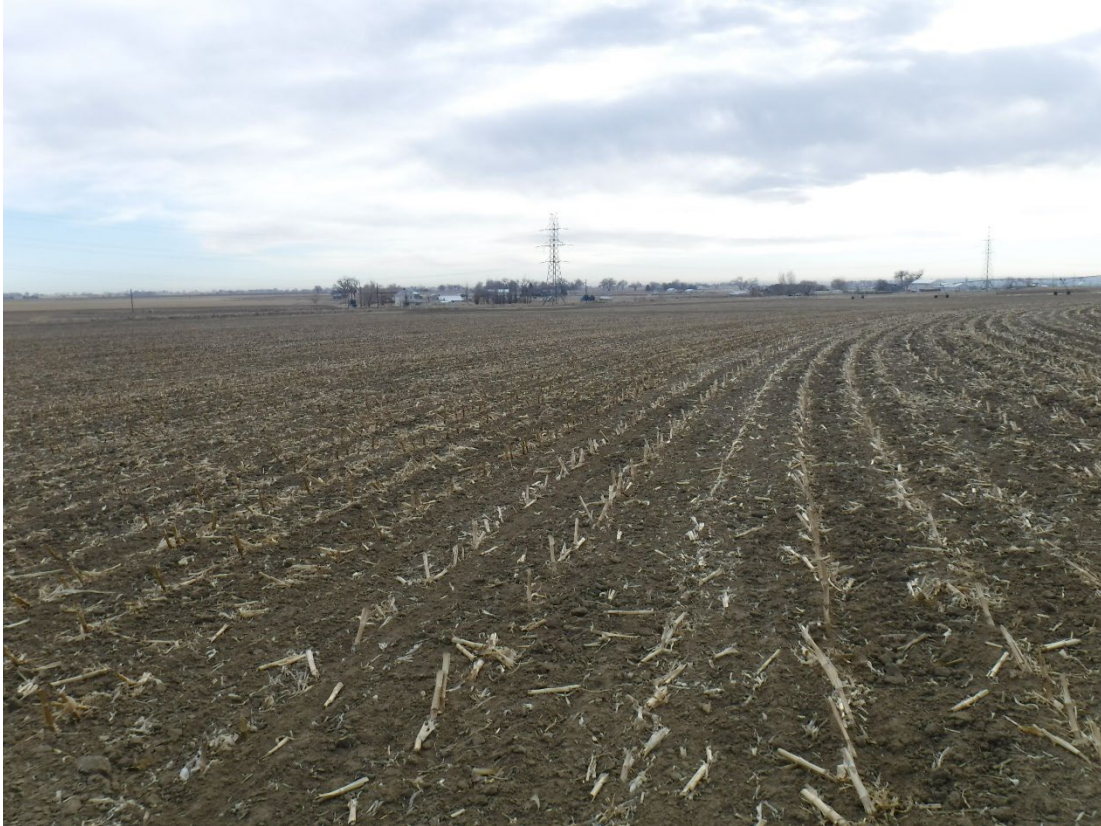
**Photo 7:** Looking southeast across the Phase I Mining Area from near the middle of the area

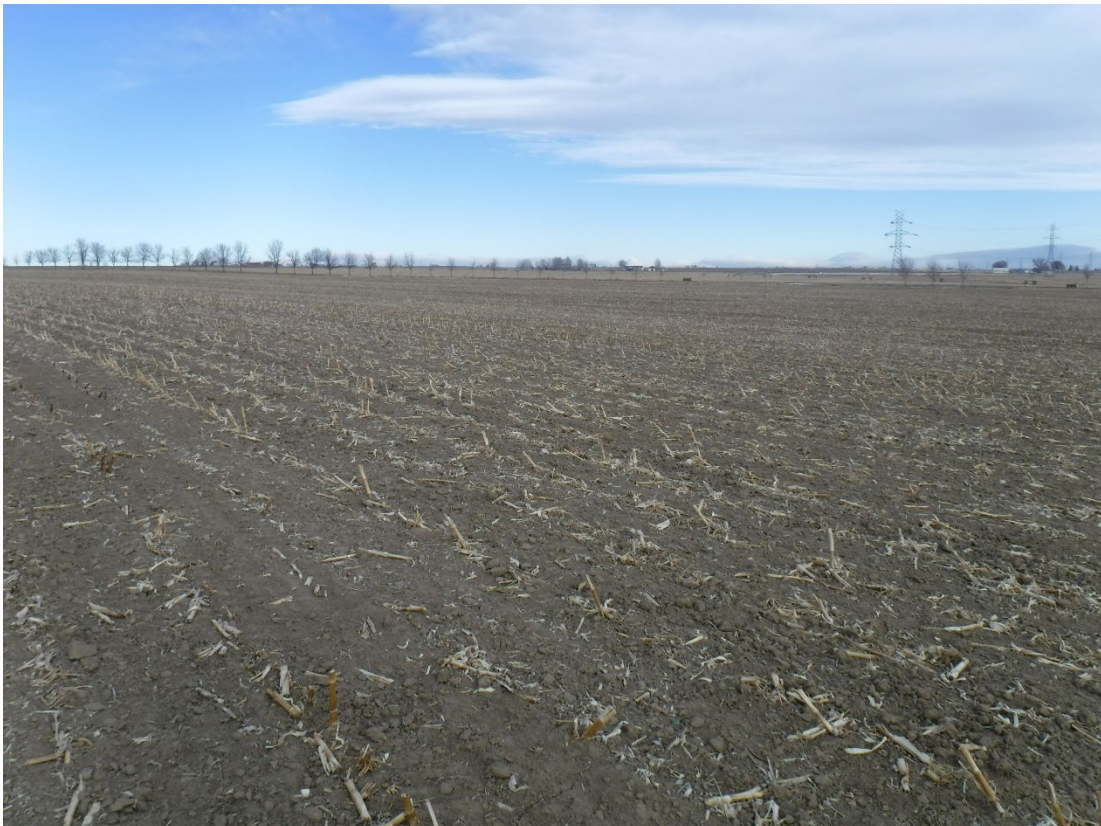
**Photo 8:** Looking north across the Phase I Mining Area from near the middle of the phase

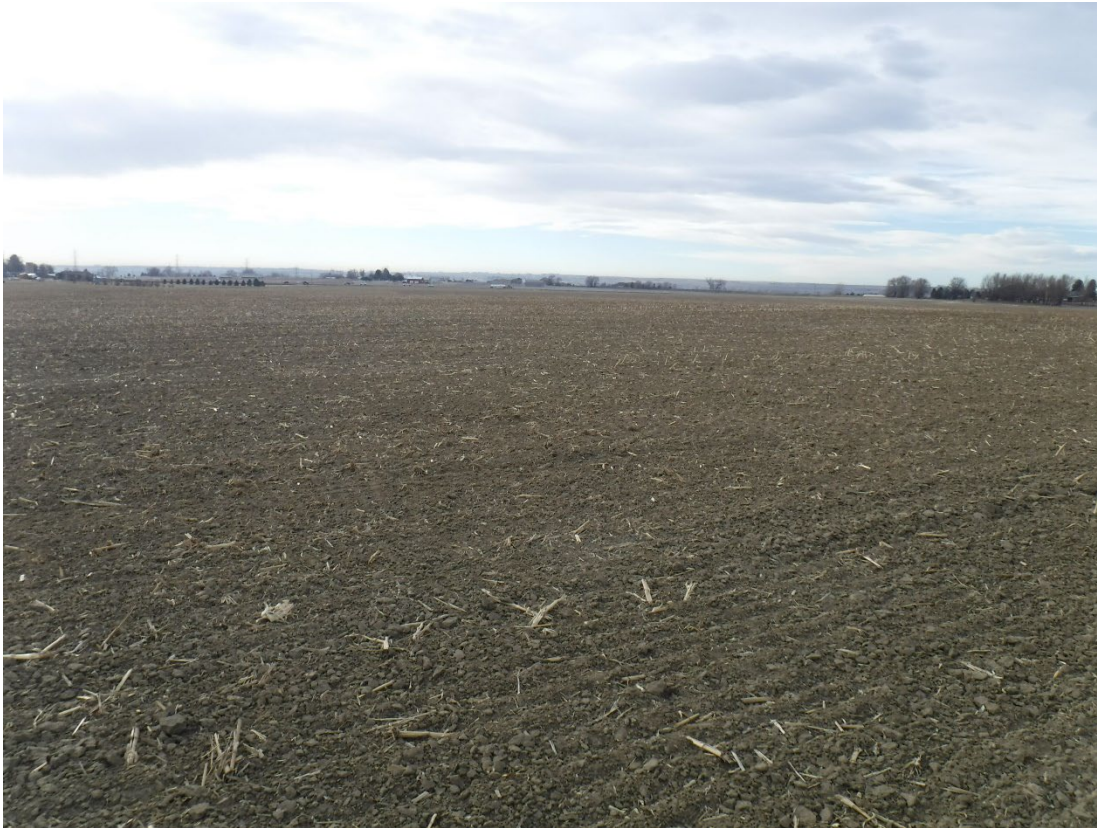
**Photo 9:** Looking south across the Phase II Mining Area from north side of the phase

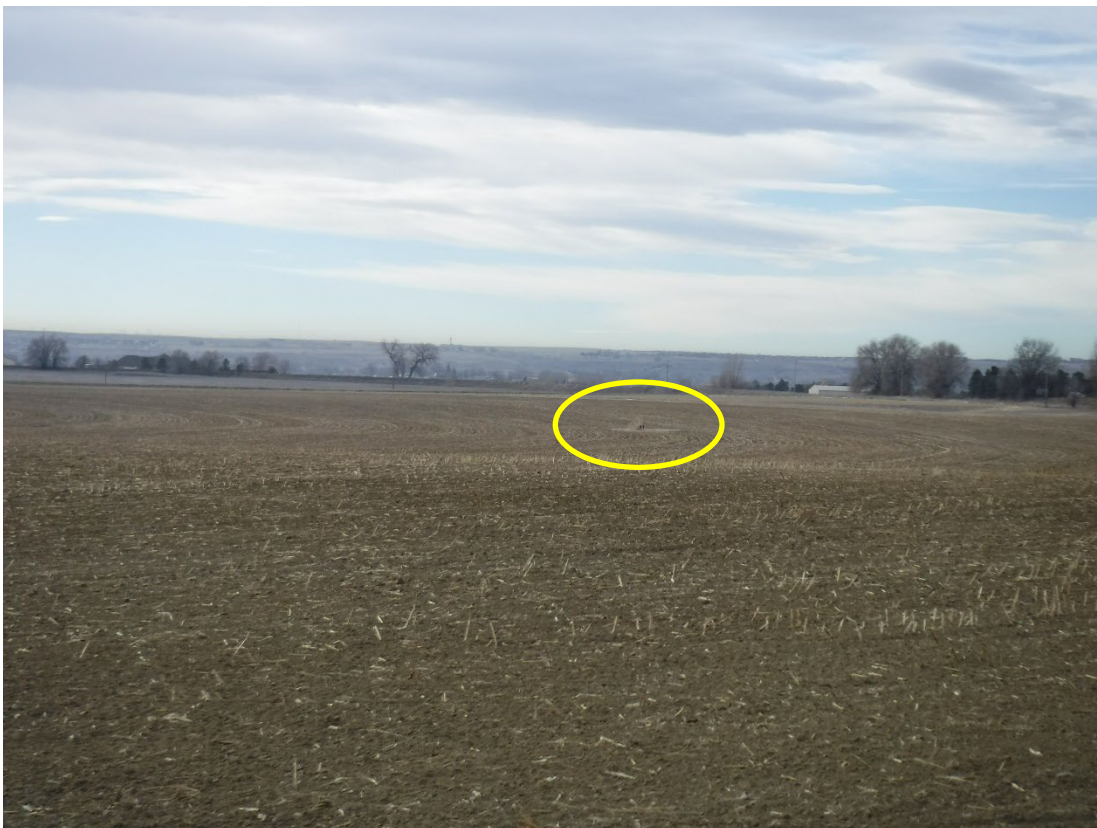
**Photo 10:** Looking south across the Phase II Mining Area plugged gas well circled
