Re: GCC Energy, LLC, King II Mine
CDRMS Permit # C-1981-035
Stoner Engineering: Quarterly Inspection: Refuse Pile 4th Quarter 2024

Re: King Coal I – Quarterly Waste Pile/Embankment Inspection

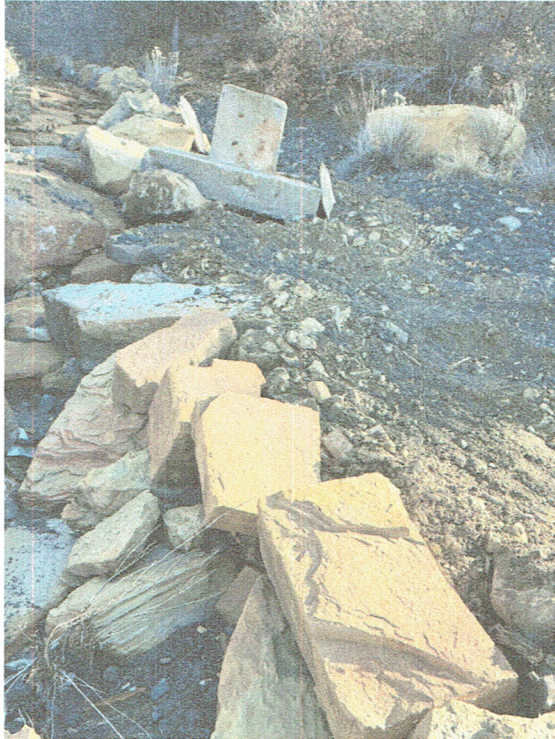
The south treated water ditch (Reach 10) and the north clear water ditch (Reach 1) appeared to be in generally good condition at the time of the inspection. The washed-out riprap of the south, treated water ditch east of the south haul road switchback has been repaired to prevent runoff from escaping the channel section (see Pic. 1). The upper section of Reach 10 where runoff washed riprap down the slope has also been improved by mixing angular riprap with the rounded to minimize future damage (see Pic. 2). These sections of the Reach 10 need to be monitored after storm events to ensure the repairs are adequate to minimize the potential for erosion.

Pic. 1 –Reach 10, channel section repaired to prevent escape of runoff.

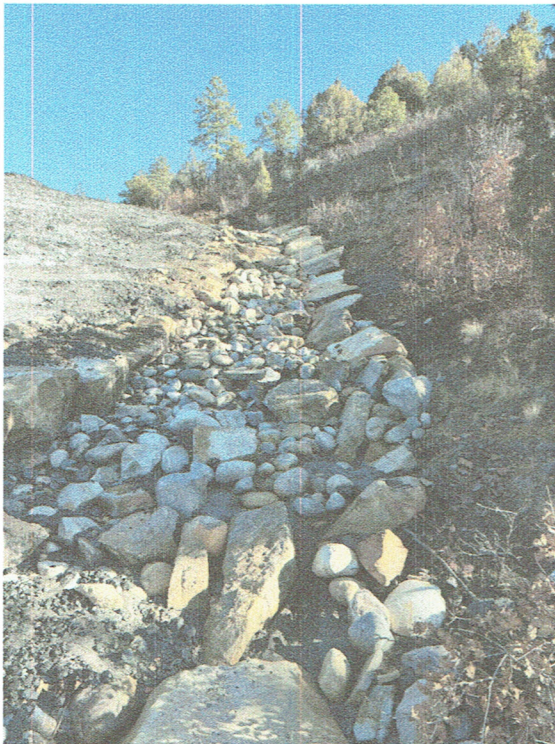
Pic. 2 – Reach 10, upper section channel riprap repaired.

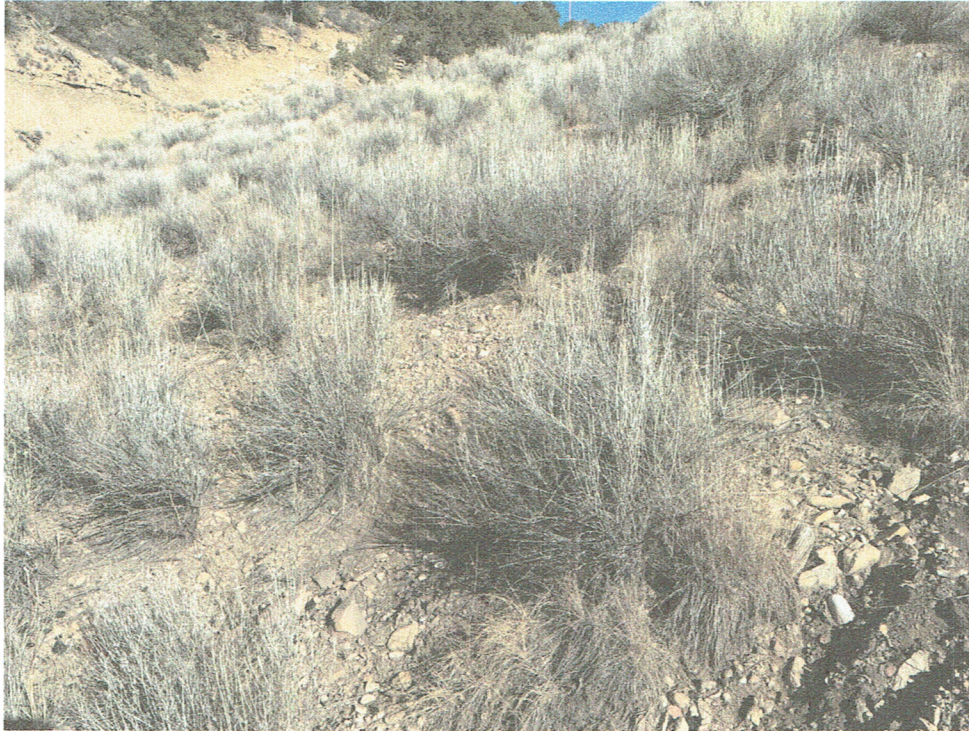
The face of the upper waste embankment pile was found to be in generally good condition (see Pic. 3). There were no signs of instability or sloughing observed on the main waste embankment pile at the time of the inspection. The waste embankment pile level appears to be relatively unchanged since the previous inspection. The grading of the upper waste piles appears to direct surface runoff away from the face of the piles and the required berming is in place. The slope of the top of the existing pile is close to that defined in the Waste Bank Design produced by Don May, 1997.

Pic. 3 – Face of the upper waste pile is in good condition.

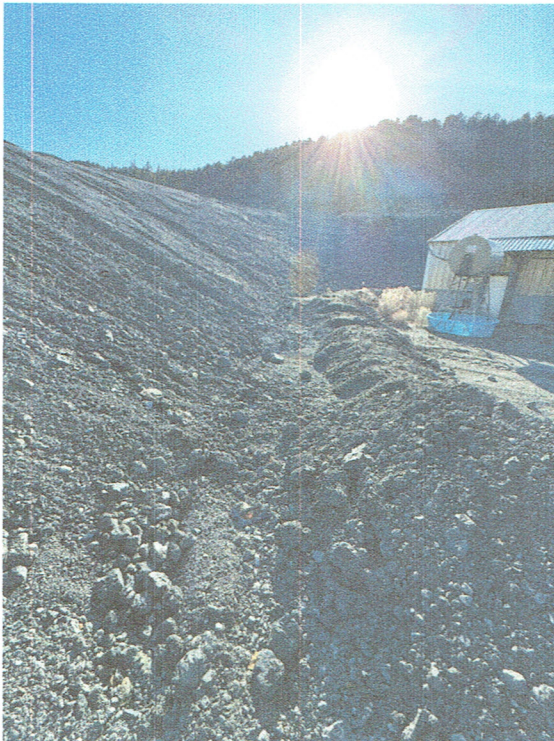
Additional fill material has been placed on the lower waste pile since the previous inspection. The face of the lower pile was found to be in good condition with no signs of instability or sloughing observed (see Pic. 4). The face of the lower waste pile is at a consistent height and the required berming is in place at the top of the pile to direct runoff away from the face of the embankment pile.

Pic. 4 – Face of the lower waste pile in generally good condition.
