Re: GCC Energy, LLC, King II Mine CDRMS Permit # C-1981-035 Stoner Engineering: Quarterly Inspection: King I UbX = Water Quality Improvements Inspection 4<sup>th</sup> Quarter 202(

Re: King Coal I – Quarterly Water Quality Improvements Inspection

Re: King Coal II - Quarterly Water Quality Improvements Inspection

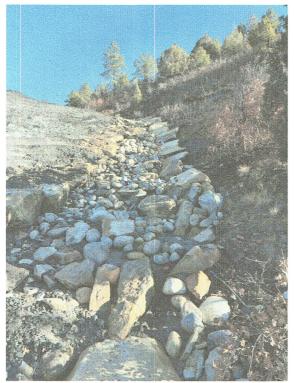
The existing ditches and culverts appear to be generally in good condition at the time of the inspection. Maintenance had been completed on the treated water ditch (Reach 10). The washed-out upper portion of the treated water ditch (Reach 10) had been repaired (see Pic. 1). The portion of Reach 10 along the face of the upper waste pile has been improved to prevent runoff from escaping the channel section (see Pic. 2). The check dams/riprap of Reach 10 along the lower haul road is in generally good condition (see Pic. 3). The erosion at the base of Reach 10 at the stilling basin was found to be in generally good condition though the west side of the channel requires some maintenance (see Pic. 4). The grading along the south side of the face of the upper waste pile was found to be in generally good condition.

Pic. 1 – Reach 10 upper section channel repair completed.

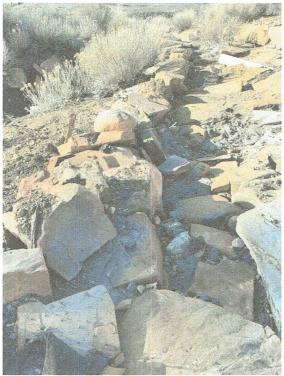
Pic. 2 – Reach 10 Channel repair middle section of upper pile.

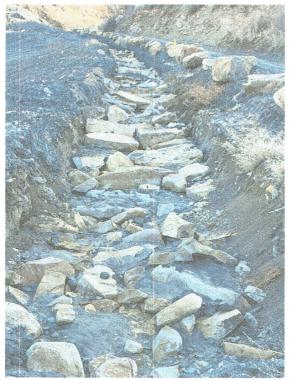
Pic. 3 – Reach 10, armored section along lower haul road.

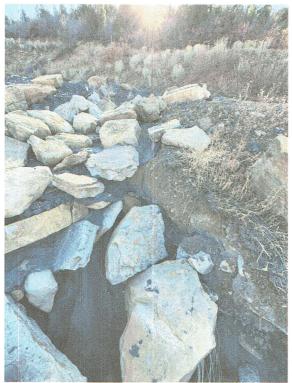
Pic. 4 – Some erosion at stilling basin at base of Reach 10.

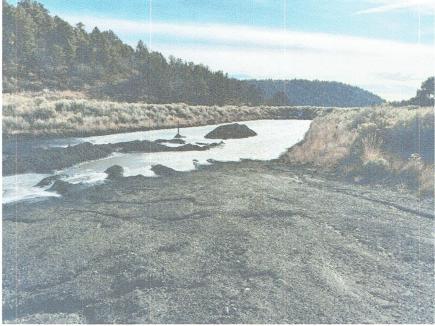
The water quality pond held roughly the same amount of water as during the previous inspection (see Pic. 1). The elevation at the bottom of the pond could not be determined due to ice/water within the pond. The current water levels make it difficult to assess the state of the sediment removal operations. It appears that sediment removal is also at the same point as the previous inspection. Excess sediment should be removed from the detention pond as soon as site/weather conditions allow.

Pic. 1 – Water level in the detention pond after recent storms.

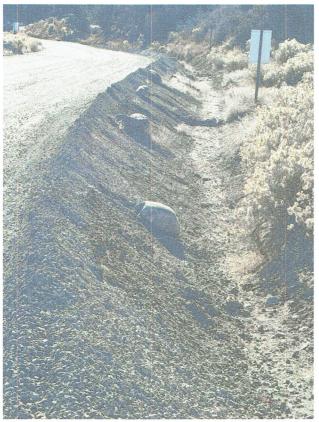
The east clear water ditch, the west clear water ditch (west of the driveway access) and the main drainage ditch (combined clear water ditches) were found to be in good condition and clean of debris (see Pic. 2).

Pic. 2 – West Clear Water Ditch.

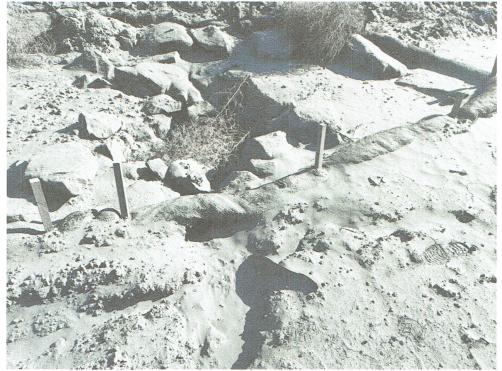
The erosion control structures for the treated water ditch located south of the scale house was found to be in good condition. The inlets located around the conveyor and coal storage piles have been improved since the previous inspection. The inlet near the vibratory processing requires additional maintenance due to ongoing operations (see Pic. 3) while the inlet east of the power station is in generally good condition (see Pic. 4). The clear water ditch along the west side of the site had been improved since the previous inspection and was free of sediment. All ditches should be inspected and repaired as necessary, especially after storm events.

Pic. 3 - Inlet east side of coal piles (vibration table) near east clear water ditch.

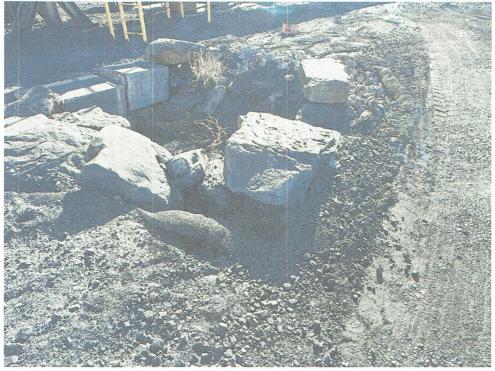
Pic. 4 --Inlet near conveyer, east of power transformers.
