**MINERALS PROGRAM INSPECTION REPORT**  
**PHONE: (303) 866-3567**

<b>MINE NAME:</b> Yocam Borrow Pit	<b>MINE/PROSPECTING ID#:</b> M-2018-020	<b>MINERAL:</b> Borrow material	<b>COUNTY:</b> Morgan
<b>INSPECTION TYPE:</b> Surety Release Inspection	<b>WEATHER:</b> Clear	<b>INSP. DATE:</b> January 15, 2025	<b>INSP. TIME:</b> 09:00
<b>OPERATOR:</b> Castle Rock Construction Company of Colorado	<b>OPERATOR REPRESENTATIVE:</b> Travis Bell	<b>TYPE OF OPERATION:</b> 111 - Construction by Government Agency	
<b>REASON FOR INSPECTION:</b> Surety Release Requested	<b>BOND CALCULATION TYPE:</b> None	<b>BOND AMOUNT:</b> \$42,500.00	
<b>DATE OF COMPLAINT:</b> NA	<b>POST INSP. CONTACTS:</b> None	<b>JOINT INSP. AGENCY:</b> None	
<b>INSPECTOR(S):</b> Patrick Lennberg	<b>INSPECTOR'S SIGNATURE:</b>

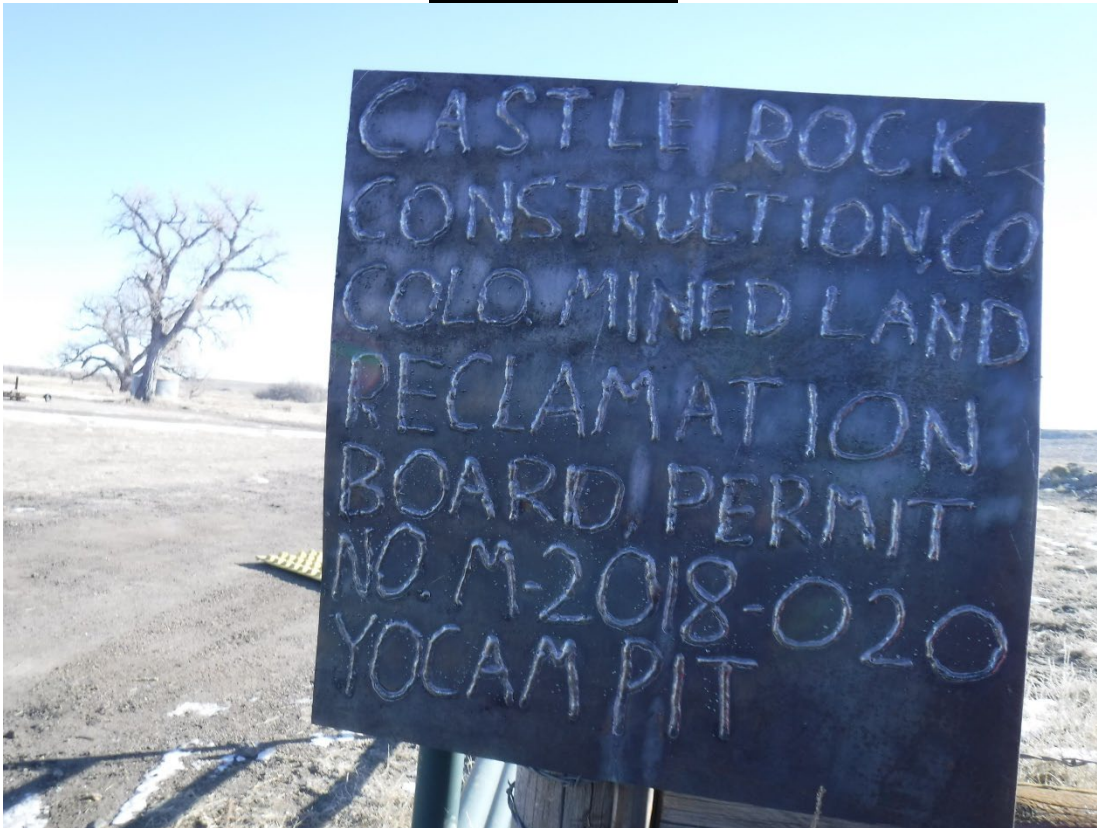
The site is located approximately 2 miles south of Orchard, Colorado in Morgan County. The site can be accessed from State Highway 144 (SH-144) approximately 2 miles north from the intersection of SH-144 and U.S. Route 34. The approved post-mining land use for the site is rangeland. The permit is located on land previously owned by John Yocum. The land is currently owned by Robin Hayes. A mine sign was posted at the primary mine entrance as required by Rule 3.1.12. The posted mine sign abates a problem that was cited during the previous inspection.

**Photo 1:** Mine sign at the primary mine entrance location

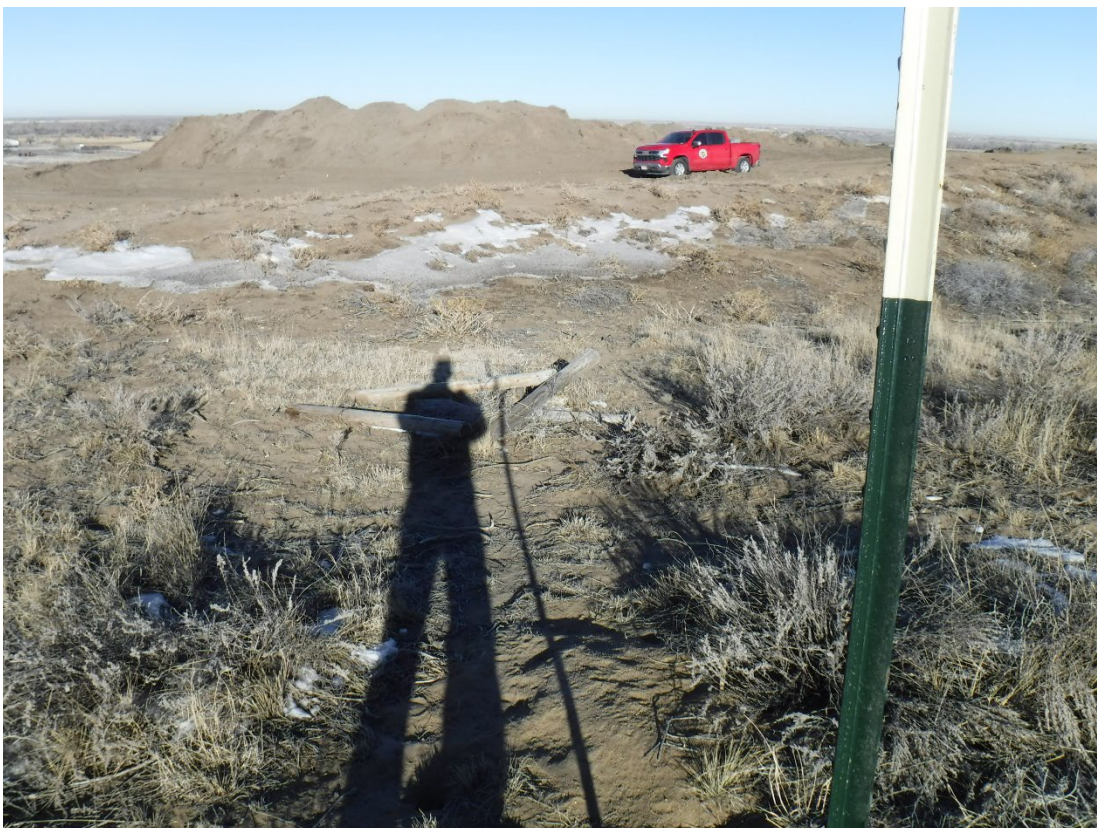
**Photo 2:** Typical permit boundary marker, SE corner pictured

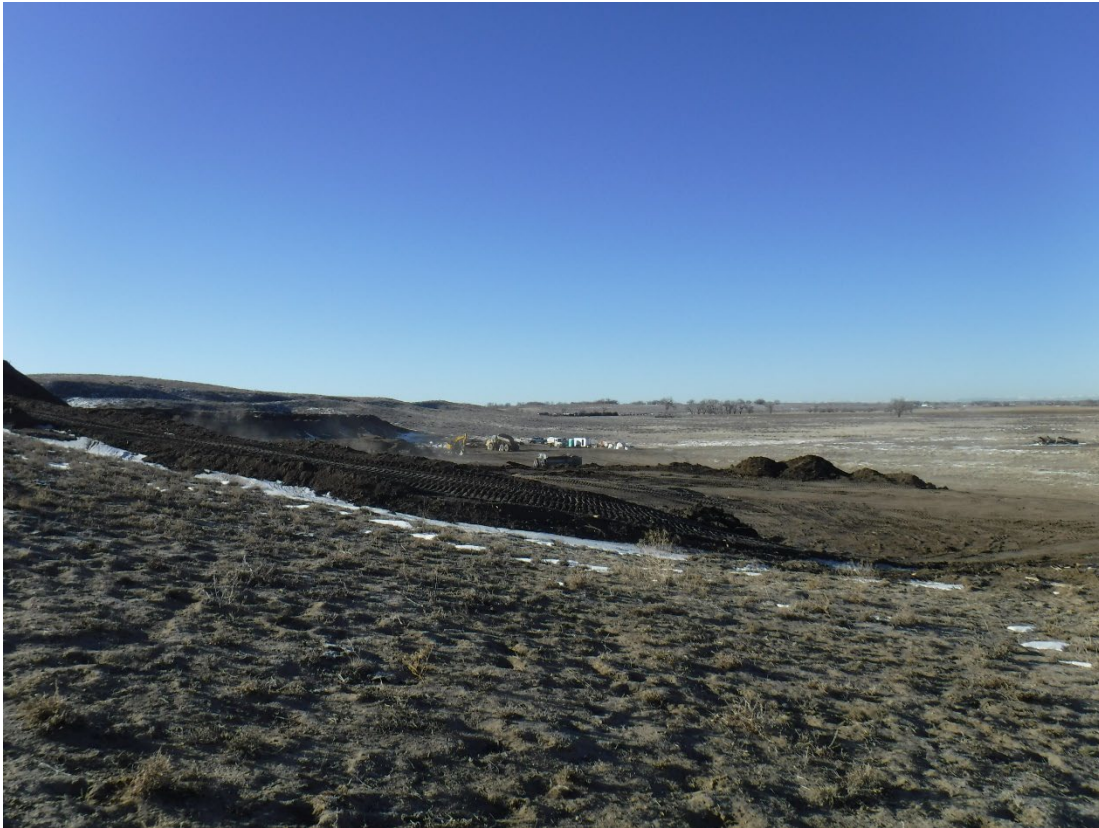
**Photo 3:** Looking south across the permit area, revegetated area in the foreground

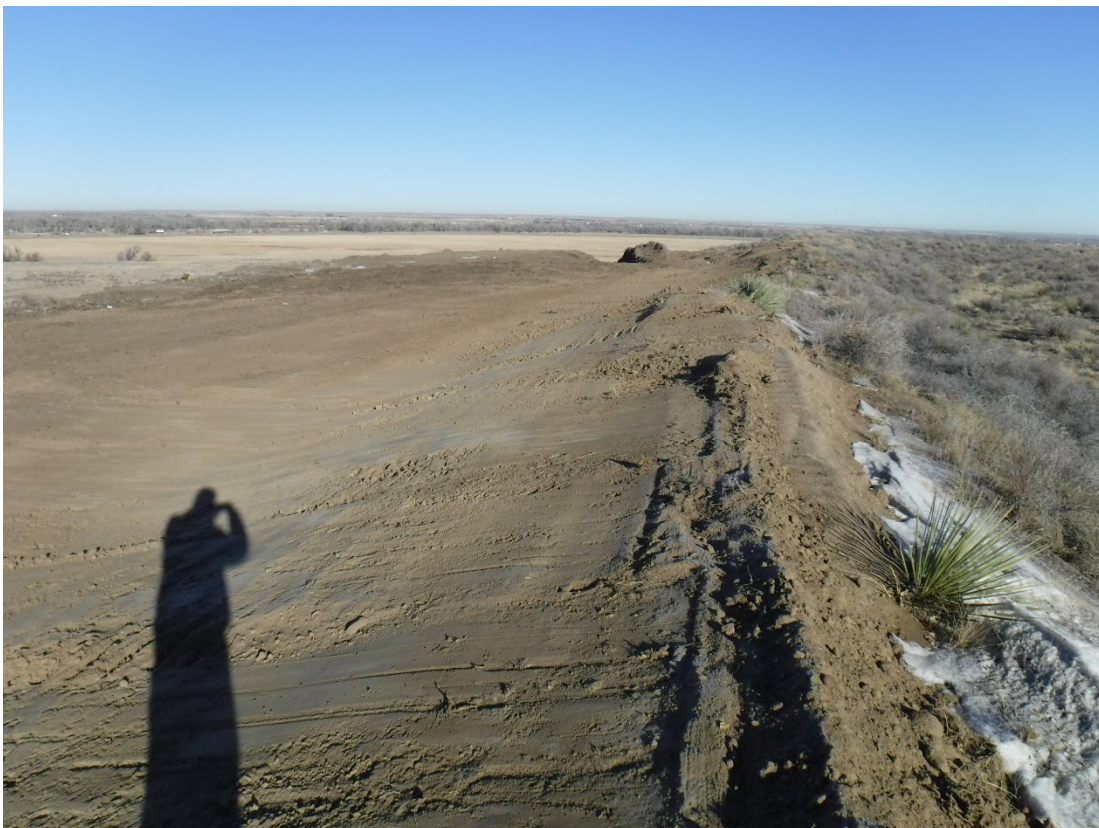
**Photo 4:** Typical backfilled area along the eastern permit boundary area

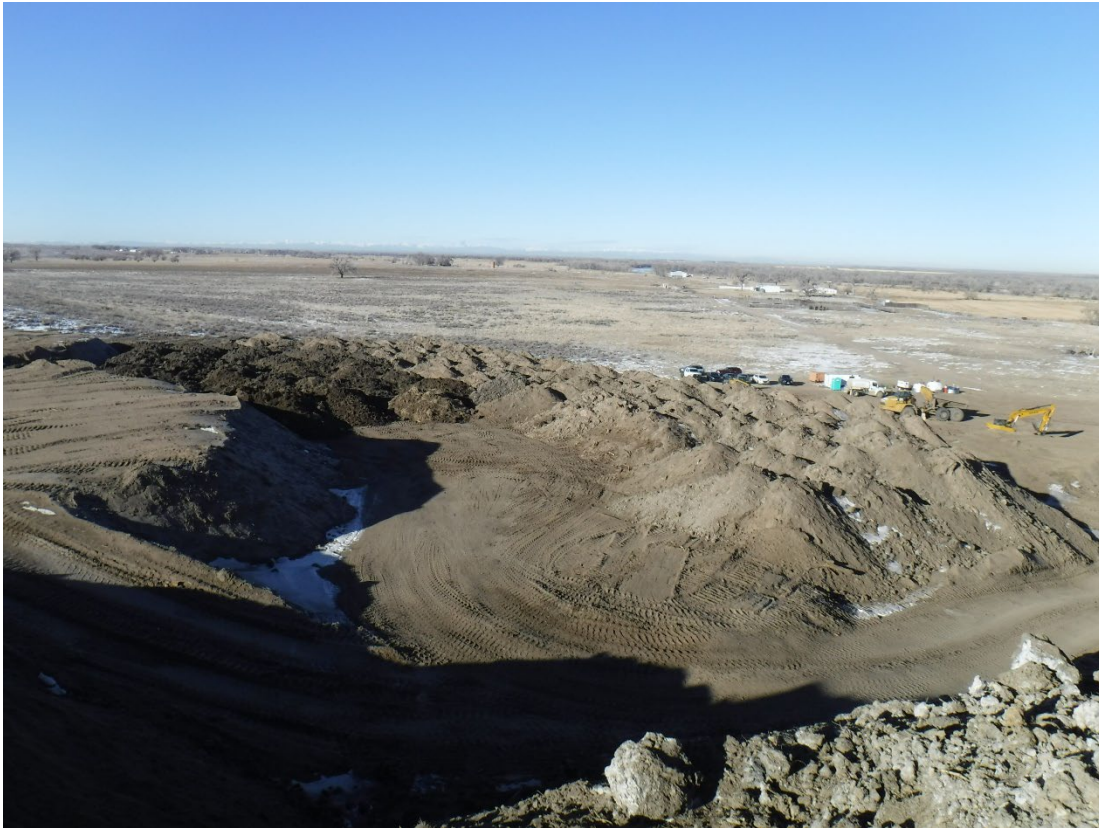
**Photo 5:** Ongoing backfill activities near the southern end of permit area

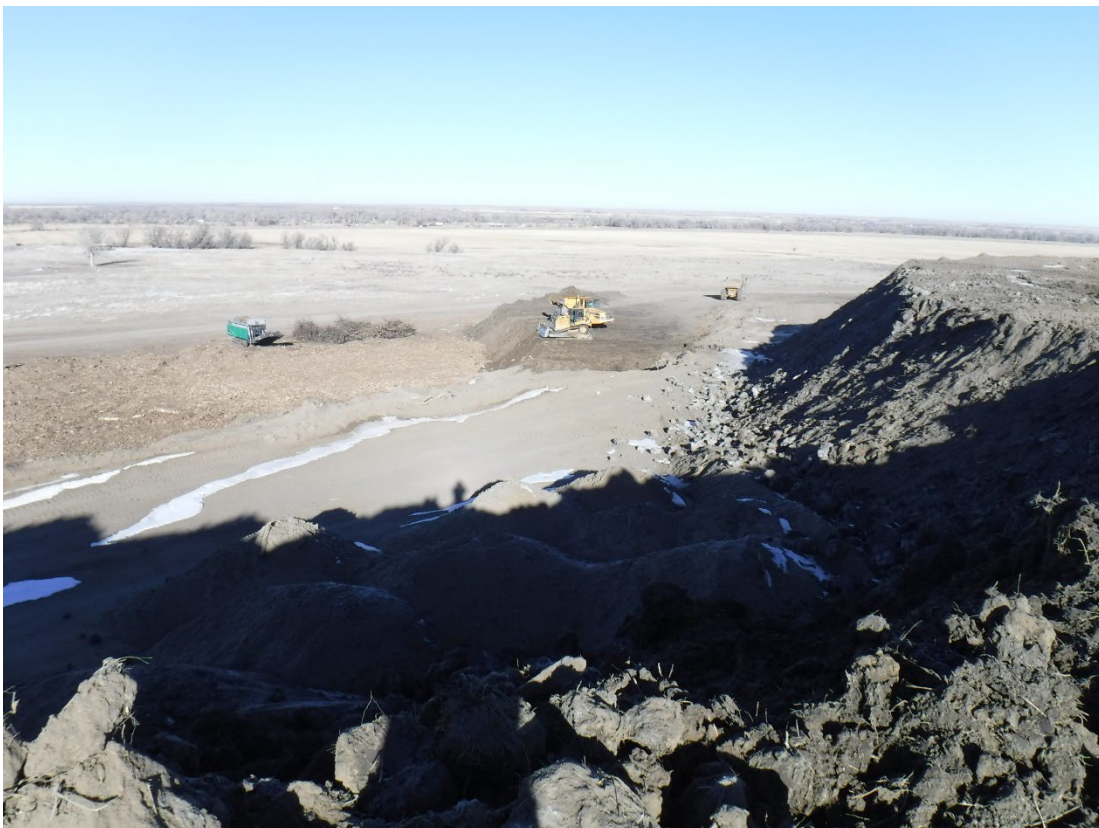
**Photo 6:** Ongoing backfill activities near the northern end of permit area

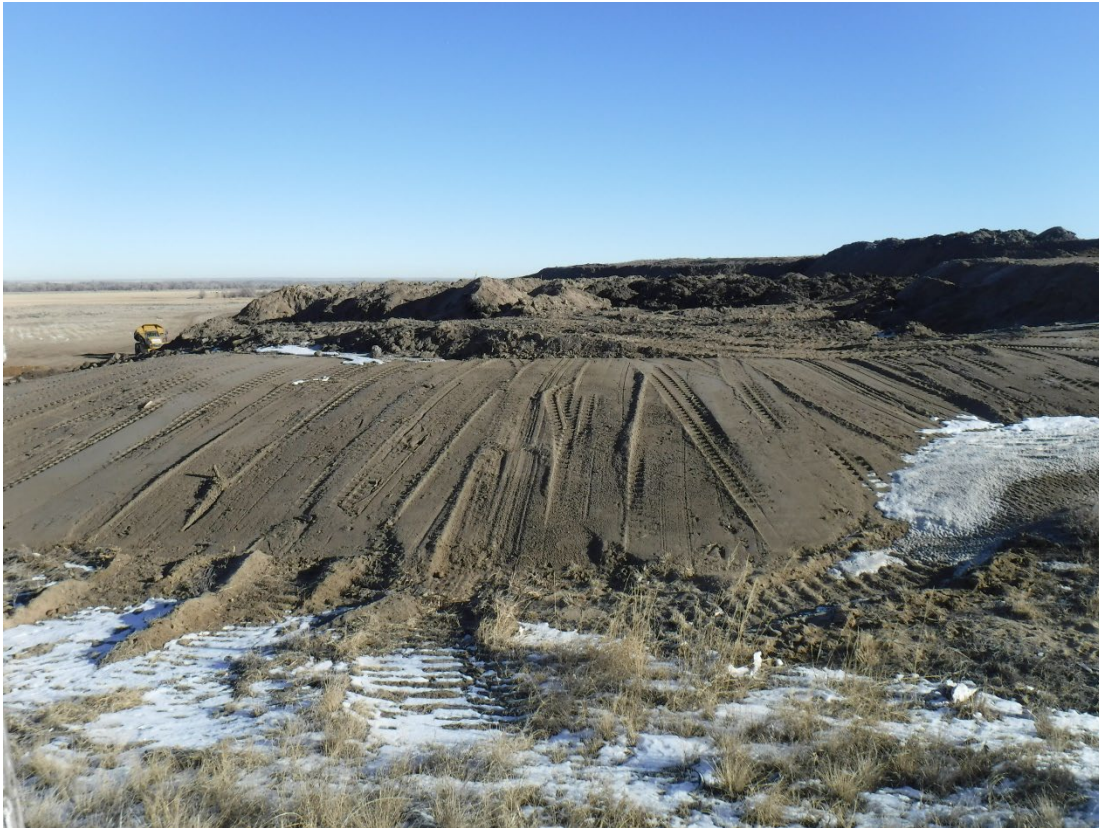
**Photo 7:** Looking north at the southern toe of slope of backfilled material

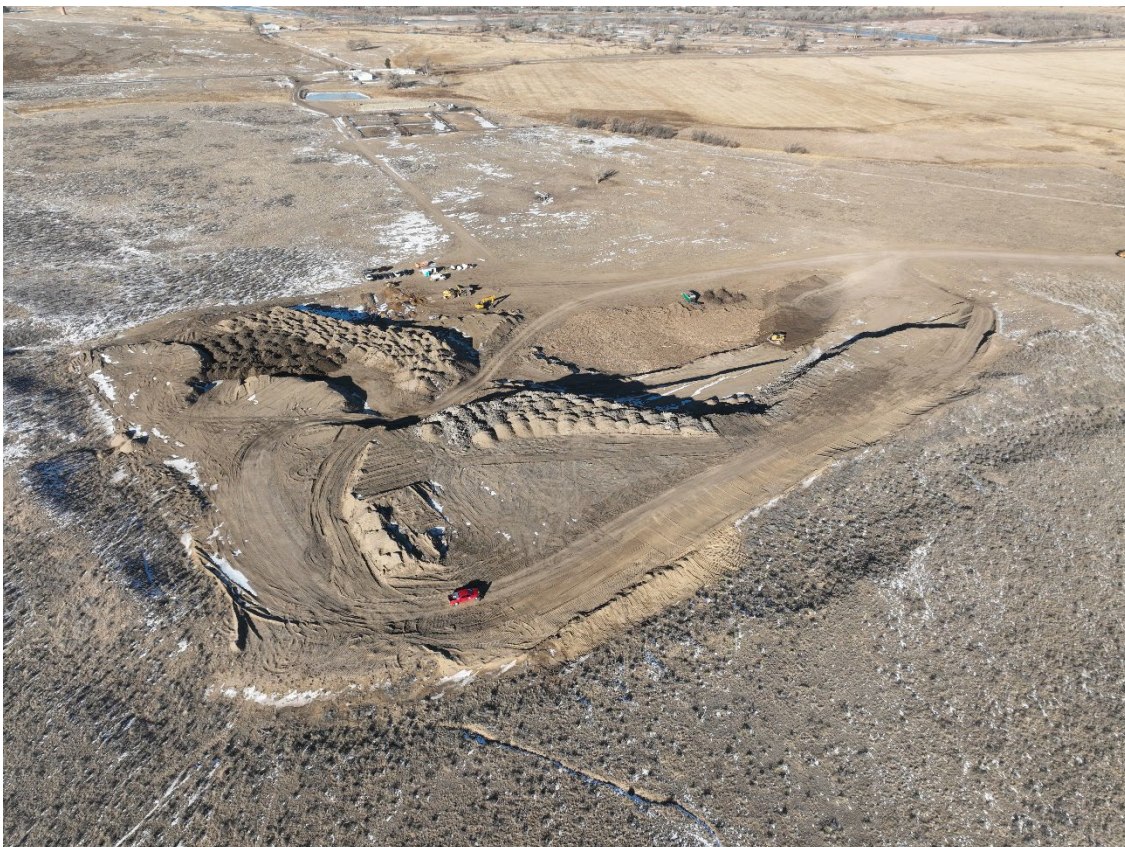
**Photo 8:** Aerial image looking from east to west across the site

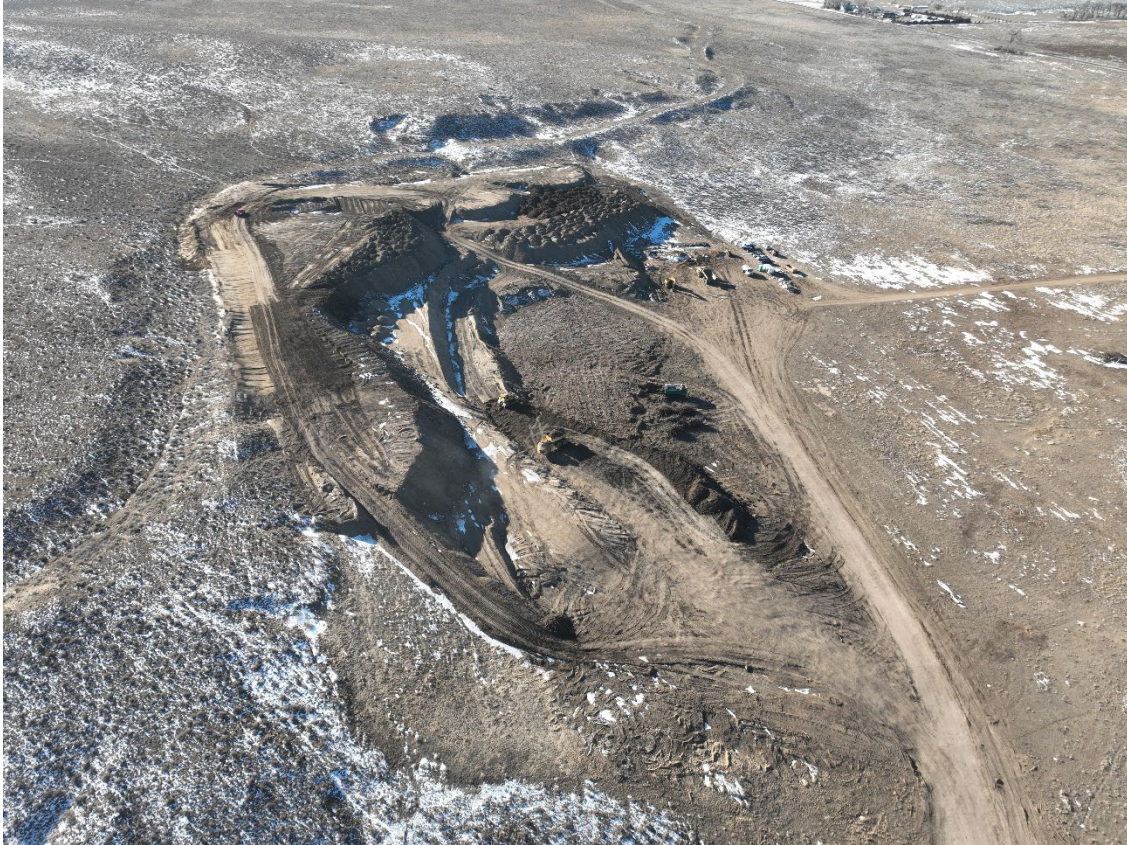
**Photo 9:** Aerial image looking from north to south across the site

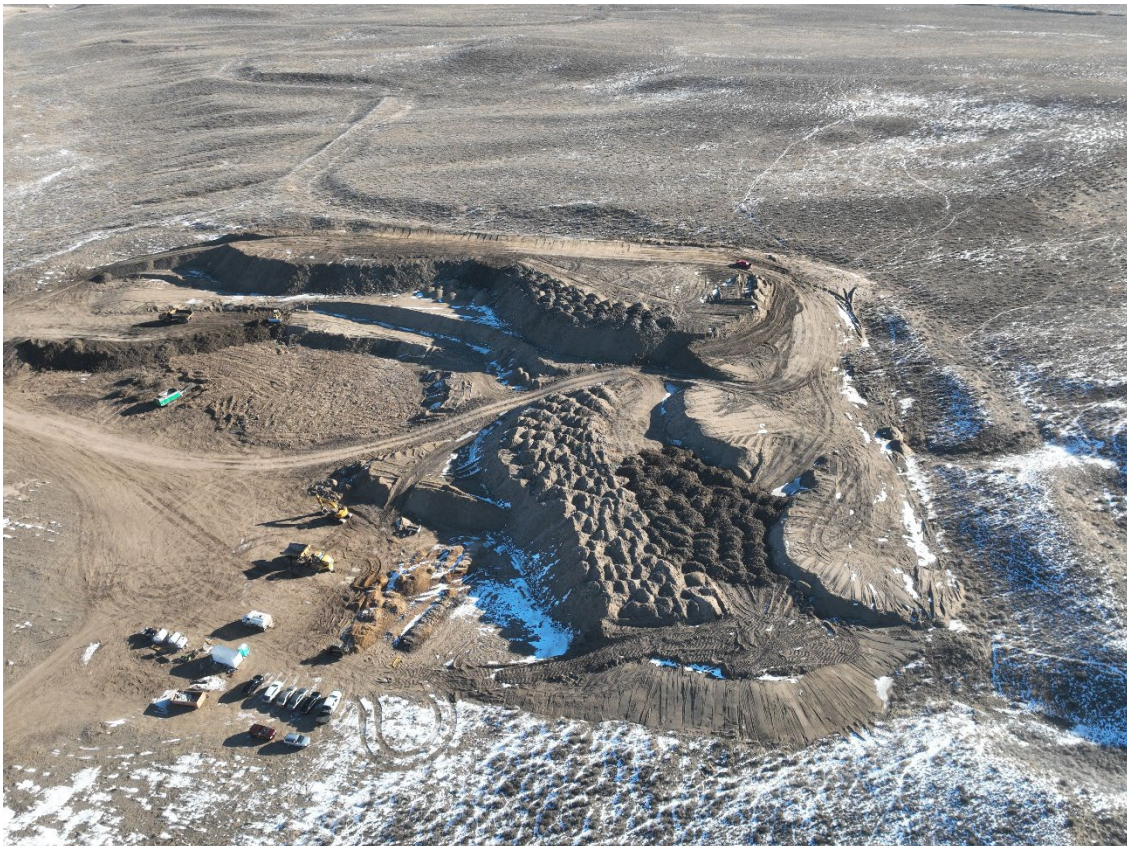
**Photo 9:** Aerial image looking from south to north across the site
