MINERALS PROGRAM INSPECTION REPORT

MINE NAME: Glacier Rock	MINE/PROSPECTING ID#: M-1994-096	MINERAL: Gravel	COUNTY: Larimer
INSPECTION TYPE: Monitoring	WEATHER: Clear	INSP. DATE: December 27, 2024	INSP. TIME: 12:30
OPERATOR: Glacier Rock Company	OPERATOR REPRESENTATIVE: Roger Hagerman	TYPE OF OPERATION: 112c - Construction Regular Operation

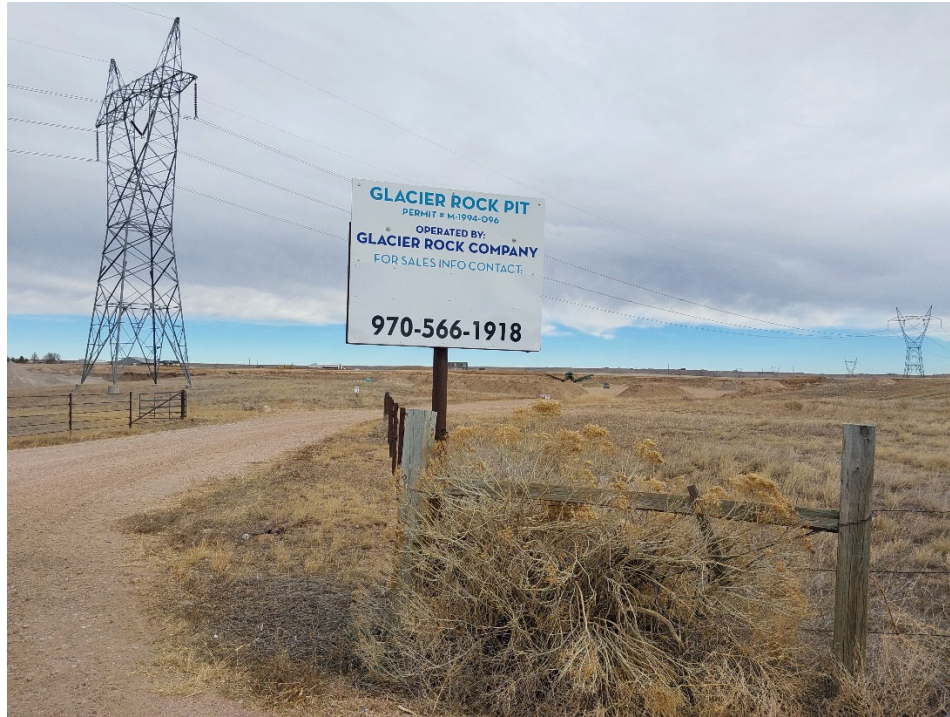
The mine entrance sign was posted at the west entrance as required by Rule 3.1.12(1), see Photo #1. The permitted boundary is partially marked by fencing along the northern, southern, and western boundaries.

Photo #1: Mine sign posted at the entrance located on the west side of the permit area.

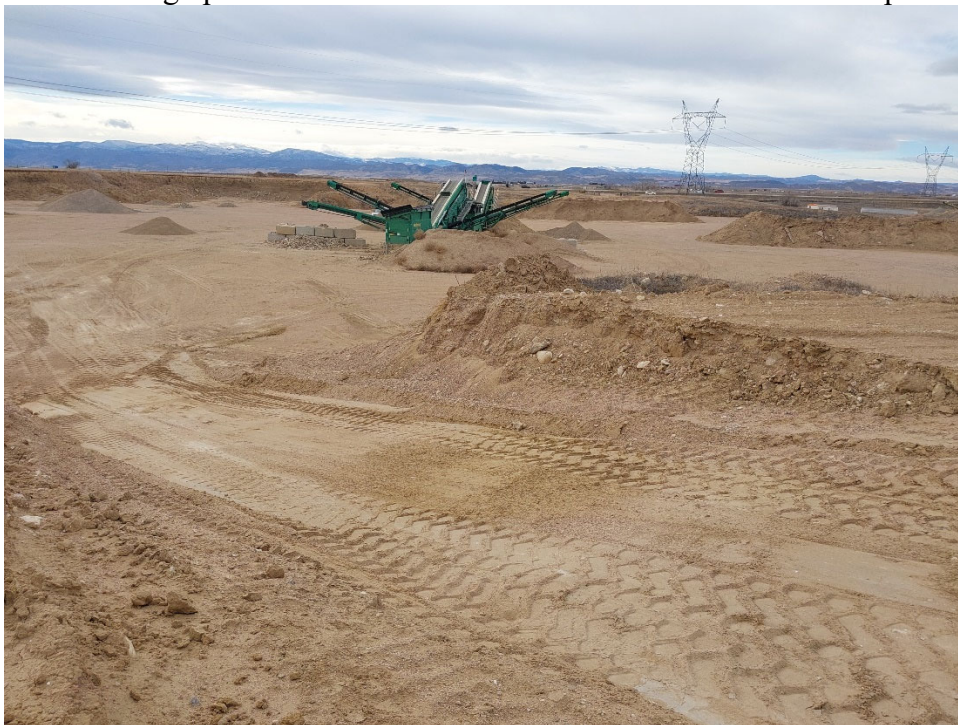
The operation does not call for any permanent processing facilities on site. There were two portable screening conveyors setup in the south-central section of the pit floor that were observed, see Photo #2.

Photo #2: View of the pit floor from the east-central portion of the pit, looking to the northwest. The portable screening plants can be seen at the central of the photo with product material stockpiles (without vegetation) and overburden and topsoil stockpiles (vegetated) viewed.

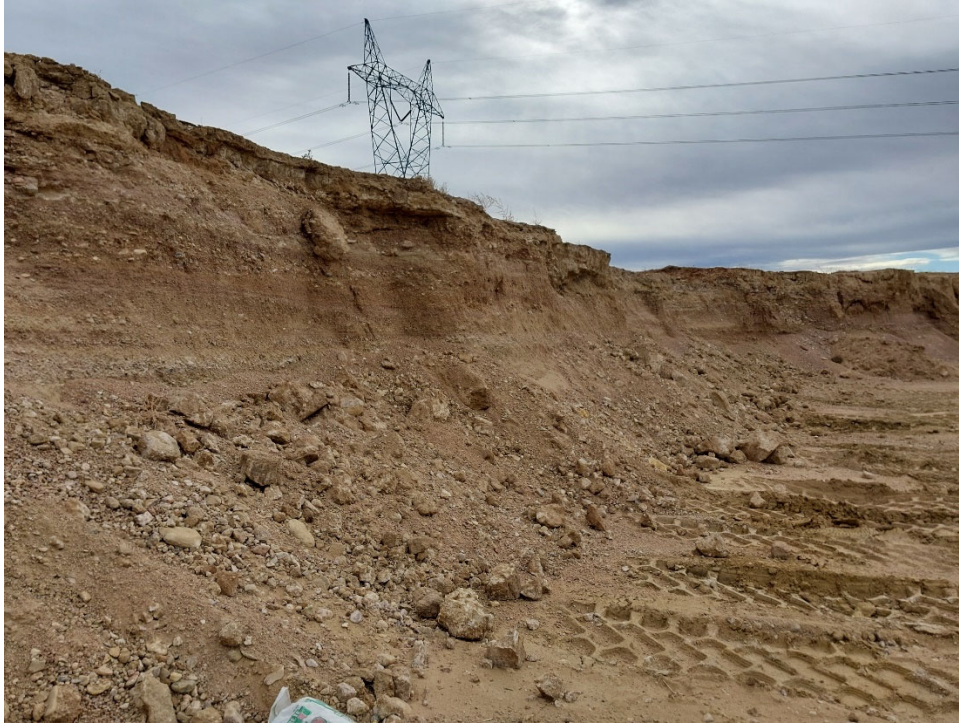
PROBLEM #1: The approved mining plan call for working slopes no greater than 3H:1V; the working slopes appeared to be near vertical. The current mine plan needs to be updated and clarified pursuant to C.R.S. 34-32.5-112 (1)(c)(VI). The Operator must provide sufficient information to describe or identify how the Operator intends to conduct the operation.

There is an issue with the general mine plan compliance. According to the mining plan that was approved with the Conversion Application (2/28/2005), the working slopes are to maintain a 3H:1V slope during the mining process. The slopes of the working areas appear to have exceeded a 3H:1V, see Photos #3, #4, and #5. The information about the required corrective action is given above; please submit the required items called for by the given due date.

Photo #3: View of the working slope, looking to the south from the east side of the pit. The working slopes appear near vertical and approximately 12 feet in height.

CORRECTIVE ACTIONS: The Operator may bring the slopes back into compliance with the currently approved mining plan of no greater than a 3H:1V gradient and provide photographs to the Division by the corrective action due date. Alternatively, the Operator may submit a Technical Revision, with the required \$216 revision fee, to update and clarify the current approved mine plan to reflect existing and proposed activities by the corrective action date. The updated mining plan and map may be included in the Technical Revision application that is to be submitted to address the problem cited for the reclamation plan compliance; only one Technical Revision needs to be submitted.

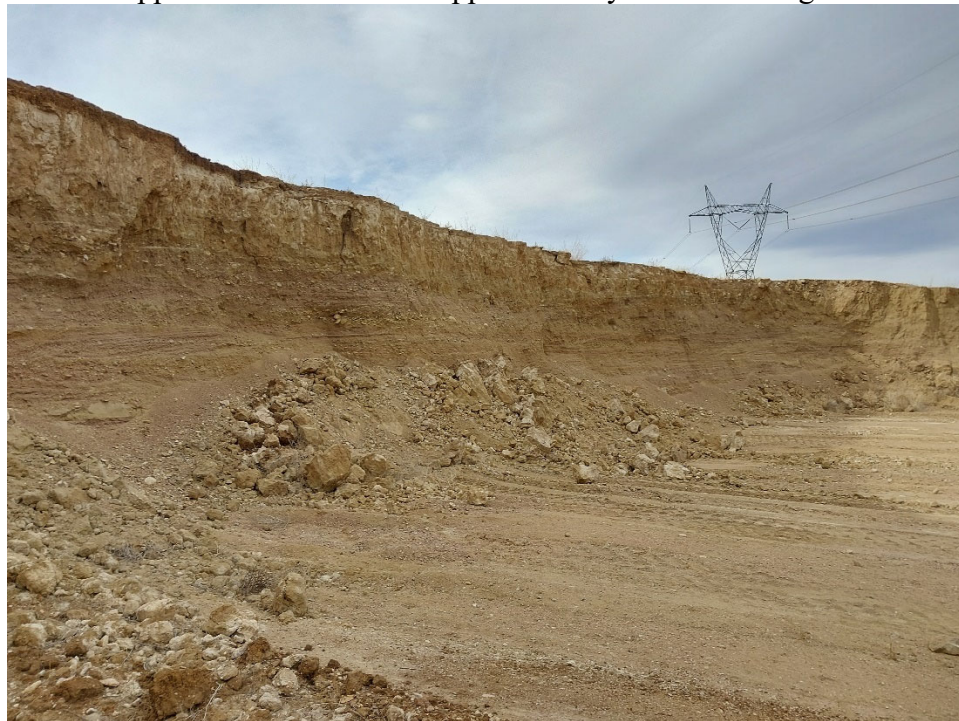
Photo #4: View of the working slope, looking west-northwest from the southwestern side of the pit. The working slopes appear near vertical and are approximately 20 feet in height.

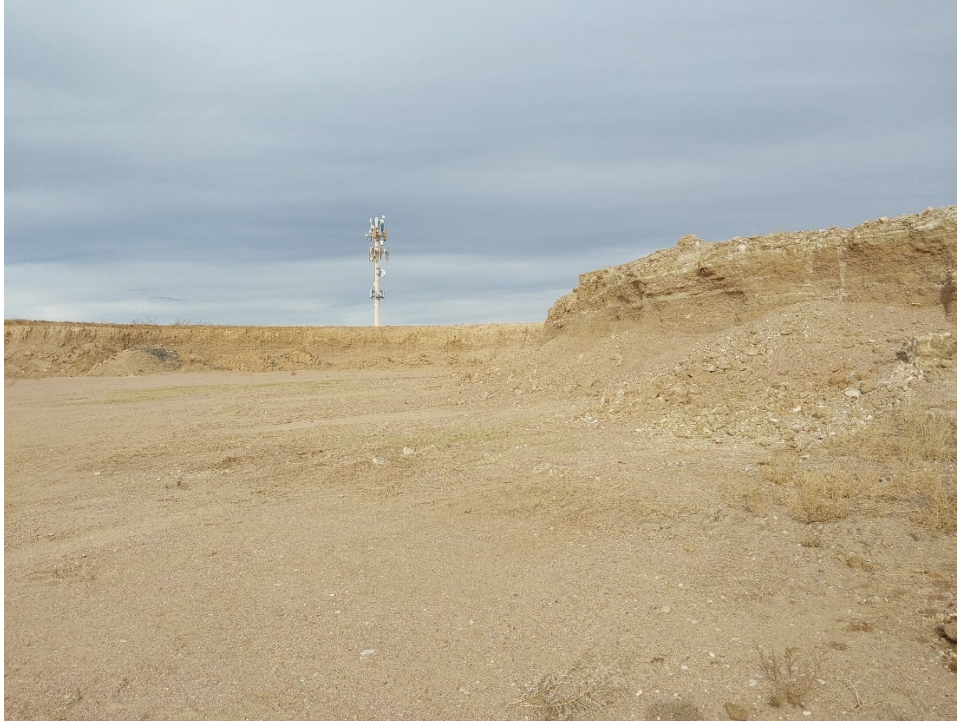
Photo #5: View of the working slope, looking to the north from the northcentral side of the pit. The working slopes appear near vertical and are approximately 18 feet in height

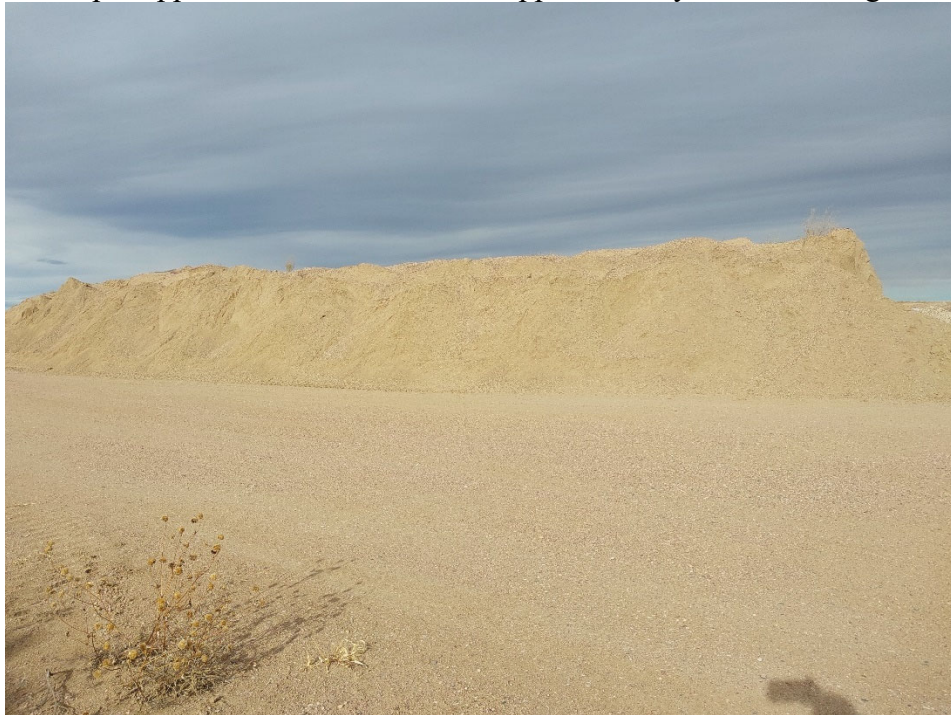
Photo #6: Stockpiled material located near the pit entrance, looking north from the south side of the southernmost stockpile.

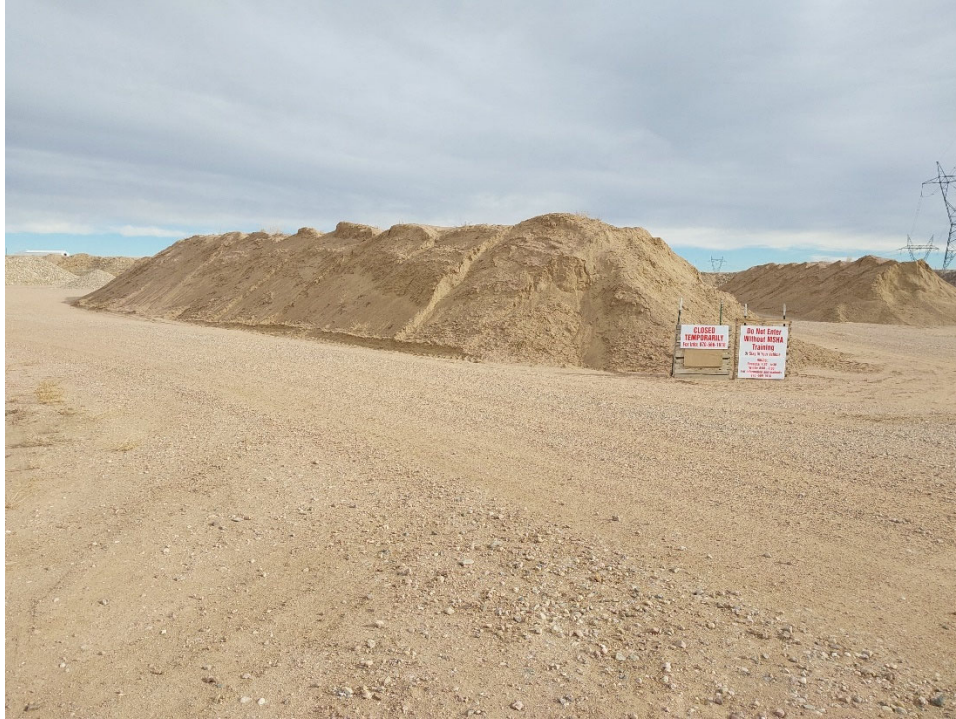
Photo #7: View of multiple stockpiles of product material from the west entrance of the site; looking to the east-southeast.

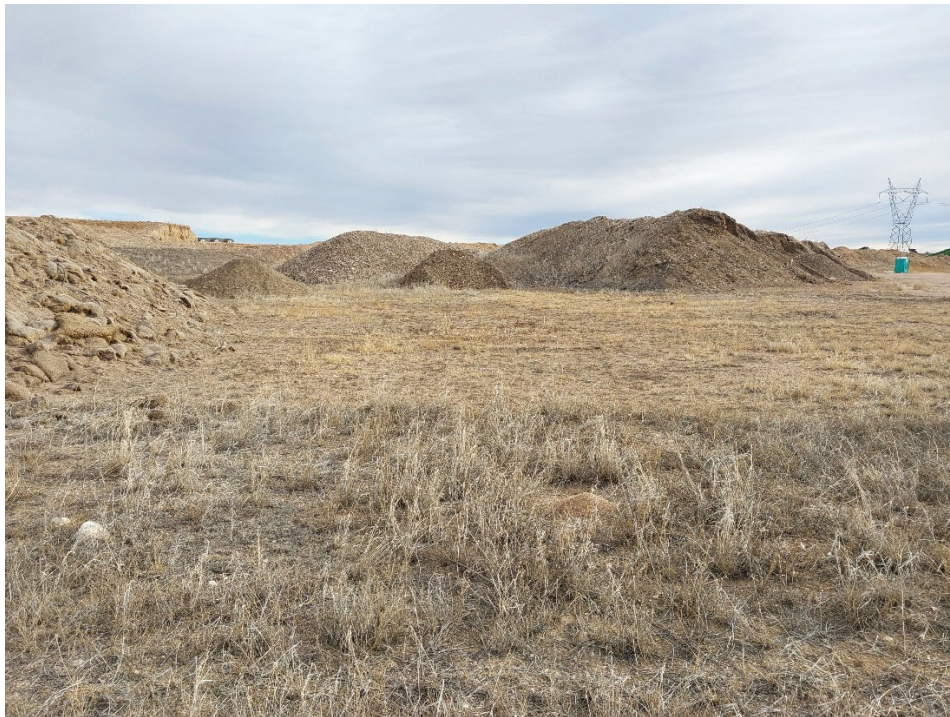
There are three primary areas where topsoil is stockpiled on the permit, all three are in the north-central area of the permit and the active mining area, see Photos #8 and #9. Topsoil stockpiles appeared to be stable, well vegetated, and sufficient in size to meet reclamation needs.

Photo #8: Multiple overburden and topsoil stockpiles located in the northcentral portion of the permit area; looking to the east-southeast. The stockpiles all appear to be vegetated and stable.

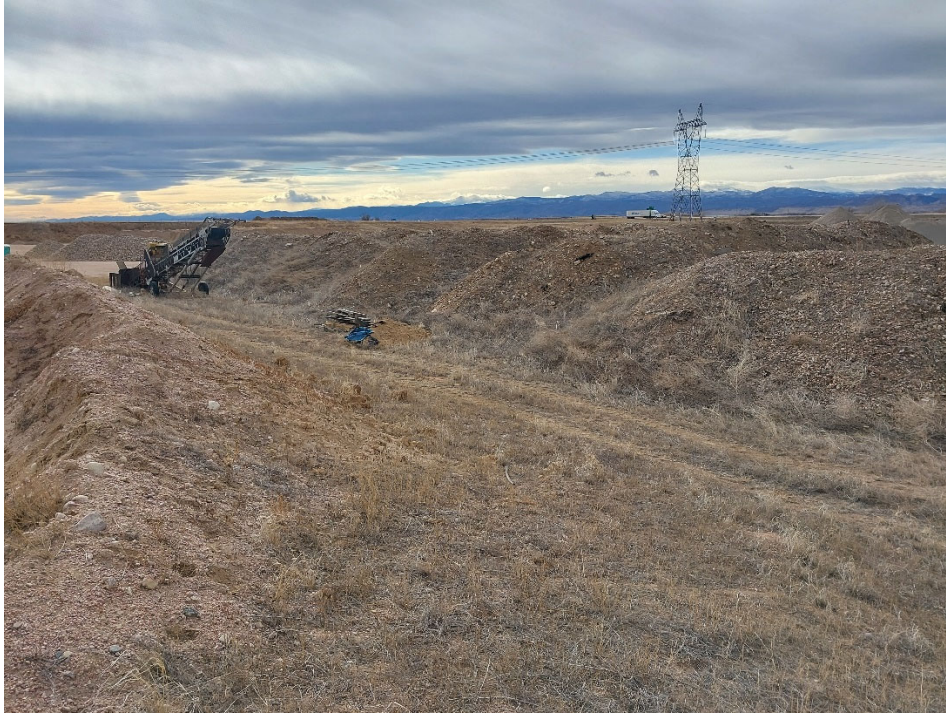
Photo #9: Multiple overburden and topsoil stockpiles located in the northcentral portion of the permit area; looking to the southwest. Stockpiles appear to be vegetated and stable.

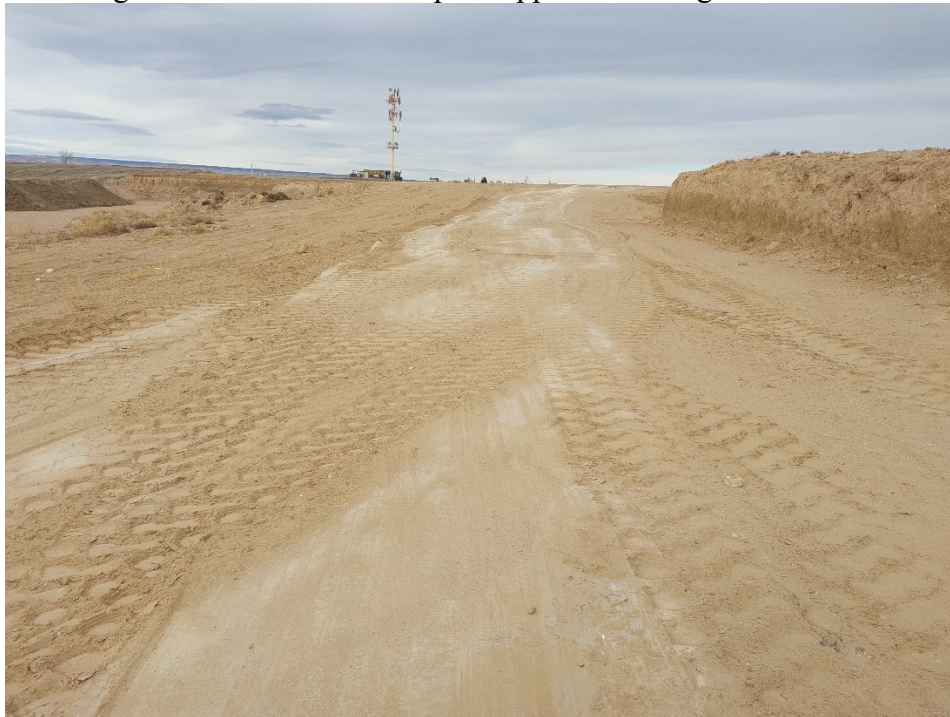
The roads on site appeared to be in good condition with no erosional issues, see Photo #10.

Photo #10: View of the haul road located on the east side of the pit.

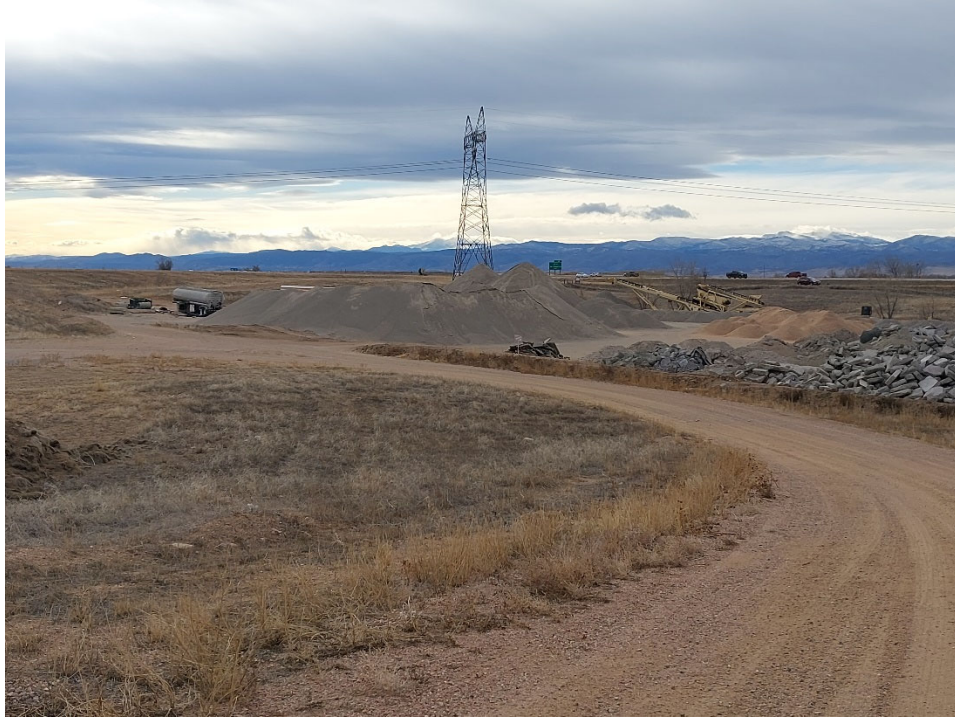
PROBLEM #2: Portions of areas that have been reclaimed were found to be re-disturbed by an aggregate recycling yard operation. This is a problem for failure to follow approved reclamation plan, or current reclamation plan needs to be updated and clarified pursuant to C.R.S. 34-32.5-116 (1). The Operator must follow approved reclamation plan or provide sufficient information to describe or identify how the Operator intends to

Approximately 2.9 acres located in the northwest area of the permitted area that had previously been reclaimed has been re-disturbed. The Operator has leased out this area to Castle Rock Construction Company of Colorado LLC for the purpose of operating an Aggregate Recycling Yard for a nearby CDOT Project located on Interstate 25. Broken pavement material is brought on site to be crushed and screened before being removed from the permit for the purpose of a road project, see Photos #11, #12, #13, and #14. The leased operation does require them to perform reclamation activities on the areas that they have disturbed. This operation started in Spring of 2024 and is scheduled to complete operations in Spring of 2026. This is also noted as a problem as it is not included in the approved mining or reclamation plan; see the citation given above for more information.

Photo #11: View of the southern area that has been leased out for an aggregate recycling yard; looking to the southwest from the haul road.

CORRECTIVE ACTIONS: The Operator shall submit a Technical Revision, with the required \$216 revision fee, to update and clarify the current approved reclamation plan to reflect existing and proposed activities, including the details of the lease agreement with the Castle Rock Construction of Colorado LLC for the aggregate recycling operation by the corrective action date.

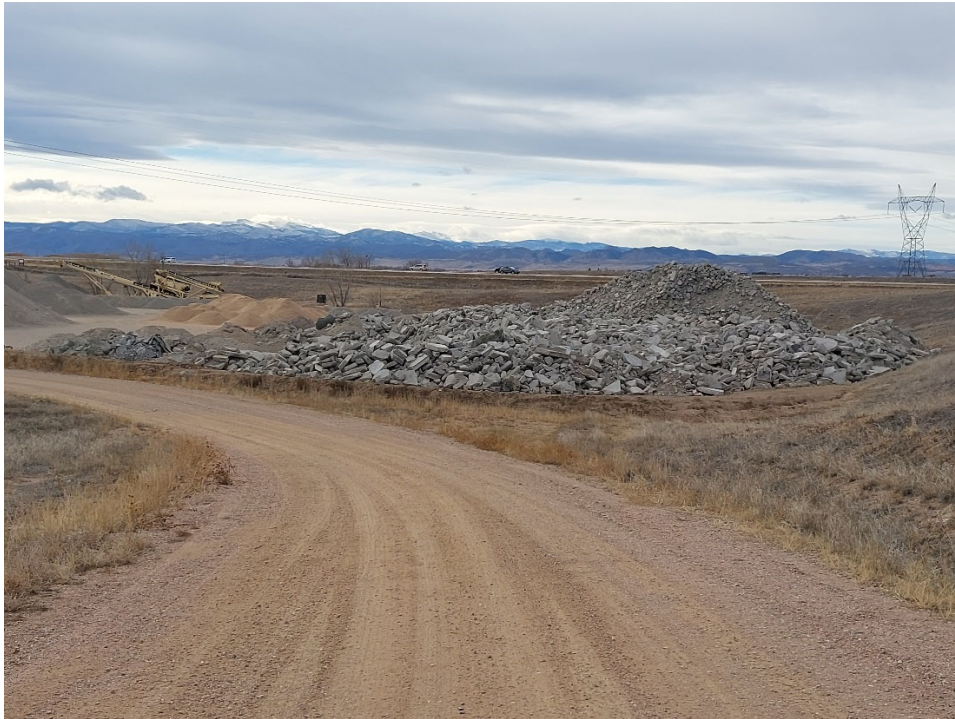
Photo #12: View of the northern area that has been leased area for the aggregate recycling yard; looking to the west from the haul road.

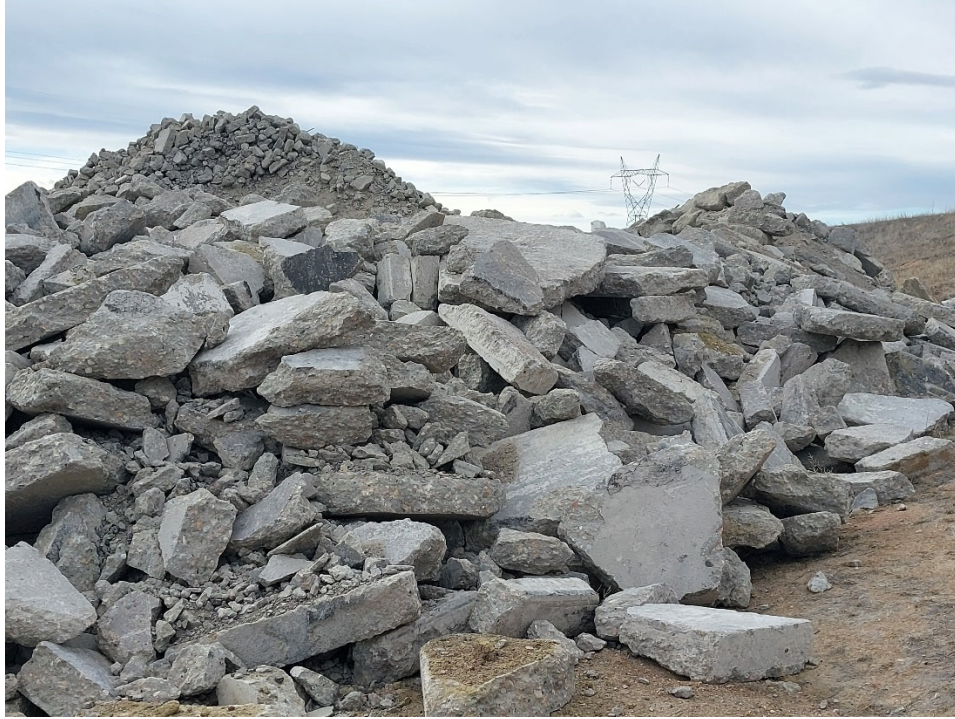
Photo #13: Stockpile of the imported pavement material brought onto the site for processing, located in the northeast of the leased area.

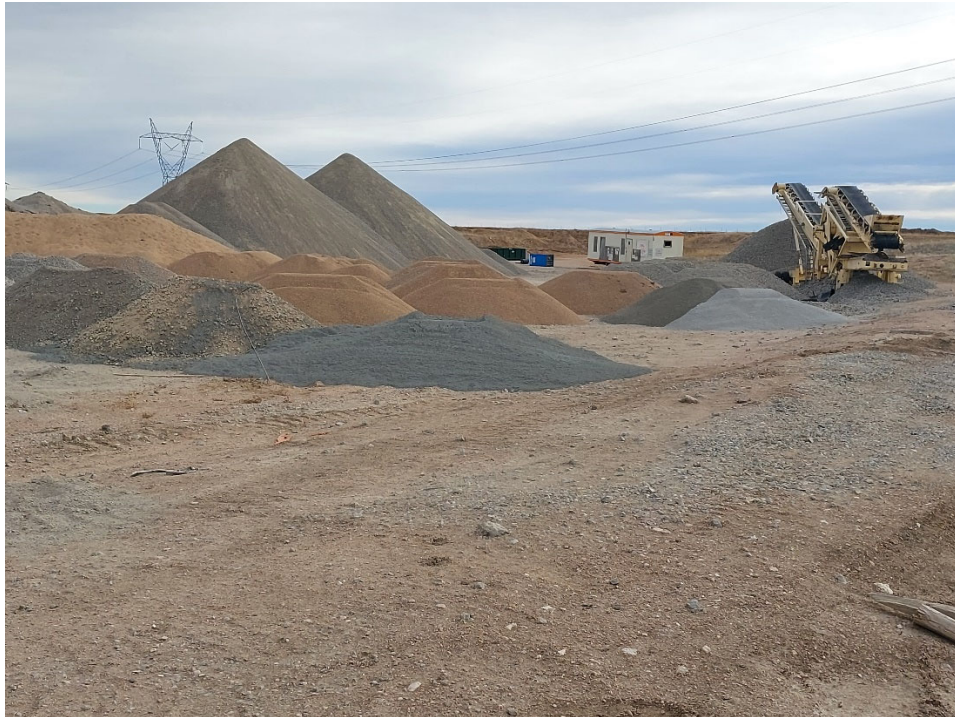
Photo #14: Stockpiles of imported pavement material after being crushed and screened; looking to the southeast from the west side of the leased portion of the permit area.
