MINERALS PROGRAM INSPECTION REPORT
PHONE: (303) 866-3567

MINE NAME: Colorado Land Board Pit	MINE/PROSPECTING ID#: M-2010-009	MINERAL: Sand and gravel and (general)	COUNTY: Washington
INSPECTION TYPE: Monitoring	WEATHER: Clear	INSP. DATE: January 15, 2025	INSP. TIME: 10:30
OPERATOR: Washington County	OPERATOR REPRESENTATIVE:	TYPE OF OPERATION: 112c - Construction Regular Operation	
REASON FOR INSPECTION: Normal I&E Program	BOND CALCULATION TYPE:	BOND AMOUNT: \$0.00	
DATE OF COMPLAINT: NA	POST INSP. CONTACTS: None	JOINT INSP. AGENCY: None	
INSPECTOR(S): Ben Hammar	INSPECTOR'S SIGNATURE:

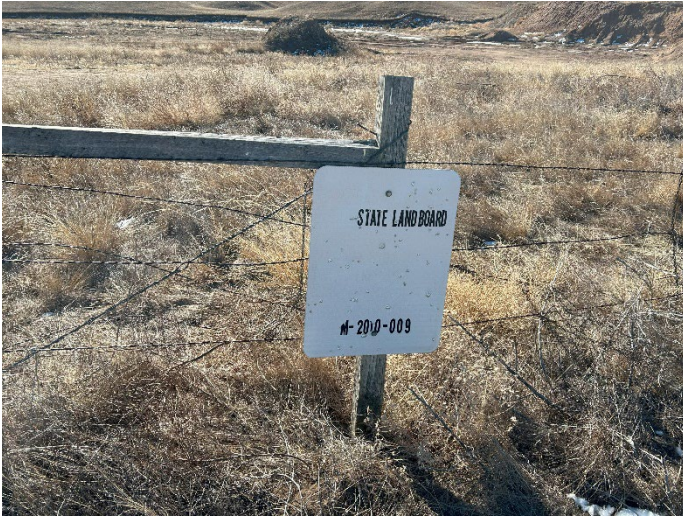
At the time of inspection the posted DRMS sign was illegible, however at the time of this report the operator has provided photo evidence of a replacement sign. As such, no problem will be cited at this time. Topsoil piles were present near the pit entrance, and appeared seeded and stable at the time of inspection. No issues related to hydrologic balance or erosion were present.

Photo 1: Inadequate DRMS sign at time of inspection.

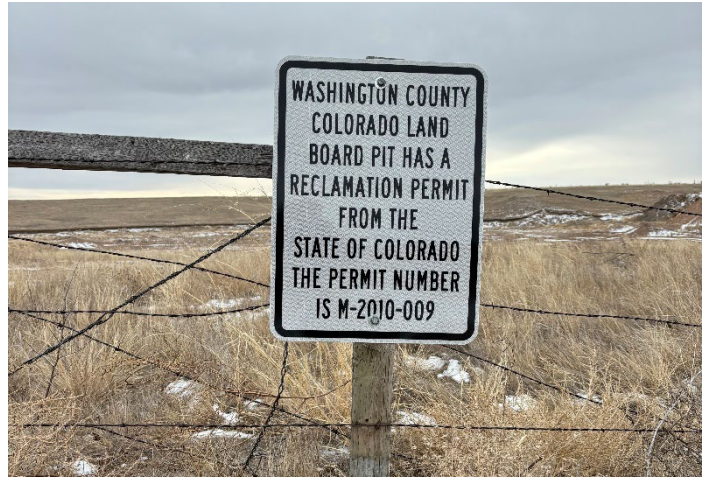
Photo 2: Posted replacement sign

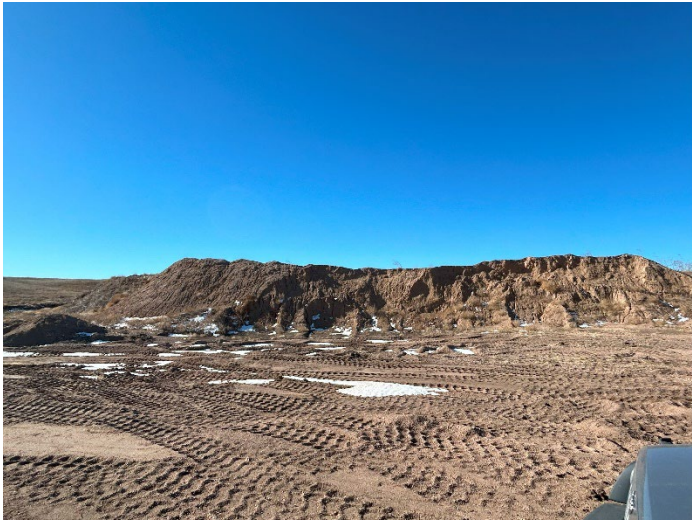
Active mining appeared to be occurring primarily on the west side of the site time of inspection, with an active highwall located on the west side of the disturbed area. The southern area of the site appears to have been reclaimed and has established vegetative cover. The operator expressed interest during the inspection to push the active highwall into the pit area to reduce disturbance to the west.

Photo 3: Active highwall located along the west boundary.

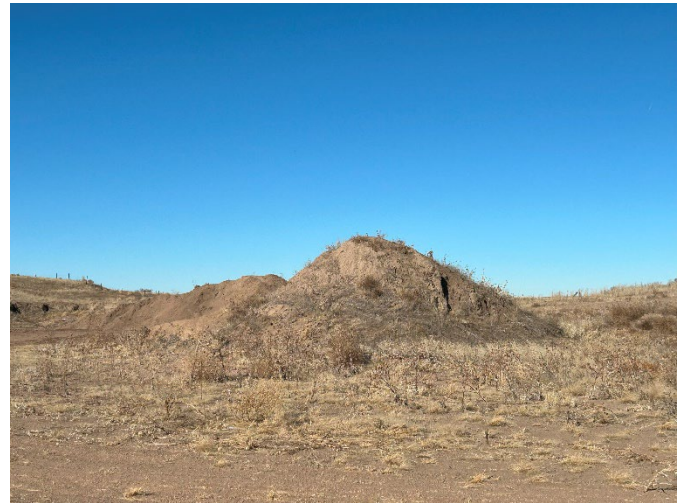
Photo 4: Seeded and stable topsoil pile located near site entrance.
