MINERALS PROGRAM INSPECTION REPORT
PHONE: (303) 866-3567

MINE NAME: Jamaco Pit	MINE/PROSPECTING ID#: M-2010-082	MINERAL: Sand and gravel	COUNTY: Lincoln
INSPECTION TYPE: Monitoring	WEATHER: Cloudy	INSP. DATE: January 23, 2025	INSP. TIME: 11:00
OPERATOR: Lincoln County	OPERATOR REPRESENTATIVE:	TYPE OF OPERATION: 110c - Construction Limited Impact	
REASON FOR INSPECTION: Normal I&E Program	BOND CALCULATION TYPE:	BOND AMOUNT: \$0.00	
DATE OF COMPLAINT: NA	POST INSP. CONTACTS: None	JOINT INSP. AGENCY: None	
INSPECTOR(S): Ben Hammar	INSPECTOR'S SIGNATURE:

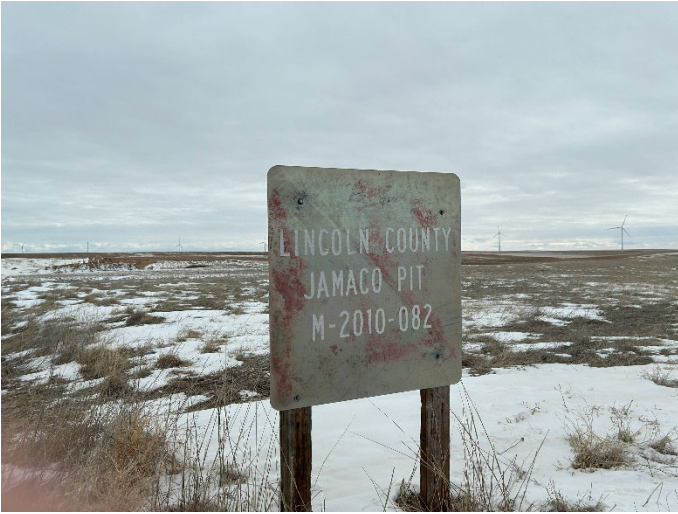
The DRMS mine sign was clearly posted at the entrance to the site. All site boundary markers were present and clearly designated the affected area. The operation appeared to be well within bounds at the time of inspection. Conditions during the inspection were partly cloudy, windy, and cold, and some snow accumulation was present during the inspection due to recent snowfall. Some frozen snow melt was present at the time of inspection, however the total amount was minimal and likely due to recent snowfall as well. No significant erosional issues were present, and no evidence of harm to the surrounding hydrologic balance was apparent.

Photo 1: Posted mine sign.

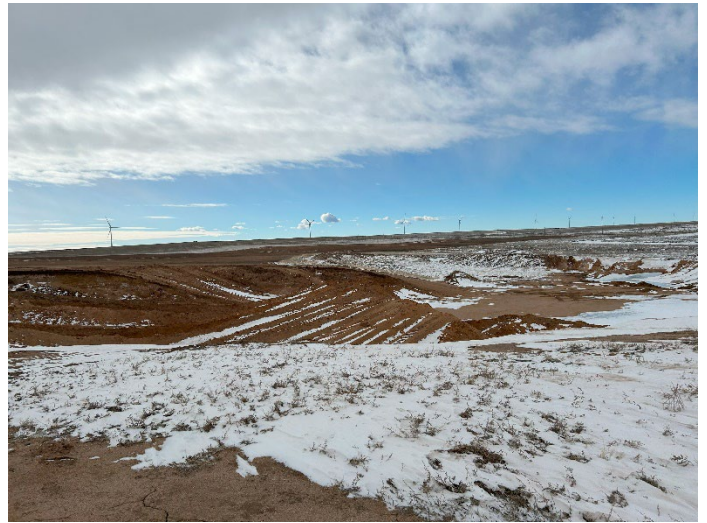
Stable topsoil piles were located along the western edge of the site, and were covered in snow at the time of inspection. No signs of erosion were present on the topsoil stockpiles. Active mining appeared to have taken place recently within the eastern portion of the site, and per conversations with the operator the site is in regular use. No other issues were present during this inspection.

Photo 2: Active pit floor.

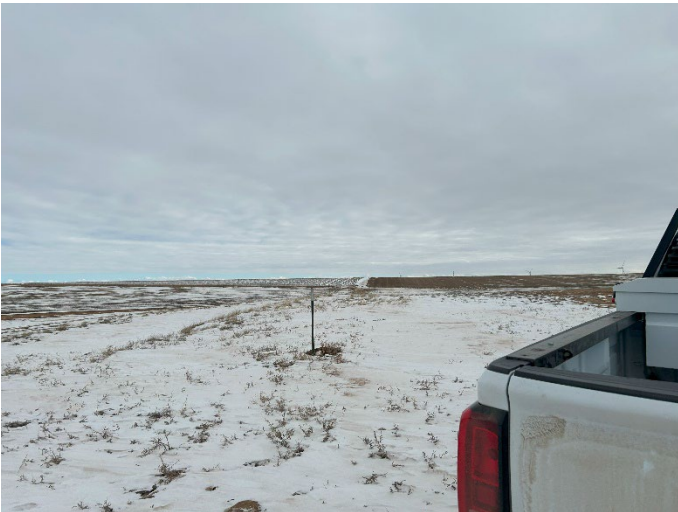
Photo 3: Example site boundary, located along the northern site boundary.

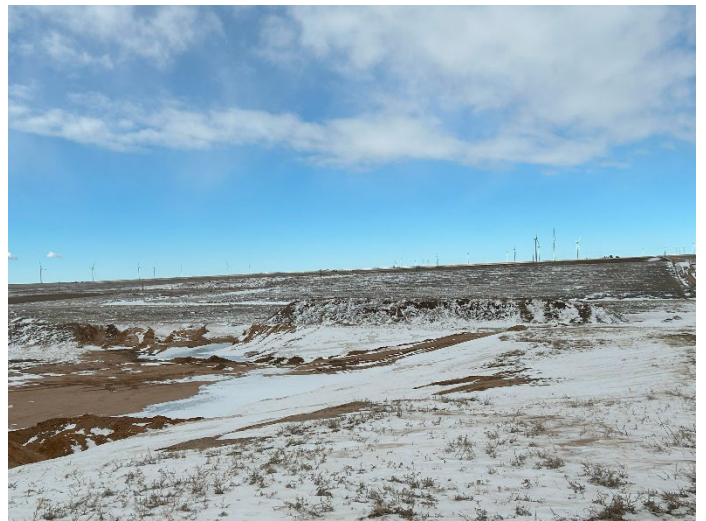
Photo 4: Seeded topsoil pile.
