<b>Permit Number:</b>	C-1981-012
Mine Name: Nev	v Flk Mine

**Operator:** New Elk Coal Company, LLC

# **INSPECTION INFORMATION**

Inspection Start Date: January 22, 2025 Inspection Start Time: 12:55 Inspection End Date: January 22, 2025 Inspection End Time: 13:50	Inspection Type: Coal Partial Inspection Inspection Reason: Normal I&E Program Weather: Cloudy
Joint Inspection Agency:	Joint Inspection Contacts:
None	
Post Inspection Agency:	Post Inspection Contacts:
None	
Inspector(s):	Inspector's Signature: Signature Date:
Amber M. Gibson	January 28, 2025

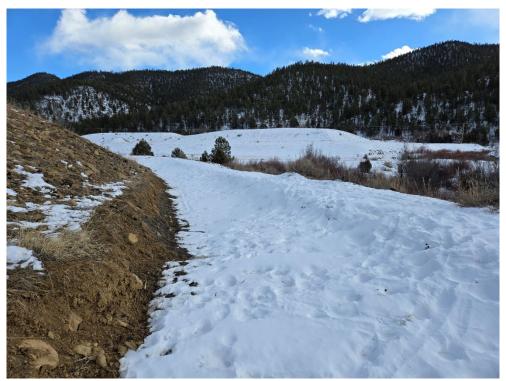
- The ditch along the west side of DWDA #1 (D3) was clear of obstructions (Photo 1) and the berm appeared to be stable and functional. No apparent structural issues were observed.

Photo 1: Looking south along D3 on the west side of DWDA #1.

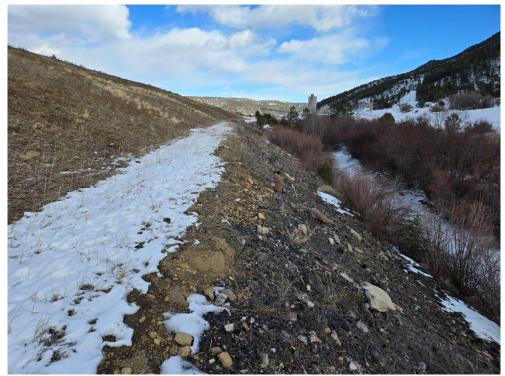
- The ditch along the south side of DWDA #1 (D4) was clear of obstructions (Photo 2) and the berm appeared to be stable and functional. No apparent structural issues were observed.

Photo 2: Looking east along D4 on the south side of DWDA #1.

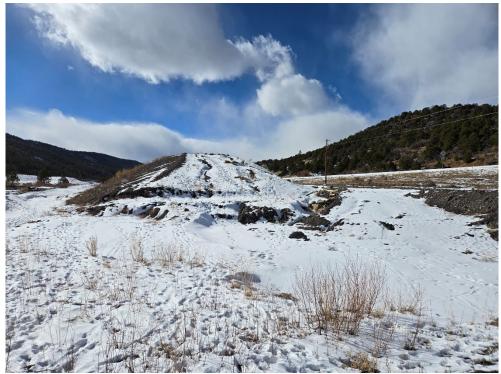
- The sediment basin at the east end of DWDA #2 held water at the time of the inspection (Photo 3). The berm around the basin appeared to be stable. The check dams along the north side of the sediment basin have filled with sediment. The Operator shall clean the check dams of sediment and ensure that the sediment control structures are functioning appropriately.

Photo 3: Looking northwest at the east side of DWDA #1. The sediment basin contained some frozen water at the time of the inspection.

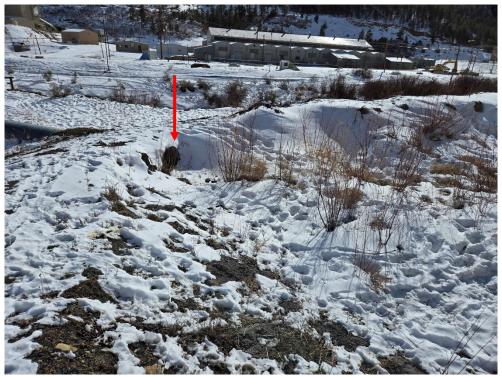
- Culvert C13 was free of obstructions (Photo 4). However, the vegetation in-front of C13 should be cleared before next spring.
- Ditch D14 on the south side of DWDA #2 appeared to be stable (Photo 5). No signs of seepage or erosion on the south side of the bank was observed.

Photo 4: Looking at the inlet for C13.

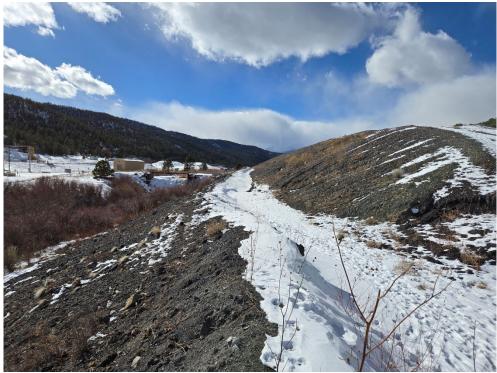
Photo 5: Looking west along the D14 on the south side of DWDA #2.

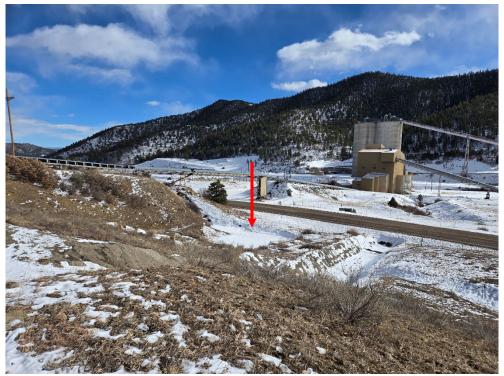
- Containment area #5 contained some frozen water and was below capacity (Photo 6).
- Pond 001A held some frozen water at the time of the inspection and was not discharging. No tears were observed in the lining at the time of the inspection (Photo 7).

Photo 6: Looking south at Containment Area #5.

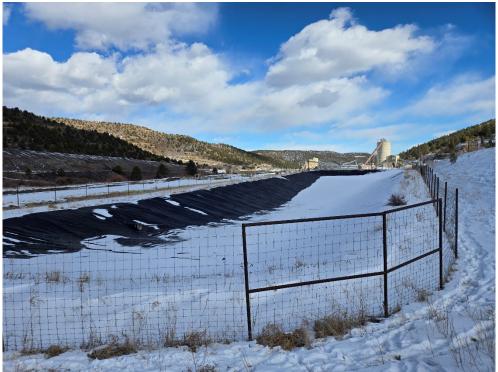
Photo 7: Looking east at Pond 001A.

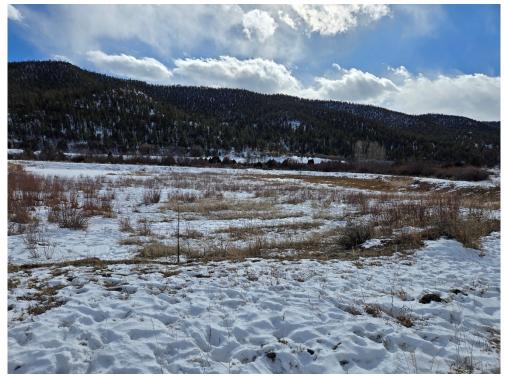
- Pond 004A contained a small amount of frozen water located within the southeast corner (Photo 8). The banks appeared to be stable at the time of the inspection.

Photo 8: Looking south at Pond 004A.

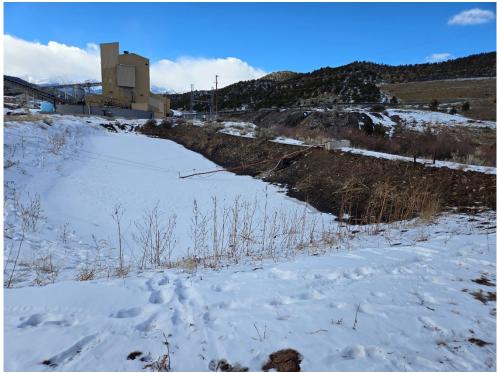
- Pond 006A contained some frozen water at the time of the inspection (Photo 9). The banks of the pond appeared to be stable.
- Pond 007A contained some frozen water at the time of the inspection. The water level was up to the lower portions of the primary spillway (Photo 10), but the pond was not discharging. The emergency spillway was free of obstructions and the embankment appeared to be stable.

Photo 9: Looking west at Pond 006A.

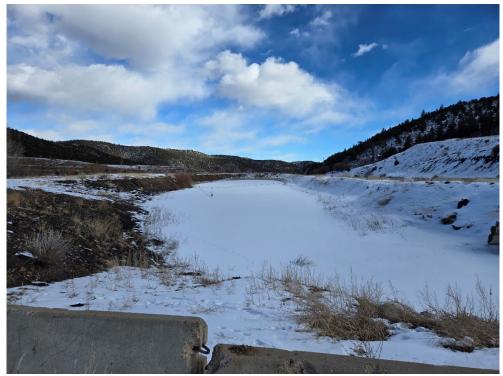
Photo 10: Looking east at Pond 007A.

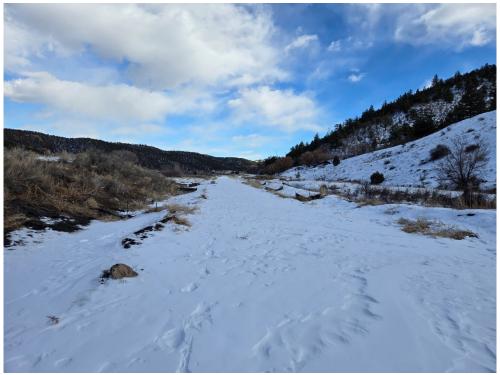
- The silt fences along the road leading to Pond 007A, within the S.A.E., are full of tumbleweeds and are damaged (Photo 11). The Operator shall clear the silt fences of vegetation/debris and repair and/or replace the fences.

Photo 11: Looking east along the road on the south side of Pond 007A. The silt fences within this S.A.E. need to be repaired and/or replaced.

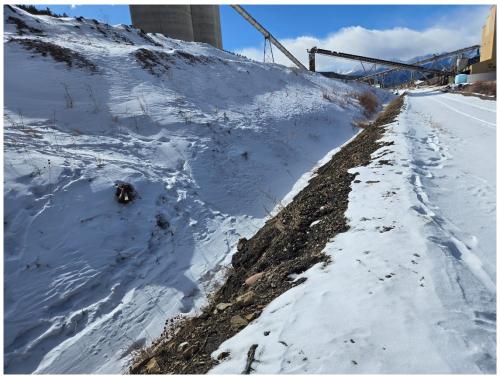
- Ditch D23 was clear of obstructions, and the berm alongside the road appeared to be stable (Photo 12).

Photo 12: Looking west along D23.

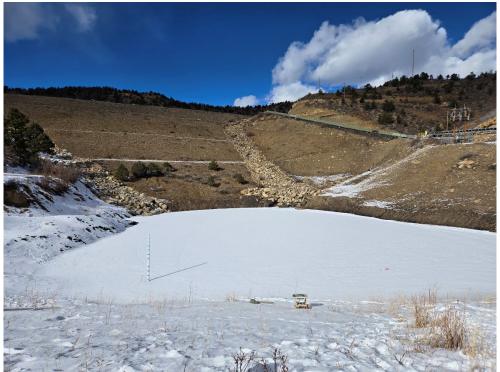
• Pond 08 contained some frozen water at the time of the inspection and was below its capacity (Photo 13). The spillways appeared clear, and the banks were stable. Pond 08 was not discharging.

Photo 13: Looking northeast at Pond 08.

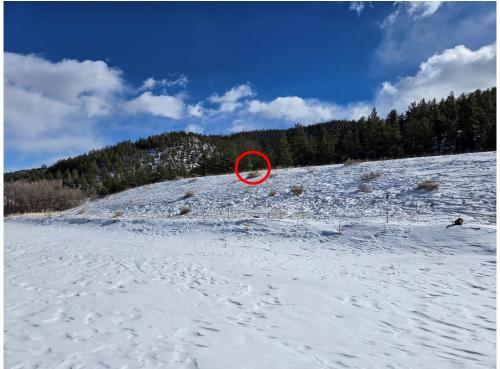
- Topsoil piles were observed throughout the site (Photo 14). Each pile was out of the way of on-going mining operations, had a sign to identify the stockpiles as topsoil, and had been stabilized with vegetative cover (except for the newest one located in the soil Stockpile Storage Area north-west of Topsoil Stockpile #1).
- The new topsoil pile shall be seeded with the approved seed mix and stabilized as soon as possible (Photo 15).
- The berm along the north side of the soil stockpile storage area, on the south side of the check dams, is intact along the western sides (Photo 16). Towards the entrance to the area, the berm will need to be restabilized as the check dams are cleaned.

Photo 14: Looking southeast at Topsoil Stockpile #1. Circled is the sign.

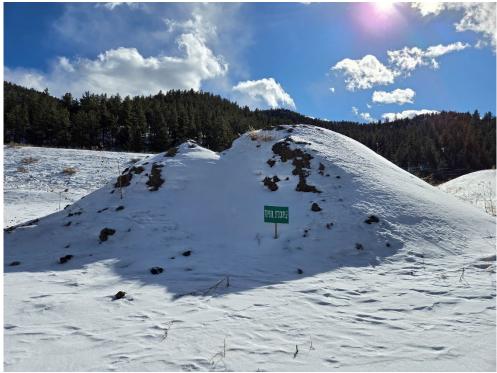
Photo 15: Looking south at the new topsoil stockpile.

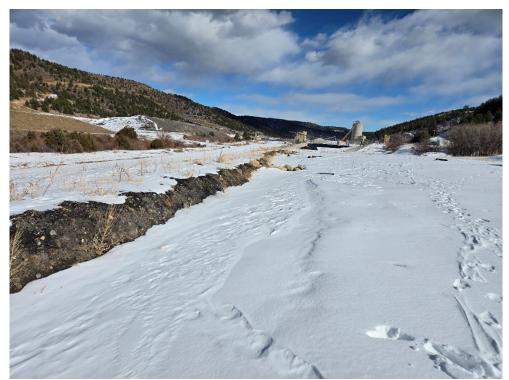
Photo 16: Looking east along the berm located on the south side of the soil stockpile storage area.
