PERMIT INFORMATION

Permit Number: C-1996-084	County: Las Animas	
Mine Name: Lorencito Canyon Mine	Operation Type: Surface	
Operator: New Elk Coal Company, LLC	Permit Status: Permanent Cessation	
Operator Address:	Ownership: Private	
Mr. John Terry		
12250 Highway 12	Operator Representative Present:	
Weston, CO 81091		
	None	
Operator Representative Signature: (Field Issuance Only)

INSPECTION INFORMATION

Inspection Start Date: January 23, 2025 Inspection Start Time: 09:52 Inspection End Date: January 23, 2025 Inspection End Time: 10:48	Inspection Type: Coal Partial Inspection Inspection Reason: Normal I&E Program Weather: Clear
Joint Inspection Agency:	Joint Inspection Contacts:
None	
Post Inspection Agency:	Post Inspection Contacts:
None	
Inspector(s):	Inspector's Signature: Signature Date:
Amber M. Gibson	January 29, 2025
	January 29, 2023

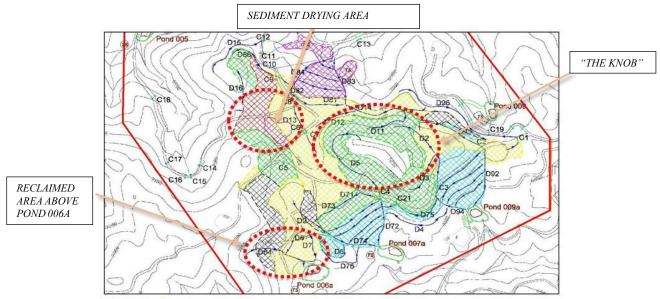
- The following items pertain to ongoing erosional issues in the areas shown in Figure 1, that pursuant to Rule 4.14.6 need to be addressed. A Technical Revision will be required to expand on the current Rill and Gully plan in the PAP. The Operator shall submit the technical revision, obtain approval, repair the erosion, and stabilize the slopes pursuant to the approved plan by December 31, 2024.

FIGURE 1. AREAS WHERE RILLS, GULLIES AND SPARSE VEGETATION HAS BEEN FOUND TO BE A PERSISTENT PROBLEM AT THE SITE ARE WITHIN THE DOTTED CIRCLE AREAS. BACKGROUND IMAGE IS THE 2020 ANNUAL REPORT MAP.

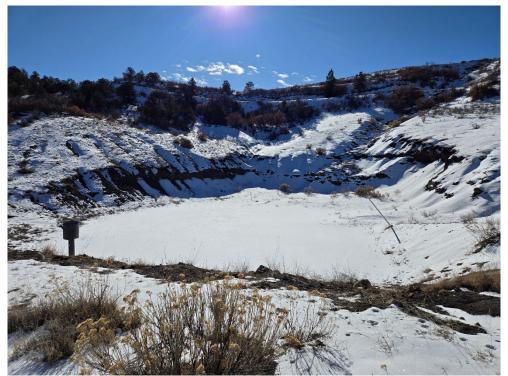
- The pond contained some frozen water at the time of the inspection. (Photo 1).
- o The pond embankment appeared to be stable and vegetated.
- o The primary and emergency spillways appeared clear and functional.
- o The flume contained some frozen water and was not discharging.

Photo 1: Looking southeast at Pond 009.

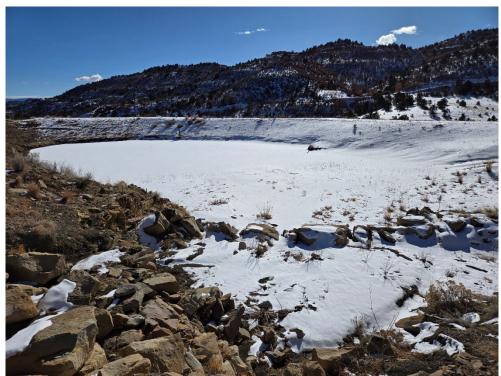
- o Pond 006a contained water (Photo 2) and was not discharging at the time of the inspection.
- The north side of the pond embankment still requires maintenance (see Item # 1 in the outstanding maintenance items list on the first page of this report).
- o The primary and emergency spillways appeared to be clear and functional.
- O The ongoing maintenance issues listed in Item #3 at the beginning of this report are still a concern. Photos 3-6 are in reference to these areas.
- O The ongoing maintenance issues listed in Item #4 at the beginning of this report are still a concern. Photo 7 is in reference to the 'Reclaimed Area Above Pond 006A'.

Photo 2: Looking southeast at Pond 006A.

- Erosion rills are forming on the north and west banks of Pond 006a. The erosion on the north bank appears to have been addressed at some point, because rebar is placed above the rills. However, it appears that the prior BMPs are no longer functioning adequately. Pursuant to Rule 4.05.5(1)(c), the Operator shall address the erosion and repair the north bank. The erosion on the west bank appears to have been caused by runoff from the road located east of Pond 006a. Pursuant to Rule 4.05.5(1)(c), the Operator shall address the erosion and repair the west bank.

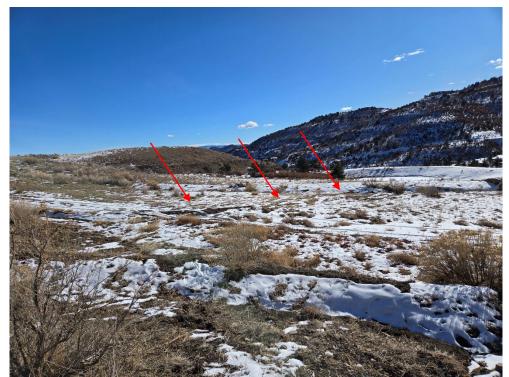
- The following items pertain to ongoing maintenance issues, cited in previous reports for the area in and around the reclaimed area above Pond 006a:
 - The ditch along the road leading to Pond 006a is eroding and nearly full of sediment. The overloaded ditch is contributing to the build-up of sediment in the check dams of ditches D8 and D64. Pursuant to Rule 4.03.2(4), the ditch along the west side of the road leading to Pond 006a needs to be cleaned out and repaired.

Photo 3: Looking southeast toward Pond 006A from the base of the Reclaimed Area Above Pond 006A. The arrows point to where erosion has cut across the road and entered into the ditch with check dams (see Photo 5).

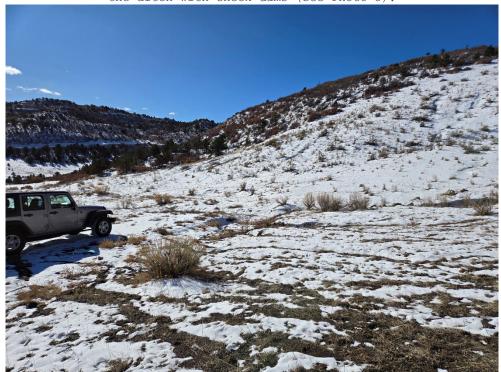
Photo 4: Looking southwest from the base of the Reclaimed Area Above Pond 006A. Sediment from erosion in this area has entered into a ditch that leads to the check

dams that are full of sediment (ditch D64 to D8/D7).

- O The check dams leading to Pond 006a, within ditches D8 and D64, are nearly full of sediment. Pursuant to Rules 4.05.3(1)(c)-(e) and 4.05.5, the Operator shall clean out the sediment from the check dams to prevent excess sediment from entering the pond.

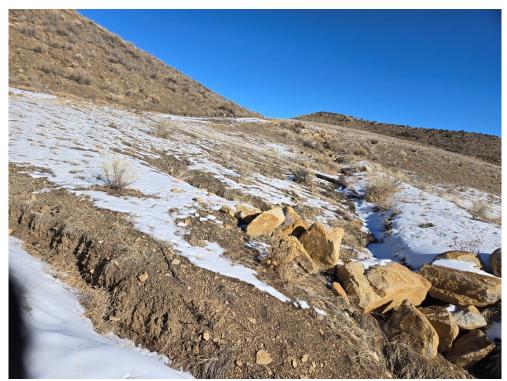
Photo 5: Looking north along ditch D8.

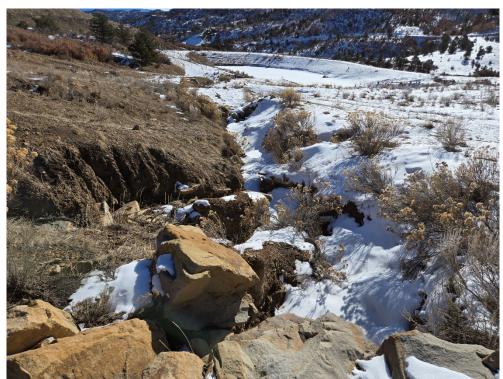
Photo 6: Looking east along where ditches D64, D8, and D7 converge. The check dams in this area need to be repaired and are no longer functioning as designed.

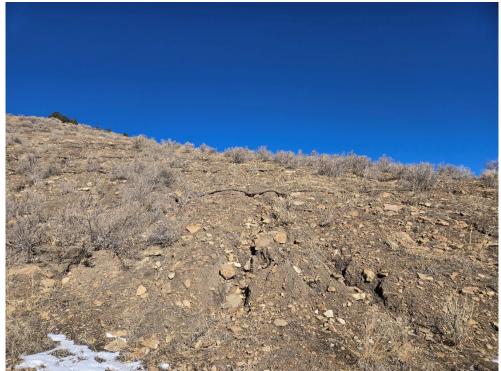
Photo 7: Looking north at the erosion on the south facing slopes of the 'Reclaimed Area Above Pond 006A'.

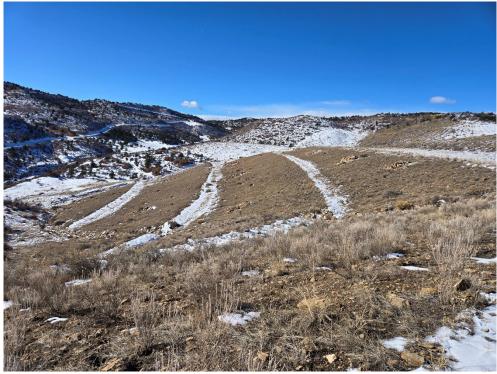
- Fill 7 was observed. Fill 7 was well vegetated and appeared stable (Photo 8).
- Fill 8 was observed. Fill 8 was well vegetated and appeared stable.

Photo 8: Looking west across Fill 7.

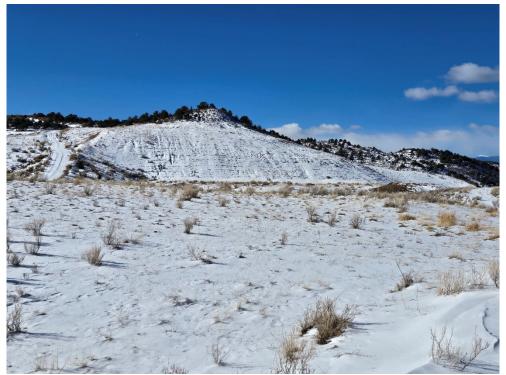
- The area above where NECC stores pond and ditch cleanings consists of a steep slope. This slope was observed during the inspection (Photo 9). Erosion rills and gullies were observed but the vegetation on this slope appears better established this year than in years previously observed by DRMS. NECC is encouraged to continue to monitor this area and conduct maintenance as needed.
- A previously disturbed area north of Fill 7 and north of the road, referred to as "The Knob", exhibits

Photo 9: Looking southwest at the erosion on the reclaimed area above the Sediment Drying Area.

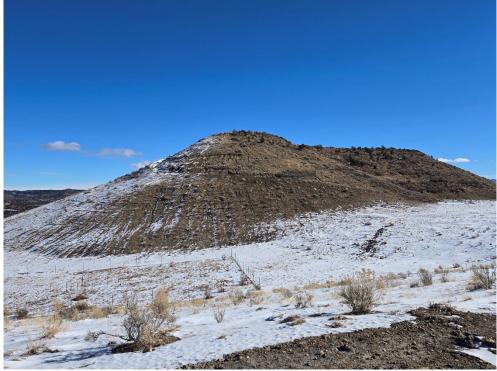
erosion on the south and west facing slopes (Photos 10-11). NECC is required to provide a plan to stabilize this area through a revision following the approval of RN5 (see ongoing maintenance item number 4). The northern slopes appear to be stable at this time (Photo 12).

Photo 10: Looking northeast at the south-facing slopes on 'The Knob'.

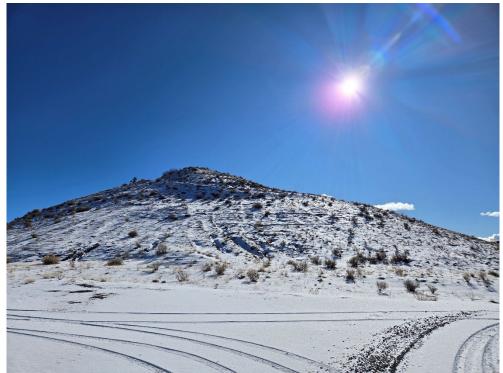
Photo 11: Looking southeast at the west-facing slopes on 'The Knob'.

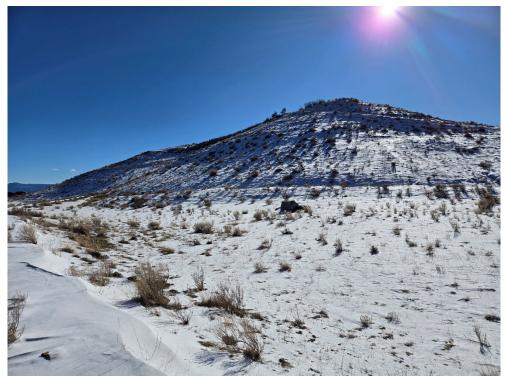
Photo 12: Looking southeast at the north-facing slopes on 'The Knob'.

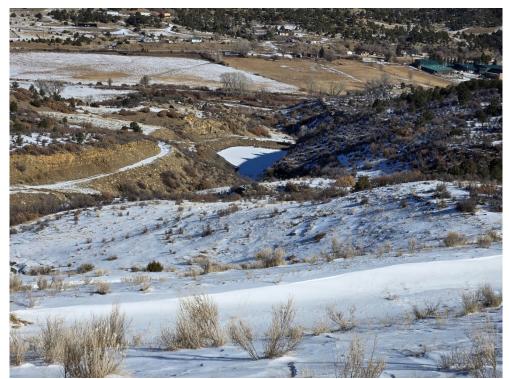
• See ongoing maintenance Item #2 and #3. The road leading down into Pond 008 has some ruts that will require repairs. The ruts and divots in the road to Pond 008 make vehicle access to the pond difficult and not advisable in adverse conditions (Photo 13).

Photo 13: Looking north from the top of Fill 8. Pond 08 contained frozen water at the time of the inspection. The roads were not safely traversable at the time of the inspection.

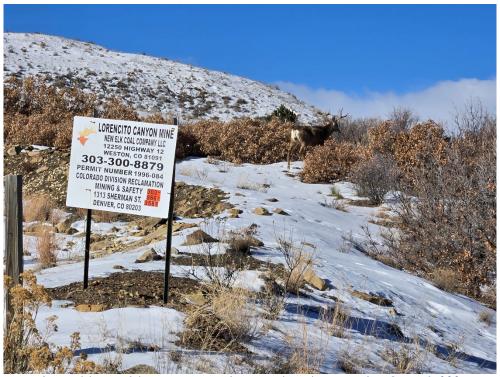
• Mine signs were posted at road entrances and at the entrance to the permit boundary in compliance with Rule 4.02 (Photo 14).

Photo 14: Looking west at the permit sign north of Pond 009.
