January Inspection reports

Here are the reports for the inspections conducted on Jan 22, 2025 at the Foidel Creek (M-1982-056) and Hayden Gulch (M-1992-081) Mines.

Permit Number: C-1992-081 Mine Name: Hayden Gulch Loadout Operator: Hayden Gulch Terminal, LLC Operator Address: Ms Miranda Kawcak 29515 Routt County Road 27 Oak Creek, CO 80467	County: Routt Operation Type: Loadout Permit Status: Active Ownership: Private Operator Representative Present: N/a	
Operator Representative Signature: (Field Issuance Only)

Inspection Start Date: January 2: Inspection Start Time: 13:00 Inspection End Date: Inspection End Time:	2, 2025		Inspection Type: Coal Partial Inspection Inspection Reason: Normal I&E Program Weather: Clear
Joint Inspection Agency:	Agency: Join		Inspection Contacts:
None			
Post Inspection Agency: Post		Post	Inspection Contacts:
None			
Inspector(s):	Inspector's Signature: Signature Date:		
Brock Bowles	Brah Samls		
			January 29, 2025

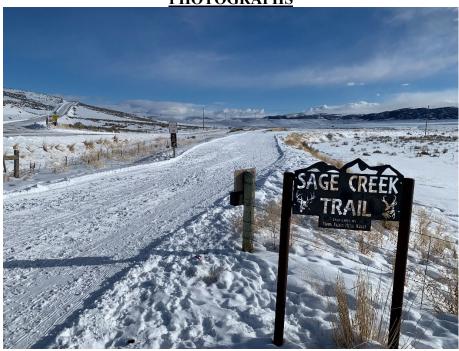
The former railroad loop is now referred to as the Sage Creek Trail. The trail was covered with snow and had been groomed for cross-county skiers (photo 1). Many ski tracks and dog tracks were seen on the trail indicating it has been used recently.

Photo 1- The railroad loop being used as a cross-country ski trail

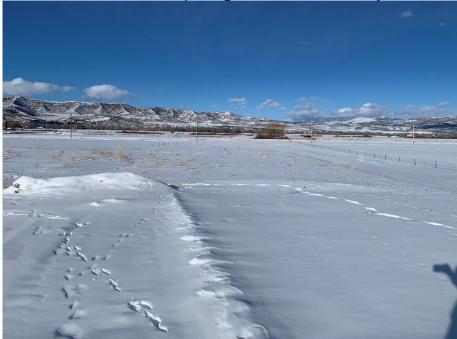
The remaining disturbed area was covered in about 1 foot of snow. Some grass tops could be seen in a section of the reclamation just north of the trail head parking area (photo 2). The section north of Hwy 40 was also covered in deep snow.

Photo 2- Reclamation north of trail head parking lot

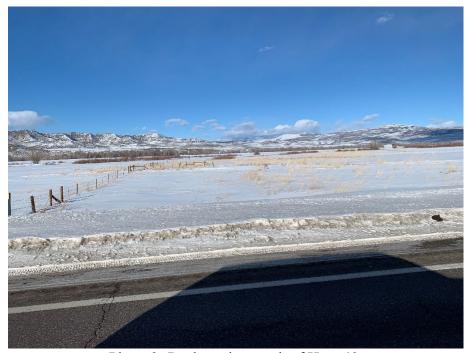
Photo 3- Reclamation north of Hwy 40.
