STATE OF  
COLORADO

## January Inspection reports

**PERMIT INFORMATION**

**Inspection Topic Summary**

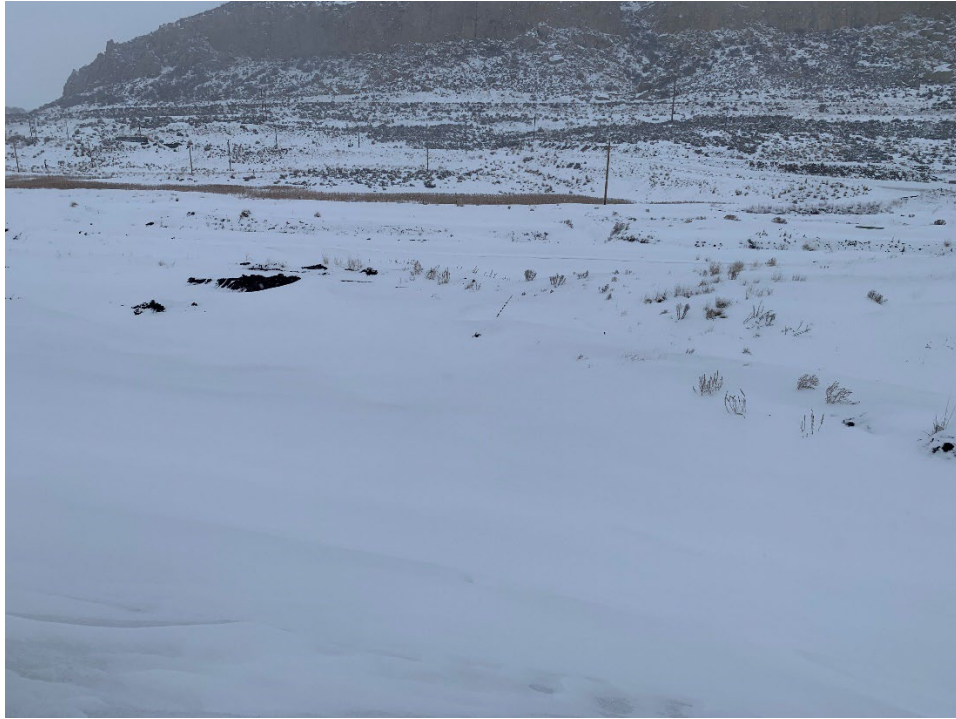
Ponds B were covered in snow and the discharge point was inaccessible. The sump above Ponds B was also covered in snow along with the inlet into the sump (photo 1).

Photo 1 – Ponds B and sump in foreground, photo facing north.

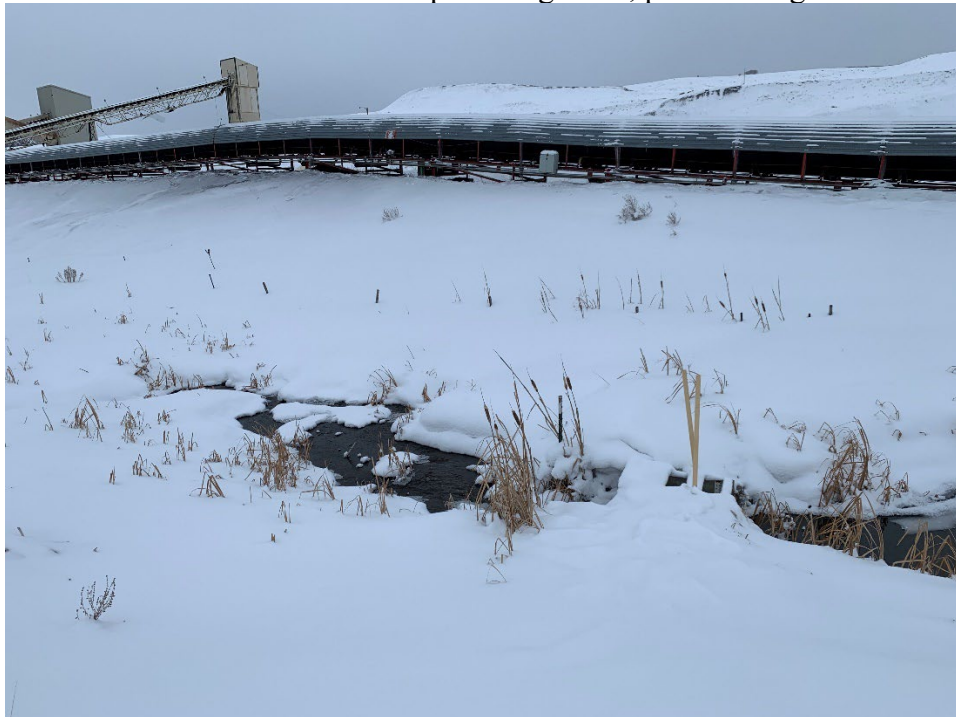
Pond D was snow covered. The wash plant was discharging water into the pond on the east side. Water was passing through the discharge point (photo 2). The pit pond was only partially covered with ice.

Photo 2- Pond D discharge point

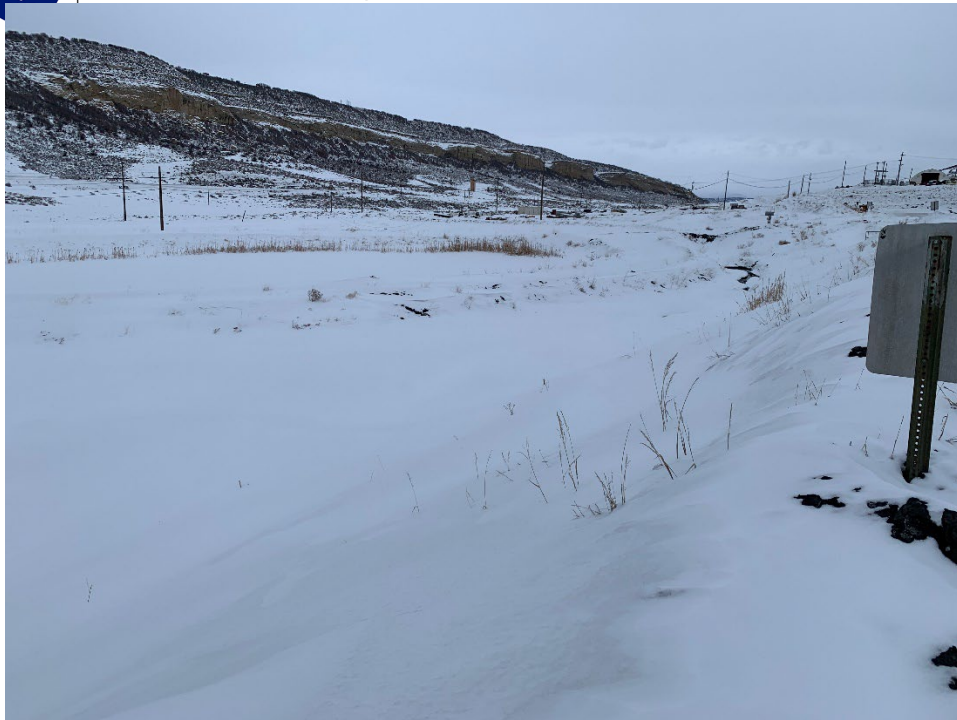
Pond E was snow covered. A small patch of snow on the east end was melted suggesting that there is some inflow to the pond (photo 3). The shallow connection channel between the two pond sections did not have melted snow, suggesting that water may not be flowing between the sections and towards the discharge point. The discharge point was buried under a drift of snow and inaccessible.

Photo 3- Pond E snow covered, photo facing east

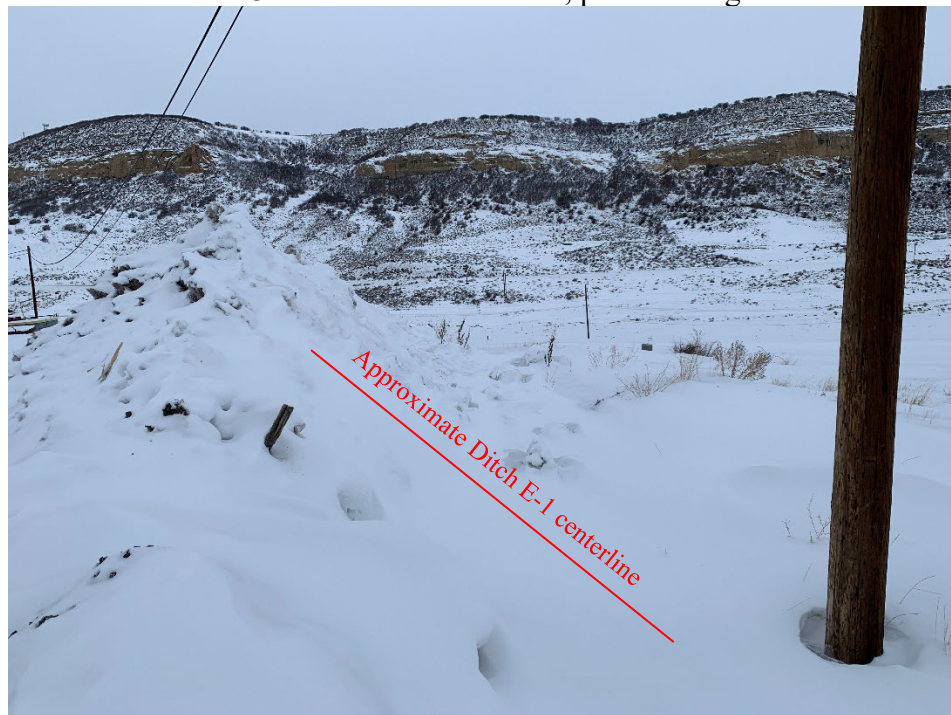
Ditch E-1 behind the maintenance shop has a very large pile of snow and debris place on top of the ditch (photo 4). The snow pile is created when the maintenance yard is plowed. **The pile of snow is blocking any potential water flow in the E-1 ditch and needs to be removed.**

Photo 4- Ditch E-1 is covered in a snow pile and needs to be cleared.

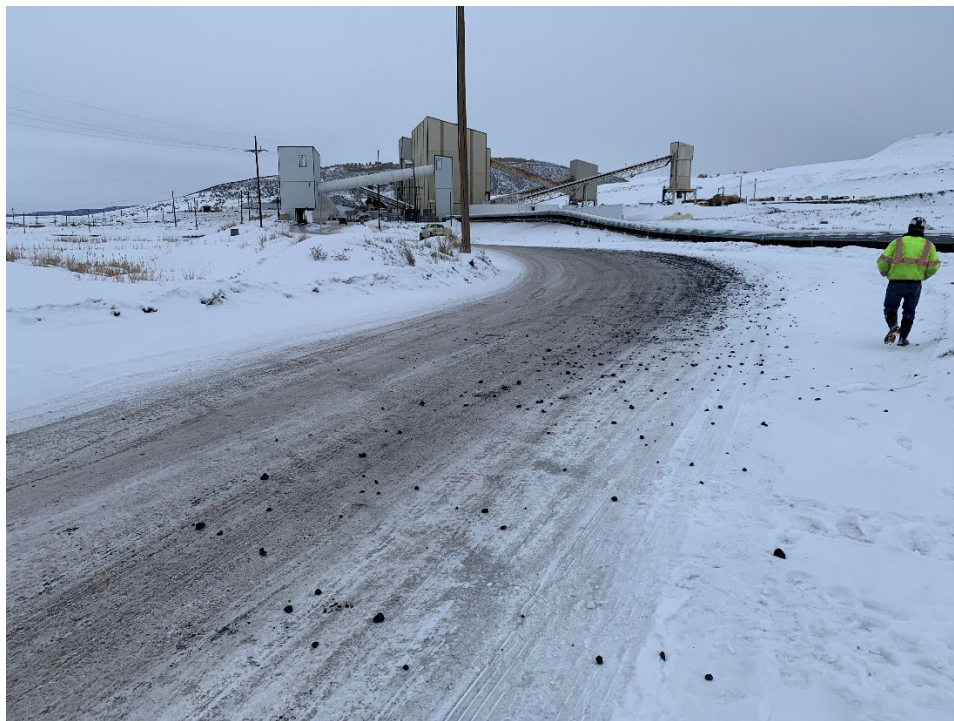
Some coal material was noted on the main haul road where the road crossed Foidel Creek. The likely source of the coal is the stoker coal haul trucks (photo 5). The coal was cleaned up and removed during this inspection.

Photo 5- Coal material on haul road next to Foidel Creek. The coal was cleaned during the inspection
