Inspection Report, Colowyo, C-1981-019

Division of Reclamation,
Mining and Safety

Permit Number: C-1981-019 Mine Name: Colowyo Coal Mine Operator: Colowyo Coal Company L.P. Operator Address: Mr Tony Tennyson 5731 State Highway 13 Meeker, CO 81641	County: Moffat, Rio Blanco Operation Type: Surface Permit Status: Active Ownership: Private
	Operator Representative Present: Tony Tennyson
Operator Representative Signature: (Field Issuance Only)

Inspection Start Date: January 27, 2025 Inspection Start Time: 12:30 Inspection End Date: January 27, 2025 Inspection End Time: 13:30		Inspection Type: Coal Partial Inspection Inspection Reason: Normal I&E Program Weather: Clear	
Joint Inspection Agency: None		Joint Inspection Contacts:	
Post Inspection Agency: None		Post Inspection Contacts:	
Inspector(s): Hunter Ridley	Inspector's Signature: <i>Hunter Ridley</i>		Signature Date: January 31, 2025

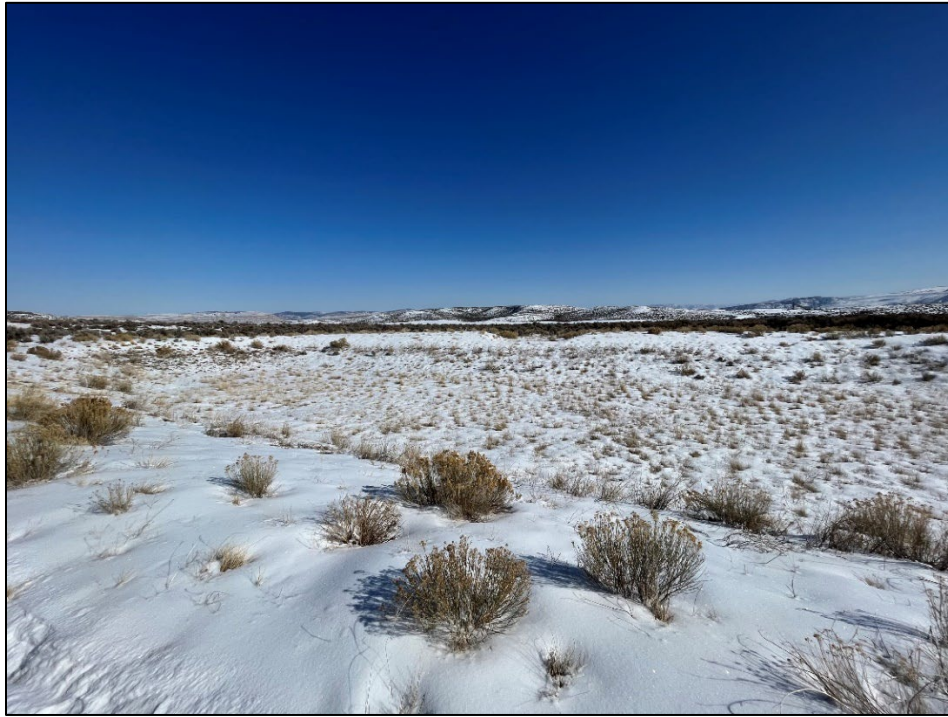
The temporary facilities area to the west of the rail loop area was observed. The pond was snow covered but appeared to be dry, as it usually is. Vegetation was still visible through the snow and overall, the pond

was stable (Photo 1). This area is used as a temporary office and equipment storage space for the highwall miner operating company.

Photo 1: Wilson Storage Pond in the Temporary Facilities area adjacent to the rail loop area.

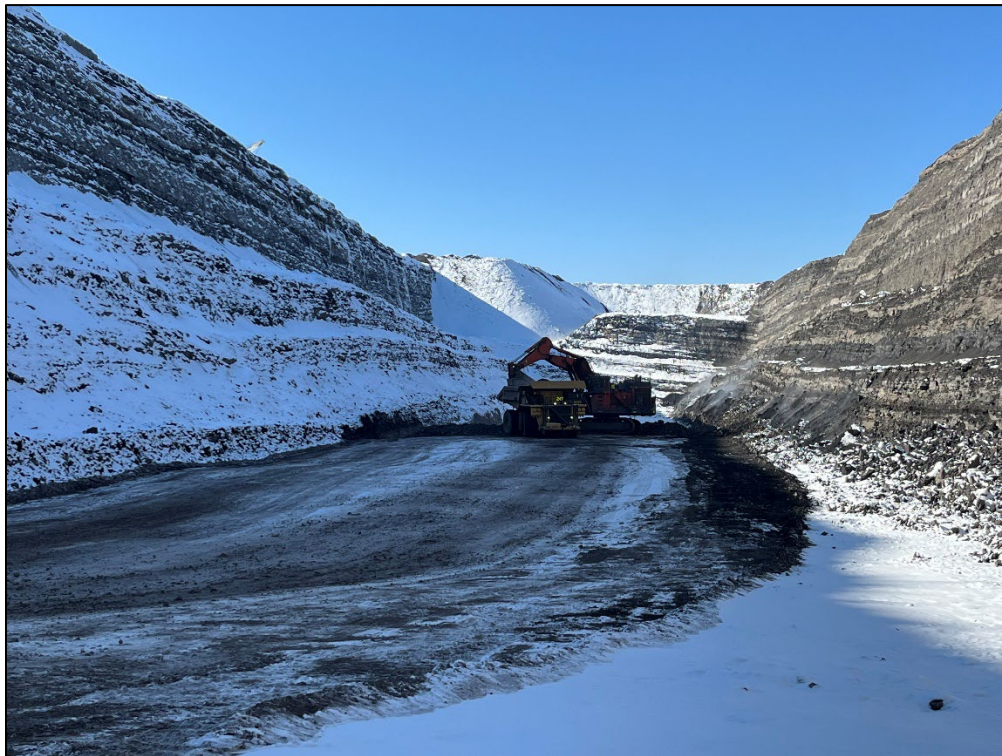
No active mining was observed during this inspection, but backfill operations were noted to be active in Collom Pit (Photos 2 and 3). No train was observed at the Gossard Loadout area during the inspection.

Photo 2: Spoil is being loaded from the central Collom Pit mining area and hauled to the eastern mined area.

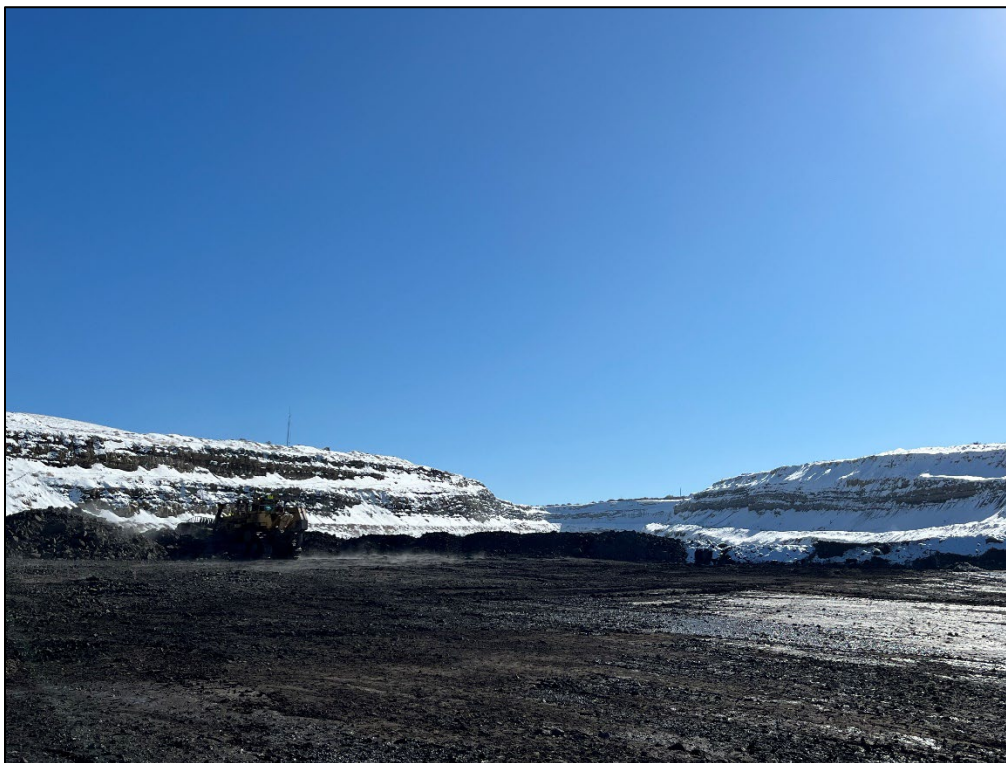
Photo 3: Active backfill occurring in the eastern mining area of Collom Pit.

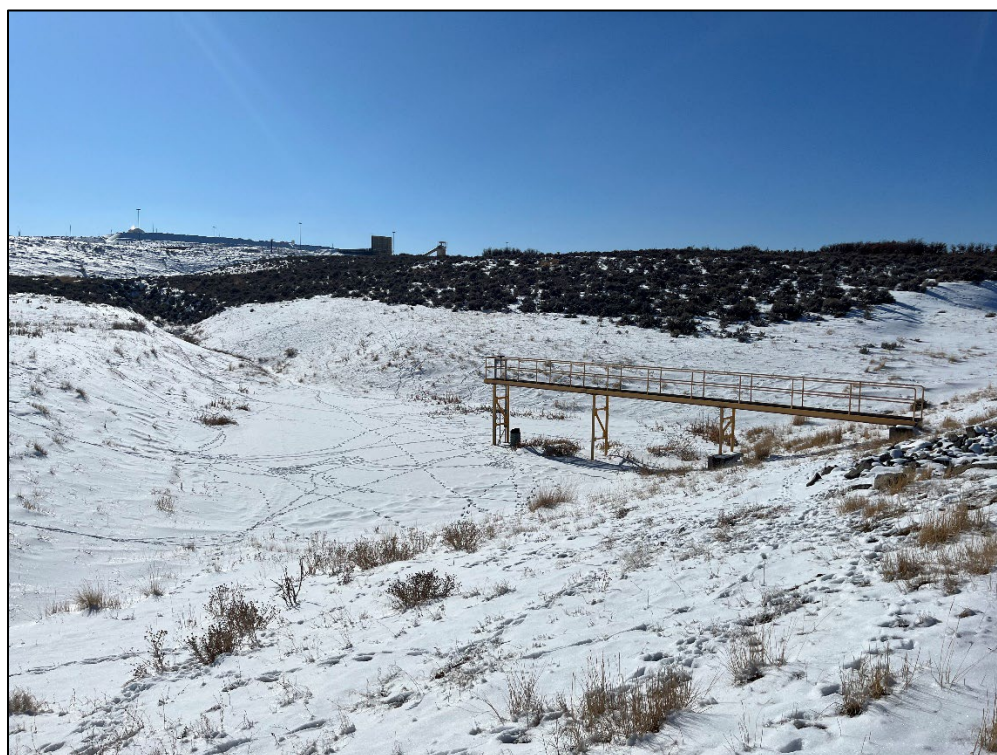
The following Ponds in the Collom Pit area were inspected this month: Section 36 Pond (Photo 4), Middle Pond (Photo 5) and Section 25 Pond (Photo 7). All ponds were snow covered, stable, and free of issues. Section 26 Pond and Sidehill Pond were inaccessible from the usual access road due to ongoing cable laying operations and regrading work being completed on the western side of the Collom spoil pile. However, the Division's aerial inspection allowed for observance of these ponds, which appeared to be snow-covered and stable (Photo 15). No outstanding problems were noted at any of the ponds. All ponds were holding water but frozen.

Photo 4: View of Section 36 Pond.

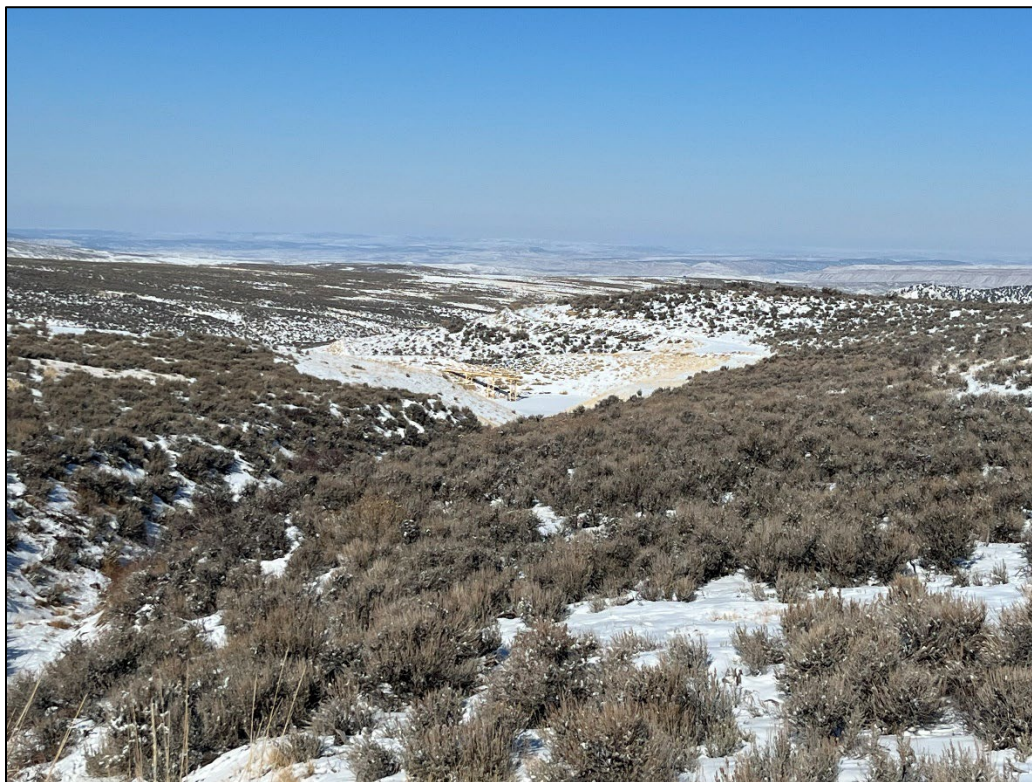
Photo 5: View north of Middle Pond.

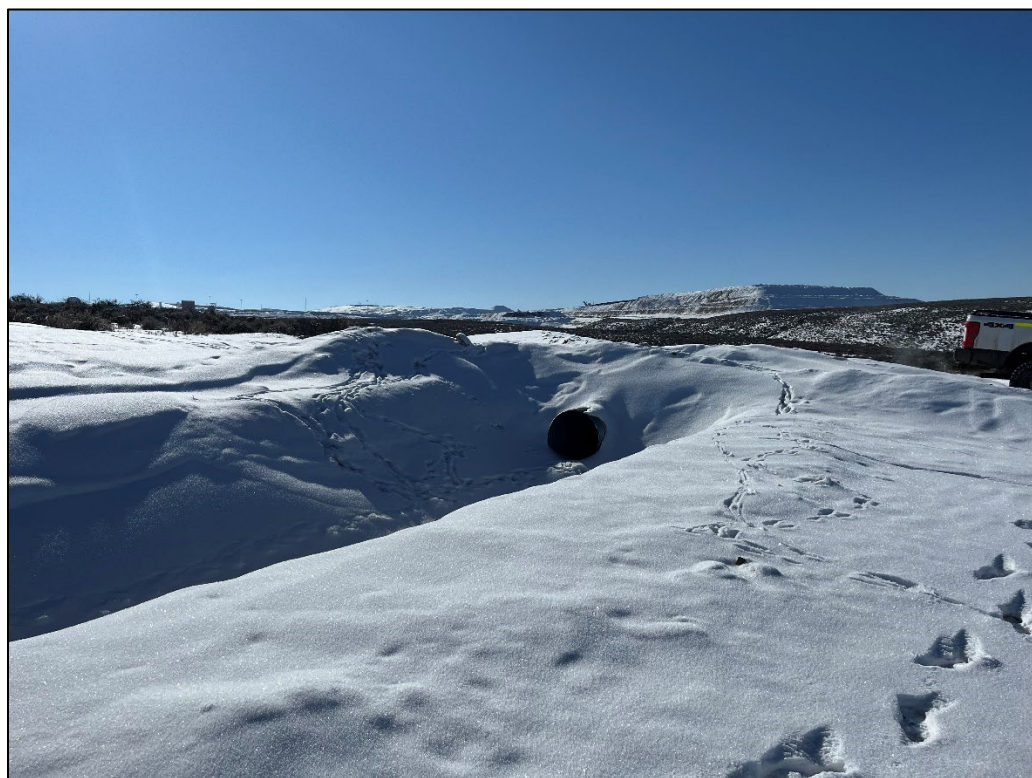
Ditch C-14 (Photo 6) was inspected on foot during this inspection. C-14 part of a series of ditches built along the Collom Haul Road and into the northern Collom pit area. This disturbance was approved by the Division under TR-160 in November of 2023. These channels manage stormwater runoff from the Collom Haul Road.

Photo 6: View southwest of ditch C-14.

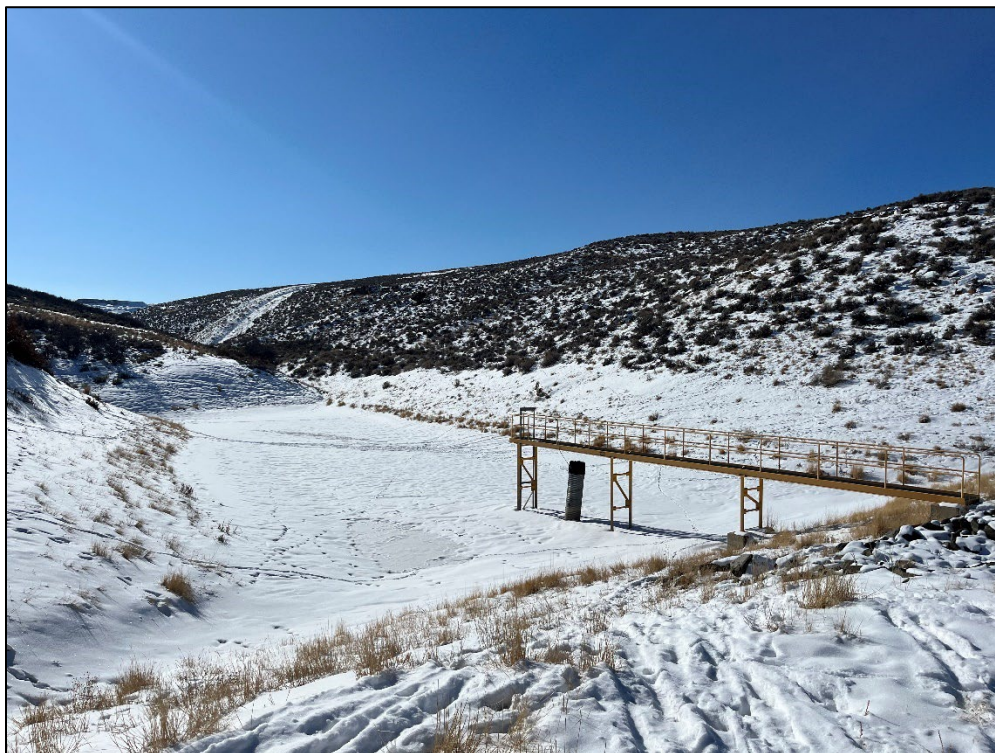
Photo 7: View of Section 25 Pond.

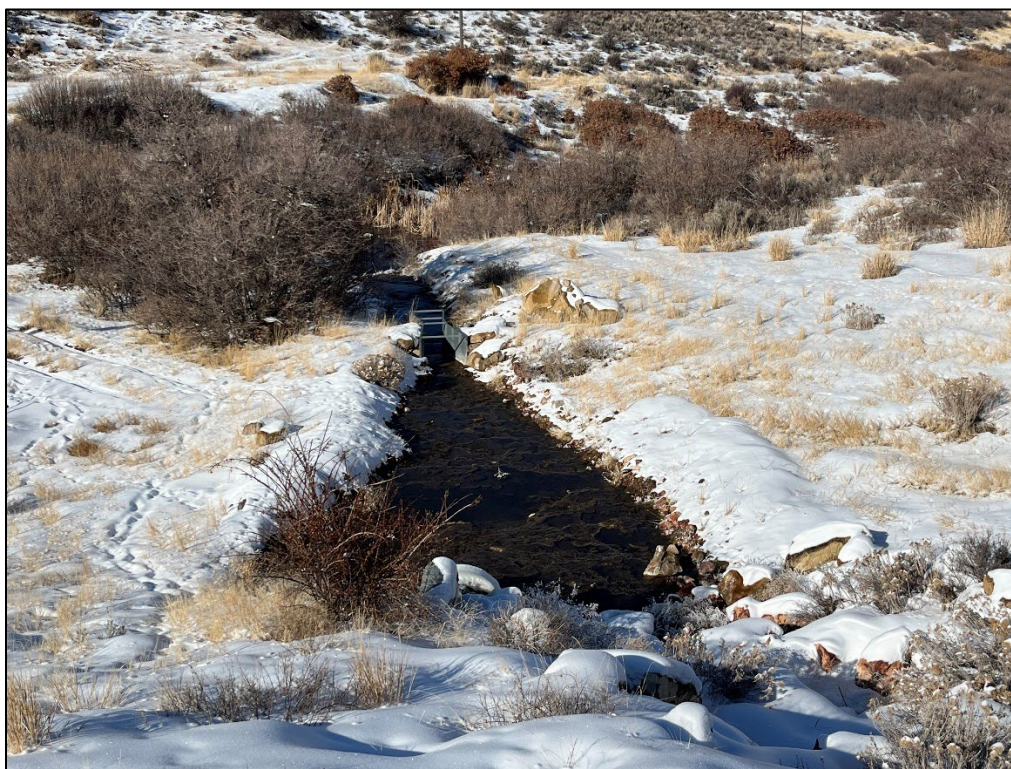
Photo 8: View north of discharge area and flume for East Taylor Pond.

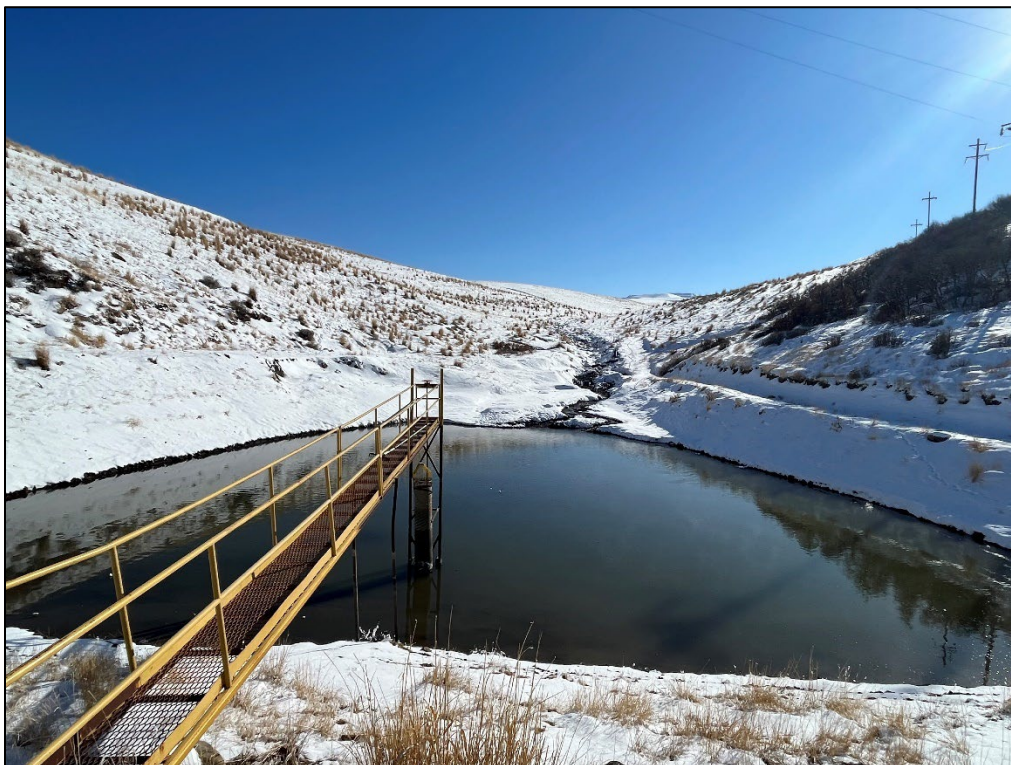
Photo 9: View south of East Taylor Pond.

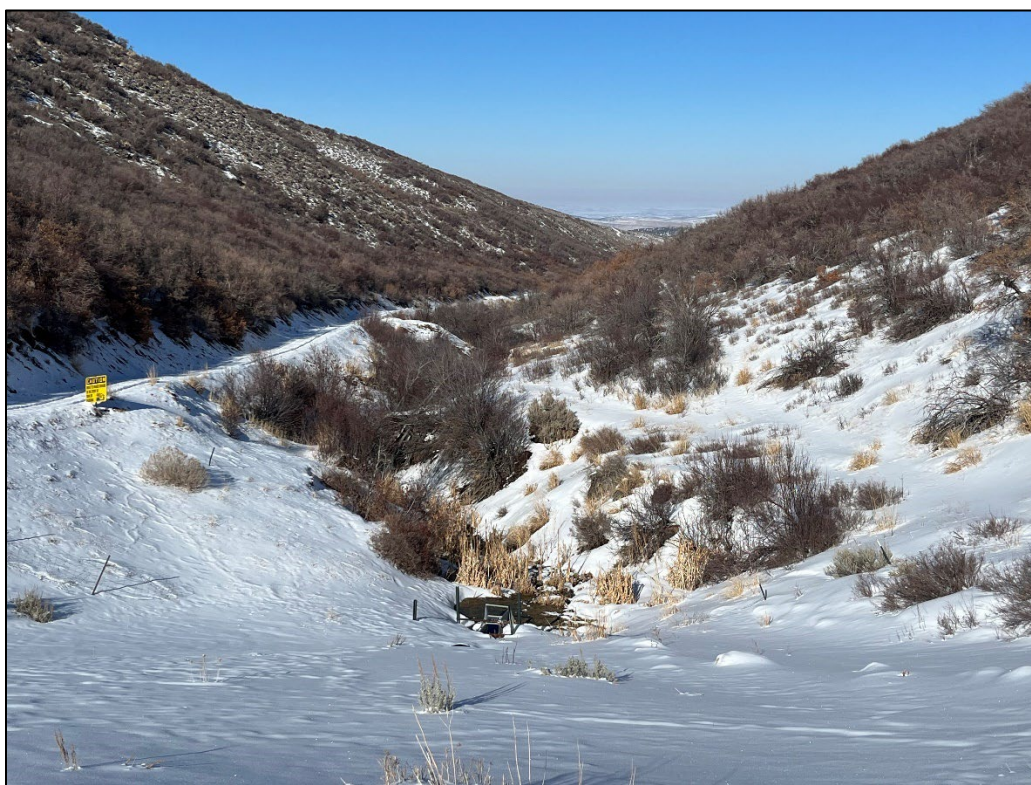
Backfill operations were observed in the eastern cut area in Collom Pit (Photo 10 and 16).

Photo 10: View north of the discharge point for West Taylor Pond.

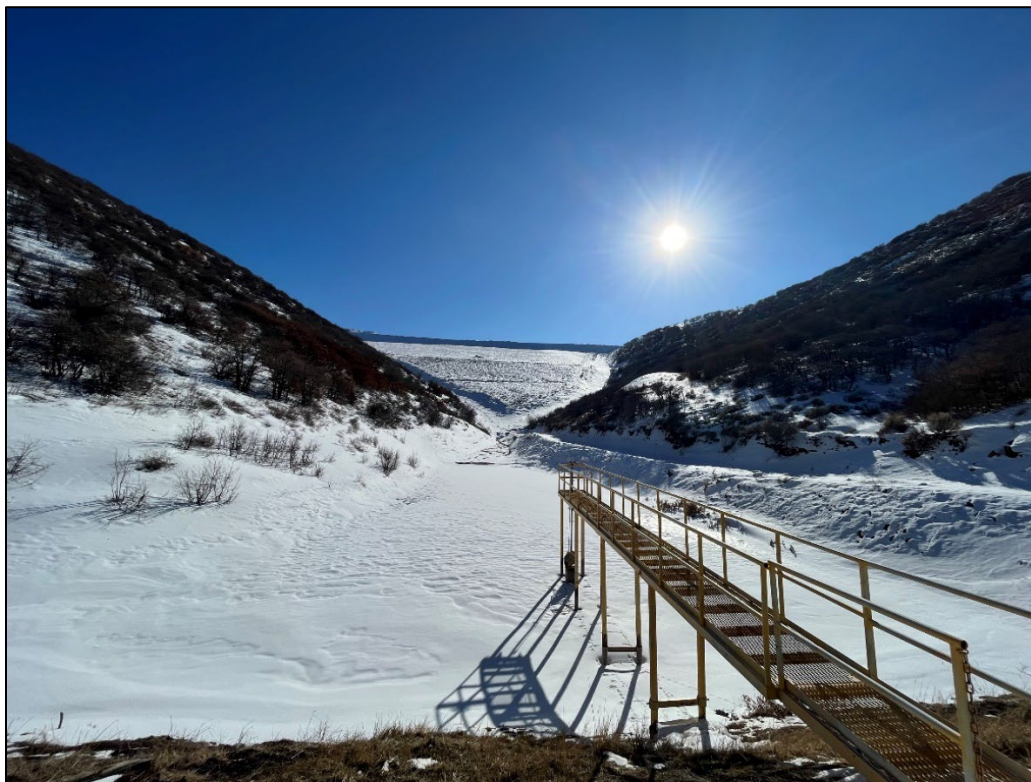
The West Taylor Valley Fill area was inspected from below at the West Taylor Pond (Photo 11). No erosional issues were noted. The pond was partially frozen, but appeared to be discharging. The face of the valley fill is well covered with vegetation which is visible through the snow. No seeps were noted along the face of the fill.

Ponds along Taylor Creek were accessible via a 4x4 offroad vehicle. West Taylor Pond (Photo 11) and its discharge point were inspected this month as part of the observance of the West Taylor Valley Fill. West Taylor Pond was holding water but was partially frozen over. Water was heard trickling down the discharge pipe (Photo 10). The West Pit Pond (Photo 12) and East Taylor Pond (Photo 9) were also inspected. Embankments were stable for all ponds and inlets and outlets remained free of obstruction. East Taylor Pond was the only pond not partially or entirely frozen over on site. Overall, no issues were noted for any of the ponds along Taylor Creek.

Photo 11: View south of the West Taylor Pond & West Taylor Valley Fill.

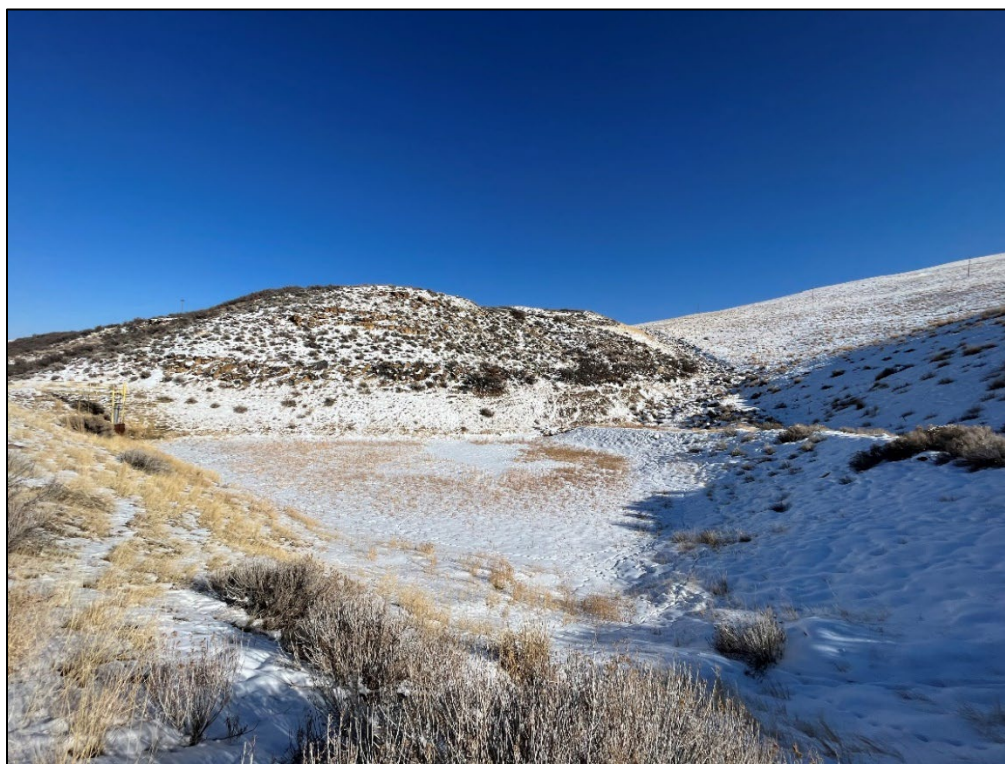
Photo 12: View east of the West Pit Pond.

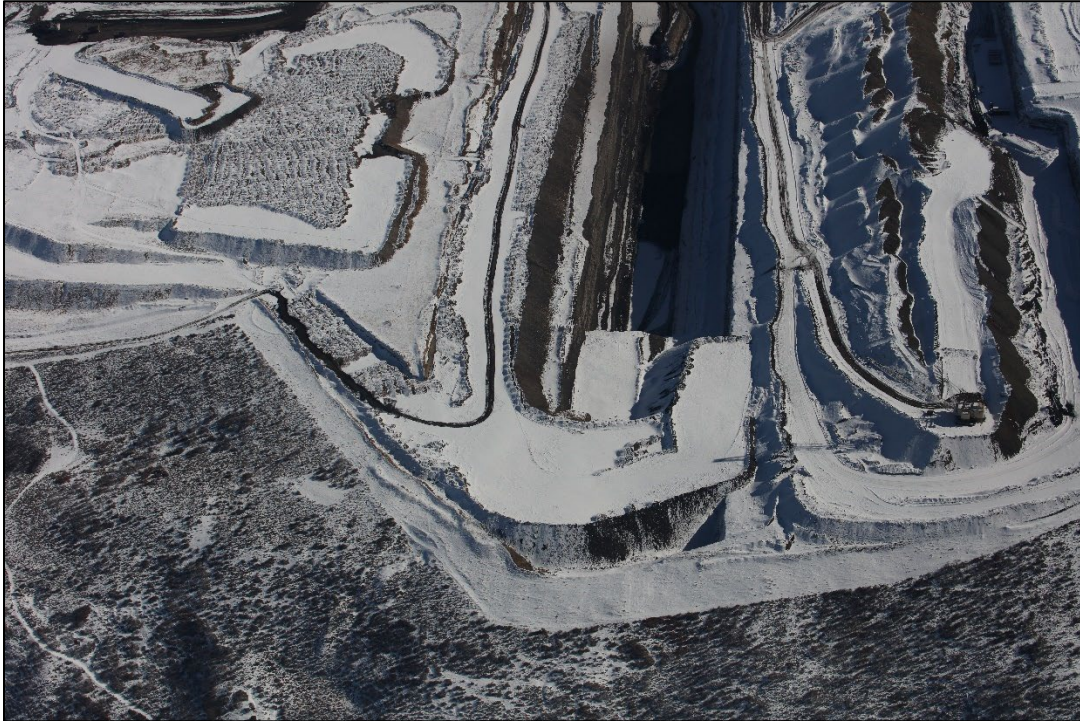
Certified Haul Roads A and B were plowed, navigable and in good condition. In pit roads were also easily navigable, though several of these were being regraded at the time of inspection in Collom Pit (Photo 13). This limited the Division's access to the western side of Collom Pit.

Photo 13: View of the access road to the western side of Collom Pit which was undergoing regrading at the time of inspection.

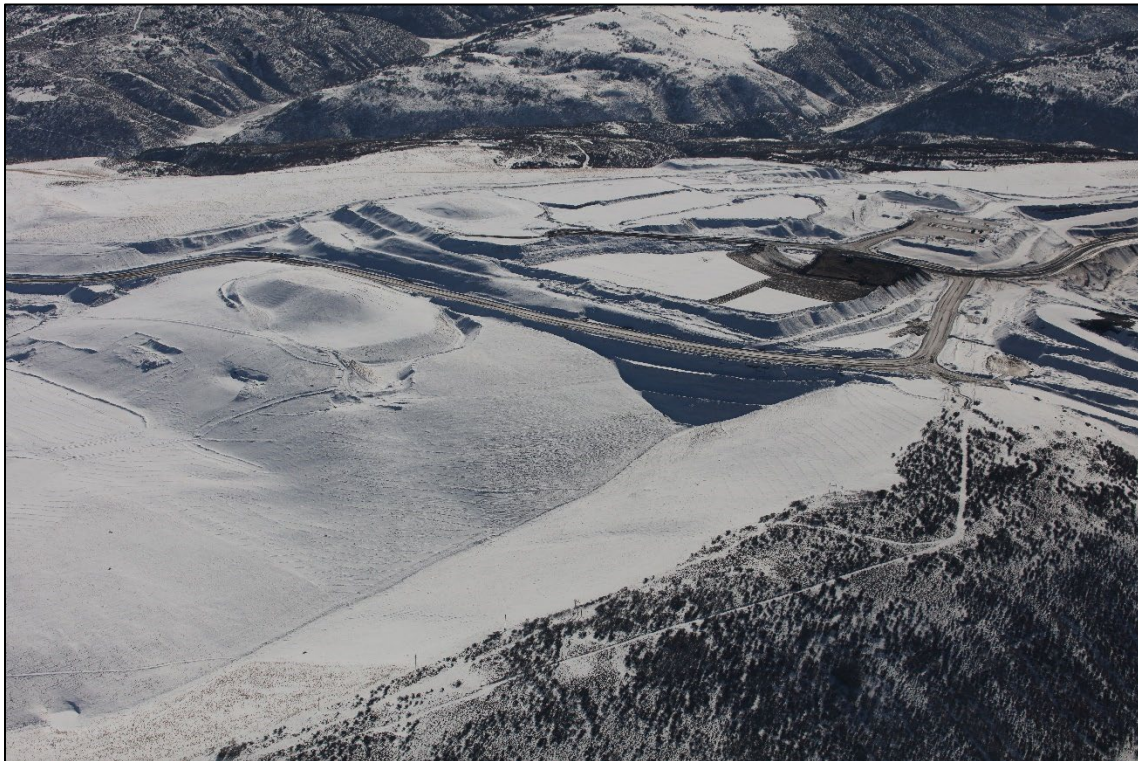
Ditches and stock ponds in the West Pit which were not accessed by the Division at the last inspection were able to be viewed from above via aerial photography (Photo 14). These features appeared stable and free of issues.

Photo 14: View of West Pit stock pond TD2, Taylor Ditch, and South Taylor Pit.

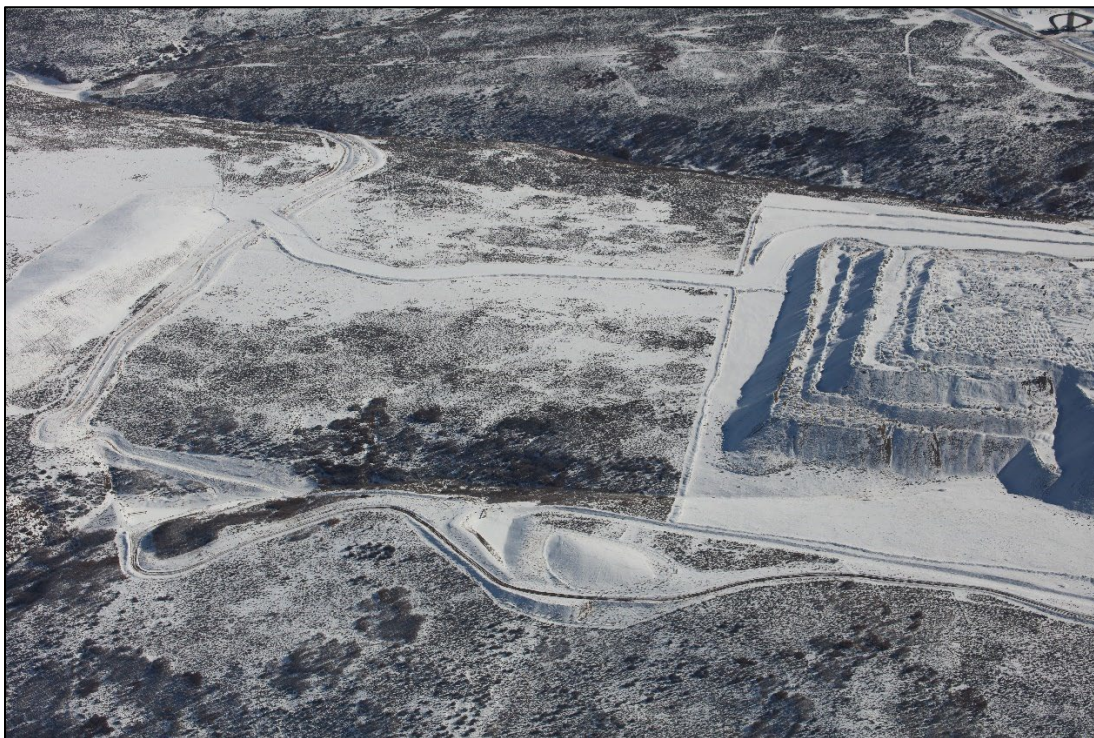
Construction and regrade of the Collom Temporary Spoil Pile continues. A shovel was noted to have been active on the spoil pile. The spoil stockpile area in Collom Pit is encompassed by a berm to ensure spoil is contained within the approved disturbance boundary of the pile (Photo 15).

The small slump areas on the east and southwest sides of Section 26 Pond were not able to be observed on the ground during this inspection but showed no signs of recent slump in the aerial photographs. Colowyo should continue to monitor this area closely for exaggerated signs of movement or degradation, especially during the upcoming snowmelt season.

The following ditches in the Collom Pit area were inspected this month via aerial photography: D-1, D-2, D-3, and D-4 (Photo 15). All channels appeared to be stable with no signs of erosion or undercutting.

Photo 15: Aerial view of the edge of the Collom spoil pile, Sidehill Pond, and Section 26 Pond. Ditches D1-D4 are also visible.

- Monitor the slump area at Section 26 Pond
- Monitor the small erosional feature in D4, repairs will be necessary if conditions worsen

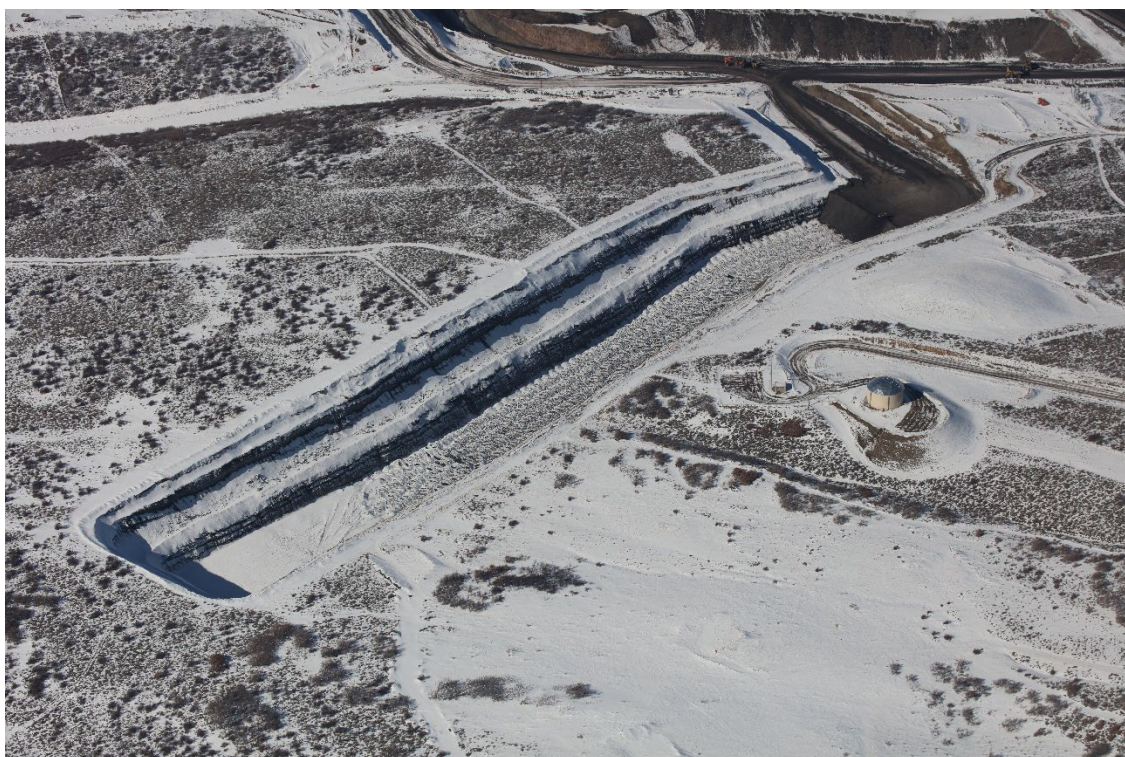
Photo 16: Backfill operations in the eastern area of Collom Pit.
