**MINERALS PROGRAM INSPECTION REPORT**  
**PHONE: (303) 866-3567**

<b>MINE NAME:</b> Pikeview Quarry	<b>MINE/PROSPECTING ID#:</b> M-1977-211	<b>MINERAL:</b> Limestone (general), granite gneiss and do	<b>COUNTY:</b> El Paso
<b>INSPECTION TYPE:</b> Monitoring	<b>WEATHER:</b> Clear	<b>INSP. DATE:</b> January 24, 2025	<b>INSP. TIME:</b> 10:00
<b>OPERATOR:</b> Riverbend Industries Inc.	<b>OPERATOR REPRESENTATIVE:</b> Jerry Schnabel	<b>TYPE OF OPERATION:</b> 112c - Construction Regular Operation	
<b>REASON FOR INSPECTION:</b> Normal I&E Program	<b>BOND CALCULATION TYPE:</b> None	<b>BOND AMOUNT:</b> \$6,805,607.00	
<b>DATE OF COMPLAINT:</b> NA	<b>POST INSP. CONTACTS:</b> None	<b>JOINT INSP. AGENCY:</b> None	
<b>INSPECTOR(S):</b> Hunter Ridley Ursula Armstrong	<b>INSPECTOR'S SIGNATURE:</b>

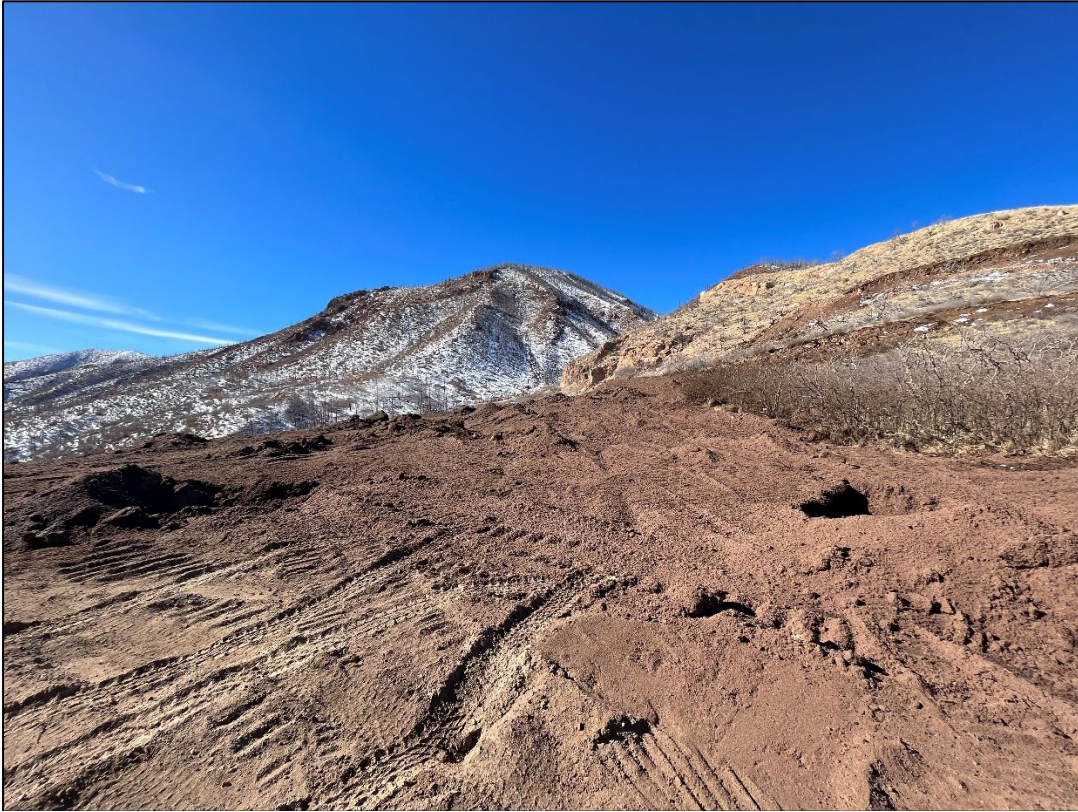
**Roads:** The site continues its work in obliterating all roads on Forest Service property, as requested by the Forest Service (Photo 1). The Forest Service has altered the heavily pocketed design of the road obliteration slightly, opting for fewer depressions in the landscape while maintaining 'pockets' here and there. This design both discourages the use of this slope as a navigable path, and creates small areas for water to collect, creating microclimates and more diverse vegetation establishment over time. Topsoil from nearby is currently being used to facilitate this road obliteration. Each portion of the road is approved by the Forest Service as Pikeview works on obliteration down the slope.

**Photo 1: Road obliteration continues on the southern, USFS area of the property.**

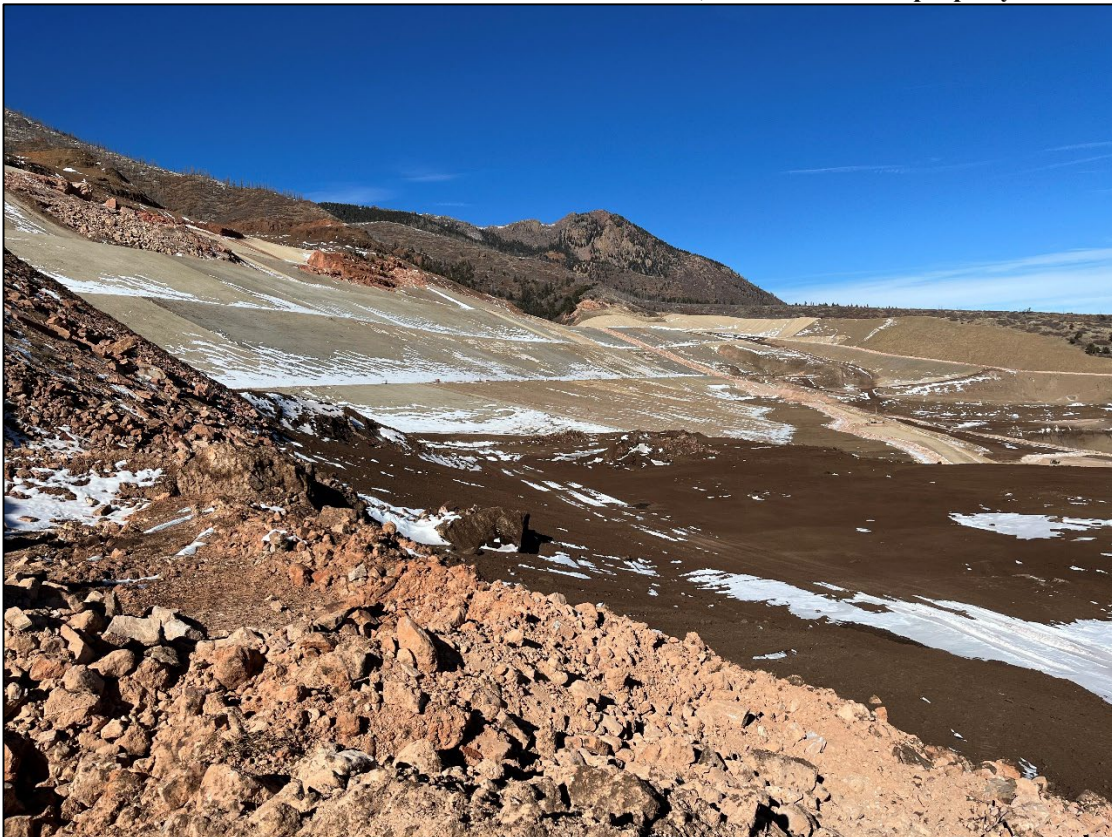
The final two tie in areas, at the Dragon's Back and lower bench area, have received final rip rap placement (Photos 3 & 4). The south borrow area is no longer being used to source rip rap material. In this area, the size of the bench has been reduced by backfilling with topsoil material, leaving a stable, talus slope above (Photo 2). The bench and topsoiled slope have been seeded with hydro mulch. A large rock outcrop remains in this benched area of Forest Service property to enhance the natural look of the slope face, similar to how the large rock and Kiewit Cliffs have been left on the buttress slope.

**Photo 2: View northwest of the graded and seeded bench in the South Borrow / South Quarry area. A talus slope remains**

**above the back sloped topsoil to the south.**

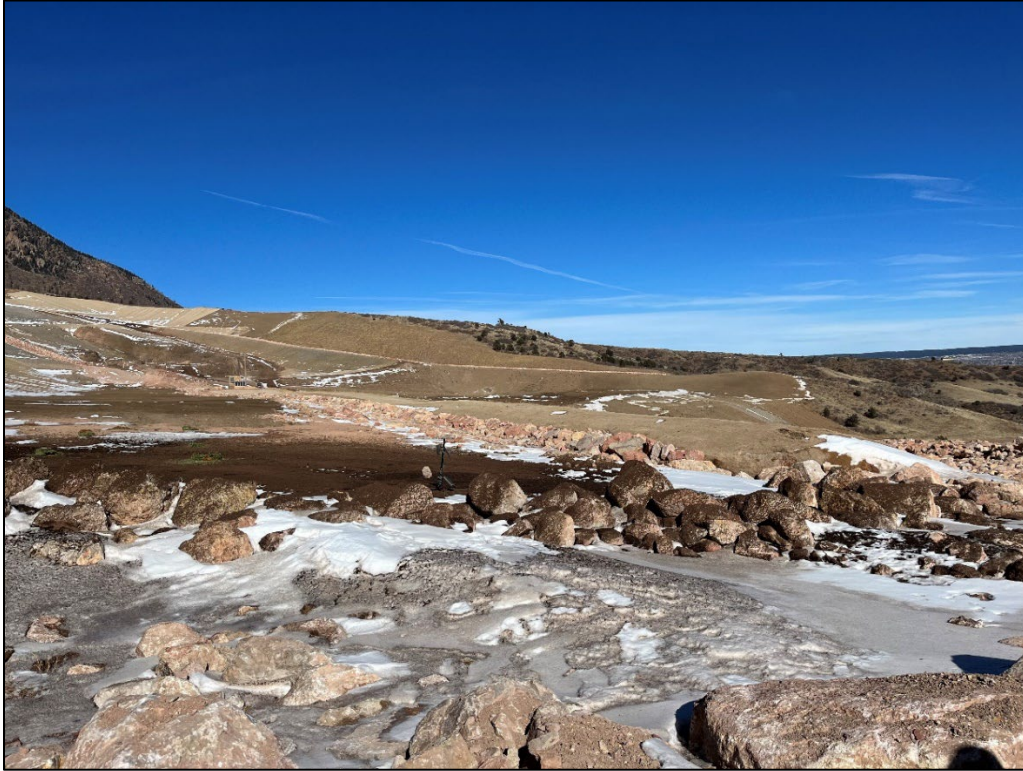
Wildlife has been active on site, tracking the heard and occasionally tagging several rams for research and management. A small camera has been set up on the lower slopes of the buttress in support (Photo 3).

**Photo 3: The tie in area just above the Leica prism level bench. A camera has been set up by CPW for use in tracking and tagging Bighorns.**

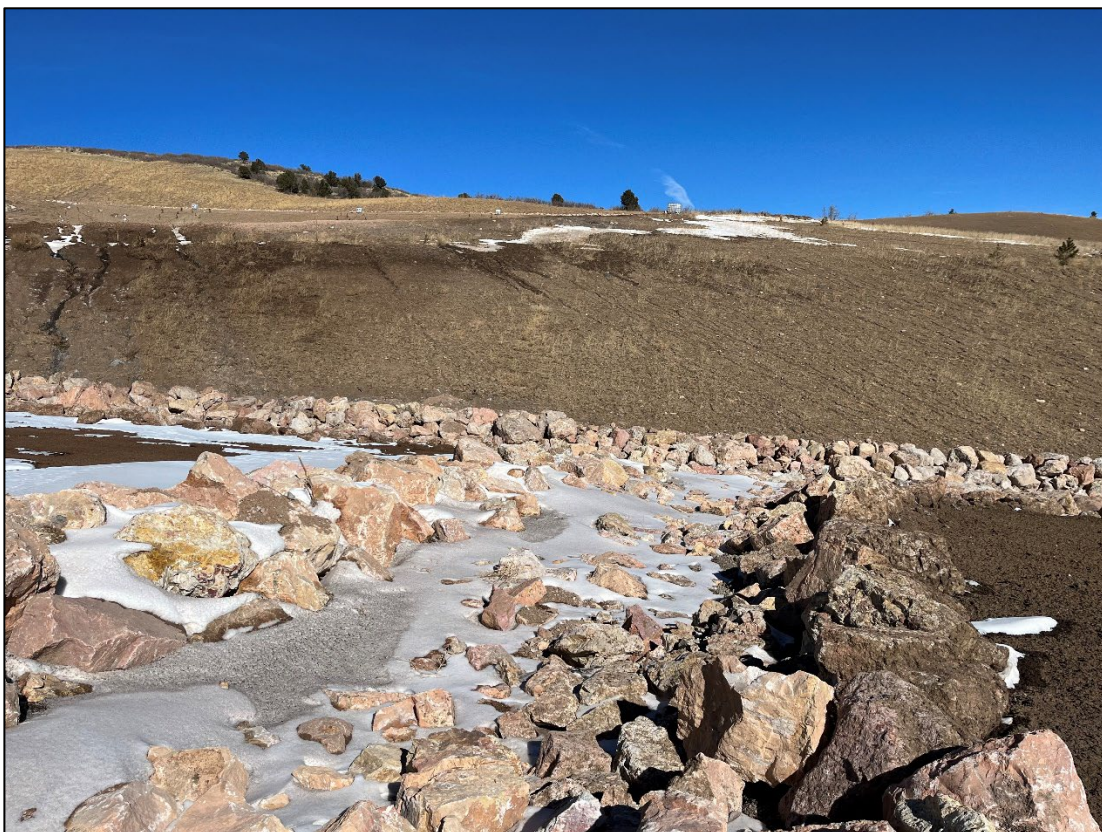
**Photo 4: The tie in area at the lower bench and North Channel.**

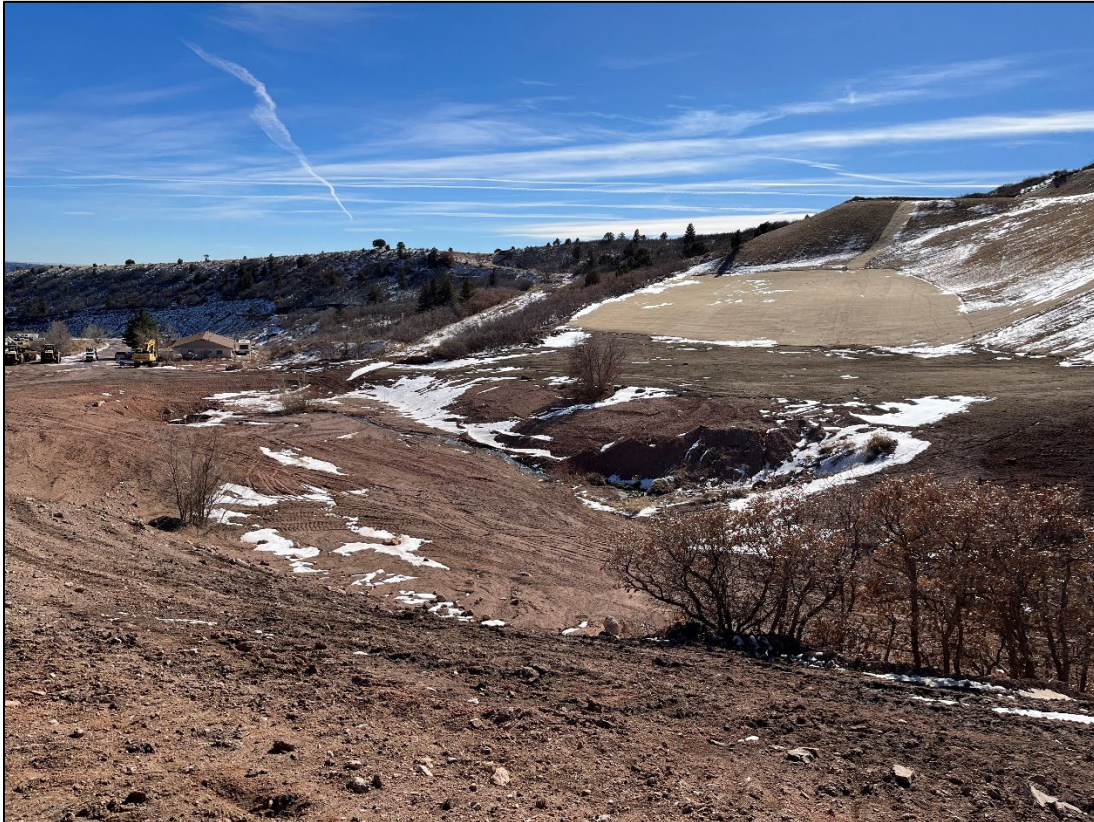
**Hydrologic Balance & Sediment Control:** The large culvert area at the eastern end of the site was noted to be diverting water successfully under the buttress as designed. Water is flowing consistently towards the eastern edge of the permit and into the adjacent open space, following natural waterways. Lay back of the western slope in this culvert area has been completed, reducing the slope grade to an ~ 2:1 – 3:1 slope (Photos 6 and 7). The Division, the site, and the City discussed plans for the installation of safety signs near the large stan pipes (Photo 5) in this area to discourage public access after the permit is released.

**Photo 5: View of the office area and drainage area for the buttress underdrains.**

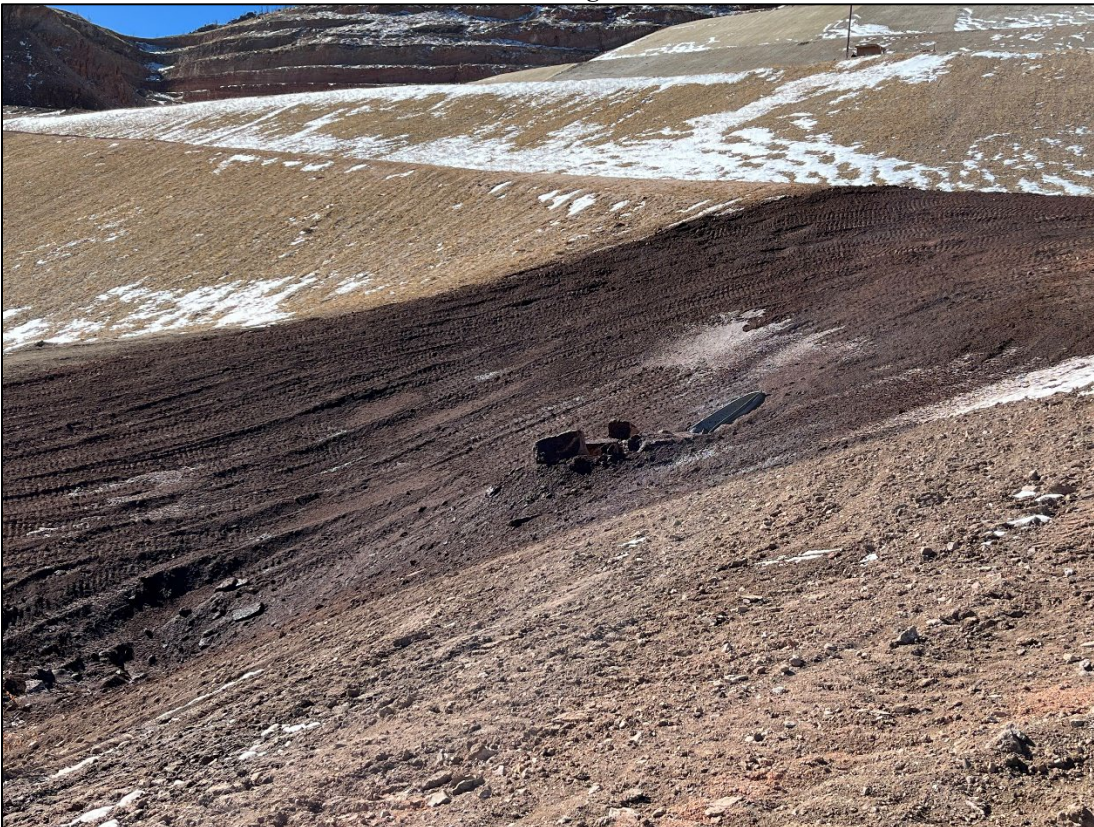
**Photo 6: The culvert area below the buttress has been extended and graded to a 2:1 / 3:1 slope.**

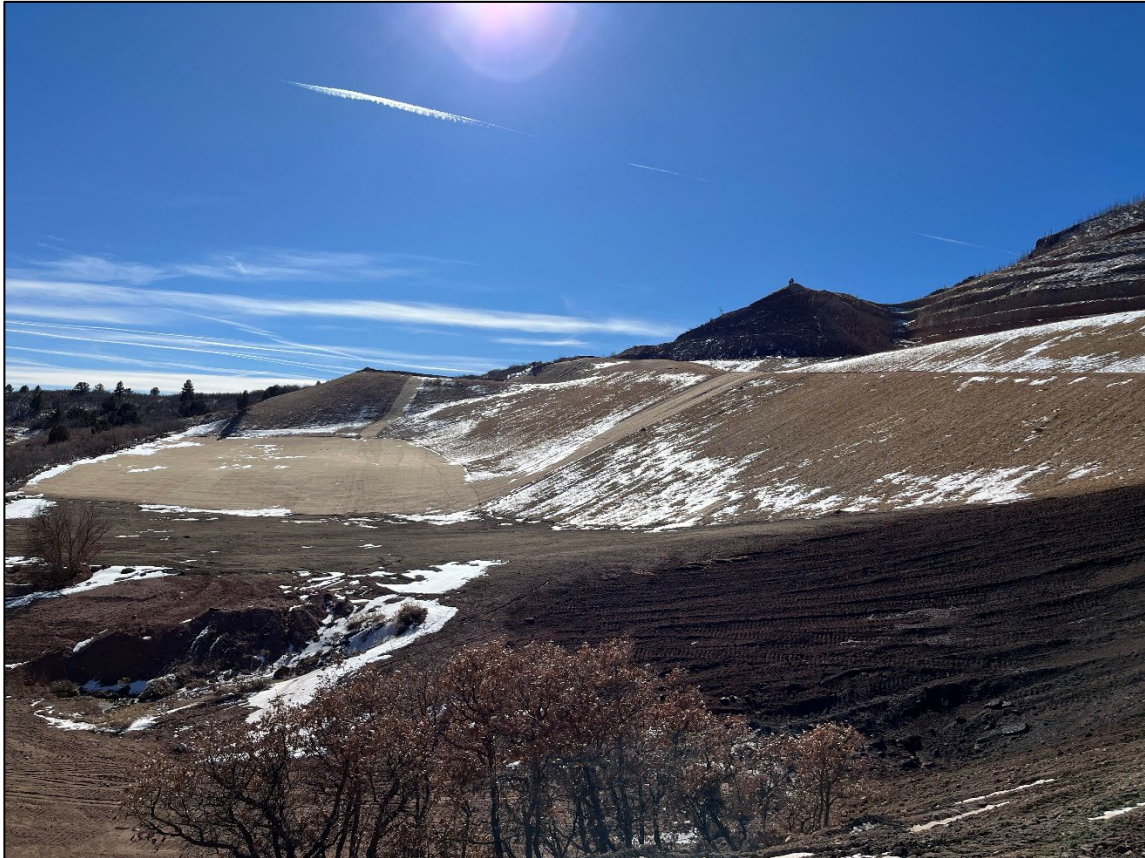
**Photo 7: View of the south borrow area and laid back eastern culvert area below the buttress.**
