Inspection Reports Jan 2025

Please find DRMS's Jan 2025 inspection reports for Williams Fork Seneca IIW and Yoast Mines. These were aerial inspections.

Division of Reclamation,
Mining and Safety

| Permit Number: C-1982-057 Mine Name: Seneca IIW Mine Operator: Seneca Property LLC Operator Address: Ms. Miranda Kawcak 29515 Routt County Road 27 Oak Creek, CO 80467 | County: Routt Operation Type: Surface Permit Status: Permanent Cessation Ownership: Private |

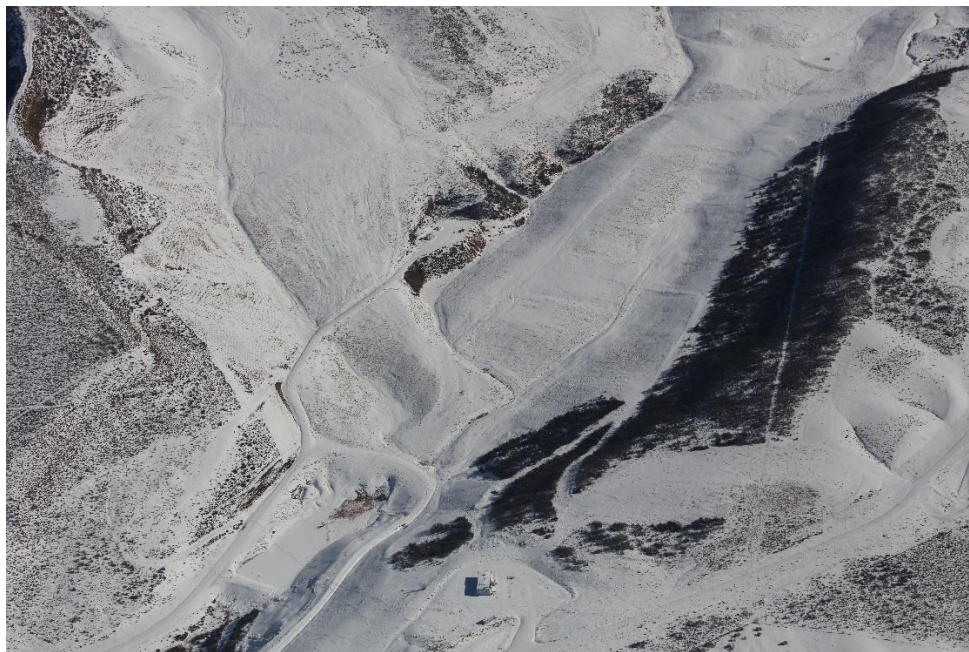
Pond banks appeared stable and vegetated. Dams appeared stable and vegetated with no signs of seepage.

No new movement was noted in the imagery between the two slumps and associated crack between them above Pond 6.

Photo 1: Pond 6 and shop above.

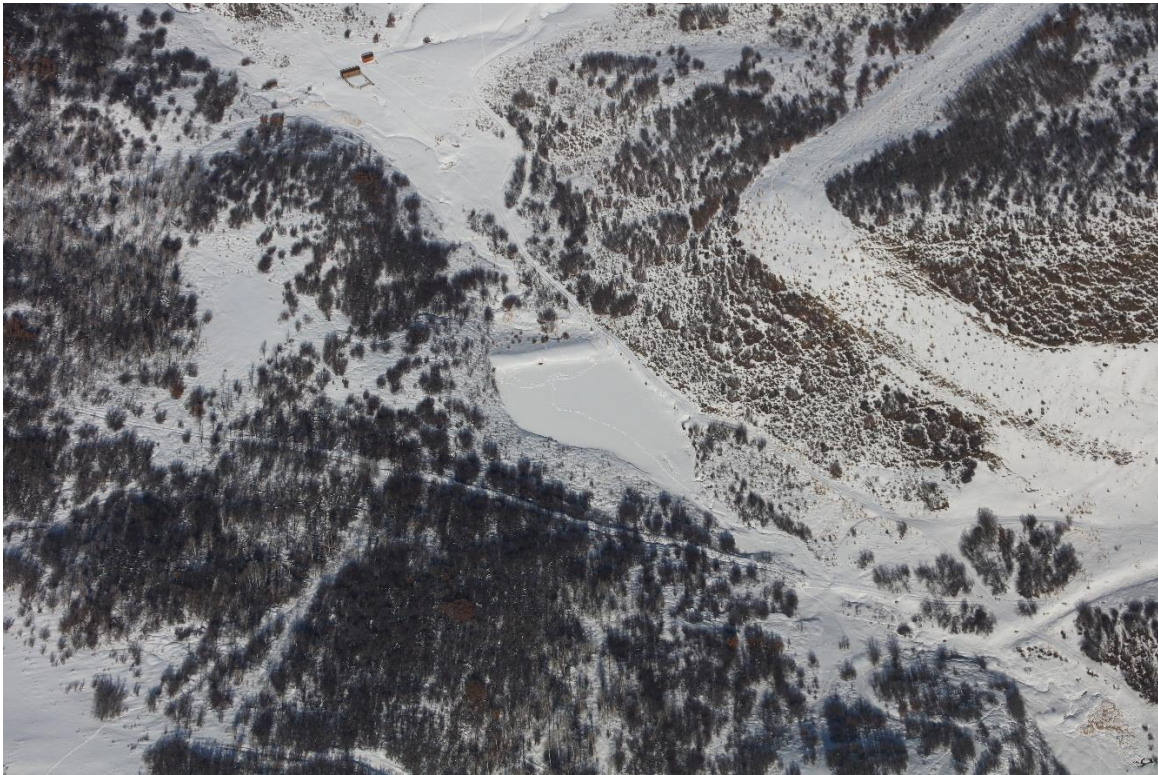
Photo 2: Pond 17.

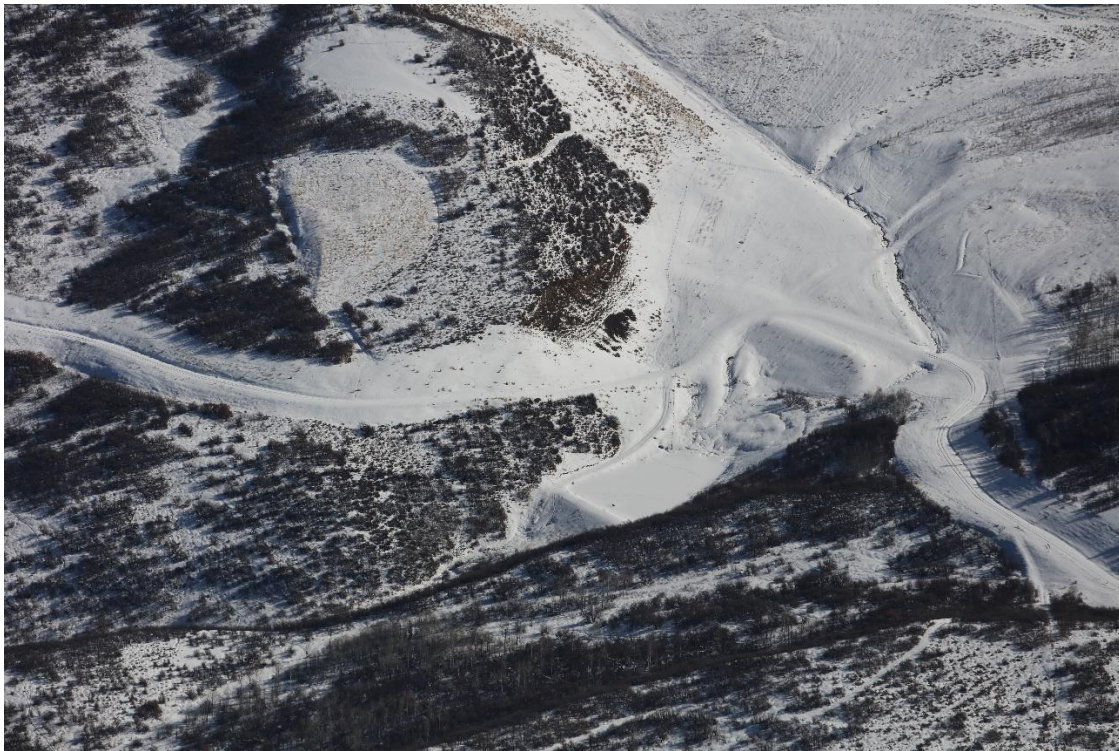
Photo 3: Pond 16 and reclaimed slopes.

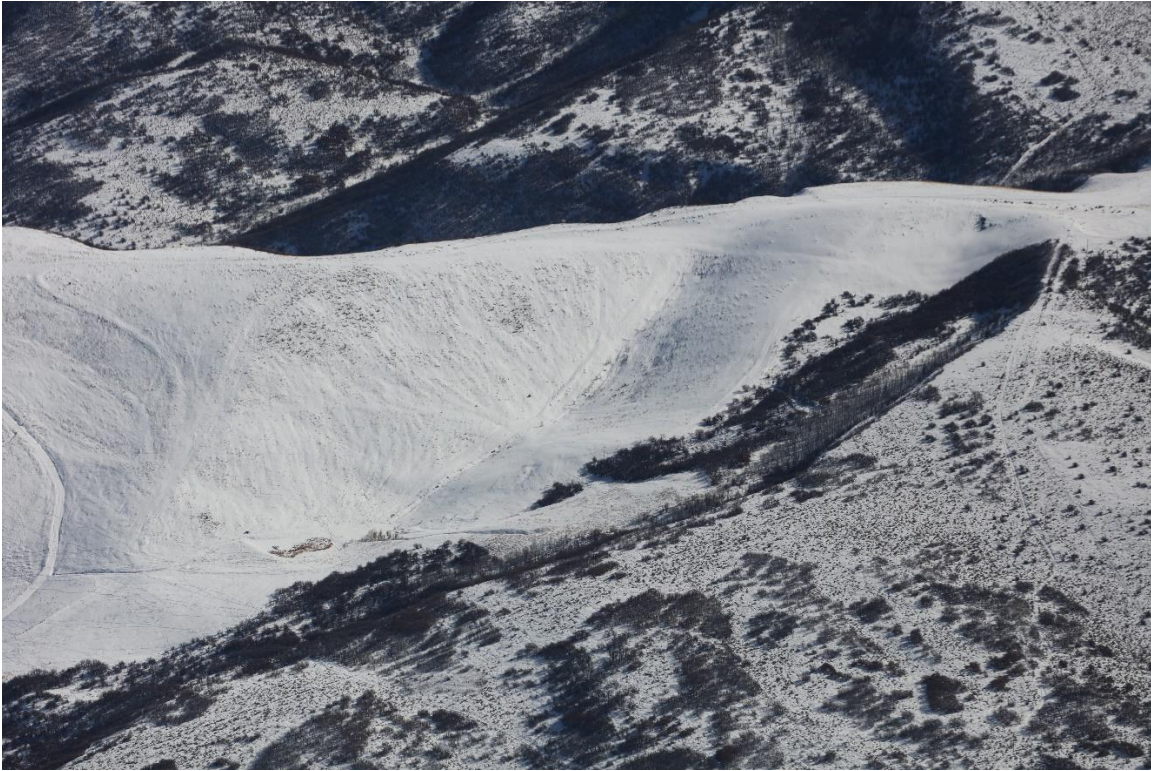
- Revegetated areas of reclamation were snow covered and appeared stable in the imagery.

Photo 4: Reclaimed slopes.

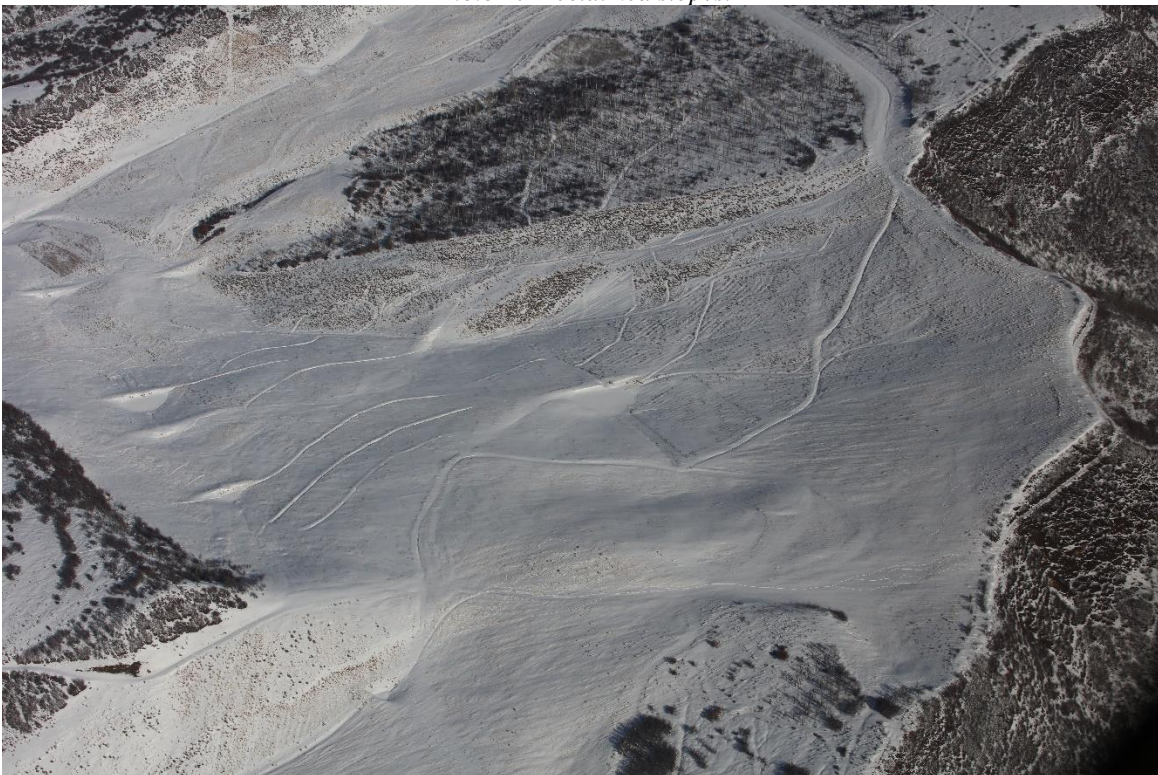
- Ditches throughout the site and along haul roads appeared to be functioning adequately. All ditches were snow covered at the time of inspection.
- All ponds, Pond 6, Pond 16, Pond 17 appeared frozen, and snow covered.

Photo 5: Reclaimed slopes and ditch network.

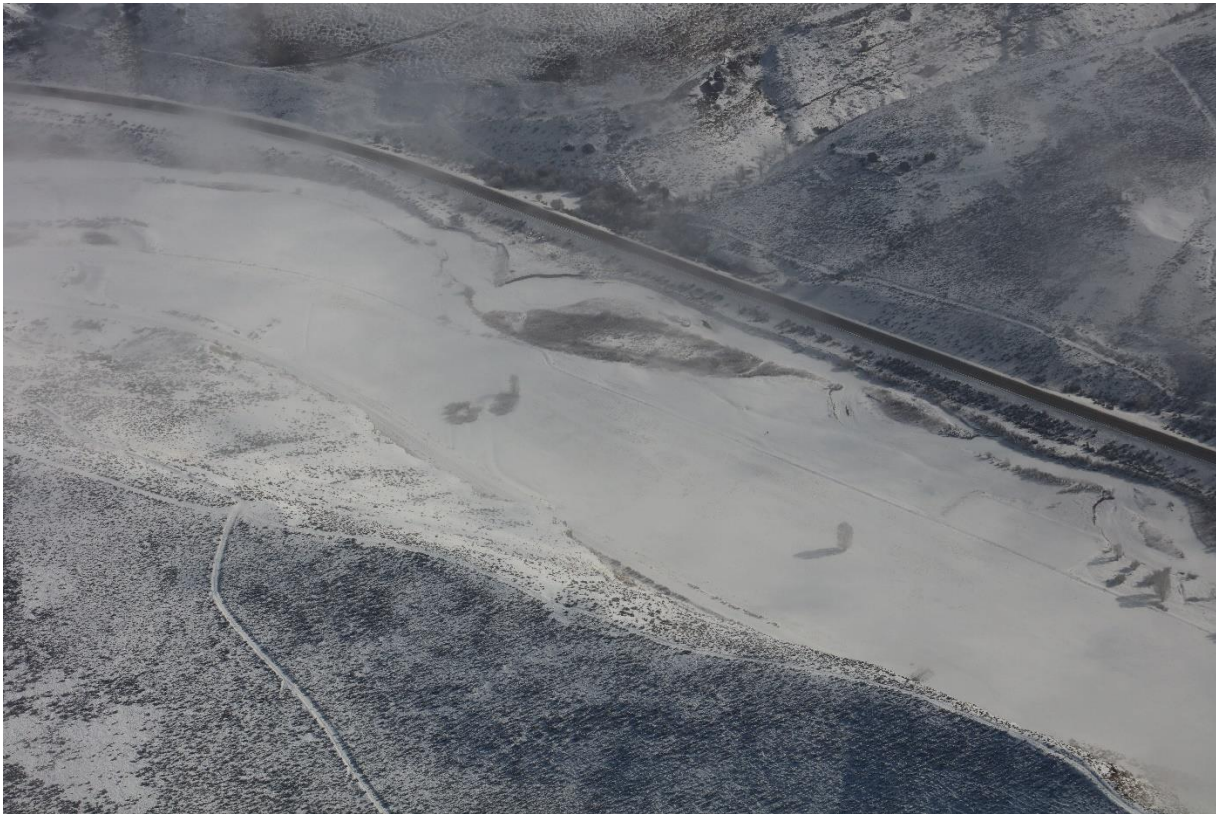
Photo 1: Williams Fork River bottom lands.

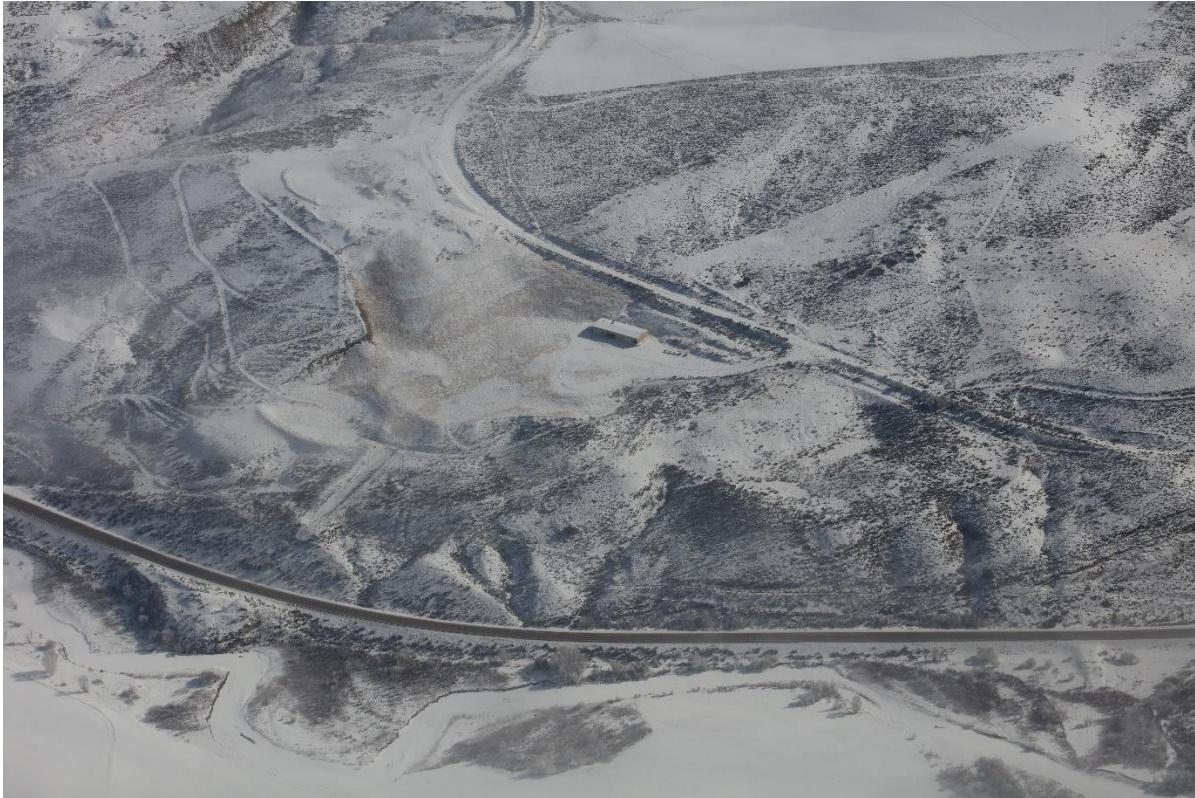
Photo 2. Slopes at the 5A portal.

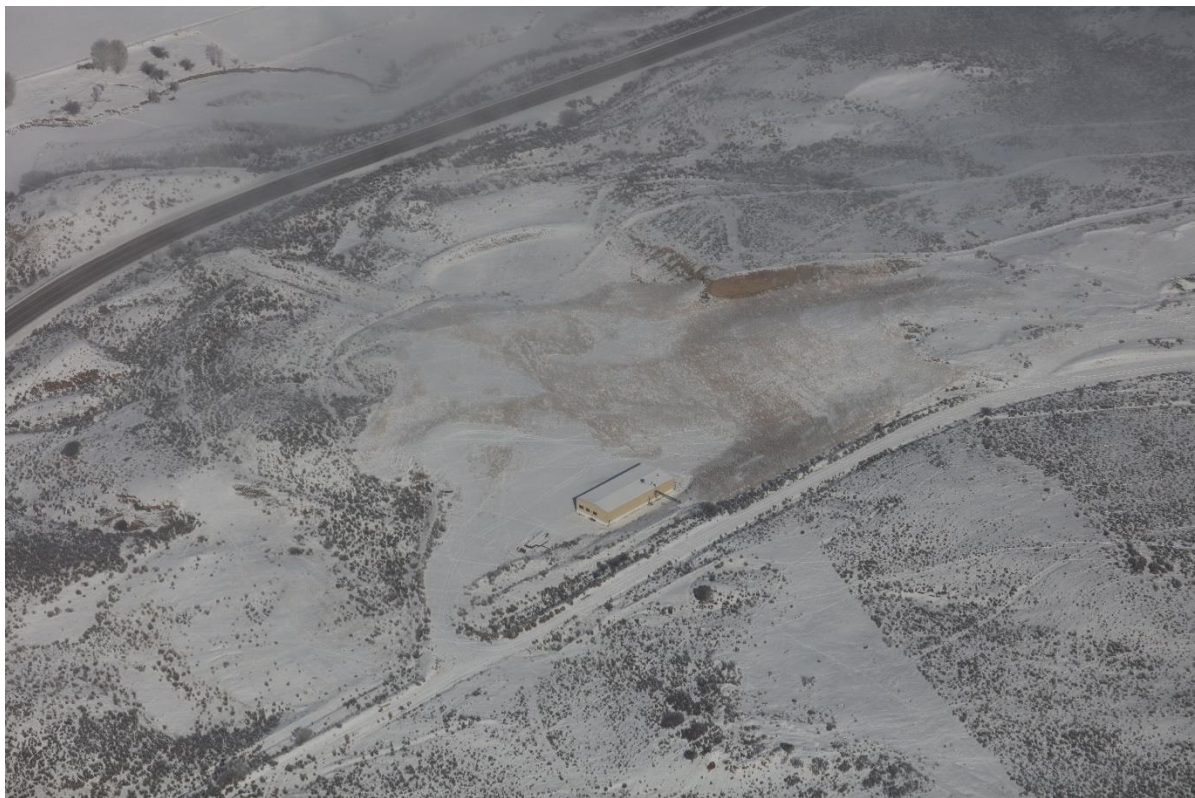
Photo 3. 5A Portal and warehouse building.

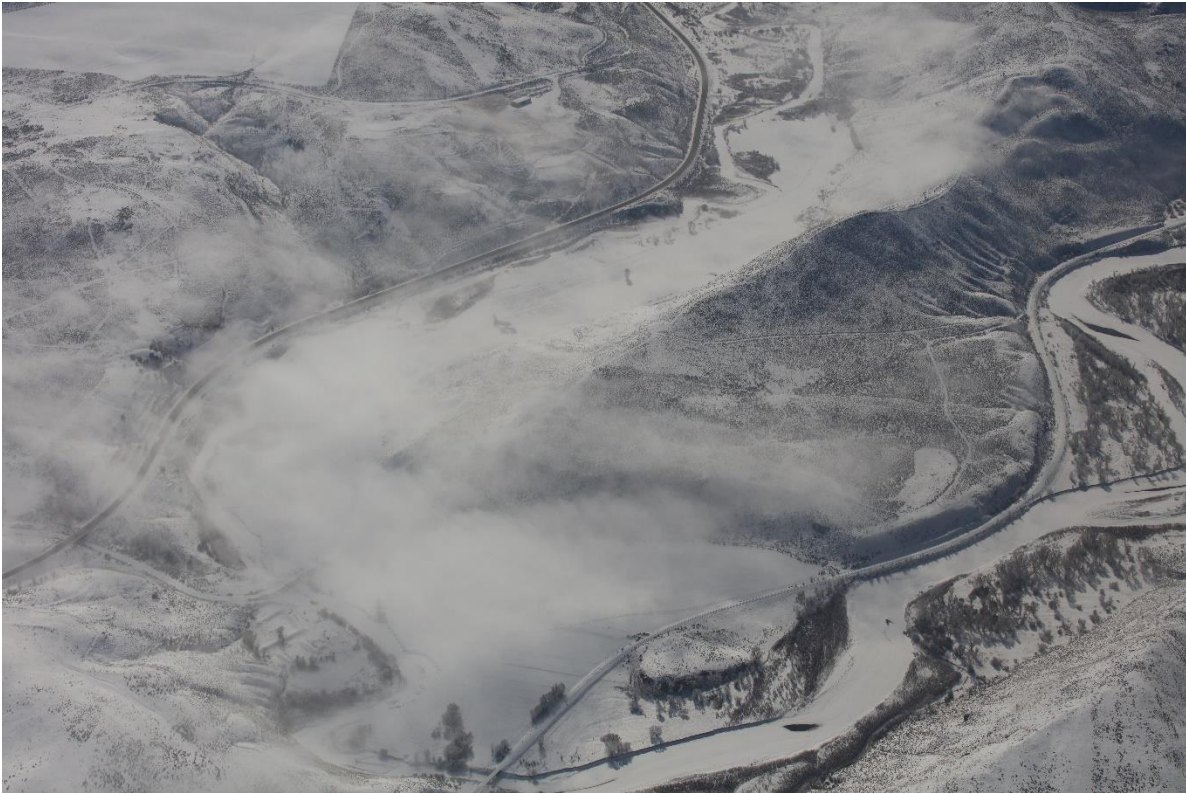
***Photo 4.** Williams Fork River.*

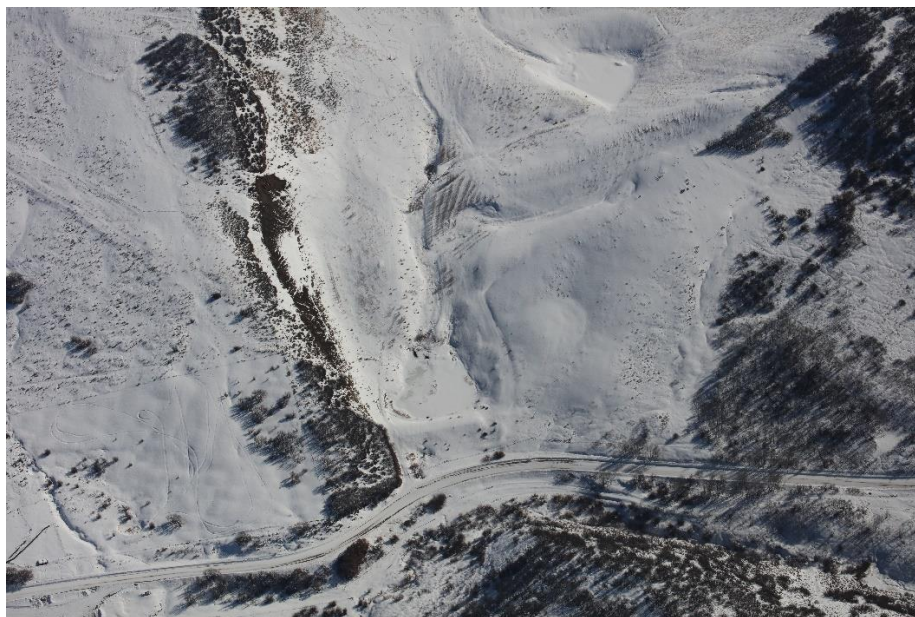
Photo 1: Pond 12 on County Road 37.

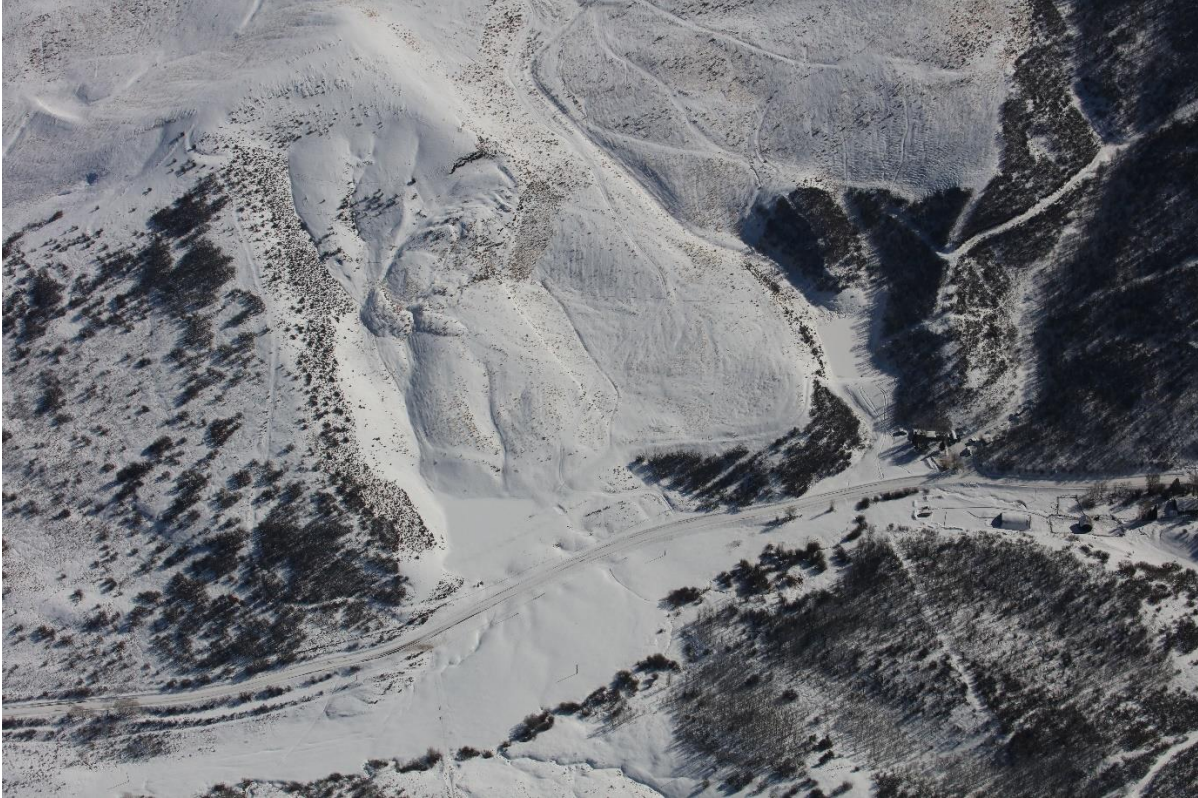
Photo 2: Ponds 13 and 14 on County Road 37 with spring fed slump above pond 13.

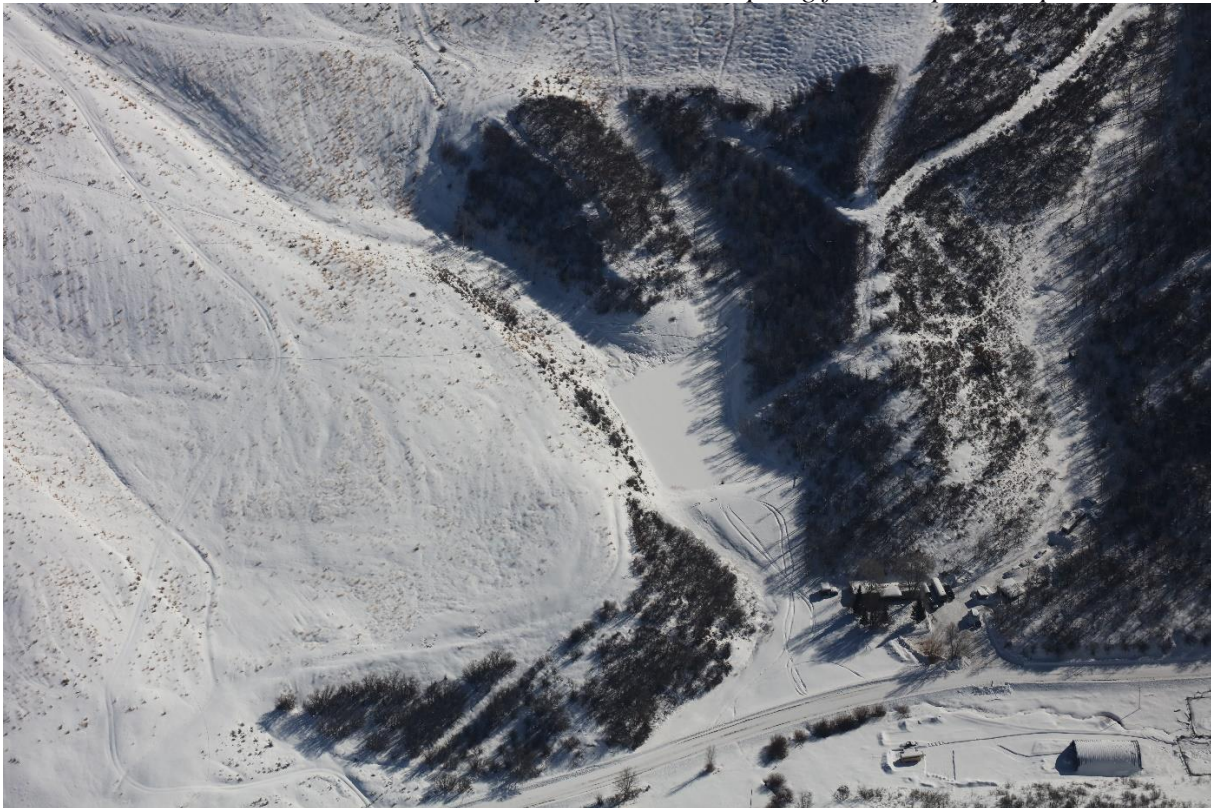
Photo 3: Pond 14 on County Road 37.

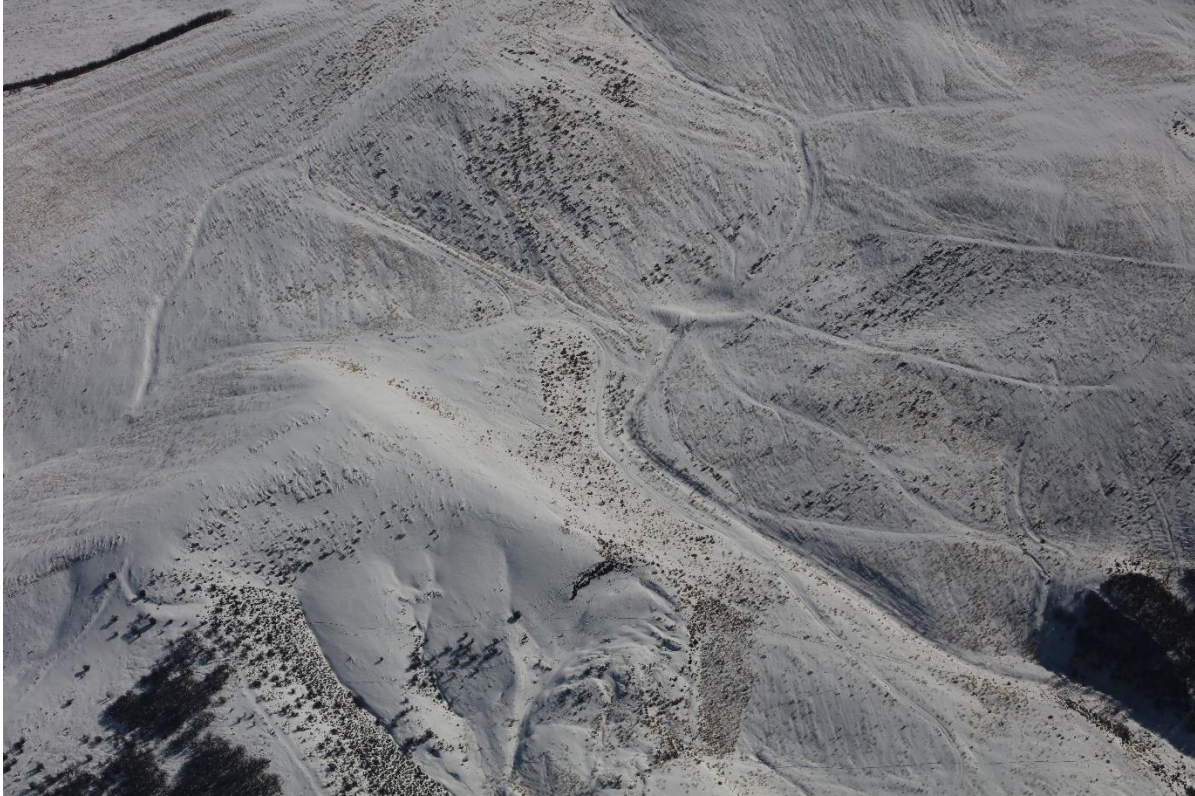
Photo 4: Reclaimed slopes and contour ditches with spring fed slump above pond 13.

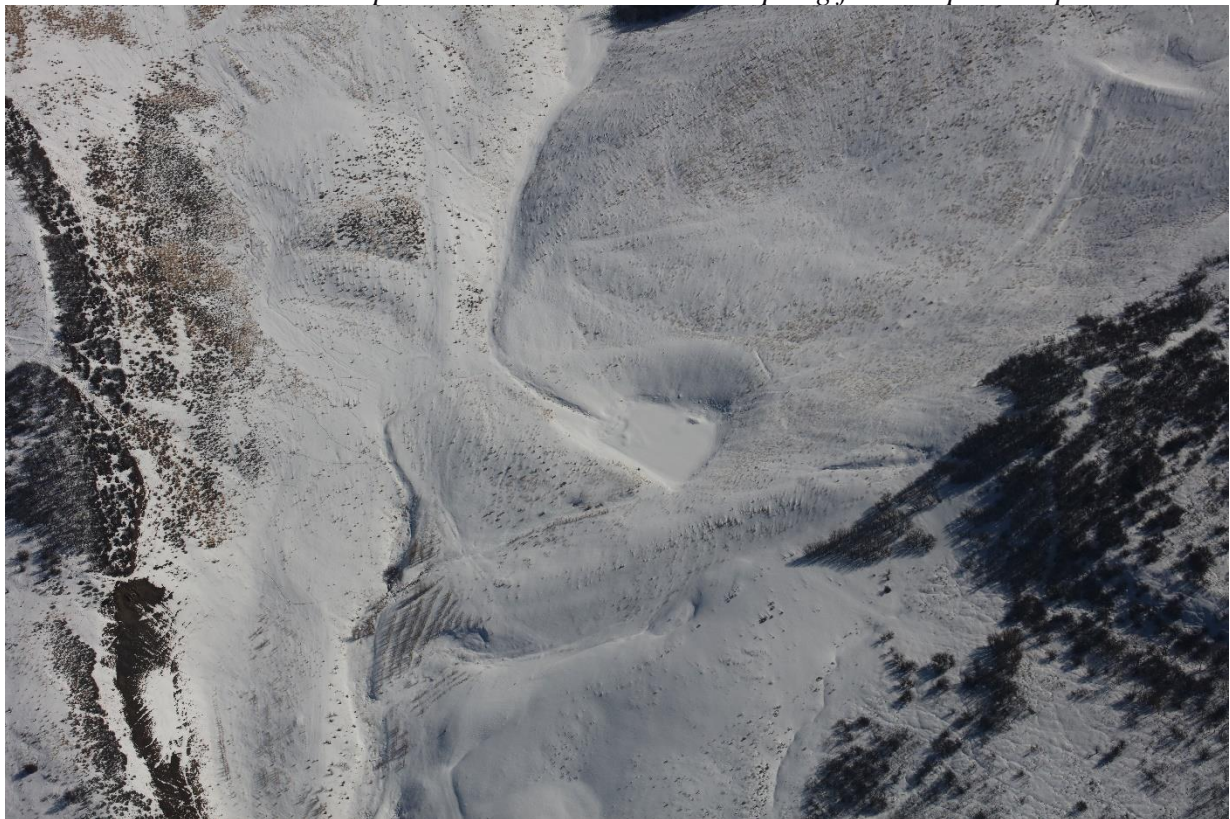
Photo 5: Reclaimed slopes above pond 12.
