## Bowie #1 inspection report

**PERMIT INFORMATION**

<b>Permit Number:</b> C-1981-038 <b>Mine Name:</b> Bowie No. 1 Mine <b>Operator:</b> Bowie Resources, LLC <b>Operator Address:</b> Mr. Basil R Bear P.O. Box 1488 Paonia, CO 81428	<b>County:</b> Delta <b>Operation Type:</b> Underground <b>Permit Status:</b> Active <b>Ownership:</b> Private
	<b>Operator Representative Present:</b>  None
<b>Operator Representative Signature: (Field Issuance Only)</b>

<b>Inspection Start Date:</b> January 30, 2025 <b>Inspection Start Time:</b> 10:35 <b>Inspection End Date:</b> January 30, 2025 <b>Inspection End Time:</b> 11:45		<b>Inspection Type:</b> Coal Partial Inspection <b>Inspection Reason:</b> Normal I&E Program <b>Weather:</b> Clear	
<b>Joint Inspection Agency:</b>  None		<b>Joint Inspection Contacts:</b>  	
<b>Post Inspection Agency:</b>  None		<b>Post Inspection Contacts:</b>  	
<b>Inspector(s):</b>  Robert Zuber, P.E.	<b>Inspector's Signature:</b>

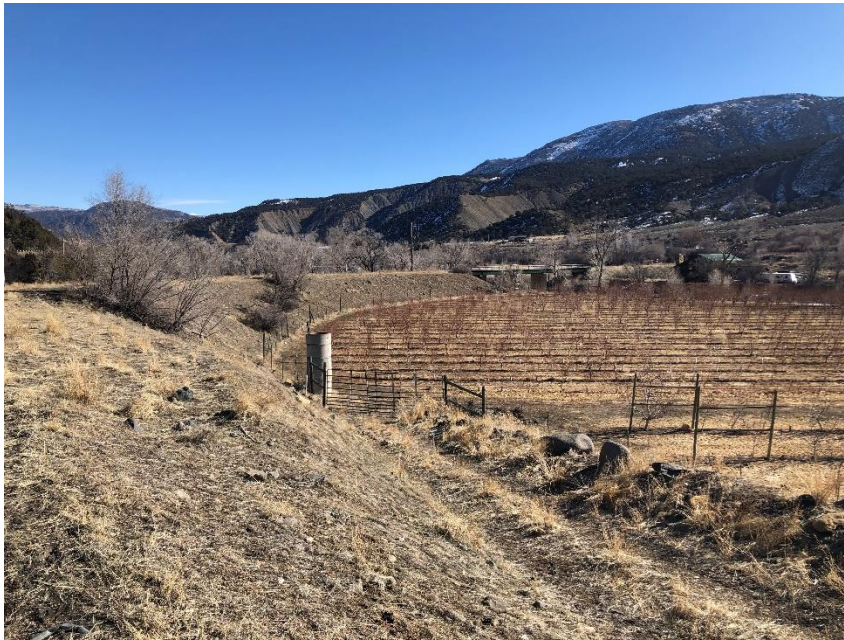
No erosion was seen at the loadout, including the steep slope between the loadout and the orchard below. The trestle across the river appears stable.

**Slope below the loadout – looking towards the bridge**

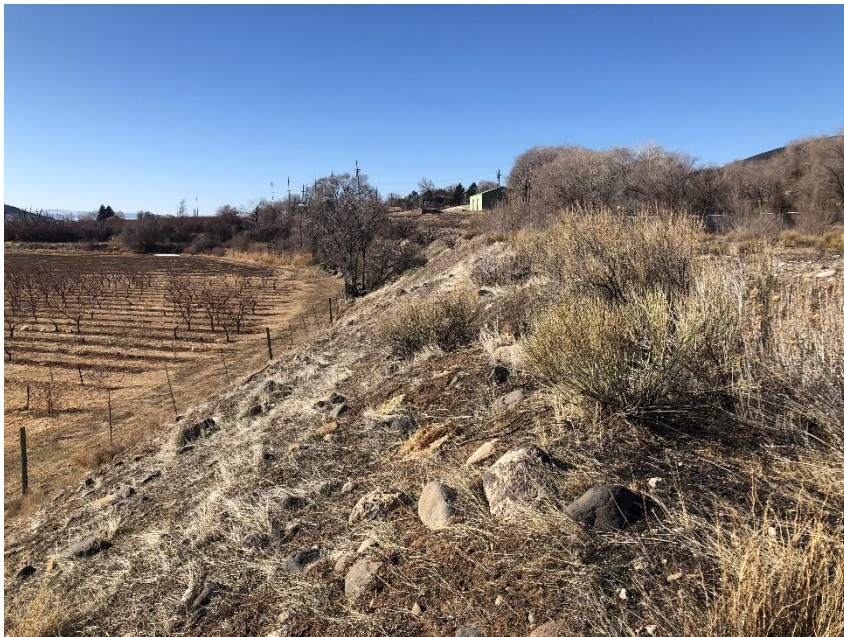
**Slope below the loadout - looking towards the entrance**

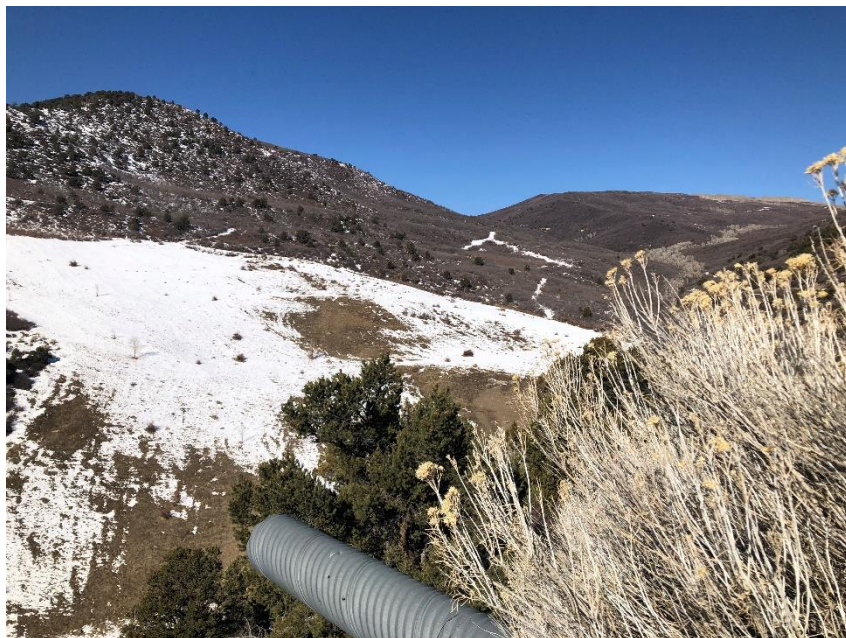
**West Mine – released area on left and unreleased area to right**

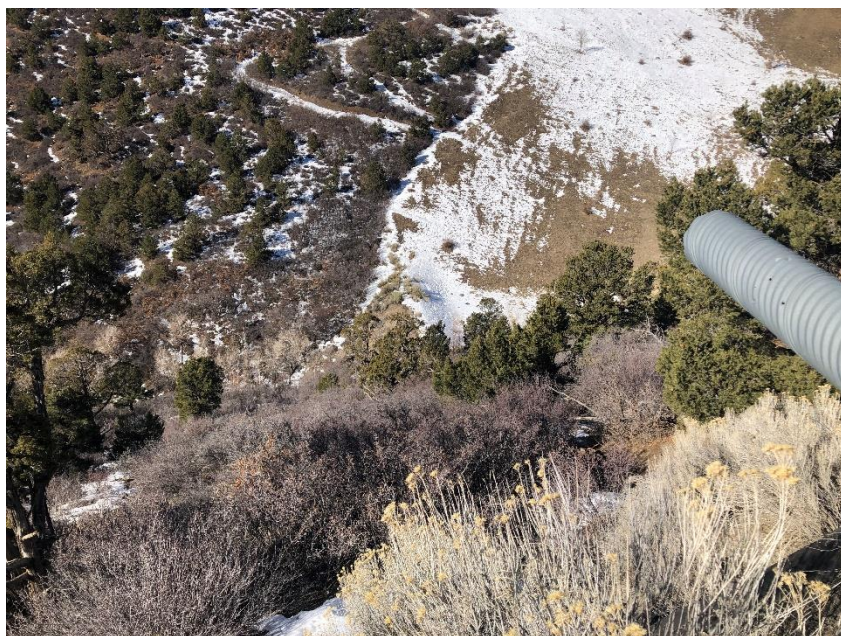
The ponds at the West Mine, and the creek below them (East Roatcap Creek), were observed from the road above. They contained a small amount of snow. No problems were identified with these ponds.

**West Mine – lower pond and drainage below**

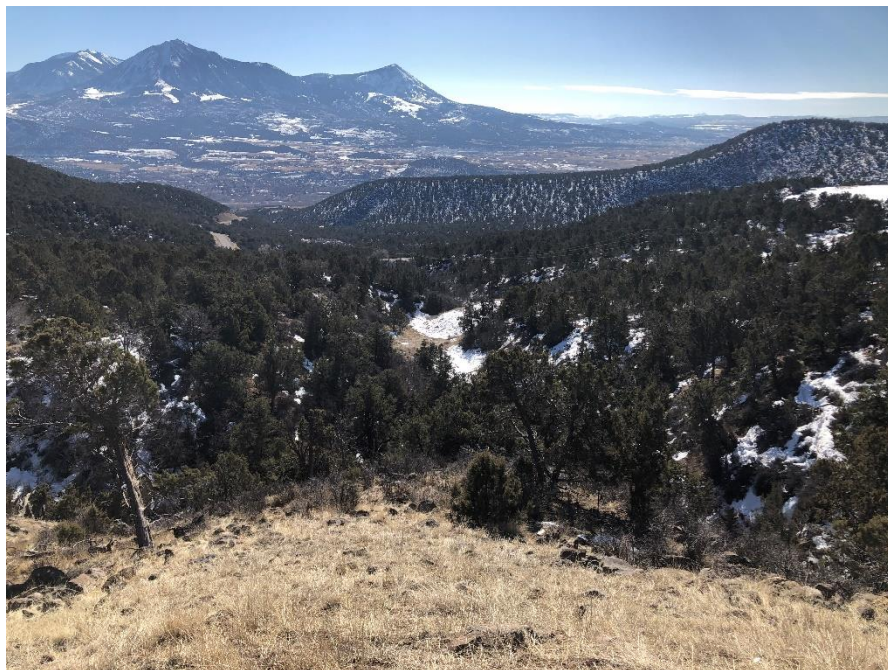
No problems were identified with the reclamation in the area of Ponds 1, 2, 3, and 4 at the East Mine. No problems were identified with the road to the ponds at the West Mine.

**East Mine -area of reclaimed ponds (Ponds 3 and 4)**

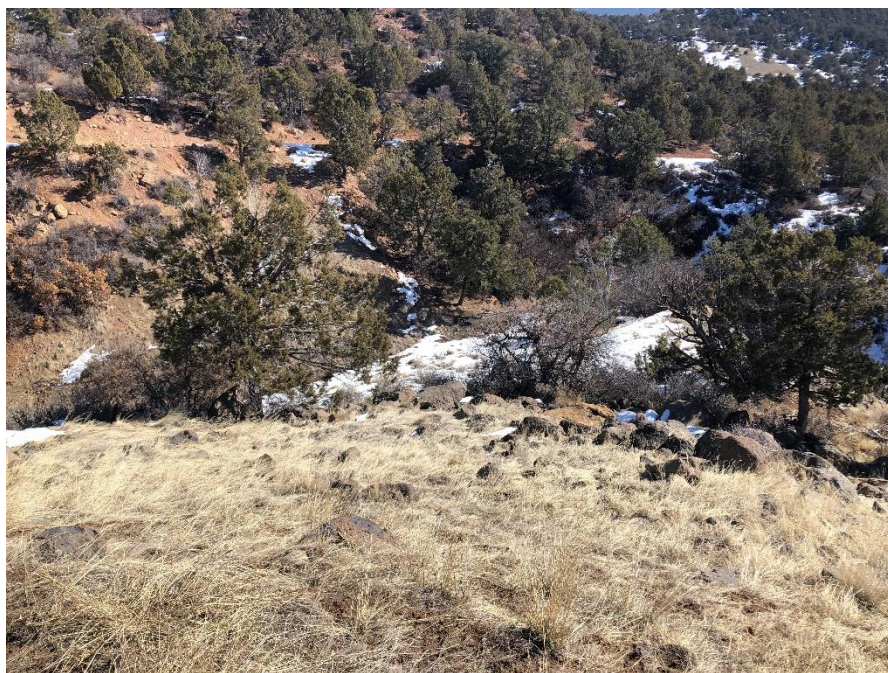
**East Mine -area of reclaimed Pond 2**
