Inspection reports- aerials for January

Permit Number: C-1992-081 Mine Name: Hayden Gulch Loadout Operator: Hayden Gulch Terminal, LLC Operator Address: Ms. Miranda Kawcak 29515 Routt County Road 27 Oak Creek, CO 80467	County: Routt Operation Type: Loadout Permit Status: Active Ownership: Private
	Operator Representative Present: N/a
Operator Representative Signature: (Field Issuance Only)

Inspection Start Date: January 28, 2025 Inspection Start Time: 13:00 Inspection End Date: January 28, 2025 Inspection End Time: 13:02	Inspection Type: Aerial Inspection Inspection Reason: Normal I&E Program Weather: Clear
Joint Inspection Agency: None	Joint Inspection Contacts:
Post Inspection Agency: None	Post Inspection Contacts:
Inspector(s): Brock Bowles	Inspector's Signature:

RECLAMATION SUCCESS - Rule 4.15, Rule 3:

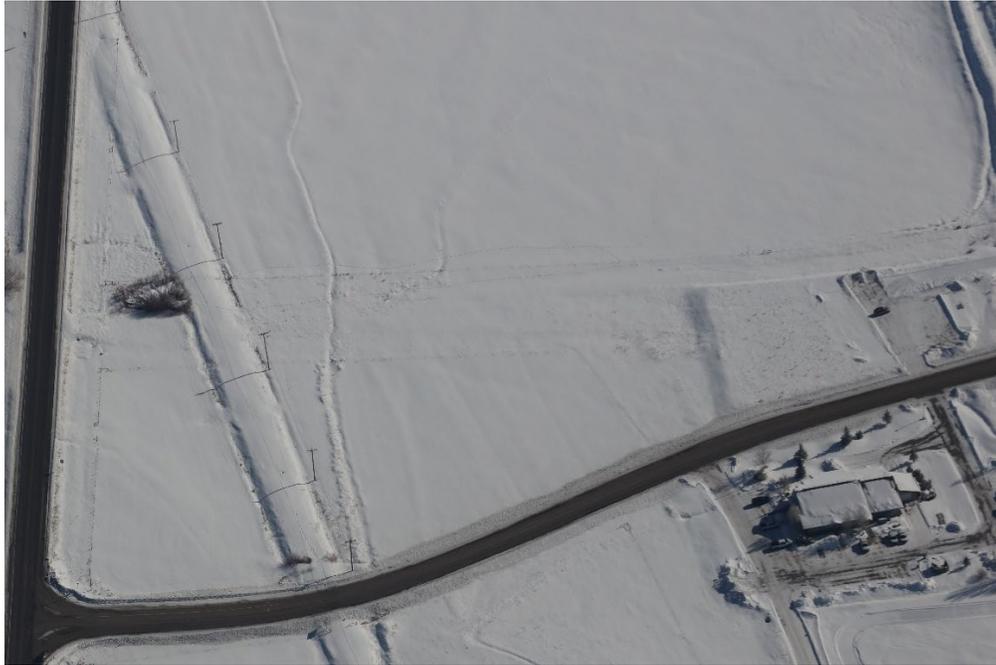
The area between the trail head parking lot and Hwy 40 is snow covered (photo 1). The trail head parking lot had been plowed and the trail had been groomed. No other disturbance was noted. Very few grass clumps are seen through the snow indicating the snow is about 12 inches deep.

Photo 1- Area between Hwy 40 and Trail head parking lot

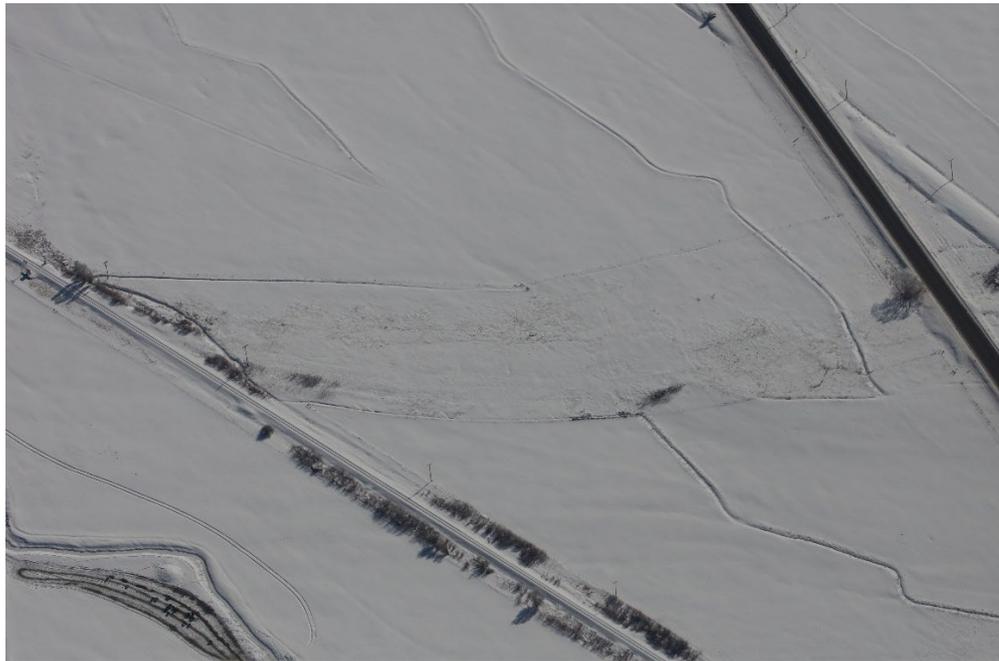
The area between Hwy 40 and the mainline is snow covered (photo 2). No disturbances were noted in this area. The grasses are more robust on this part of the reclamation and can be seen through the snow. The ditches are full of snow.

Photo 2- Area between Mainline and Hwy 40
