Inspection reports- aerals for January

Miranda and Mike,
Attached are the aerial inspection reports for the Foidel Creek (C-1982-056) and Hayden Gulch LO (C-1992-081) on January 28, 2025.
Brock

PERMIT INFORMATION

INSPECTION INFORMATION

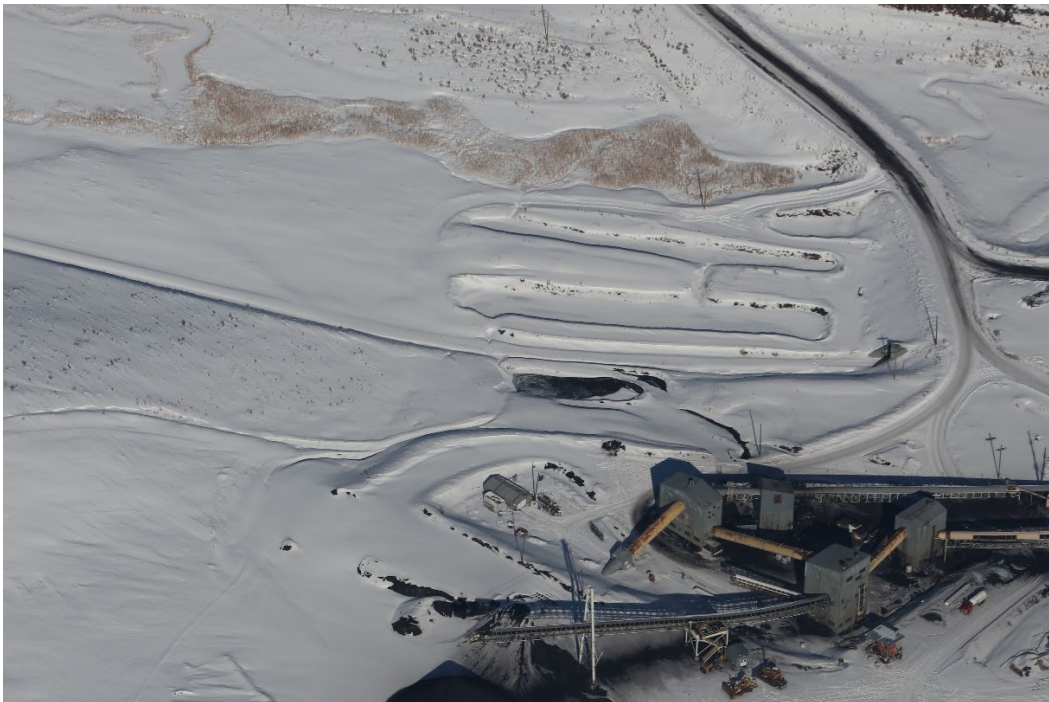
Photo 1- Ponds B and sump

The B Ponds were snow covered. The sump above the ponds was mostly melted indicated water was flowing into the sump (photo 1).

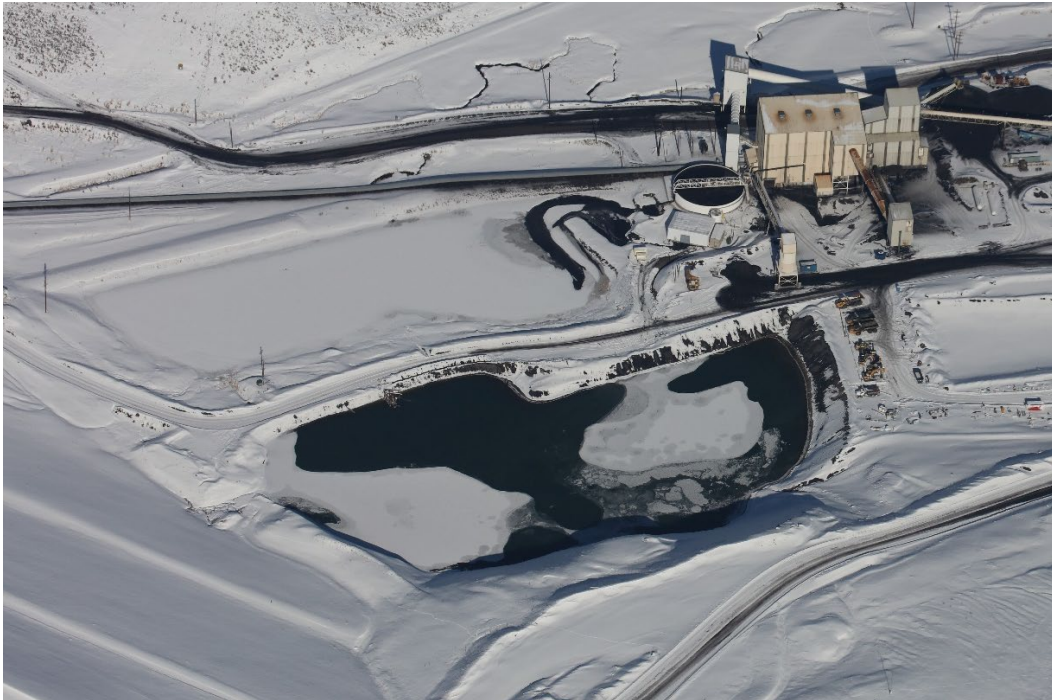
Photo 2- Pit Pond and D Pond

Pond D is mostly snow covered. The east end of the pond is melted indicating water is entering the pond. The discharge point is also melted indicating water is being discharged. The pit pond is about 1/2 snow covered (photo 2).

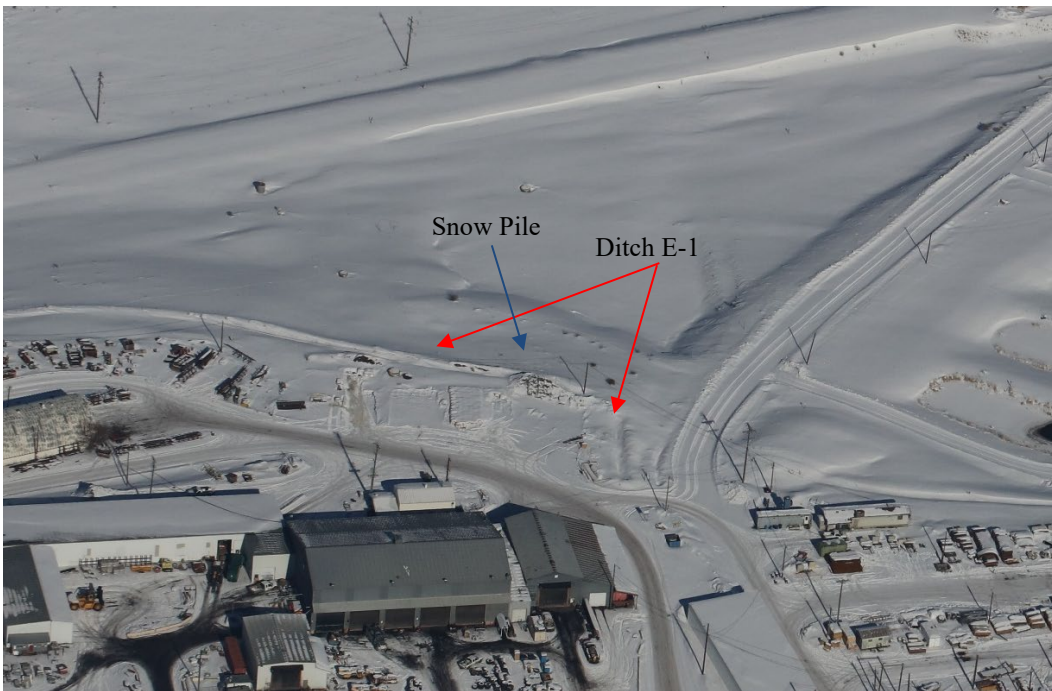
The snow pile located on Ditch E-1 has not been removed (photo 3). This snow pile was documented in the January 22, 2025 inspection report and needs to be removed.

Photo 3- Snow pile blocking Ditch E-1

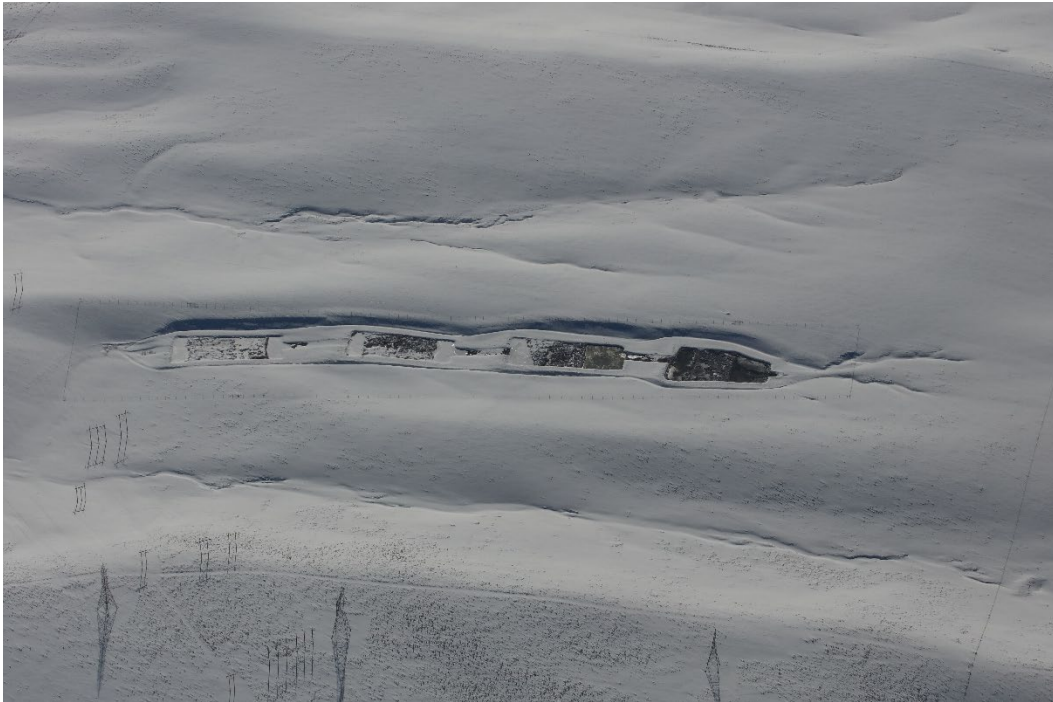
Photo 4- Four treatment pond near the 6MN facilities

The 4 Passive Treatment ponds were partly covered with snow and ice (photo 4). The discharge ditch leading from the ponds to the 6MN Reservoir was melted indicating that water is flowing to the reservoir (photo 5). The 6MN reservoir was snow covered.

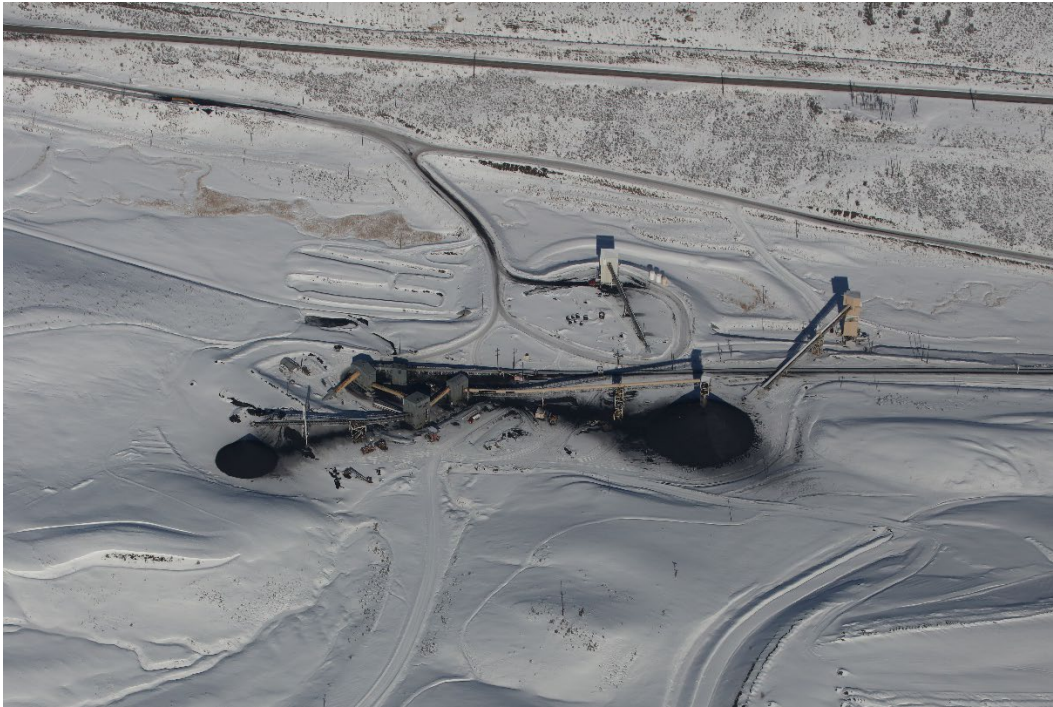
Photo 6 – Train Loadout area and BOB

A small pile of coal was also stacked on the BOB pile (photo 6).
