**MINERALS PROGRAM INSPECTION REPORT**  
**PHONE: (303) 866-3567**

<b>MINE NAME:</b> Meadow Hollow Quarry	<b>MINE/PROSPECTING ID#:</b> M-2009-006	<b>MINERAL:</b> Sandstone (silica, stone, quartzite)	<b>COUNTY:</b> Larimer
<b>INSPECTION TYPE:</b> Monitoring	<b>WEATHER:</b> Clear	<b>INSP. DATE:</b> December 27, 2024	<b>INSP. TIME:</b> 09:30
<b>OPERATOR:</b> Colorado Quarry I, LLC	<b>OPERATOR REPRESENTATIVE:</b> Bret Lundwick & Jay Panzarella	<b>TYPE OF OPERATION:</b> 110c - Construction Limited Impact

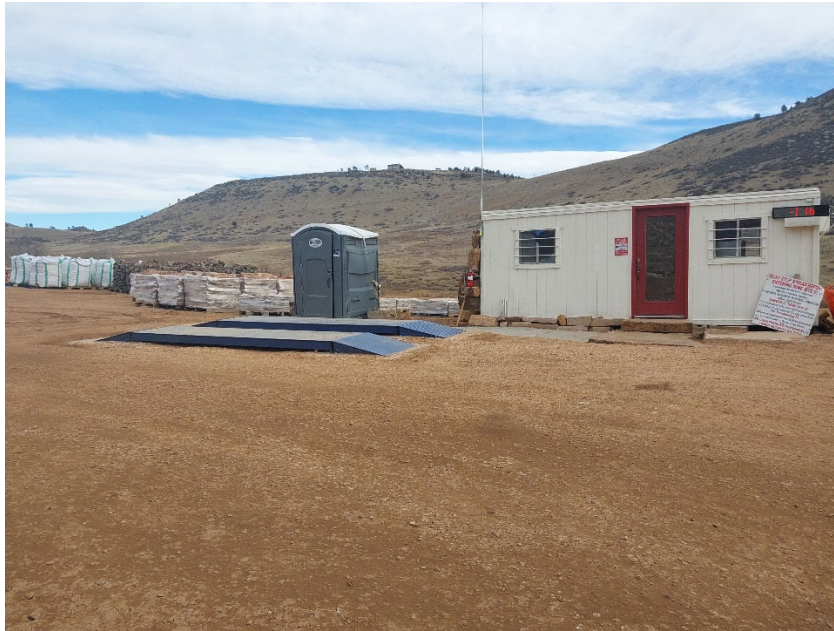
Photo #1: Scale and scale house located just to the north of the northeastern portion of the permit boundary.

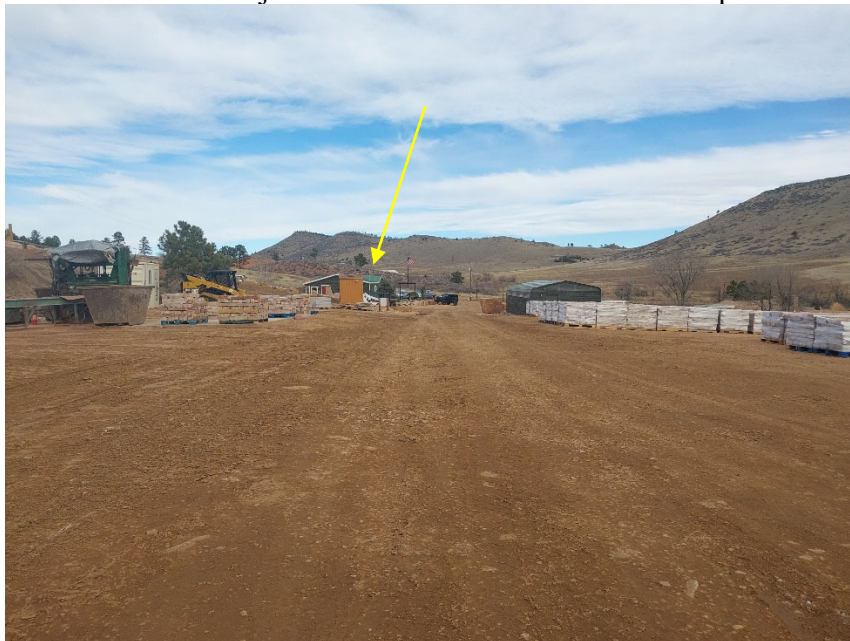
Photo #2: Looking north up the road that leads to the pit entrance, the pit entrance and permit boundary is located just behind the point of view. The yellow arrow is pointing to the office for the operation, palletized material can be seen on either side of the road and on the west side of the road equipment can also be seen.

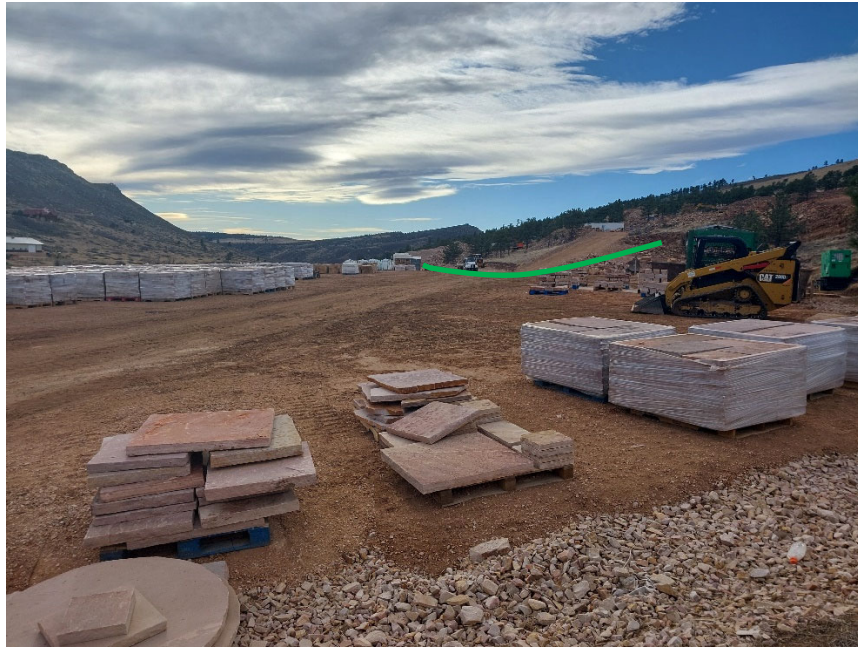
Photo #3: Looking south from the northwest area of the road that leads to the pit, located outside the permit boundary. The palletized material and equipment used for the operation can be seen. The green line marks the approximate location of the permit boundary.

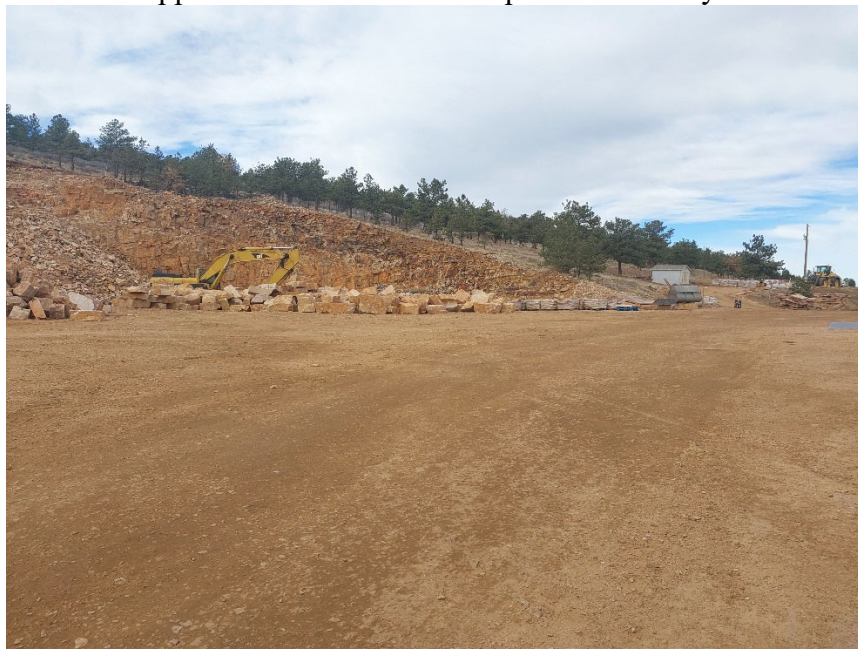
Photo #4: View of material and equipment stored on the pit floor of the pre-law quarry located just north of the permitted area. Looking to the northwest from the approximate northeast edge of the permit boundary.

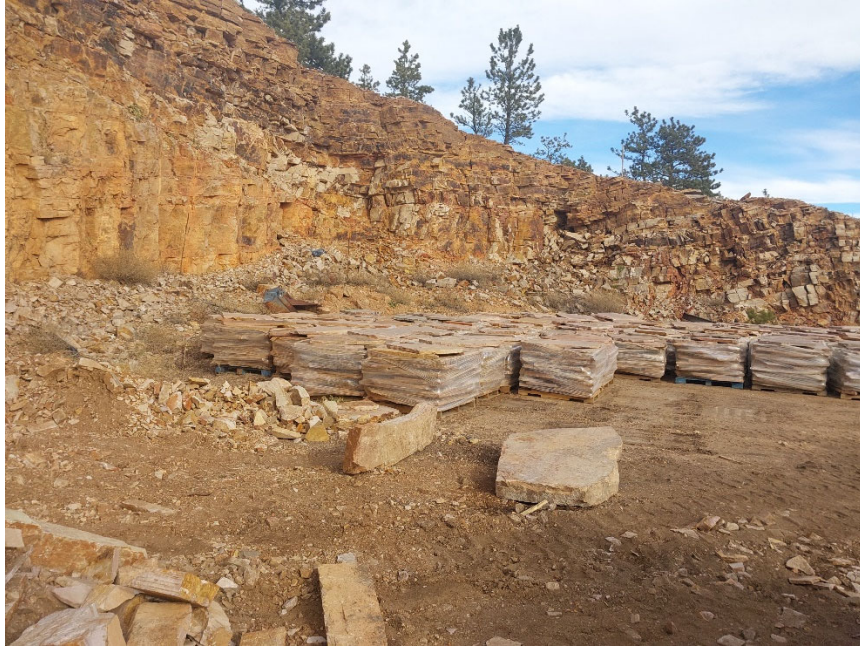
Photo #5: Palletized material stored along the back wall of the pre-law quarry; looking to the north from the center of the pit floor of the pre-law disturbance, north of the permit boundary.

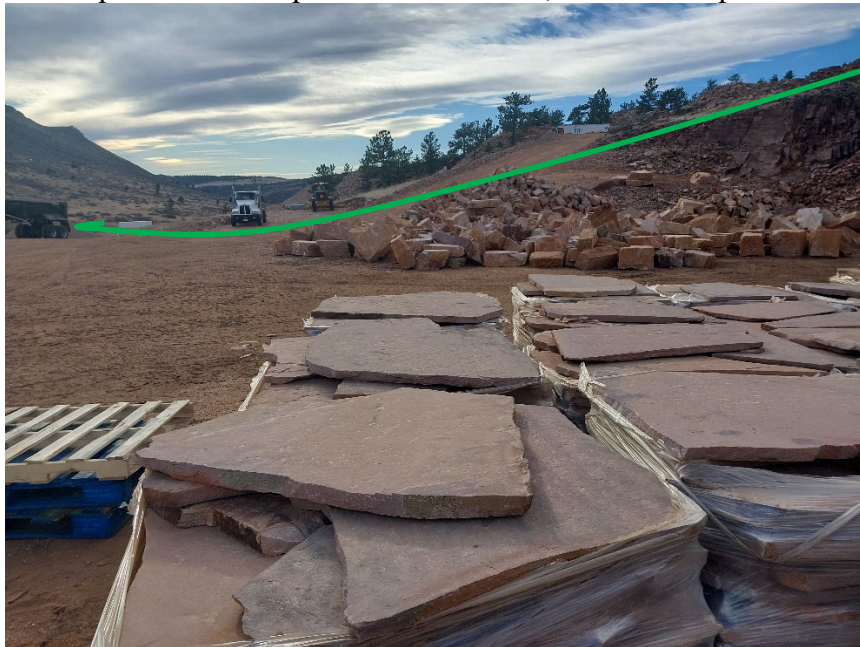
Photo #6: View looking south from outside the approved permit area on the north side of the pit floor of the pre-law quarry. The green line marks the approximate permit boundary.

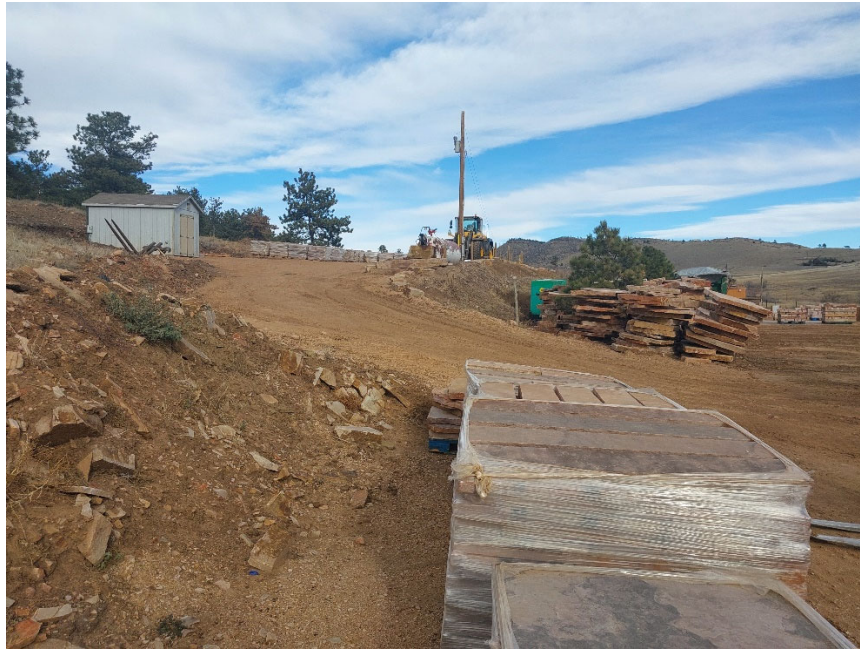
Photo #7: The western portion of the lands being used for the mining operation viewed from outside the approved permit area on the north side of the pre-law quarry, looking to the north-northwest.

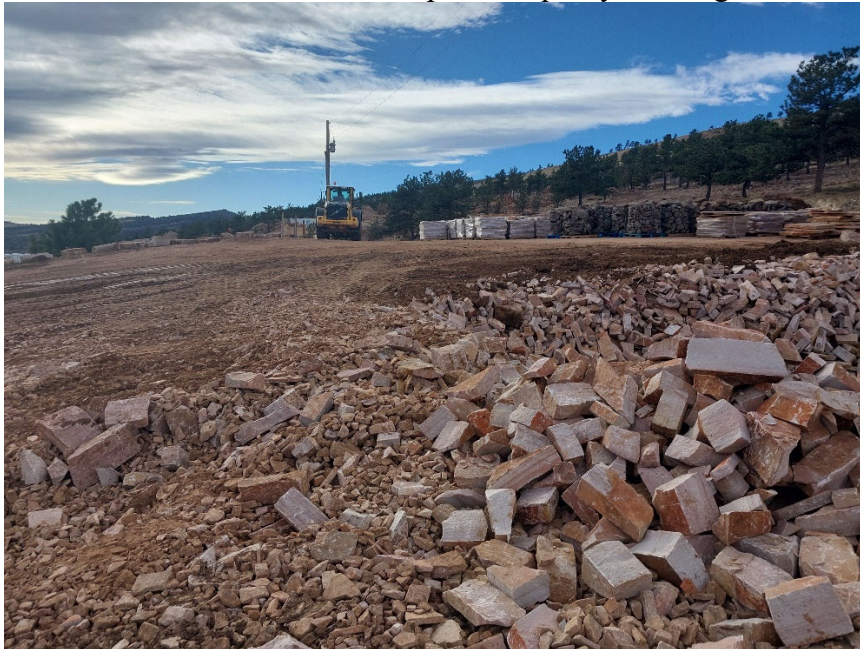
Photo #8: View of the western portion of the land being used for mining purposes outside the permitted area, looking south from south of the office. Palletized material and equipment are being stored in an area that has been graded.

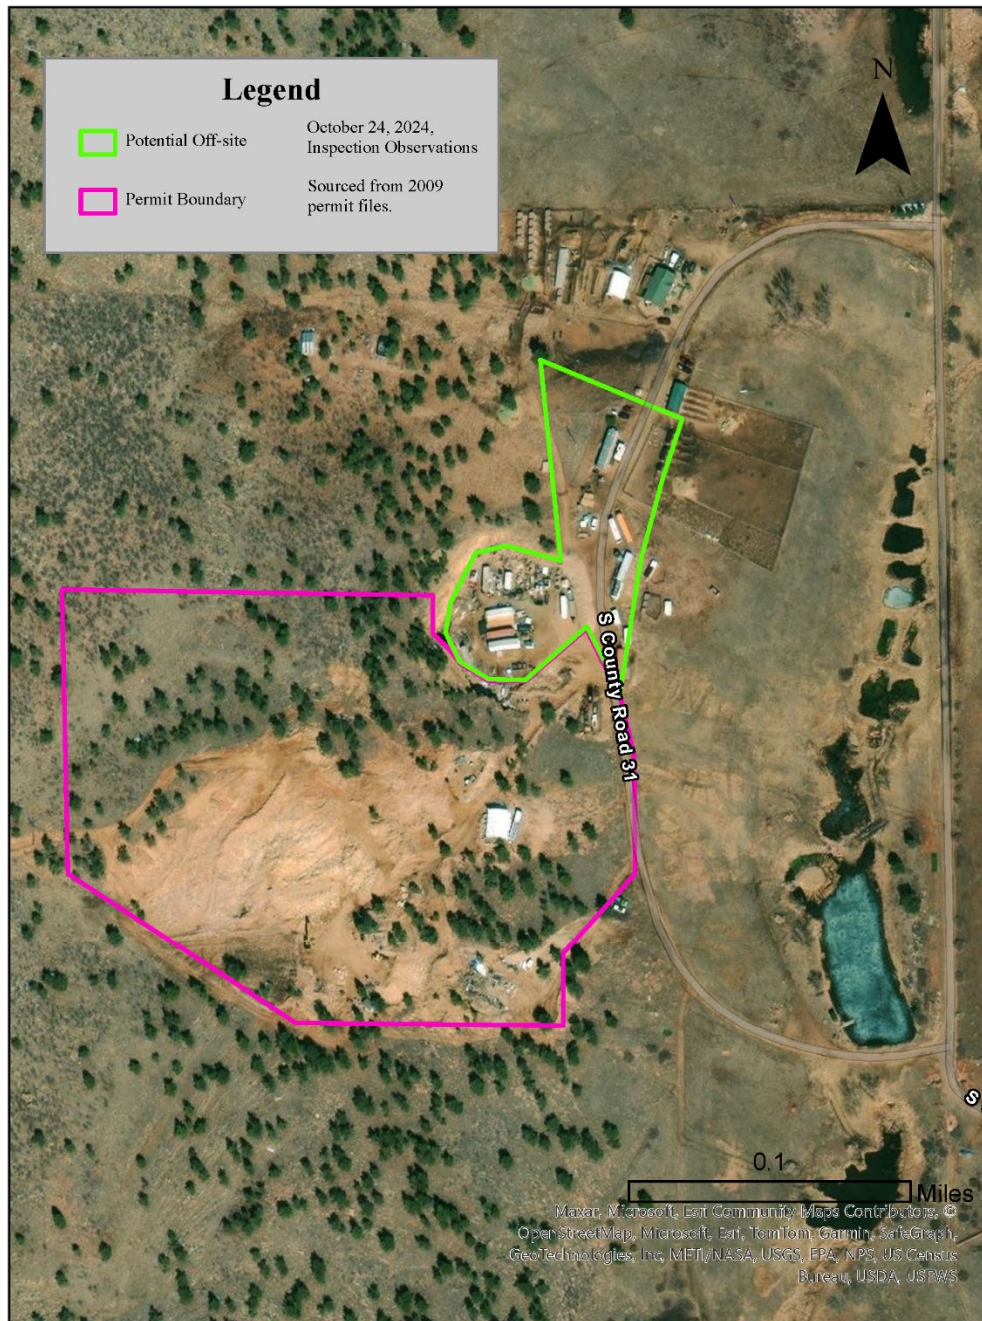
**POSSIBLE VIOLATION:** Land has been affected outside of the approved permit boundary. This is a possible violation at this time pursuant to: 1.) C.R.S. 34-32.5-109(1) for failure to first obtain from the board or office a reclamation permit prior to engaging in a new operation. AND/OR 2.) C.R.S. 34-32.5-116(4)(i) for failure to protect areas outside of the affected land from slides or damages occurring during the mining operation.

During the inspection, it was found that there was off-site damage located to the north-northeast of the permit area, covering approximately 1.79 acres. The area was being used by the mine for storage of product material, palletized product material, material handling equipment, material processing equipment, a shed used for storing chemicals and hand tools, a truck scale, and a scale house. The area to the northwest of the extent of the off-site disturbed areas (see Figure 1 below) appears to have been graded for storing product material, according to satellite images. **This has been cited as a possible violation for off-site damage affecting approximately 1.79 acres outside of the approved affected land.** The Division will bring this matter to the Mined Land Reclamation Board (MLRB) for a hearing for consideration of a possible violation pursuant to C.R.S. 34-32.5-116(4)(i) for failure to protect areas outside of the approved affected land from slides or damages, and/or for failure to first obtain a reclamation permit prior to engaging in a new operation in accordance with C.R.S. 34-32.5-109(1). The schedule and other details for the MLRB hearing will be provided to the operator in a separate document to be sent via certified mail.

Figure 1: Map showing the current permit boundary (in pink) and the extent of the land found to be used for mining purposes (in green). The area outlined in green measures 1.79 acres.

**CORRECTIVE ACTIONS:** This possible violation will require a hearing before the Mined Land Reclamation Board (MLRB). The schedule and other details for the MLRB hearing will be provided under a separate document to be sent via certified mail to the operator.
