COLORADO
 Division of Reclamation,
 Mining and Safety
 Department of Natural Resources

Permit Number: C1981010 Mine Name: Trapper Mine Operator: Trapper Mining, Inc. Operator Address: Mr. Graham Roberts P.O. Box 187 Craig, CO 81626	County: Moffat Operation Type: Surface Permit Status: Active Ownership: Federal
	Operator Representative Present: Graham Roberts
This report was issued electronically from the Divisions' Denver Office.

Inspection Start Date: 28 January 2025 Inspection Start Time: 9:00 a.m. Inspection End Date: 29 January 2025 Inspection End Time: 16:30 p.m.	Inspection Type: Complete Inspection Inspection Reason: Normal I&E Program Weather: Clear
Joint Inspection Agency: OSM	Joint Inspection Contacts:
Post Inspection Agency: None	Post Inspection Contacts:
Inspector(s): Robin A. Reilley, M.S. GISP Brock Bowles	Inspector's Signature:

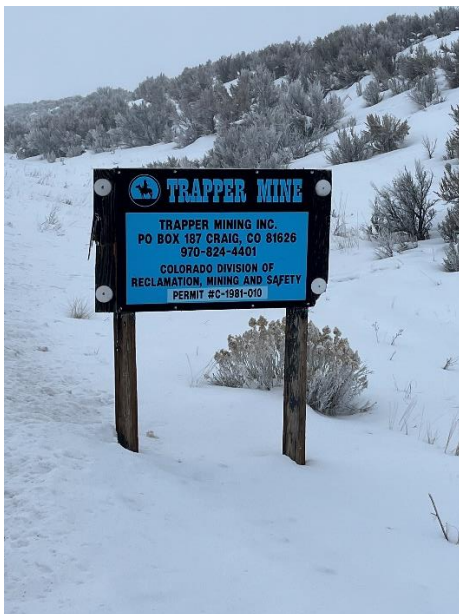
- The mine identification sign was in place at the site entrance from the Highway 13. The sign was intact, displaying all required information: mine name, operator name, address, phone number, DRMS permit number and contact information.
- The blasting sign was also situated at the entrance displaying all the required blasting safety information.

Photo 1: Mine Identification sign at site entrance.

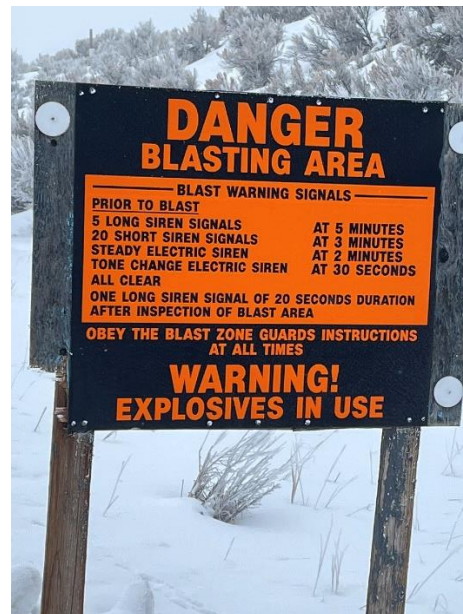
Photo 2: Blasting notification sign at site entrance.

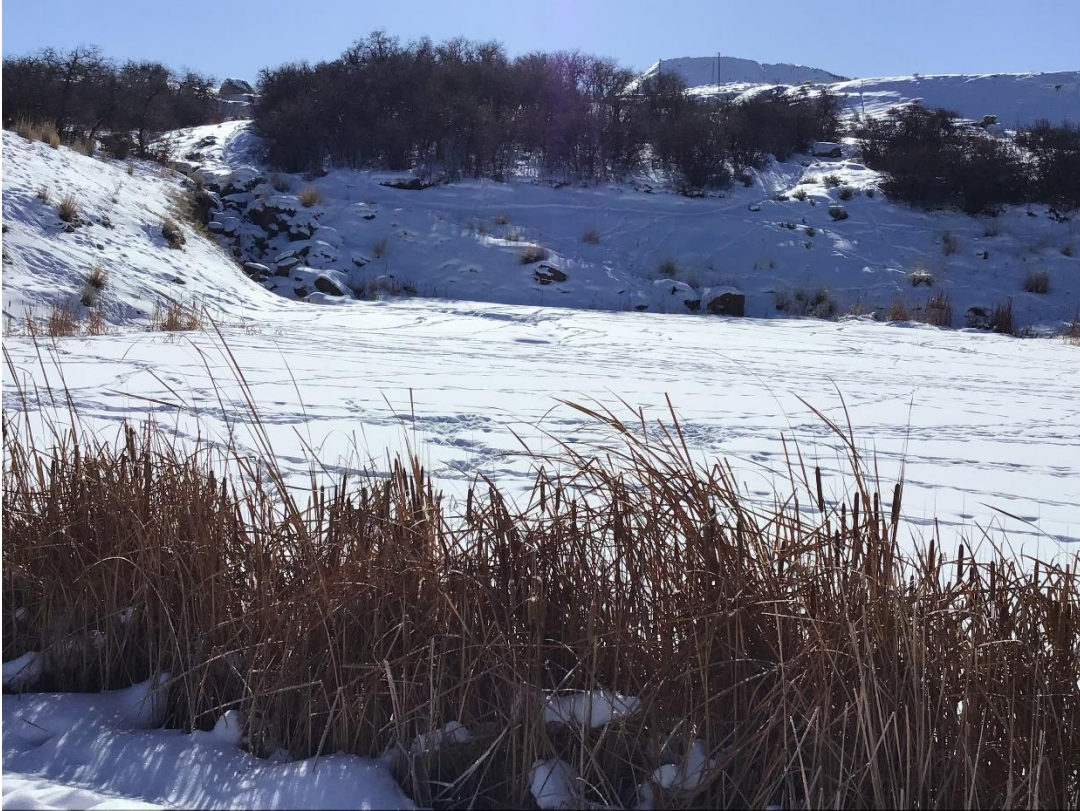
- East Middle Flume frozen and snow covered. No apparent discharge at the time of inspection. On the pond dredging list for 2025 field season.
- Middle Flume #3 was frozen, and snow covered and held water at the time of inspection. No apparent discharge was observed.

Photo 3: East Middle Flume frozen and snow covered. No apparent discharge.

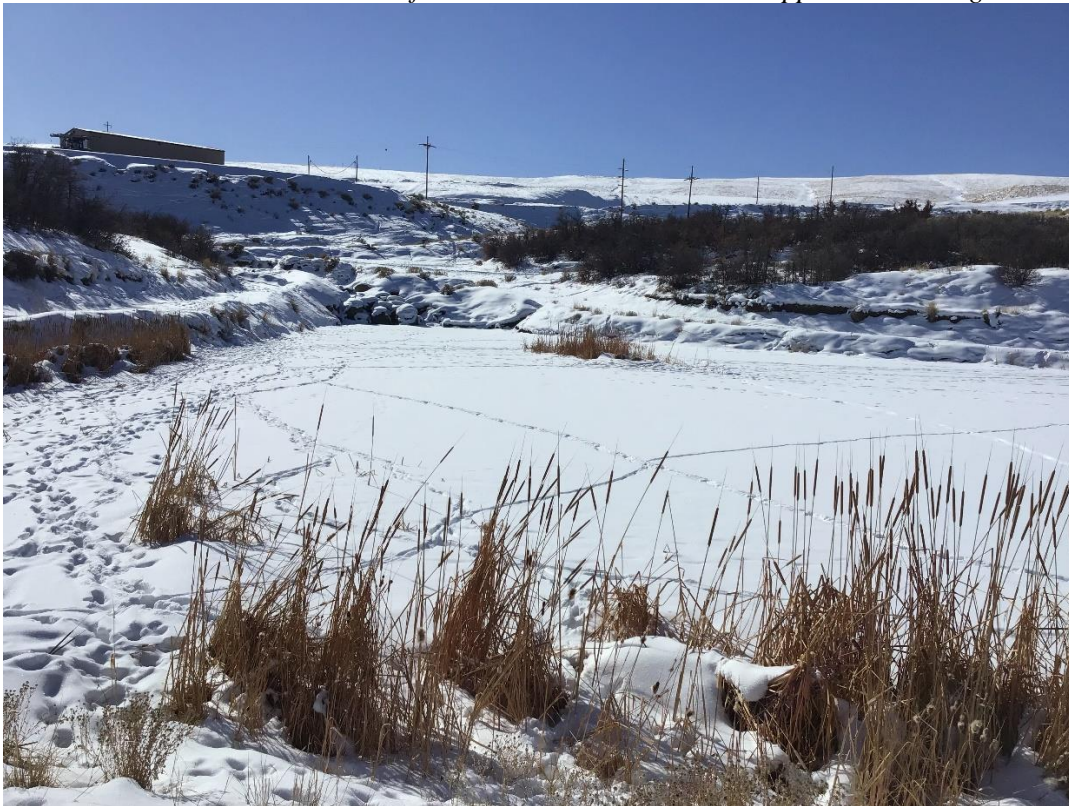
Photo 4: Middle Flume #3 frozen and snow covered, no apparent discharge.

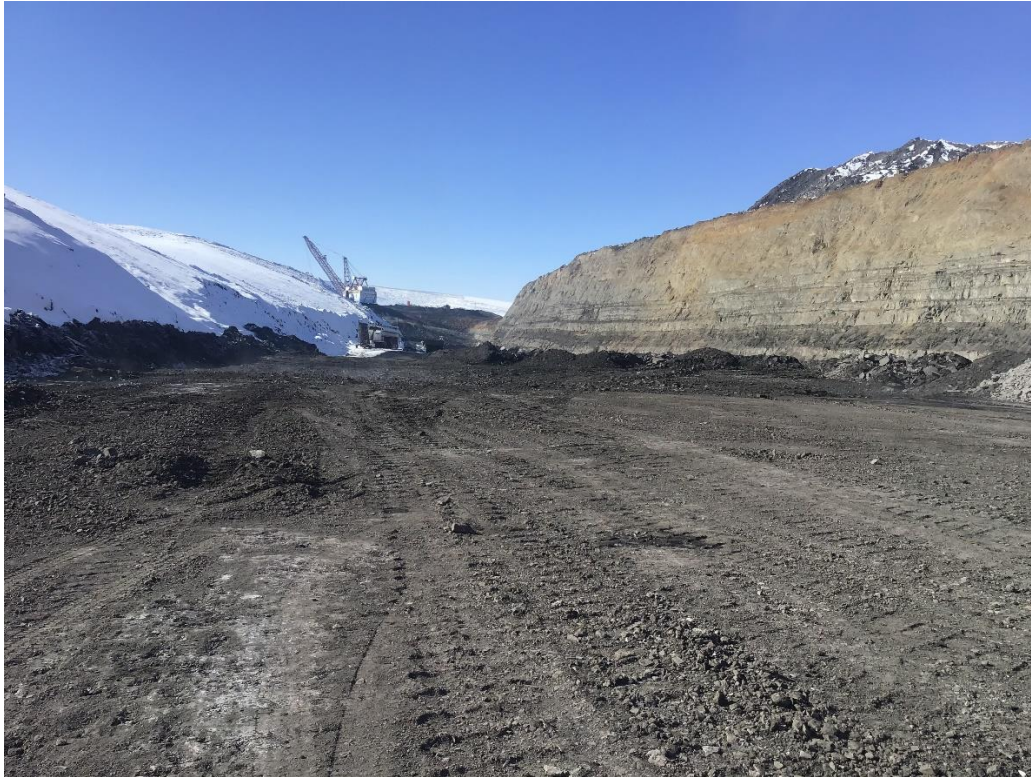
J Pit West: The Queen Ann dragline was staged and excavating at the west end of the pit at the time of inspection. Excavations should be finished in a month and have the pit ready for highwall mining.

Photo 5: J Pit West dragline activities, looking west.

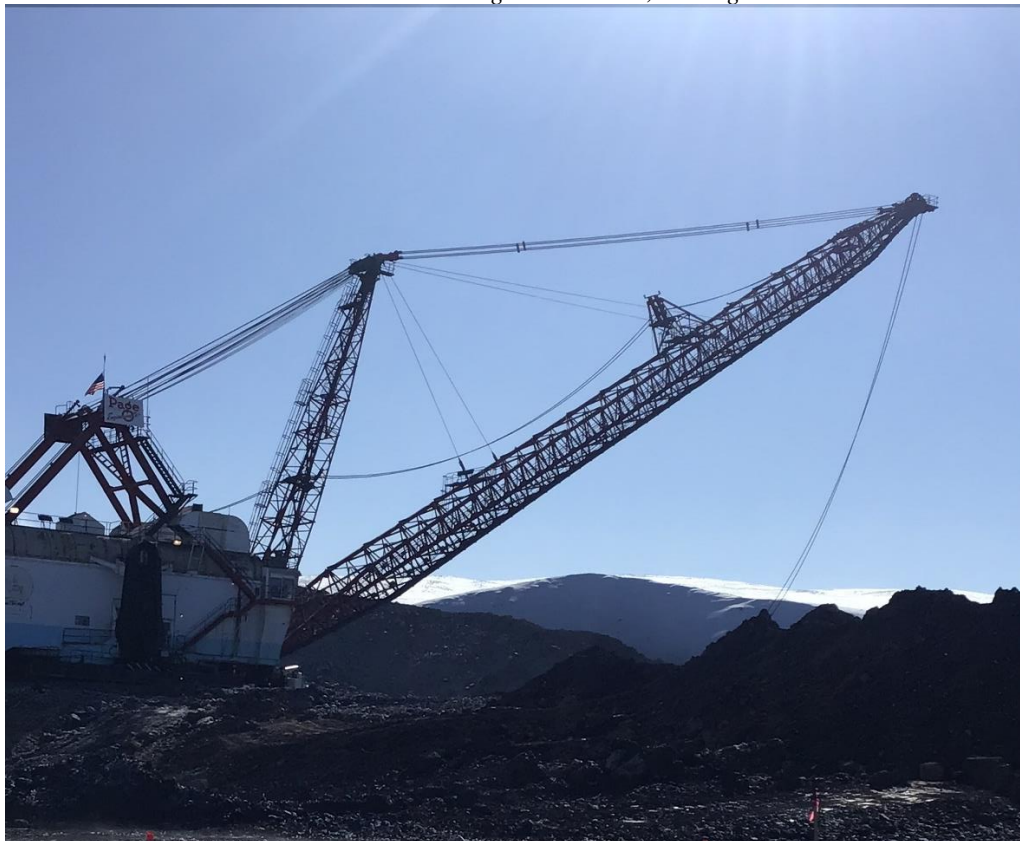
Photo 6: J Pit dragline activities, looking south.

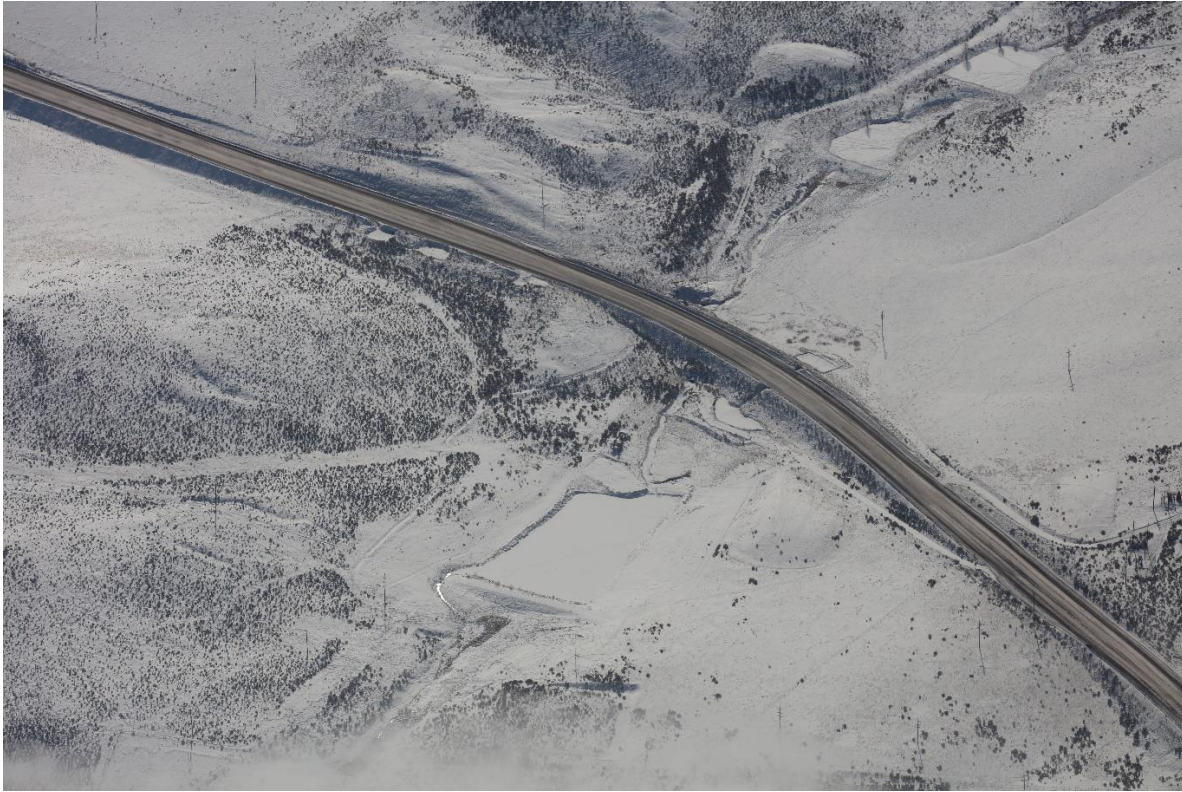
Photo 7: Frozen and snow covered Johnson Pond System.

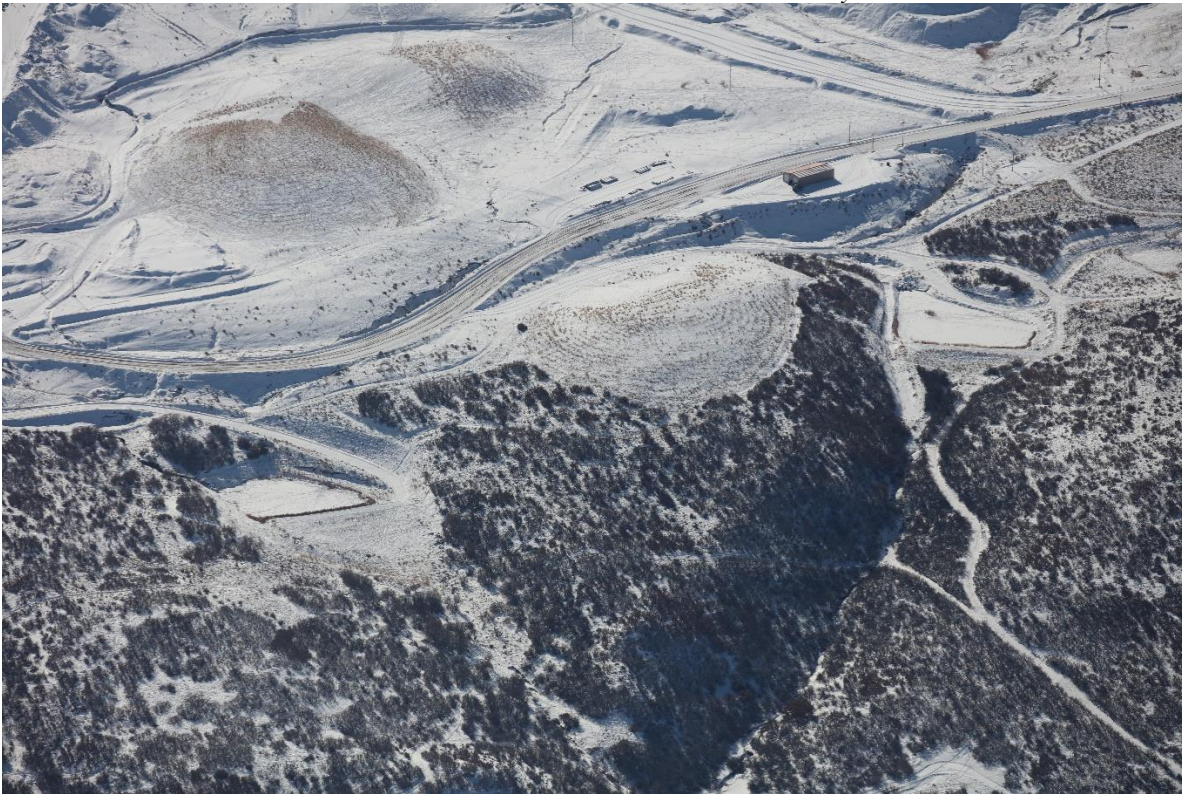
Photo 8: Frozen and snow covered Flume Pond System.

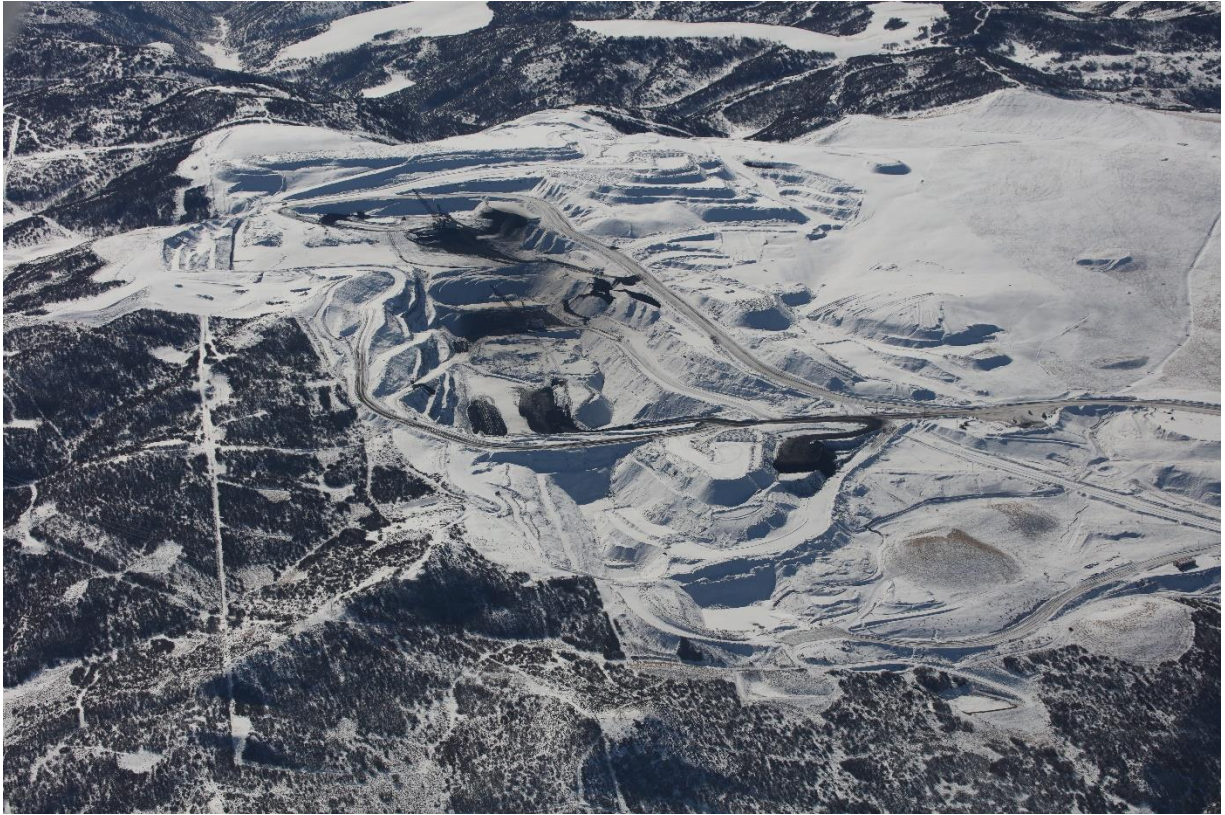
L Pit: The Baby Doe and Molly are staged in the L pit. Coal was being loaded and hauled. Mining is occurring in the K and L seams.

Photo 9: L Pit activities looking south.

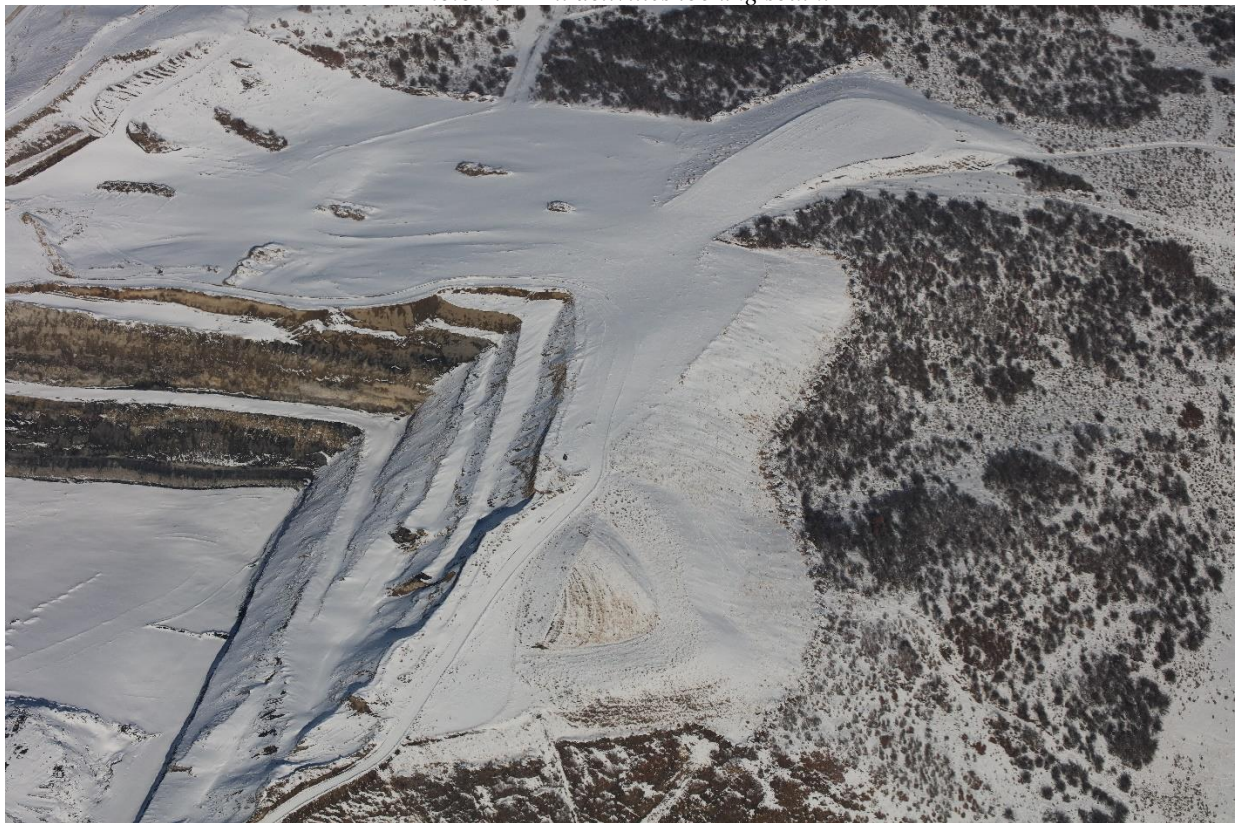
Photo 10: Southeast corner of L Pit activities looking northeast.

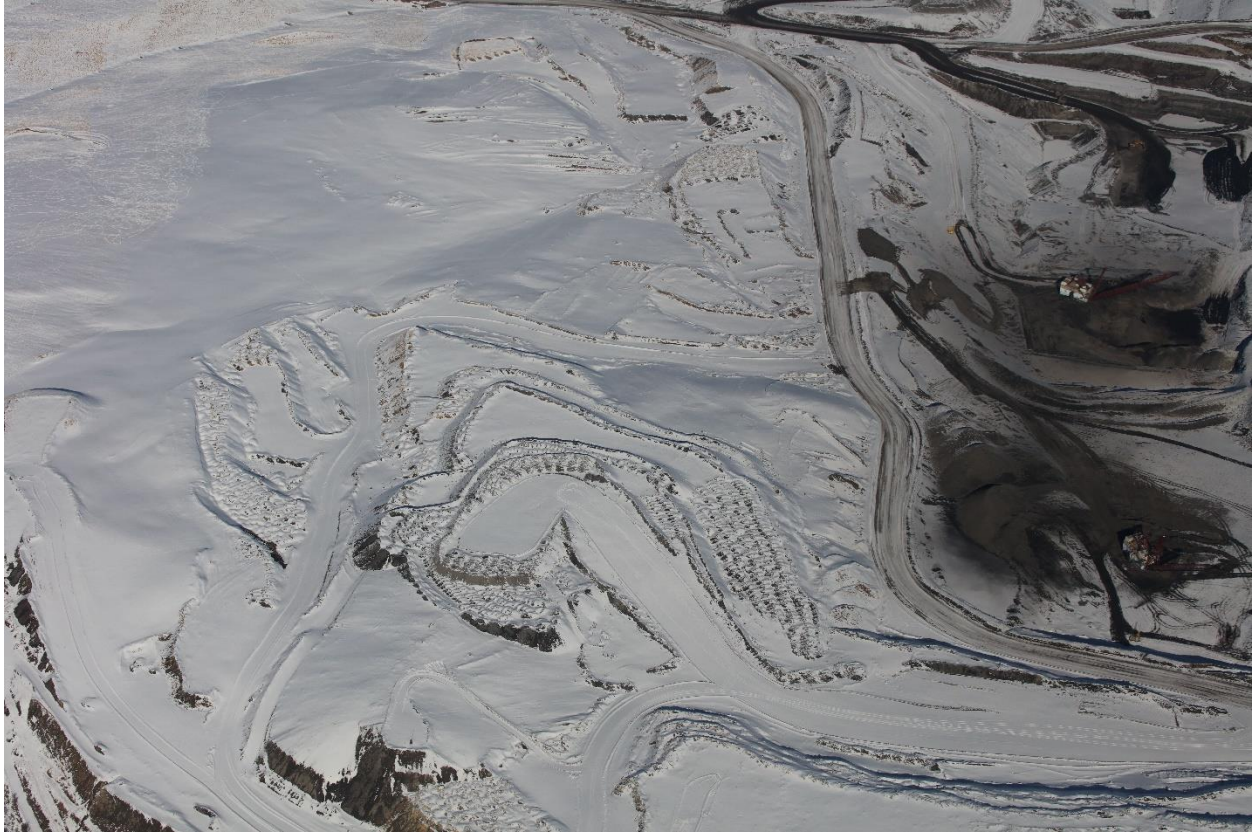
Photo 11: L Pit overburden stockpiles to the west of the pit.

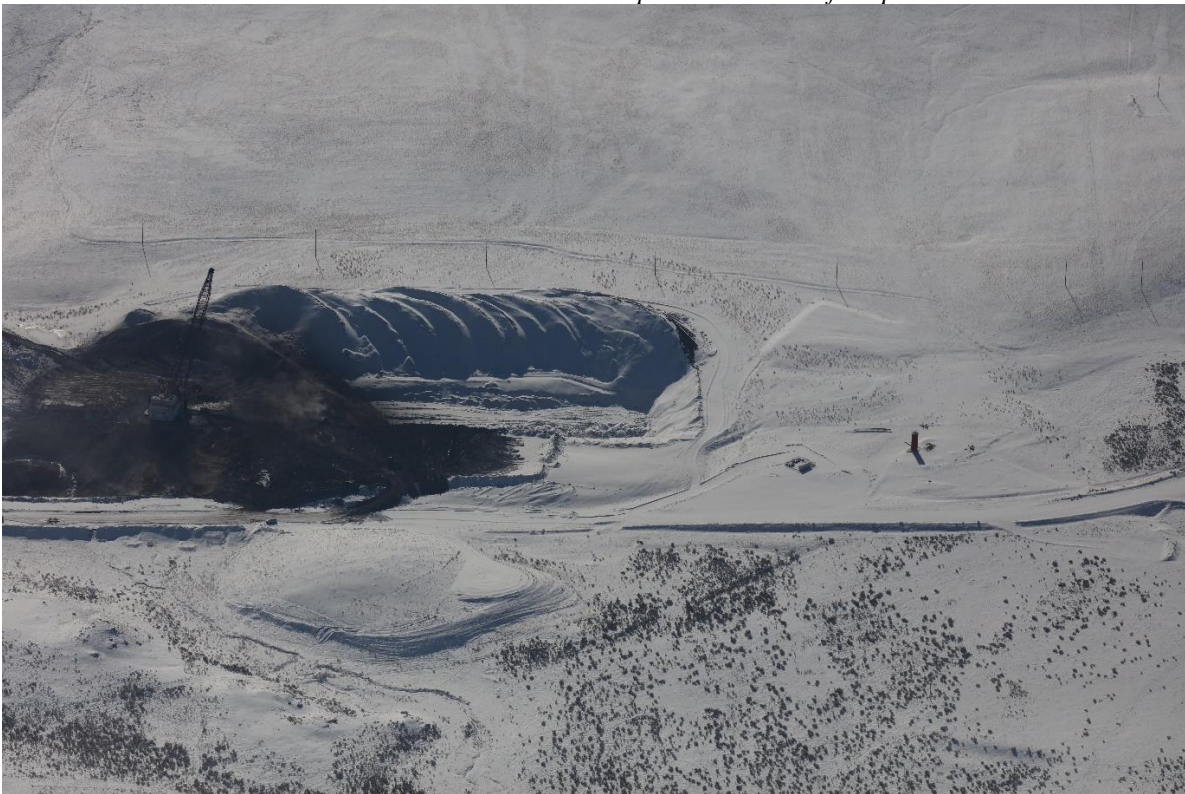
Photo 12: J Pit West activities with spoil ridges in background.

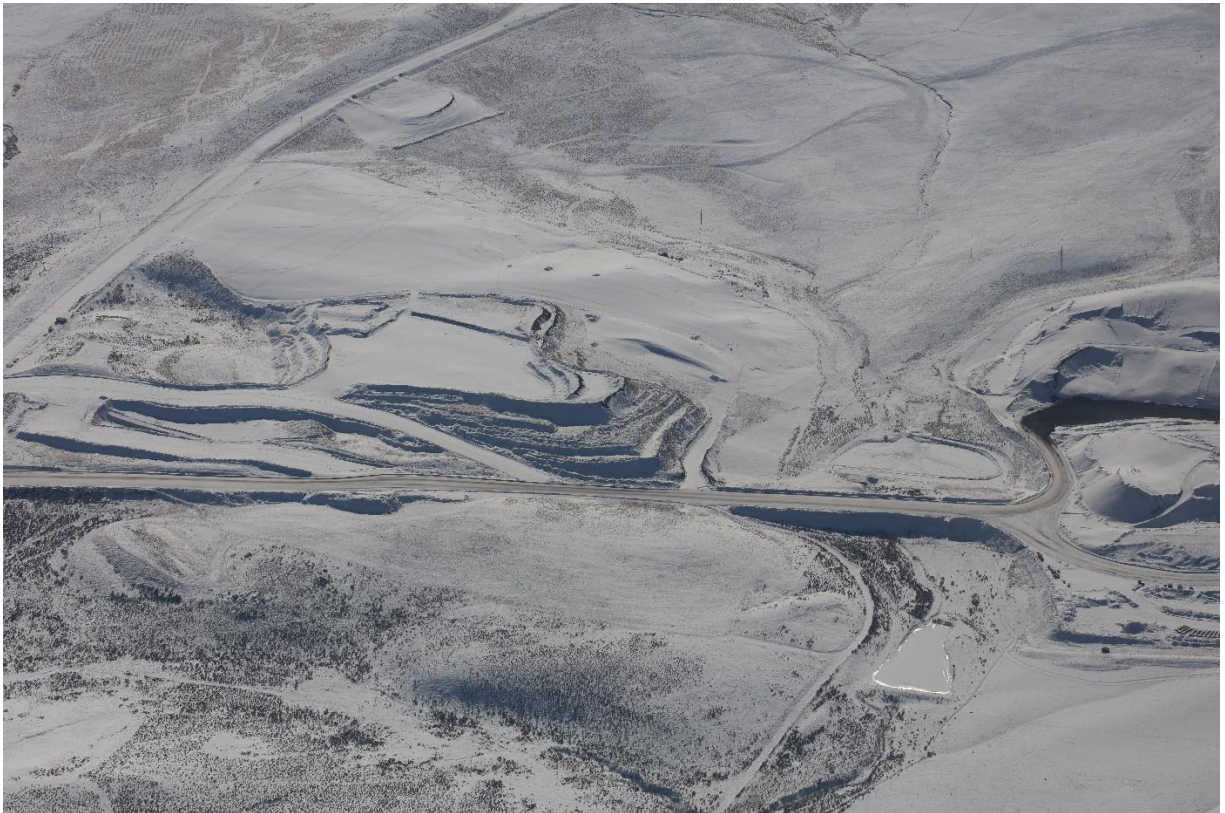
Photo 13: No Name Pond system near I and J Pits.

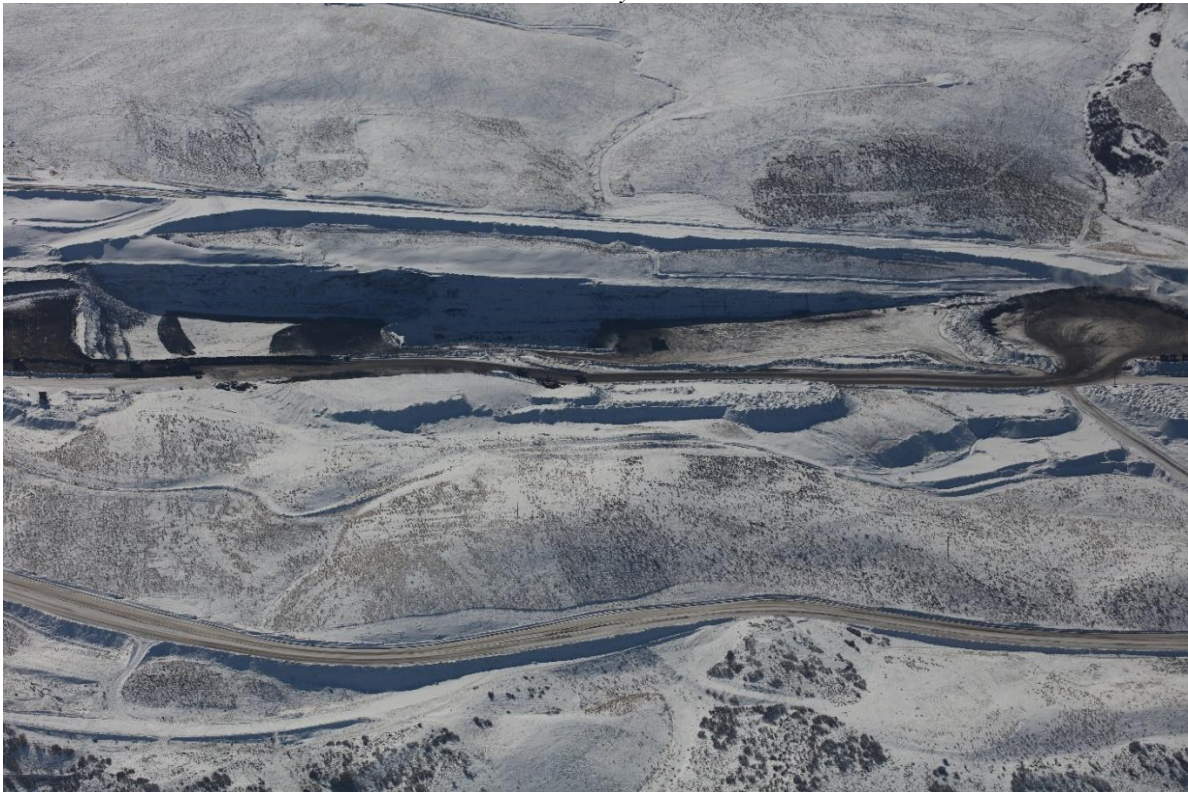
N Pit: Building a spoil dump at west end of N Pit.

Photo 13: N Pit activities.
