### MINERALS PROGRAM INSPECTION REPORT

<b>MINE NAME:</b> Limon Sand & Gravel Resource	<b>MINE/PROSPECTING ID#:</b> M-2024-053	<b>MINERAL:</b> Sand and gravel	<b>COUNTY:</b> Lincoln
<b>INSPECTION TYPE:</b> Preoperation Inspection	<b>WEATHER:</b> Inclement/prevented Inspect	<b>INSP. DATE:</b> January 22, 2025	<b>INSP. TIME:</b> 09:30
<b>OPERATOR:</b> Mid-States Materials, LLC	<b>OPERATOR REPRESENTATIVE:</b>	<b>TYPE OF OPERATION:</b> 112c - Construction Regular Operation

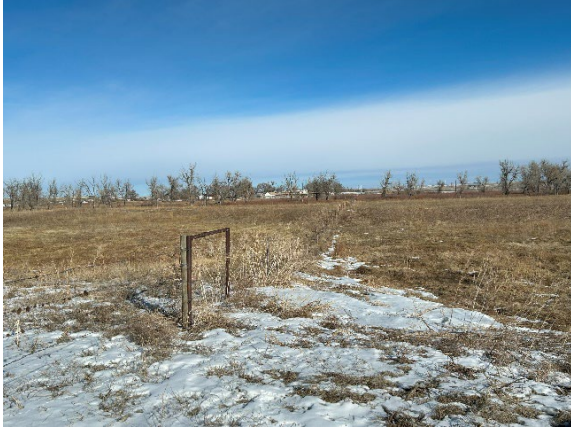
Photo 1: Eastern fenceline's condition prior to mining.

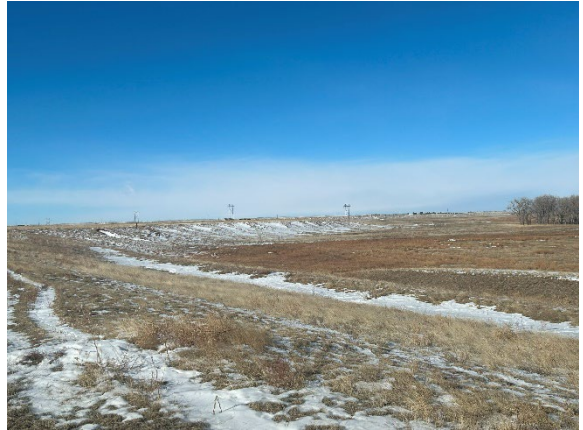
The reclaimed 111c permit was observed, and reclamation appeared to be complete and adequate at the time of inspection. No evidence of affected lands caused by the existing 112c permit located on-site was observed, and generally the remainder of the site appeared to be vacant rangeland.

Photo 2: Reclaimed 111 permit.

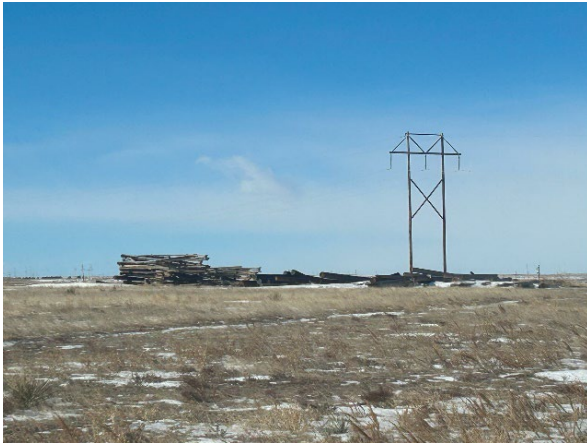
Photo 3: What appears to be a laydown area in support of the transmission lines.

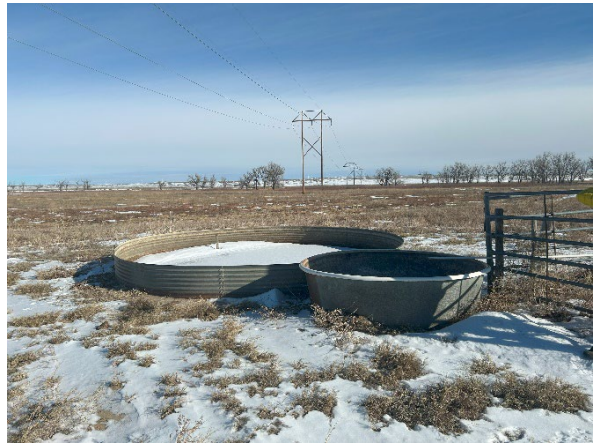
Photo 4: Central stock well as it appears prior to mining.
