MINERALS PROGRAM INSPECTION REPORT
PHONE: (303) 866-3567

MINE NAME: Western Aggregates	MINE/PROSPECTING ID#: M-1988-108	MINERAL: Shale	COUNTY: Jefferson
INSPECTION TYPE: Monitoring	WEATHER: Clear	INSP. DATE: January 16, 2025	INSP. TIME: 10:00
OPERATOR: Arcosa LWB, LLC	OPERATOR REPRESENTATIVE:	TYPE OF OPERATION: 112c - Construction Regular Operation	
REASON FOR INSPECTION: Normal I&E Program	BOND CALCULATION TYPE: Complete Bond	BOND AMOUNT: \$4,495,000.00	
DATE OF COMPLAINT: NA	POST INSP. CONTACTS: None	JOINT INSP. AGENCY: None	
INSPECTOR(S): Ben Hammar Zach Trujillo	INSPECTOR'S SIGNATURE:

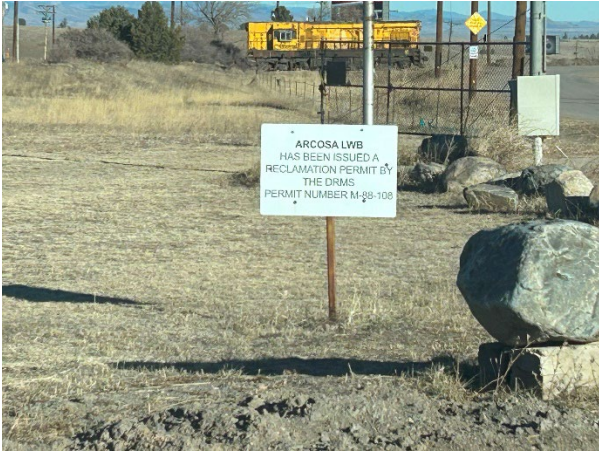
All relevant signs and boundary markers were observable during the inspection, including both the areas around the processing facility and quarry. Standard fenceposts marked the perimeter, and the mine sign appeared to be in good condition. No impact to Coal Creek was observable during the inspection, and all fuel storage was contained within double-lined containers.

Photo 1: Mine identification sign.

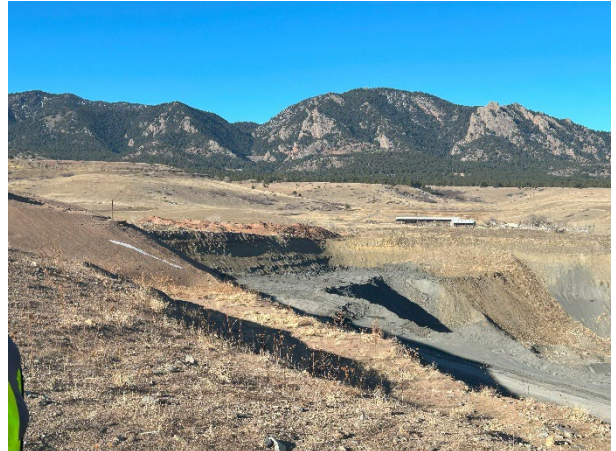
Currently the post-mining land use is rangeland with a small section of developed water resources to serve as a stock pond within the quarry area. The plant area is planned to continue to be used for some form of material processing following the reclamation of the quarry. Currently the operator is approved to utilize waste fines and overburden to slope areas of the quarry undergoing reclamation. No blasting is performed or planned at this site, and evidence of active reclamation is present along the western slope of the quarry. Active mining appears to currently be taking place in the southern slope.

Photo 2: Example of an active slow in quarry.

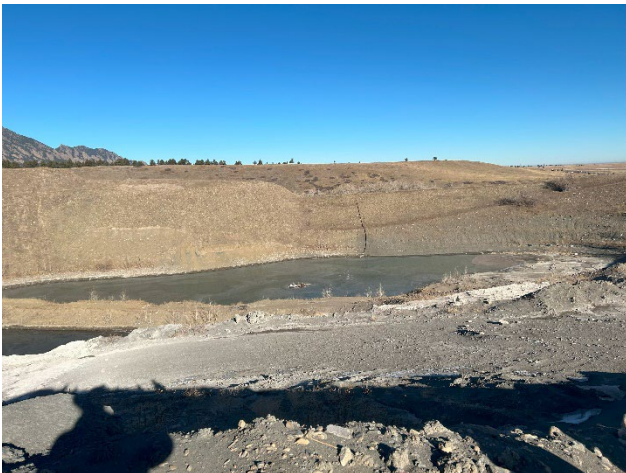
As mentioned, final reclamation will include a permanent stock pond in the northeast corner of the quarry. Currently runoff is stored within the quarry floor due to the highly impermeable clays present on the pit floor and is pumped for use in the processing plant as approved within the current mining plan. No significant issues related to the local hydrologic balance, or the mining plan at large were observed during this inspection.

Photo 3: Current pond status, example reclaimed slopes, and pump.

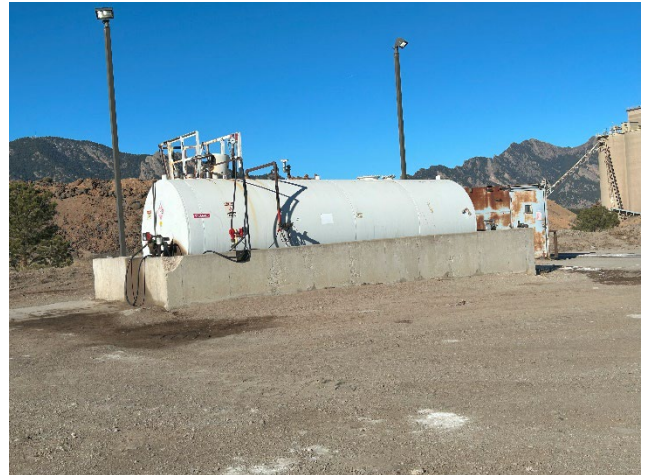
Photo 4: Double-lined fuel storage near processign area.

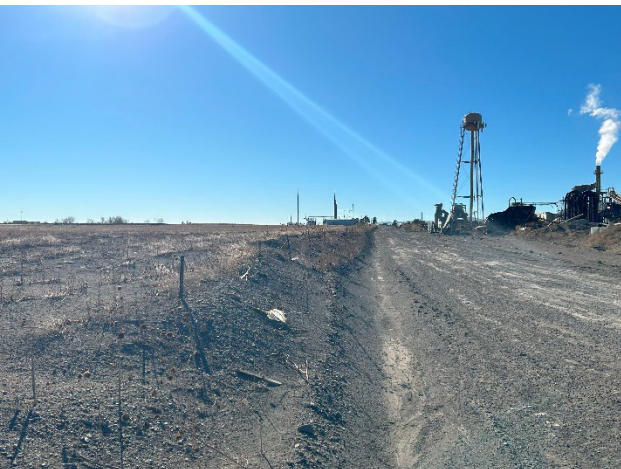
Photo 5: Example boundary fenceline, eastern boundary shown.
