**MINERALS PROGRAM INSPECTION REPORT**  
**PHONE: (303) 866-3567**

<b>MINE NAME:</b> Grizzly Ridge Pit	<b>MINE/PROSPECTING ID#:</b> M-1984-152	<b>MINERAL:</b> Sand and gravel	<b>COUNTY:</b> Montrose
<b>INSPECTION TYPE:</b> Monitoring	<b>WEATHER:</b> Clear	<b>INSP. DATE:</b> January 23, 2025	<b>INSP. TIME:</b> 16:20
<b>OPERATOR:</b> Montrose County	<b>OPERATOR REPRESENTATIVE:</b> None	<b>TYPE OF OPERATION:</b> 110c - Construction Limited Impact	
<b>REASON FOR INSPECTION:</b> Normal I&E Program	<b>BOND CALCULATION TYPE:</b> None	<b>BOND AMOUNT:</b> \$0.00	
<b>DATE OF COMPLAINT:</b> NA	<b>POST INSP. CONTACTS:</b> None	<b>JOINT INSP. AGENCY:</b> None	
<b>INSPECTOR(S):</b> Dustin Czapla	<b>INSPECTOR'S SIGNATURE:</b>

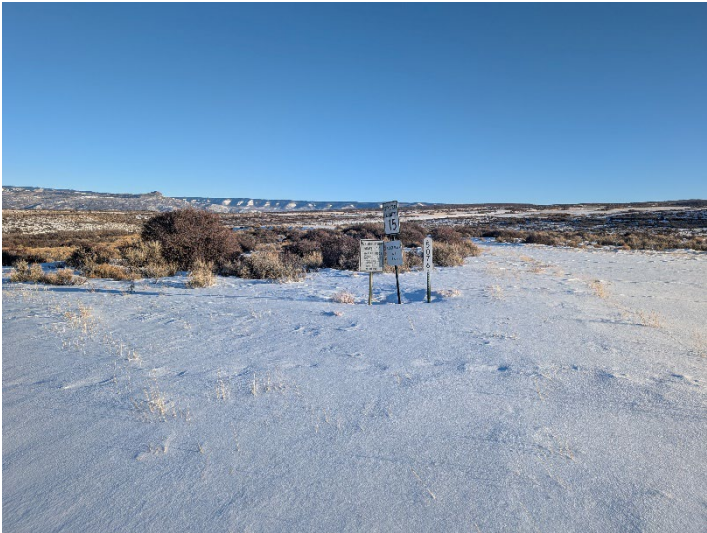
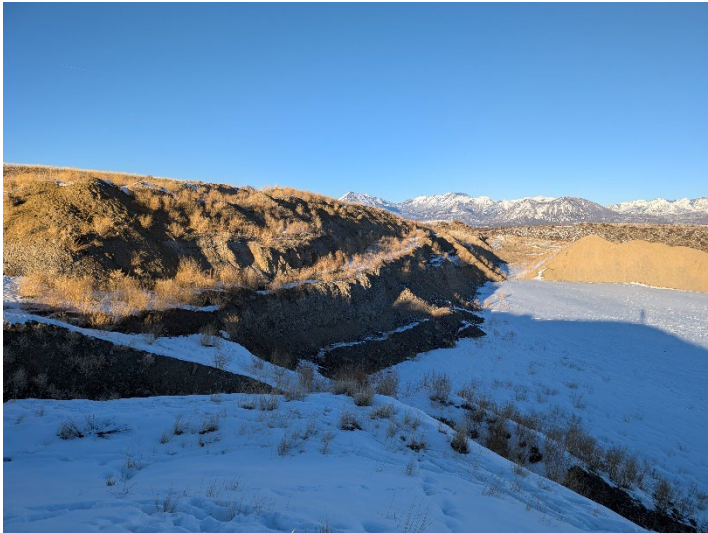
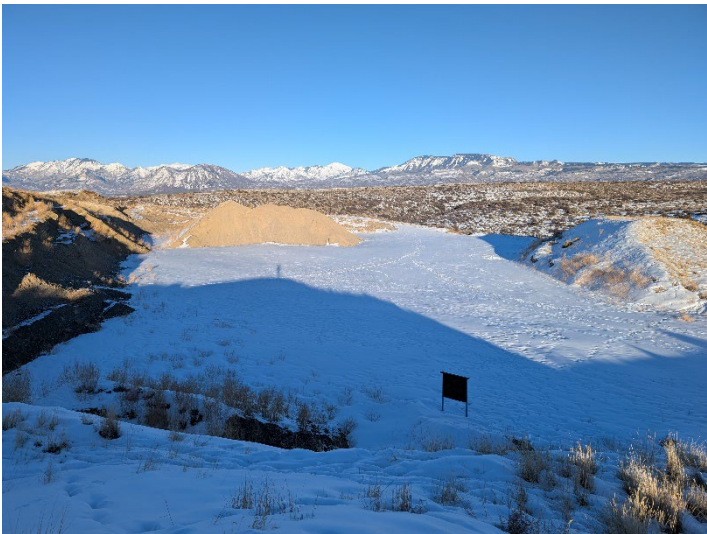
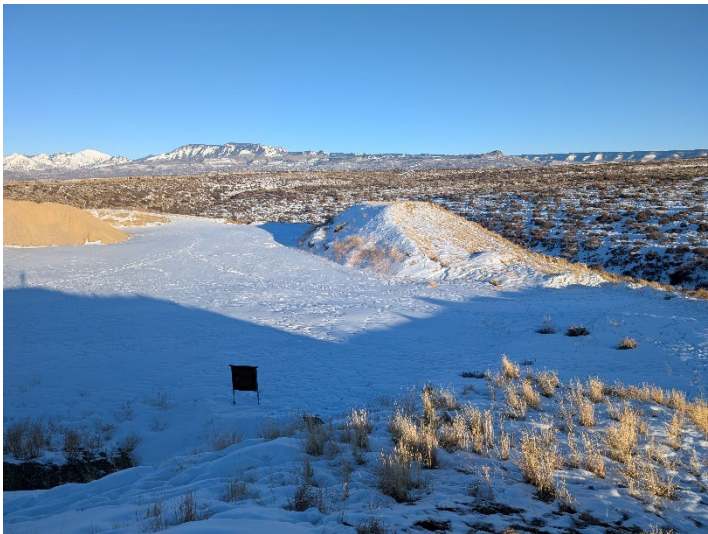
Mining is progressing to the west and north. A highwall, approximately 30 feet in height and spanning approximately 500 linear feet, is near vertical to approximately 1H:1V where sloughing has occurred. Topsoil is stockpiled in the southeast part of the pit. A crushed gravel stockpile is located in the north part of the pit.
