MINERALS PROGRAM INSPECTION REPORT

MINE NAME: BLM Olathe Pit	MINE/PROSPECTING ID#: M-1986-037	MINERAL: Sandstone	COUNTY: Montrose
INSPECTION TYPE: Monitoring	WEATHER: Clear	INSP. DATE: January 23, 2025	INSP. TIME: 14:30
OPERATOR: Colorado Department of Transportation	OPERATOR REPRESENTATIVE: NONE	TYPE OF OPERATION: 110c - Construction Limited Impact	
REASON FOR INSPECTION: Normal I&E Program	BOND CALCULATION TYPE: None	BOND AMOUNT: \$0.00	
DATE OF COMPLAINT: NA	POST INSP. CONTACTS: None	JOINT INSP. AGENCY: None	
INSPECTOR(S): Dustin Czapla	INSPECTOR'S SIGNATURE:

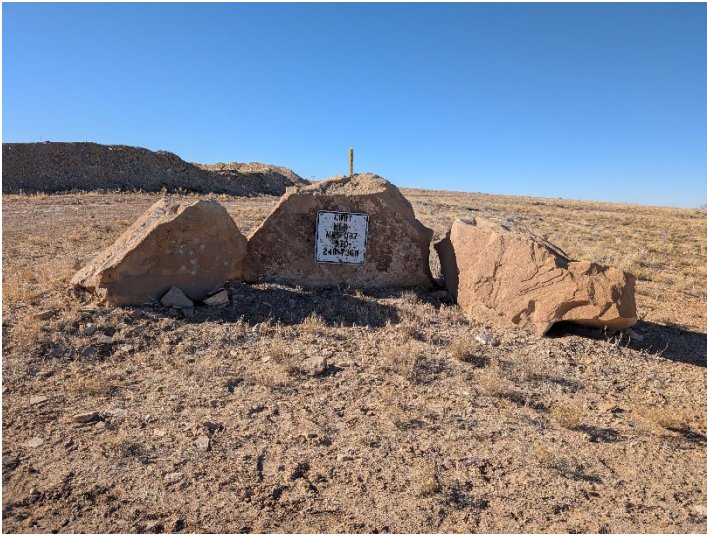
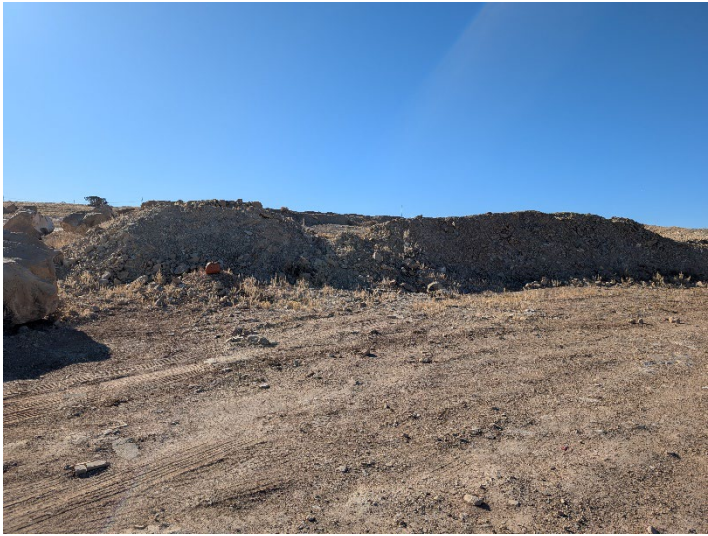
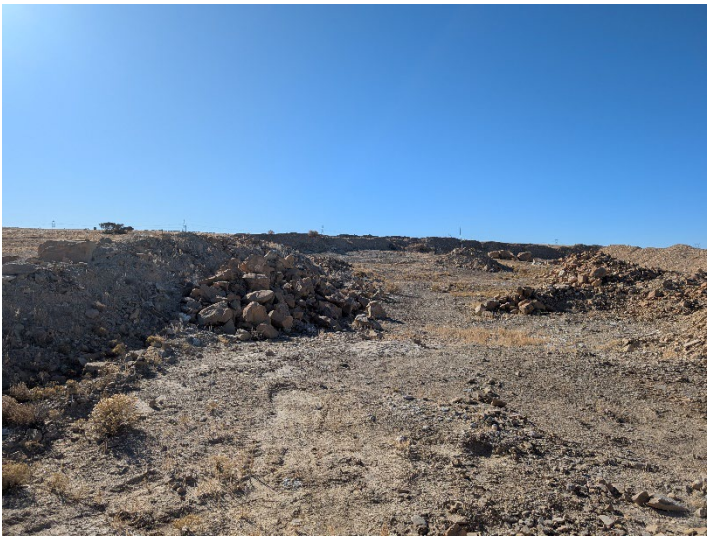
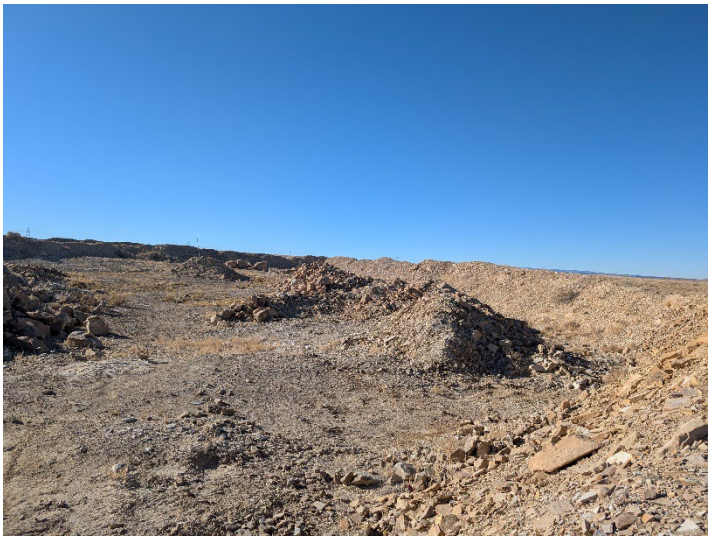
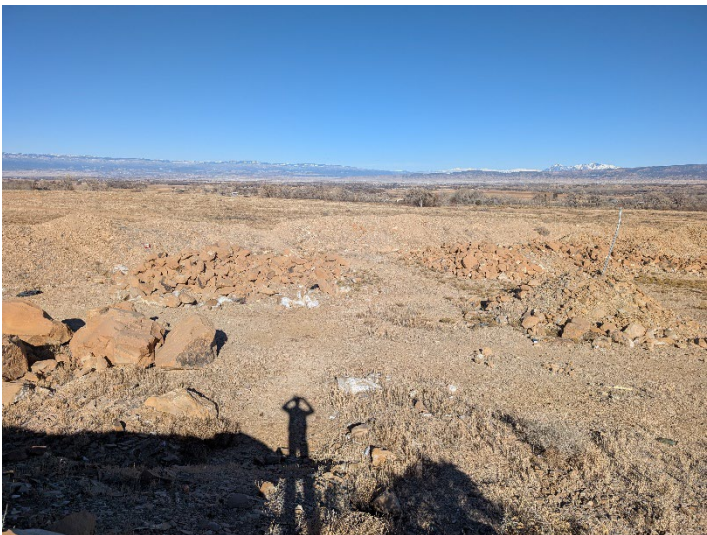
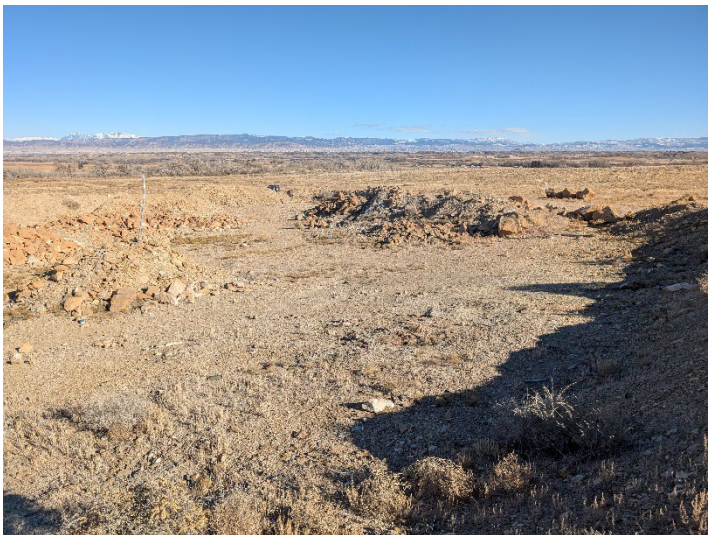
This inspection was conducted as part of the Division of Reclamation, Mining and Safety's (Division) normal monitoring program. A representative for the operator was not present. Photographs are included with this report to illustrate some of the conditions observed.
