MINERALS PROGRAM INSPECTION REPORT
PHONE: (303) 866-3567

MINE NAME: Thompson Pit	MINE/PROSPECTING ID#: M-2022-046	MINERAL: Sand and gravel	COUNTY: Montrose
INSPECTION TYPE: Monitoring	WEATHER: Clear	INSP. DATE: January 23, 2025	INSP. TIME: 13:50
OPERATOR: Montrose County	OPERATOR REPRESENTATIVE: Curtis Milton	TYPE OF OPERATION: 112c - Construction Regular Operation	
REASON FOR INSPECTION: Normal I&E Program	BOND CALCULATION TYPE:	BOND AMOUNT: \$0.00	
DATE OF COMPLAINT: NA	POST INSP. CONTACTS: None	JOINT INSP. AGENCY: None	
INSPECTOR(S): Dustin Czapla	INSPECTOR'S SIGNATURE:

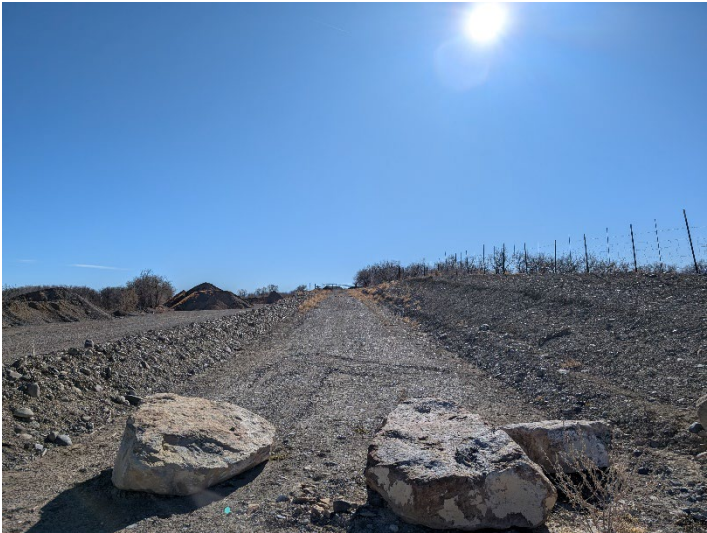
The access road is well maintained.

Access road from the Neal Pit

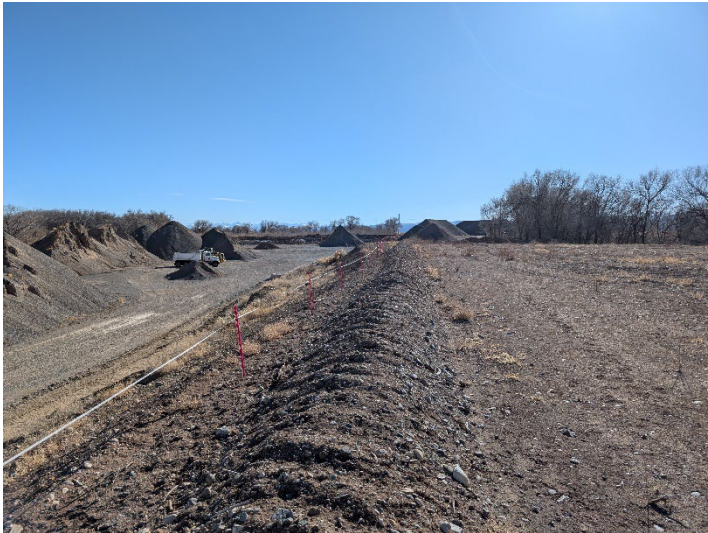
The affected area was marked by posts and fencing that were clearly visible and adequate to delineate the affected area boundary.

Neal Pit is on the left side of fence, Thompson Pit on the right

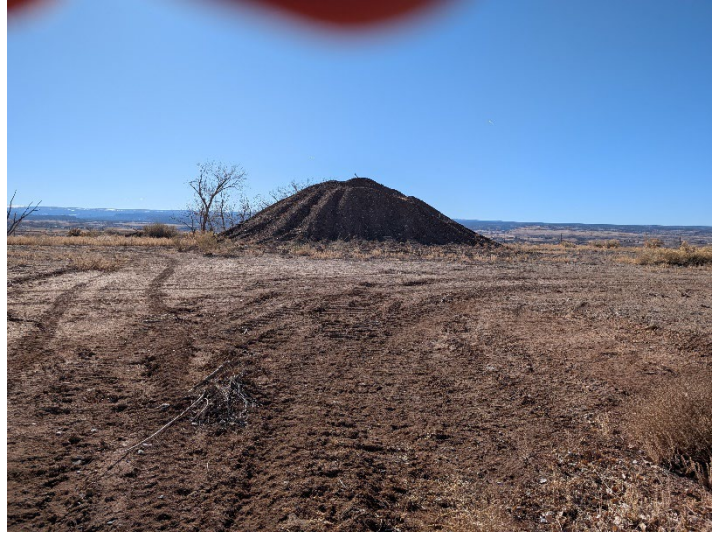
The access road from the Neal Pit has been constructed and mining has commenced in the south part of the Phase 1 area. Topsoil has been stripped and placed on the south end of the Phase 2 area. The operator is reminded that pursuant to Rule 3.1.9, topsoil stockpiles should be stabilized with a vegetative cover and stored in configurations so that it is protected from erosion. This stockpile is stored at the crest of a hill with the potential for some erosional loss. A berm, or other such measures, should be constructed around the south and west sides of the topsoil to prevent erosional loss. Several crushed gravel stockpiles are located in the Phase 1 pit.

Topsoil stockpile at south end of Phase 2 area
