## C1980007, West Elk Mine, January Inspection Report

**PERMIT INFORMATION**

<b>Inspection Start Date:</b> January 22, 2025 <b>Inspection Start Time:</b> 09:30 <b>Inspection End Date:</b> <b>Inspection End Time:</b>		<b>Inspection Type:</b> Coal Partial Inspection <b>Inspection Reason:</b> Normal I&E Program <b>Weather:</b> Cloudy	
<b>Joint Inspection Agency:</b>  None		<b>Joint Inspection Contacts:</b>	
<b>Post Inspection Agency:</b>  None		<b>Post Inspection Contacts:</b>	
<b>Inspector(s):</b>  Leigh Simmons	<b>Inspector's Signature:</b>

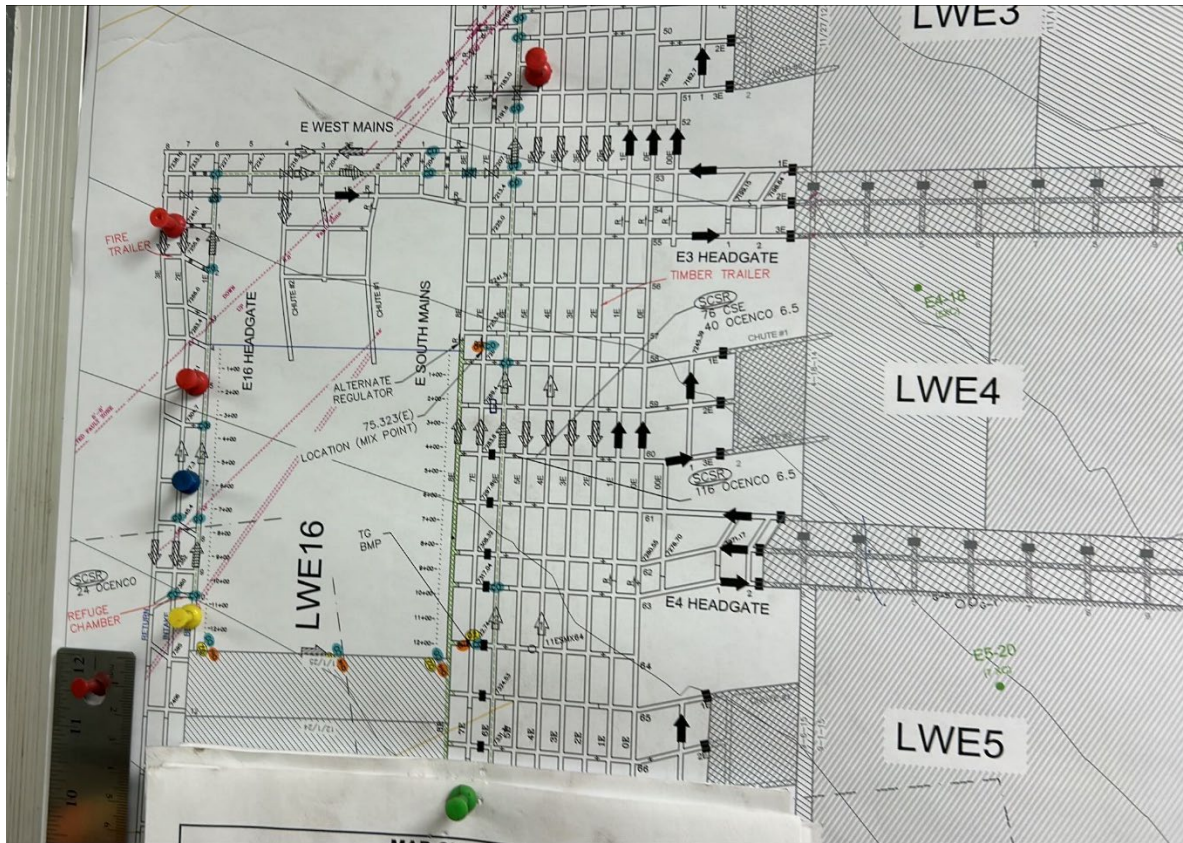
Longwall mining of the LWE16 panel was in progress, between cross-cuts 11 and 10 on the head gate. The longwall had not been active in January.

Figure 1: Mine map showing longwall progress

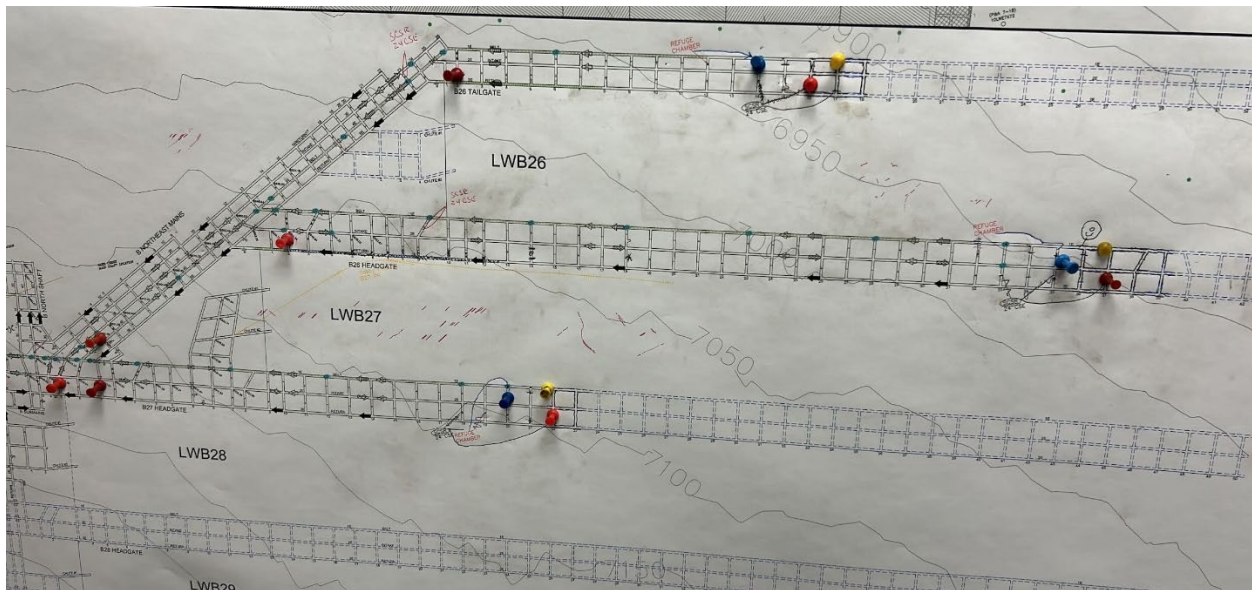
Three development crews were working: in the B26 tail gate at around cross-cut 18, in the B26 head gate at around cross-cut 39, and in the B27 head gate at around cross-cut 23.

Figure 2: Mine map showing B-seam development progress

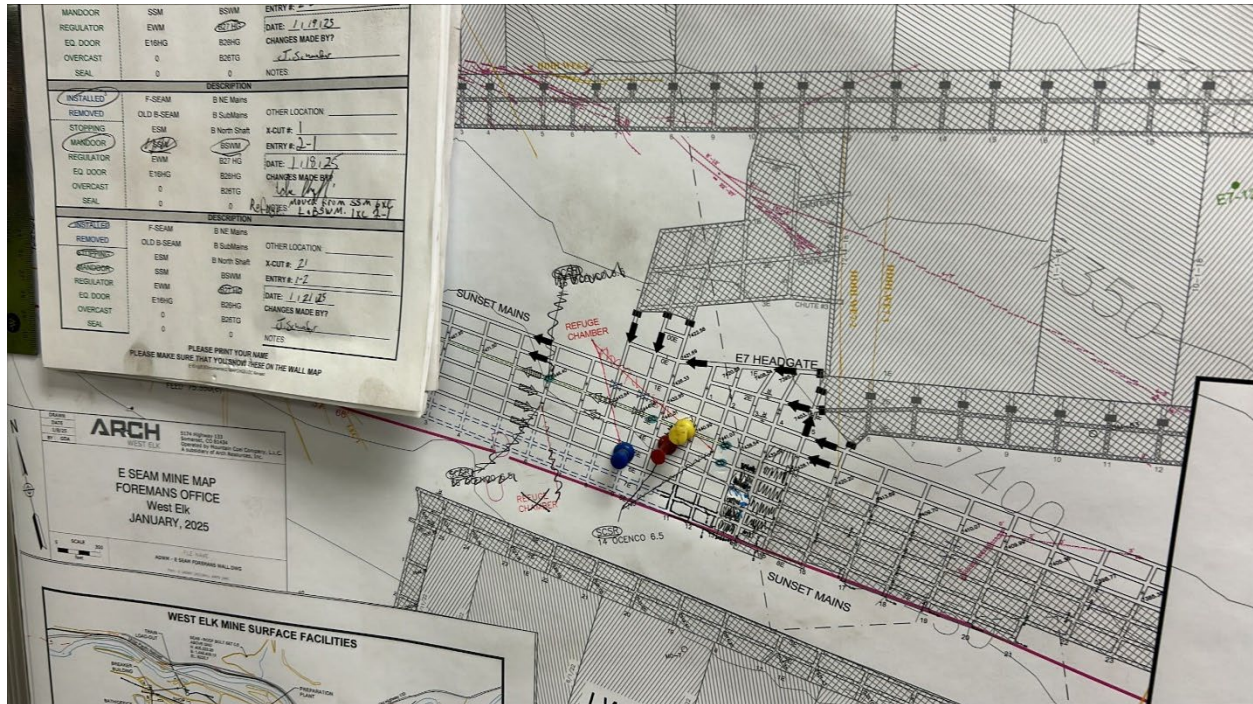
Contractors with Phoenix Mining continued to work on pillaring of the Sunset Mains, the job was expected to be completed by March 2025.

Figure 3: Mine map showing pillaring progress

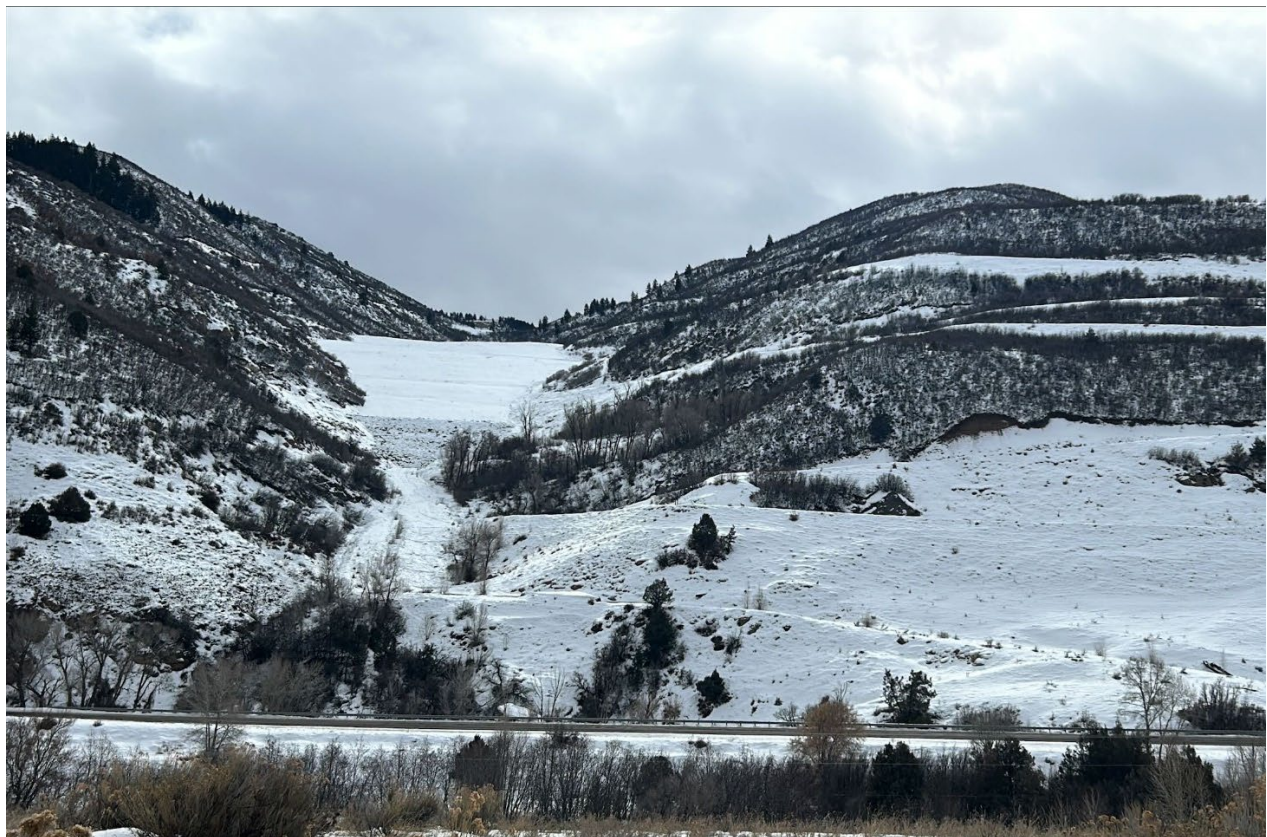
Figure 4: RPEE

The RPEE was not accessible, but the outcrops could be seen from across the river. The pile was snow-covered and there was no sign of any instability.

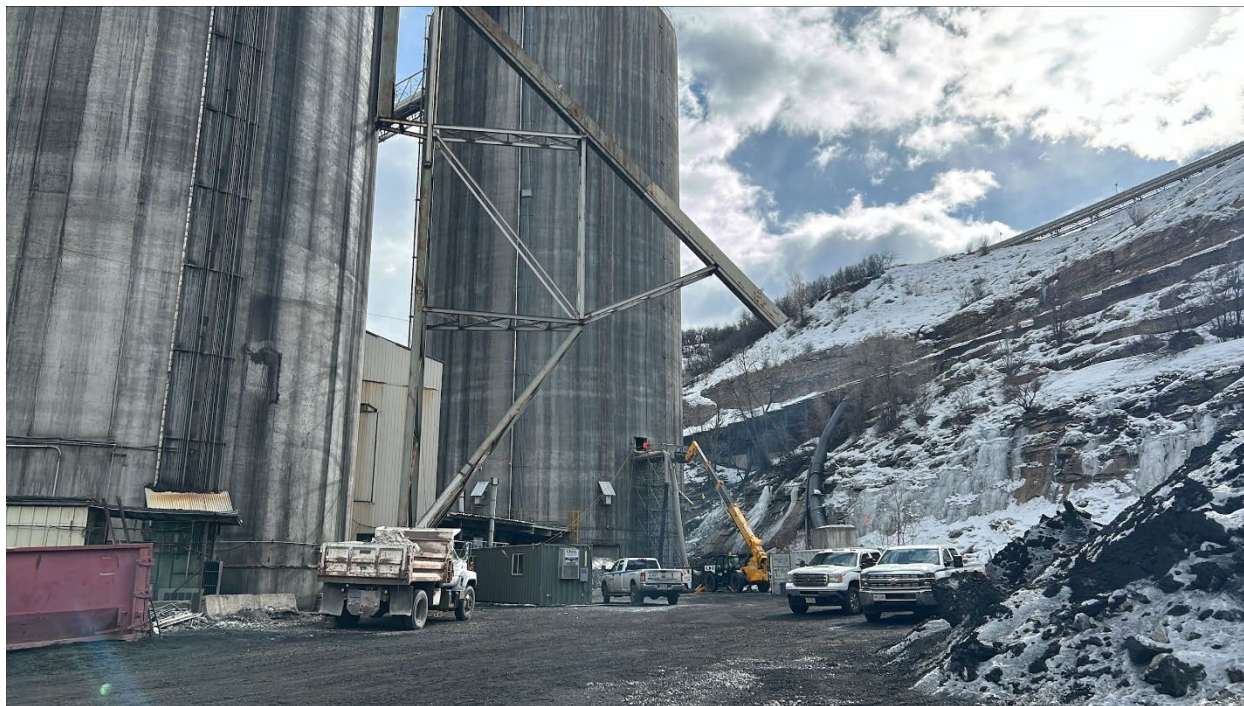
The project to line silo 2 was still in progress. Concrete from the silo was being brought to the RPE. Work had not begun on the loadout drainage project, but a contract for the earth work had been awarded. MCC expected to review the design provided by their engineering contractor. **If significant changes from the previously approved design are made the Permit Application Packet should be updated with a Minor Revision.**

Figure 5: Silo 2

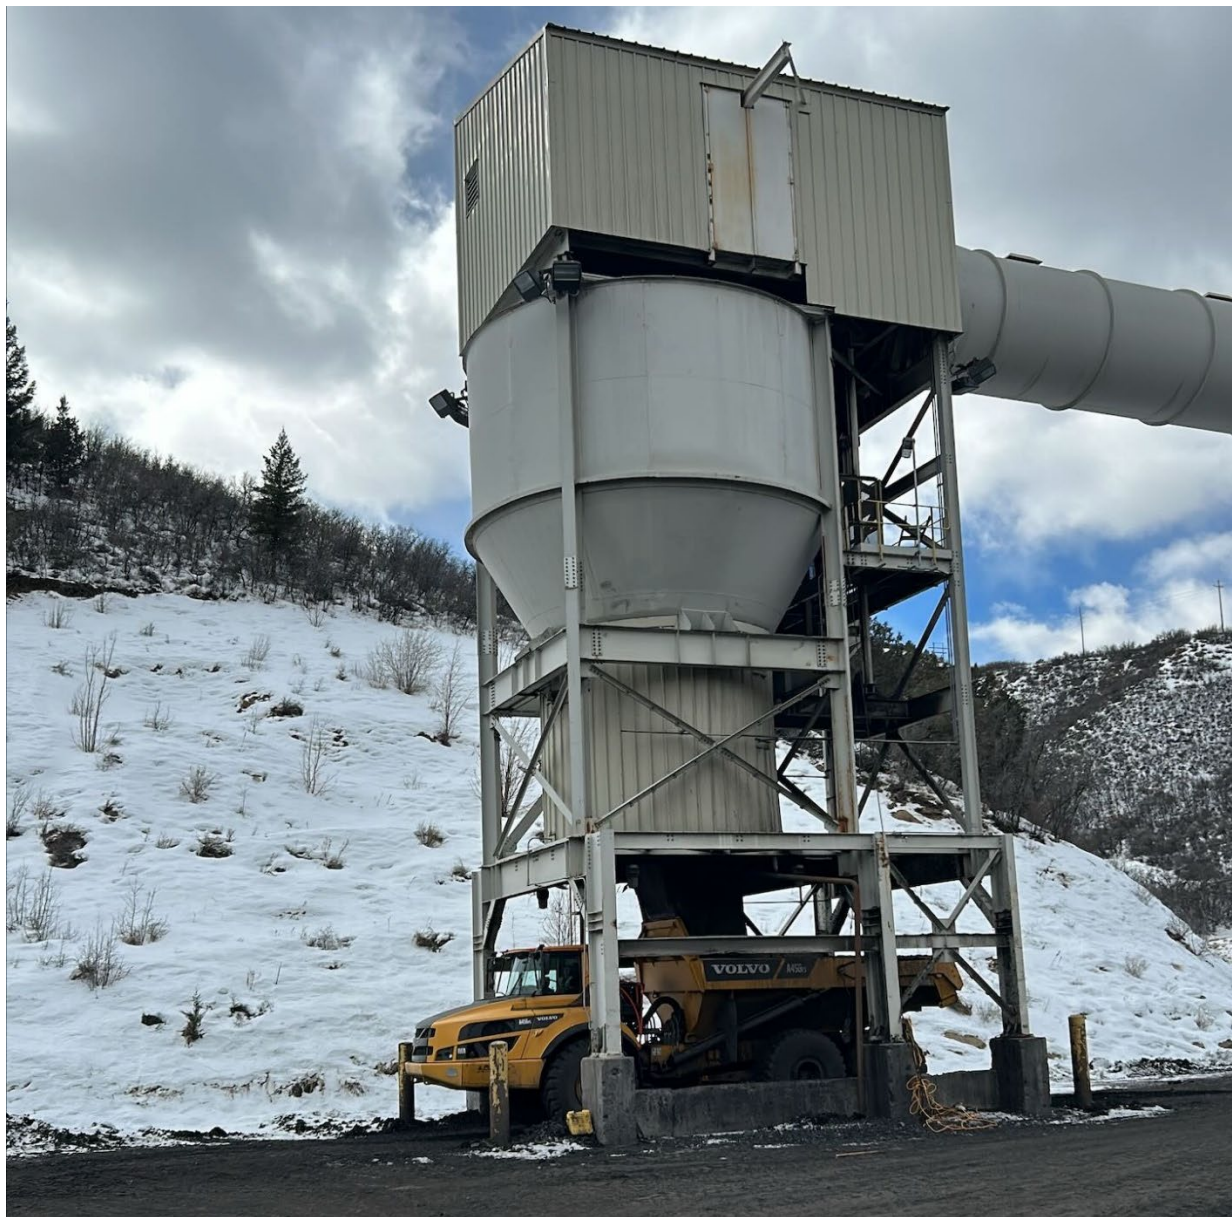
The processing plant continued to operate intermittently, to process material from the development sections. Waste material was being temporarily stockpiled on the RPE. The material was being compacted and graded to aid drainage.

*Figure 9: Processing waste*

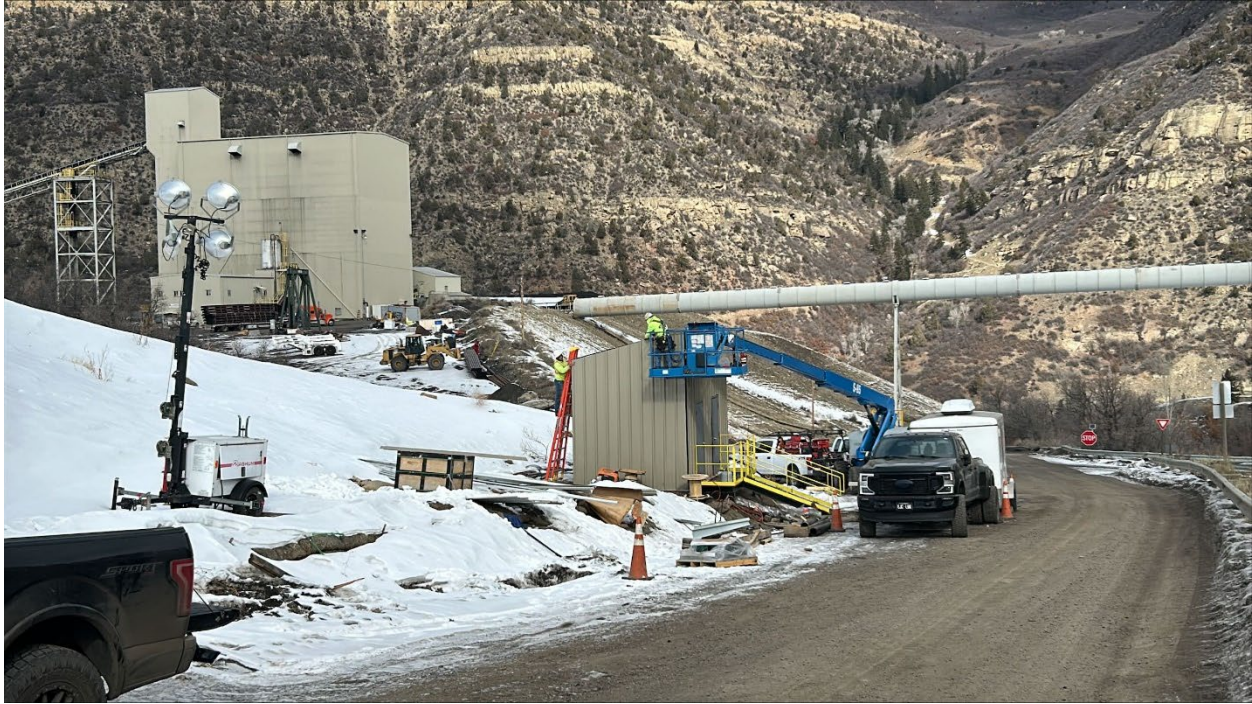
The pump had been set on the Box Canyon North well, after a series of technical complications with pipe and fitting compatibility. The pumphouse building was under construction at the time of the inspection. The aim was to bring the pump online by the end of January.

Figure 10: BCN well pumphouse
