## MINERALS PROGRAM INSPECTION REPORT

<b>MINE NAME:</b> Schumacher Pit #3	<b>MINE/PROSPECTING ID#:</b> M-2006-072	<b>MINERAL:</b> Gravel, clay (general)	<b>COUNTY:</b> Logan
<b>INSPECTION TYPE:</b> Monitoring	<b>INSPECTOR(S):</b> Nikie Gagnon	<b>INSP. DATE:</b> August 4, 2022	<b>INSP. TIME:</b> 11:00
<b>OPERATOR:</b> Jeffrey L. Schumacher	<b>OPERATOR REPRESENTATIVE:</b> Jeff Schumacher	<b>TYPE OF OPERATION:</b> 112c - Construction Regular Operation	
<b>REASON FOR INSPECTION:</b> Normal I&E Program	<b>BOND CALCULATION TYPE:</b> Complete Bond	<b>BOND AMOUNT:</b> \$31,800.00	
<b>DATE OF COMPLAINT:</b> NA	<b>POST INSP. CONTACTS:</b> None	<b>JOINT INSP. AGENCY:</b> None	
<b>WEATHER:</b> Clear	<b>INSPECTOR'S SIGNATURE:</b>

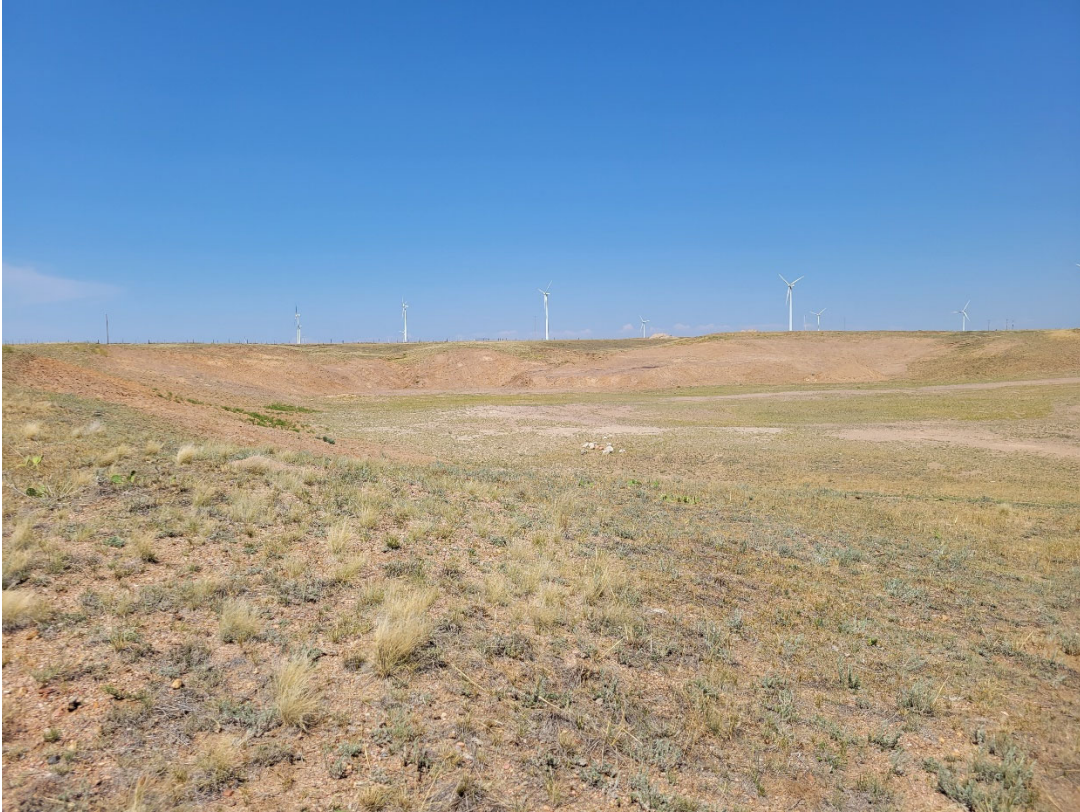
Looking northwest at western highwall and pit area.

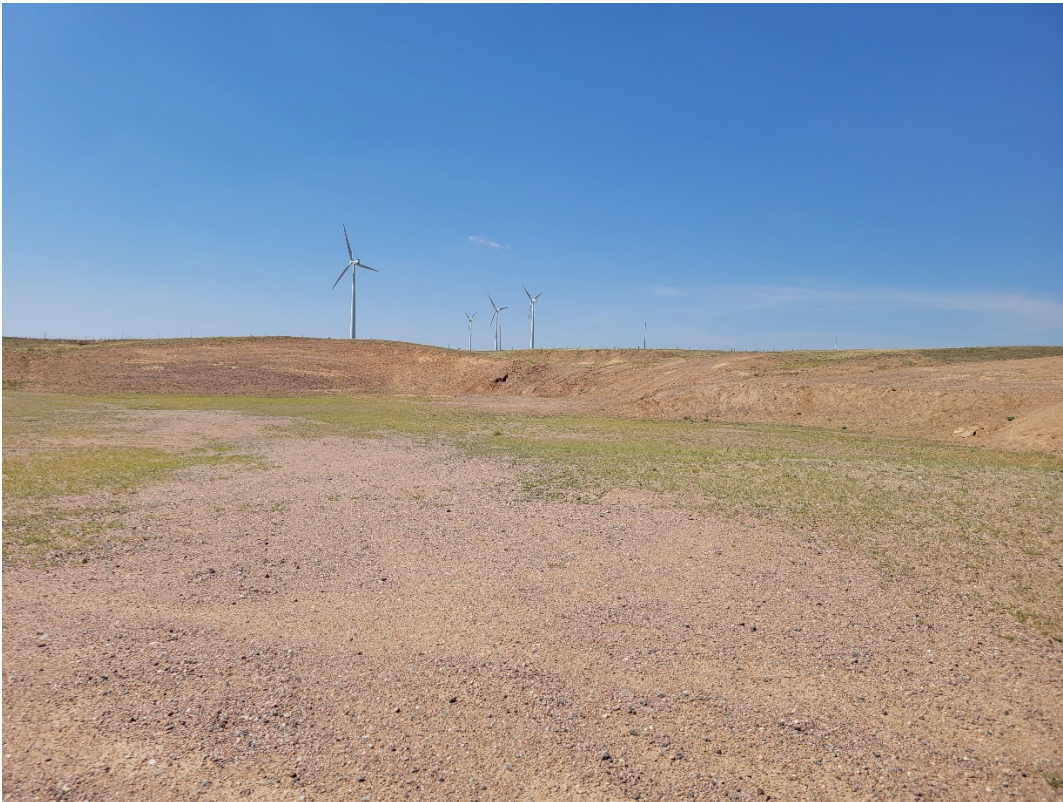
Looking southwest at western highwall and pit area.

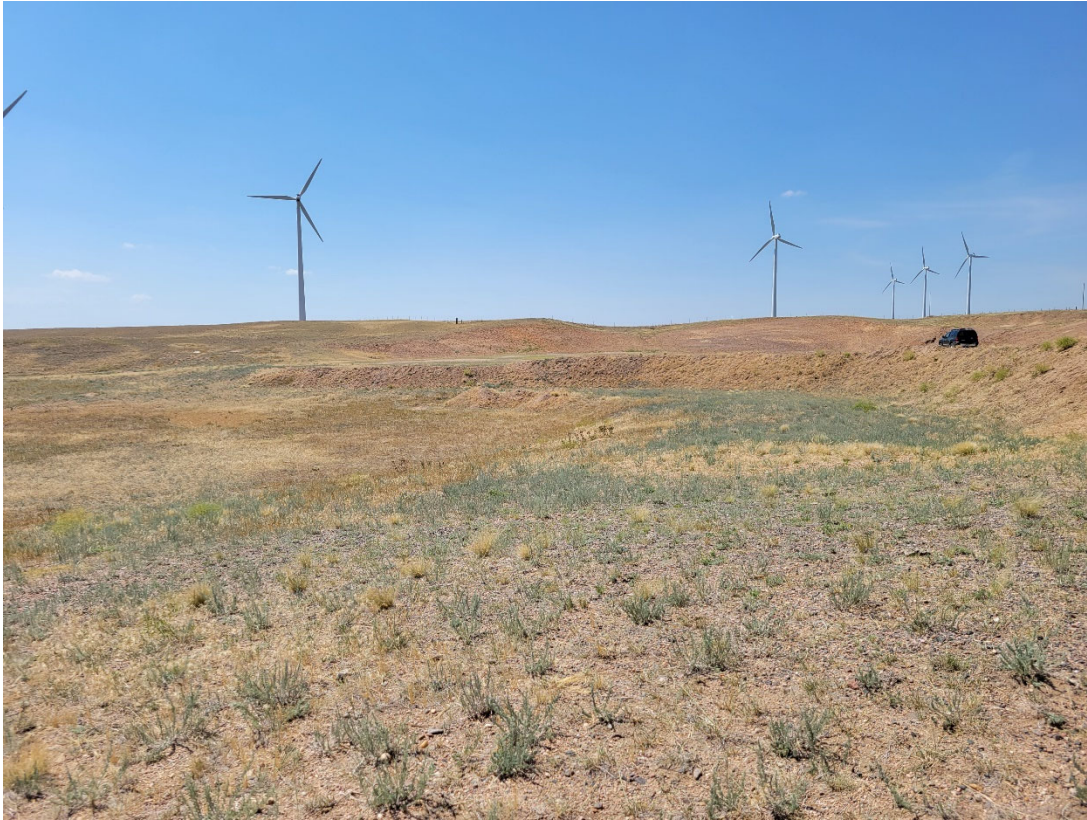
Roads: The active mining area is accessed via a graded gravel road.

Looking west below western highwall and access road.

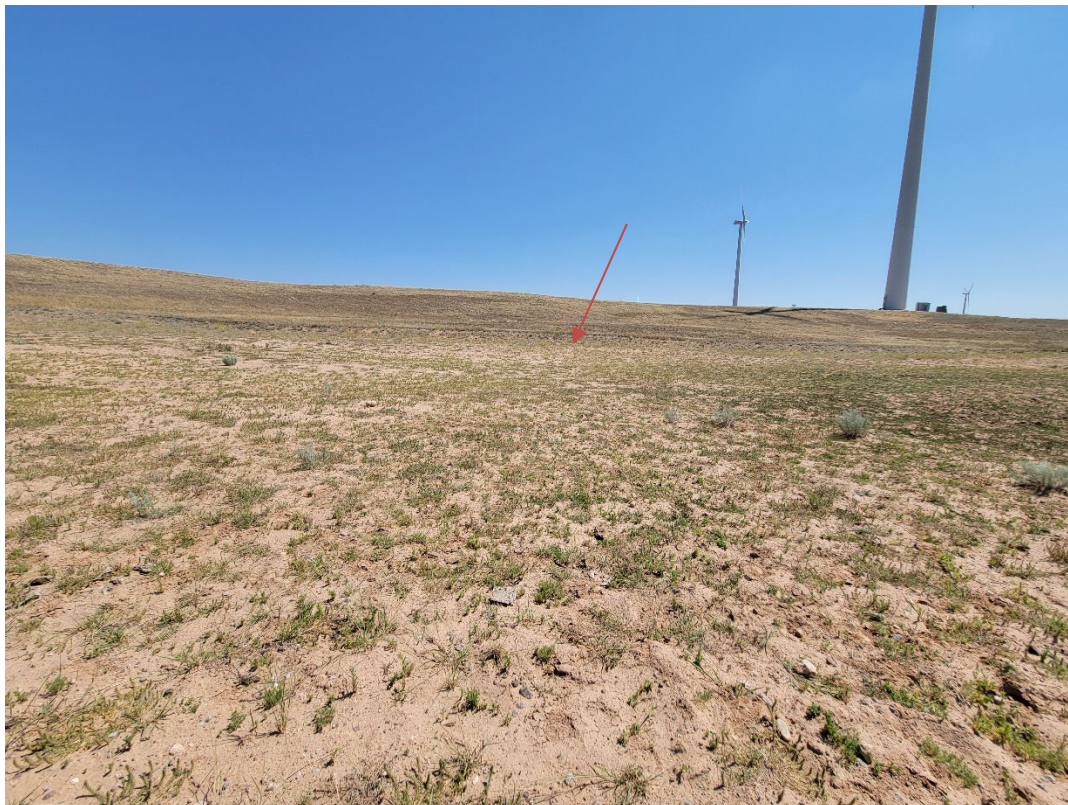
Hydrologic Balance: The pit was dry during the inspection. No erosion rills or gullies of concern were noted in either mining area.

Looking at the eastern highwall and pit. No recent disturbance.  
Stormwater appears to flow to low point in the pit marked by red arrow.

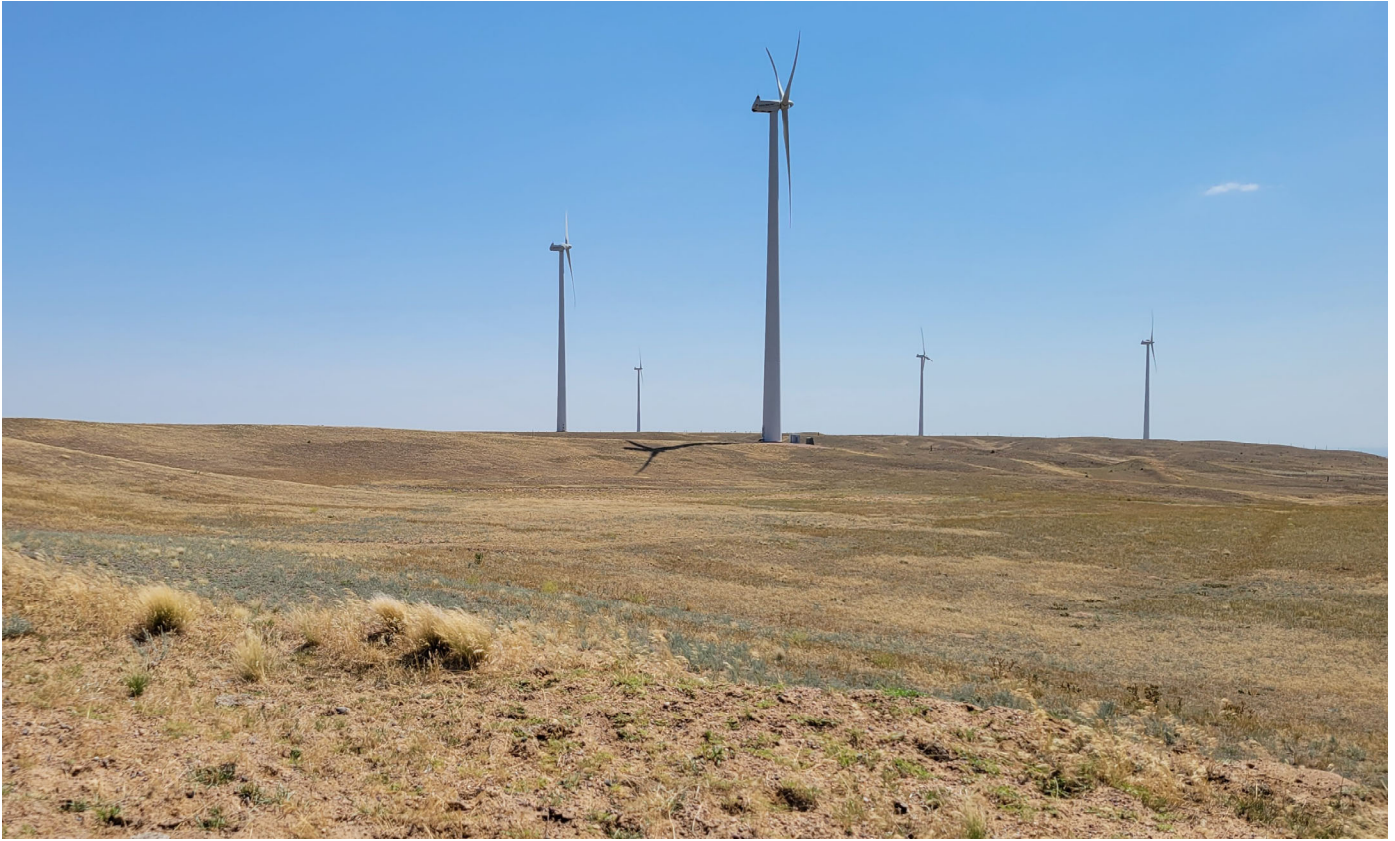
Looking southeast at eastern highwall and pit.

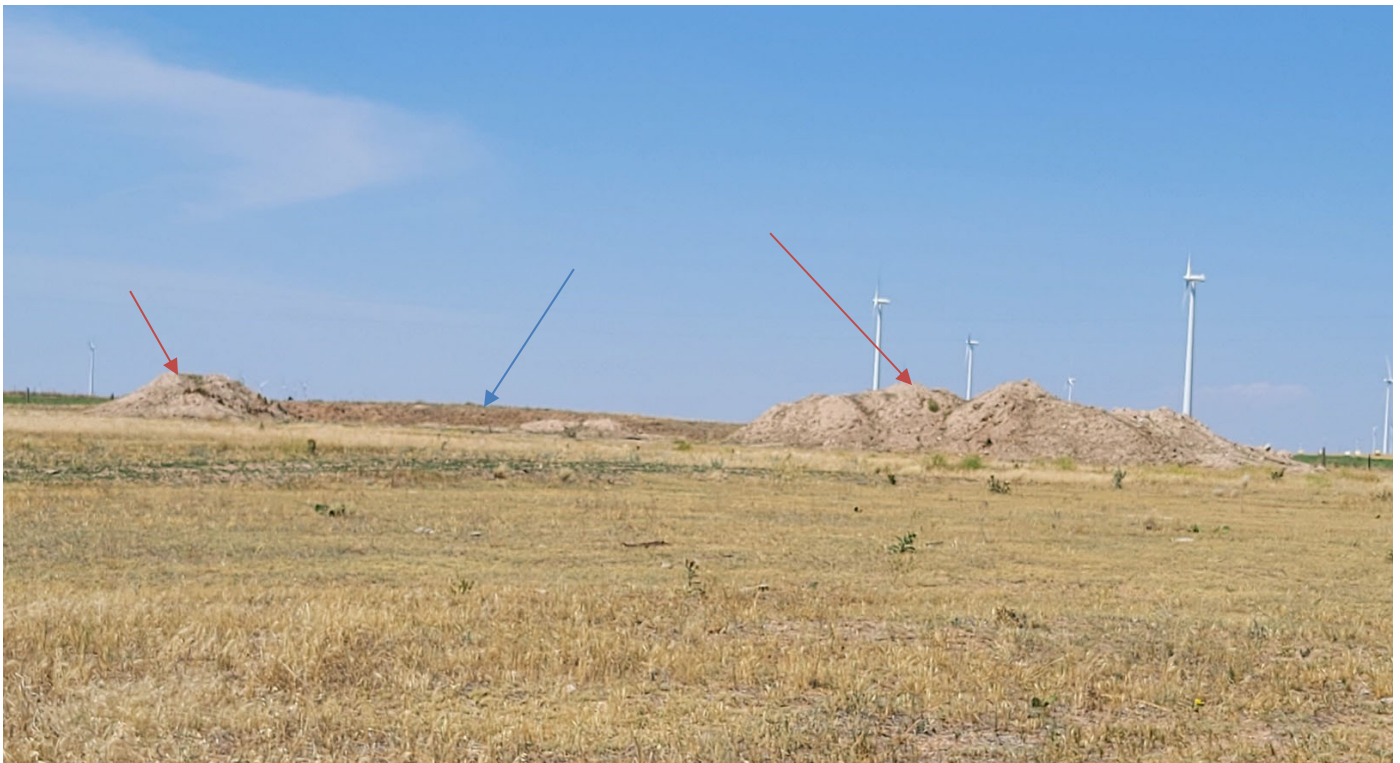
Topsoil: Topsoil is stockpiled along the western permit boundary near the entrance. This pile is vegetated and stable. Two other dirt stockpiles were noted within the permit boundary in front of the topsoil pile. Mr. Schumacher stated that the smaller pile is overburden from the site and the other pile is material brought in from a nearby State bridge project. This inert material will be used as soil additive to aid in revegetation efforts since the topsoil on site is limited.

Blue arrow points to topsoil stockpile along western boundary of the permit area.  
Red arrows point to fill material to be used for future reclamation.

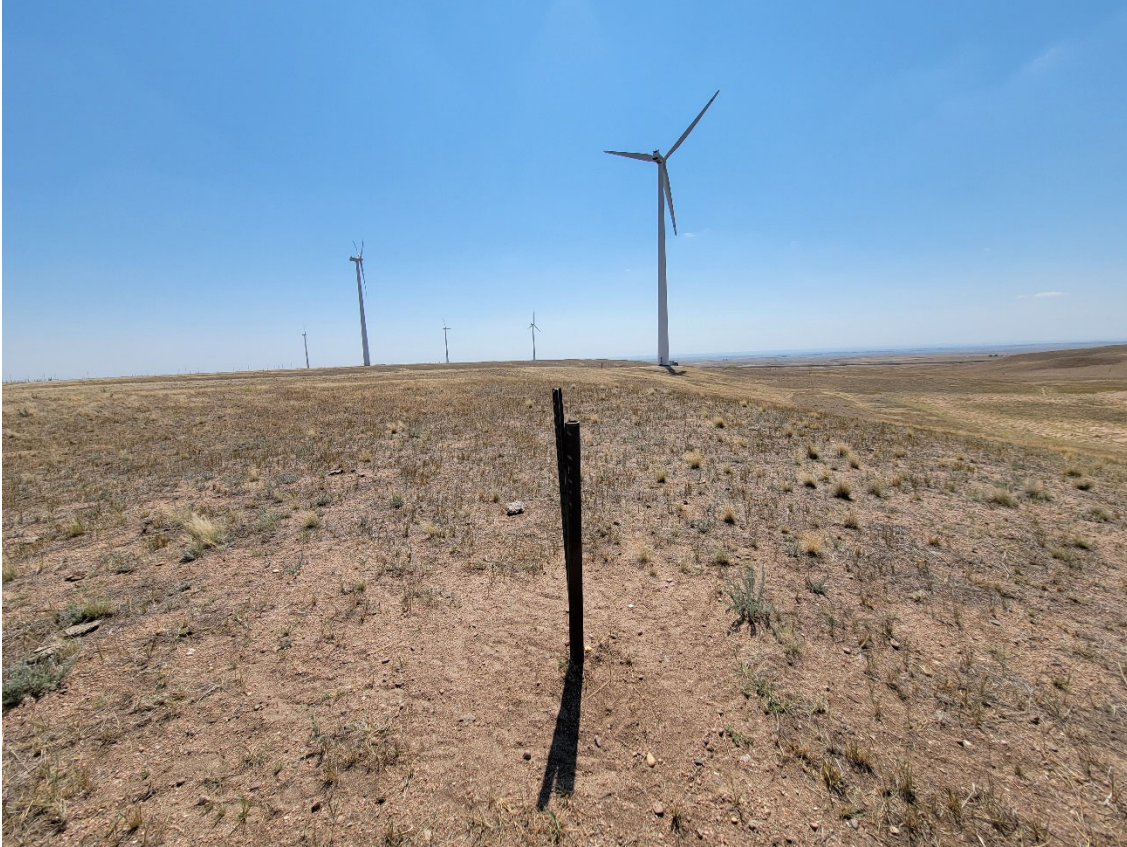
Signs and Markers: The mine identification sign was posted at the entrance and the permit boundary is clearly marked with posts.

Looking south along ridge above the eastern highwall. Northern edge permit boundary marker in foreground.
