MINERALS PROGRAM INSPECTION REPORT
PHONE: (303) 866-3567

| MINE NAME: Cadgene Pit | MINE/PROSPECTING ID#: M-1983-158 | MINERAL: Sand and gravel | COUNTY: Montrose |
| INSPECTION TYPE: Monitoring | WEATHER: Clear | INSP. DATE: February 5, 2025 | INSP. TIME: 13:40 |

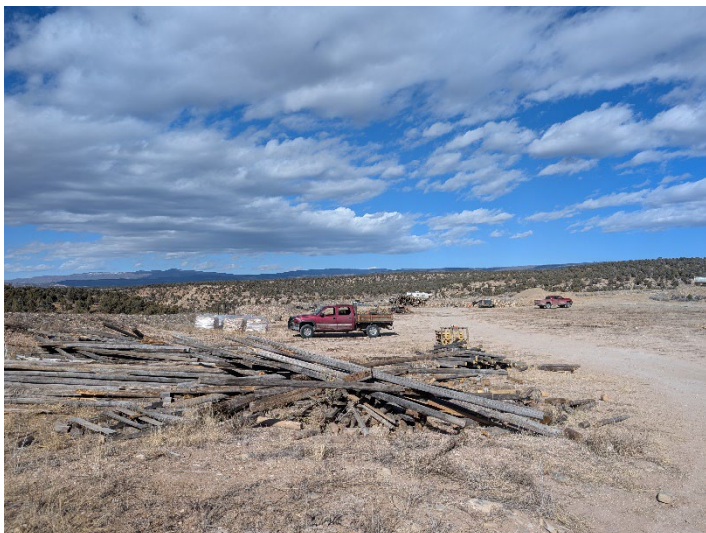
The west portion of the pit floor area is currently being utilized for what appeared to be a firewood operation. This would be consistent with the terms approved through TR01 as a use by the landowner.

West part of pit floor where firewood operations are occurring

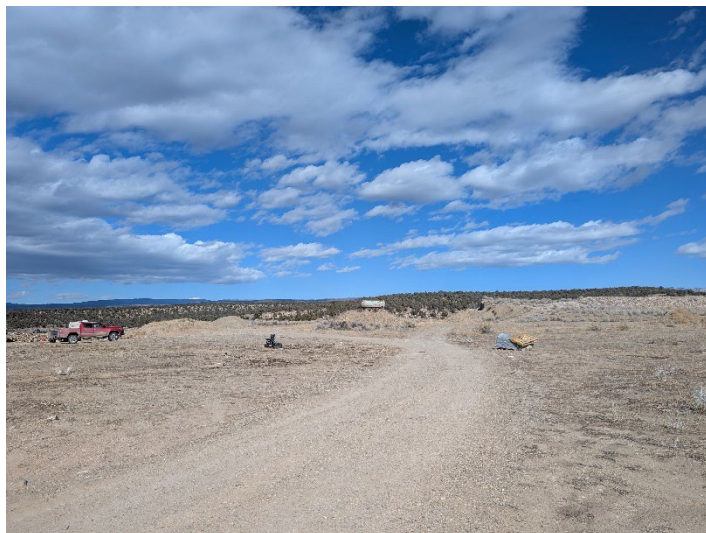
West part of pit floor

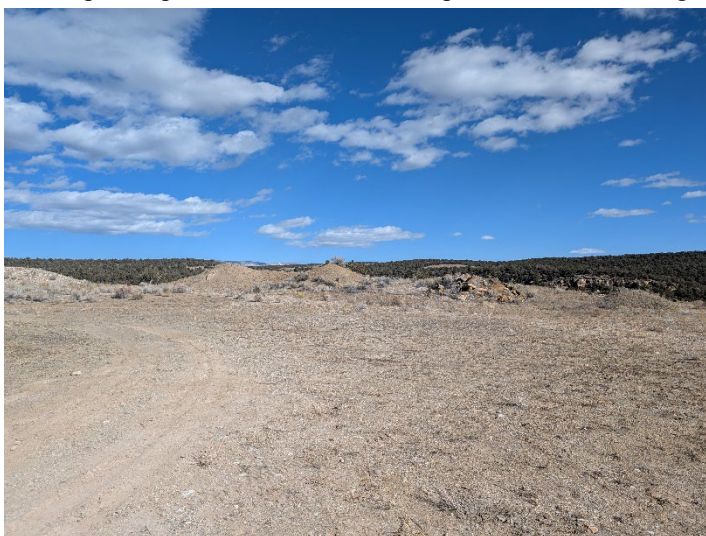
Stockpiles left in pit for landowner use

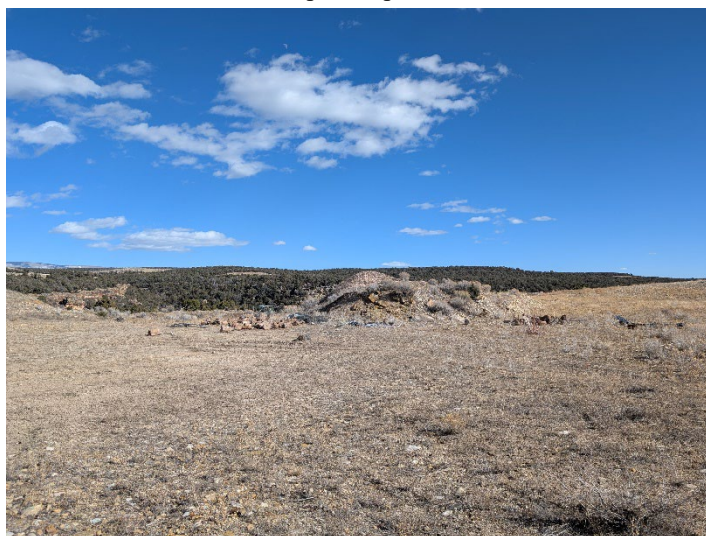
Stockpiles left in pit for landowner use

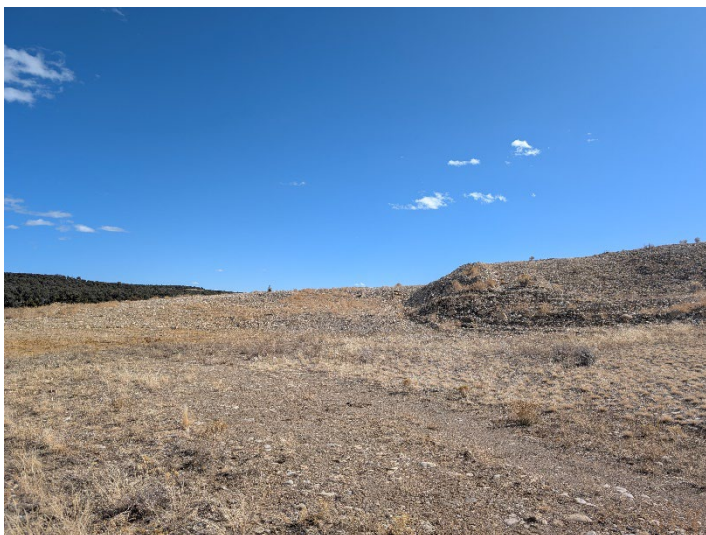
Reclamation work was completed at the site in 2019-2020. The highwall on the south side of the pit has been graded to 3H:1V or less. A small portion of the highwall in the far east part of the pit has been left for use by the landowner. This was approved through TR01. Vegetation on the slope is well established. The pit floor is to be left as a flat gravel area for use by the landowner. The stockpiles remaining on the pit floor are also to be left in place for use by the landowner. This was approved through TR01.

Small highwall left on east side of pit for landowner use

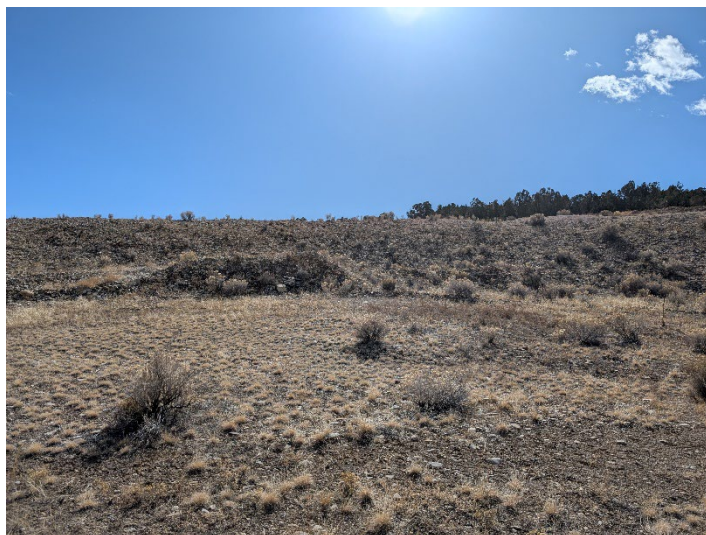
Reclaimed slope on east side of pit

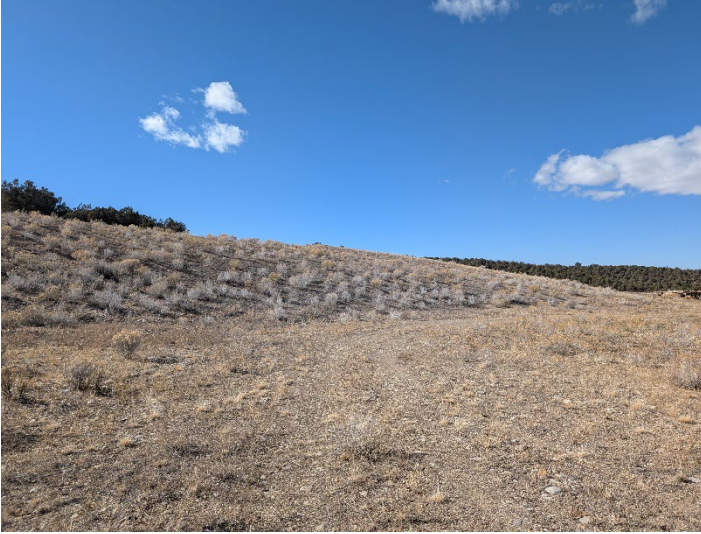
Reclaimed slope on south side of pit

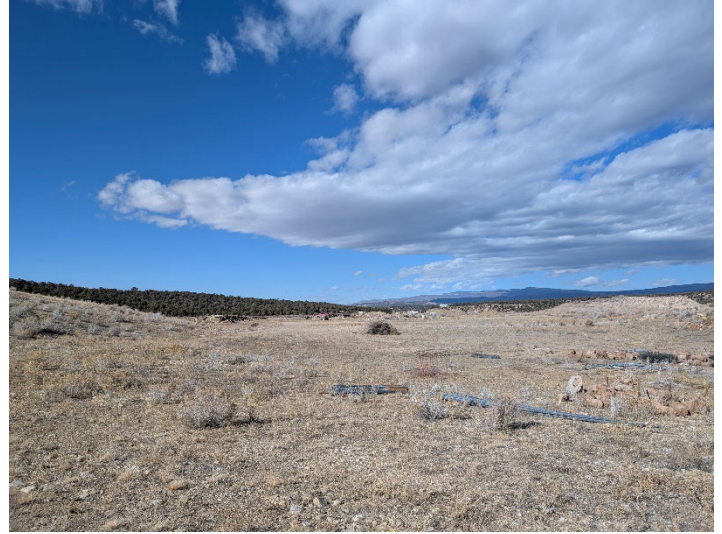
Pit floor viewed from east facing west
